**Allision of Staten Island Ferry *Andrew J. Barberi*
St. George, Staten Island, New York
October 15, 2003**

Marine Accident Report

NTSB/MAR-05/01

Abstract: This report discusses the allision of the passenger ferry *Andrew J. Barberi* with maintenance pier B-1 at the Staten Island ferry terminal on October 15, 2003. The ferry carried an estimated 1,500 passengers and 15 crewmembers. Ten passengers died in the accident and 70 were injured. An eleventh seriously injured passenger died 2 months later. Damages totaled more than \$8 million, with repair costs of \$6.9 million for the *Andrew J. Barberi* and \$1.4 million for the pier.

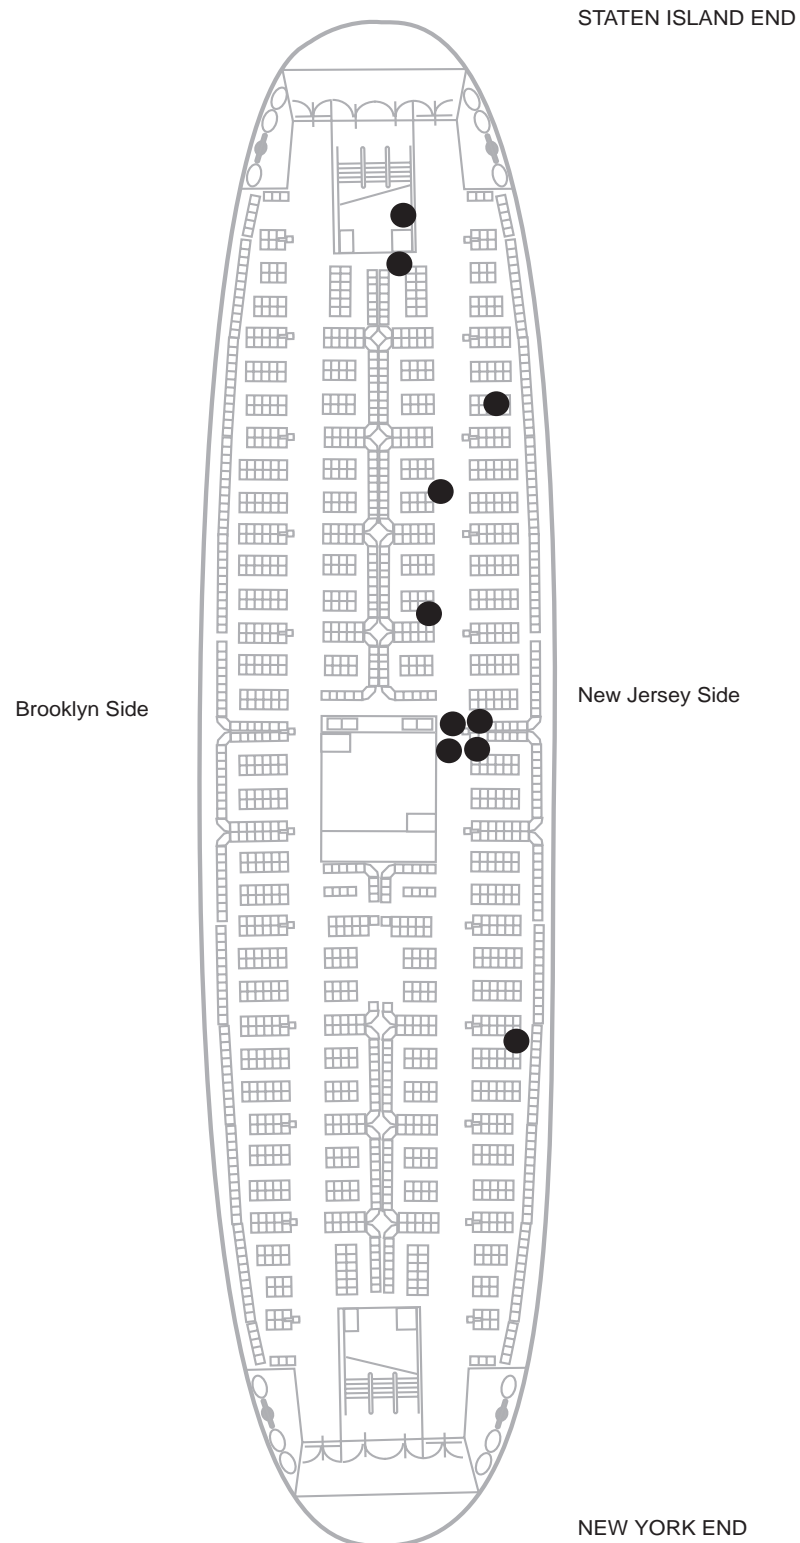
Ten passengers were found dead by emergency response personnel who met the vessel after it docked.⁴² Emergency personnel identified the locations of the fatally injured passengers several days after the accident. All the fatally injured passengers were found on the New Jersey side of the vessel's main deck (figure 10). The cause of death of the fatally injured was blunt force trauma and its consequences, with numerous severe injuries to head, torso, and extremities.

Figure 10. Locations on main deck where emergency personnel recovered bodies of fatally injured passengers. When emergency personnel arrived on board, some bodies had been moved from where fatal injuries occurred.
