Report on the investigation of
the fatality on board
passenger cruise ship
Saga Rose
in Southampton, England
on 11 June 2008

Marine Accident Investigation Branch
Carlton House
Carlton Place
Southampton
United Kingdom
SO15 2DZ

Report No 01/2009
January 2009

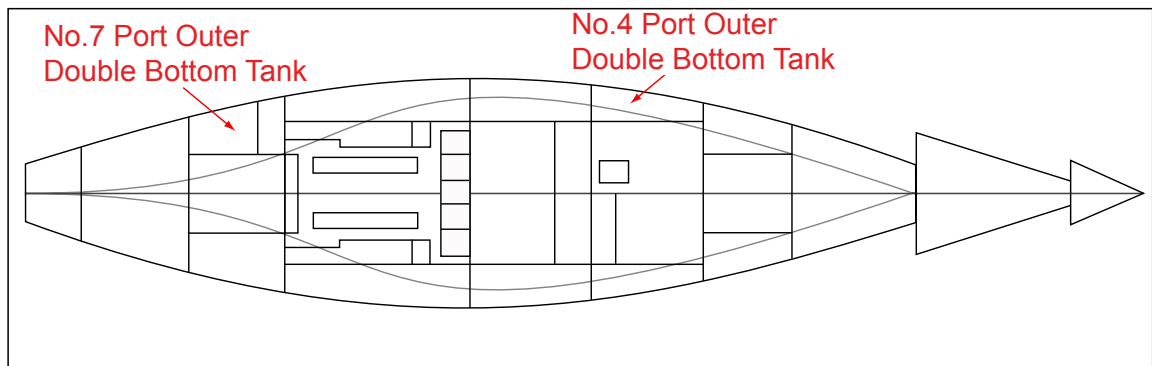
Figure 1

Extract of vessel's tank plan

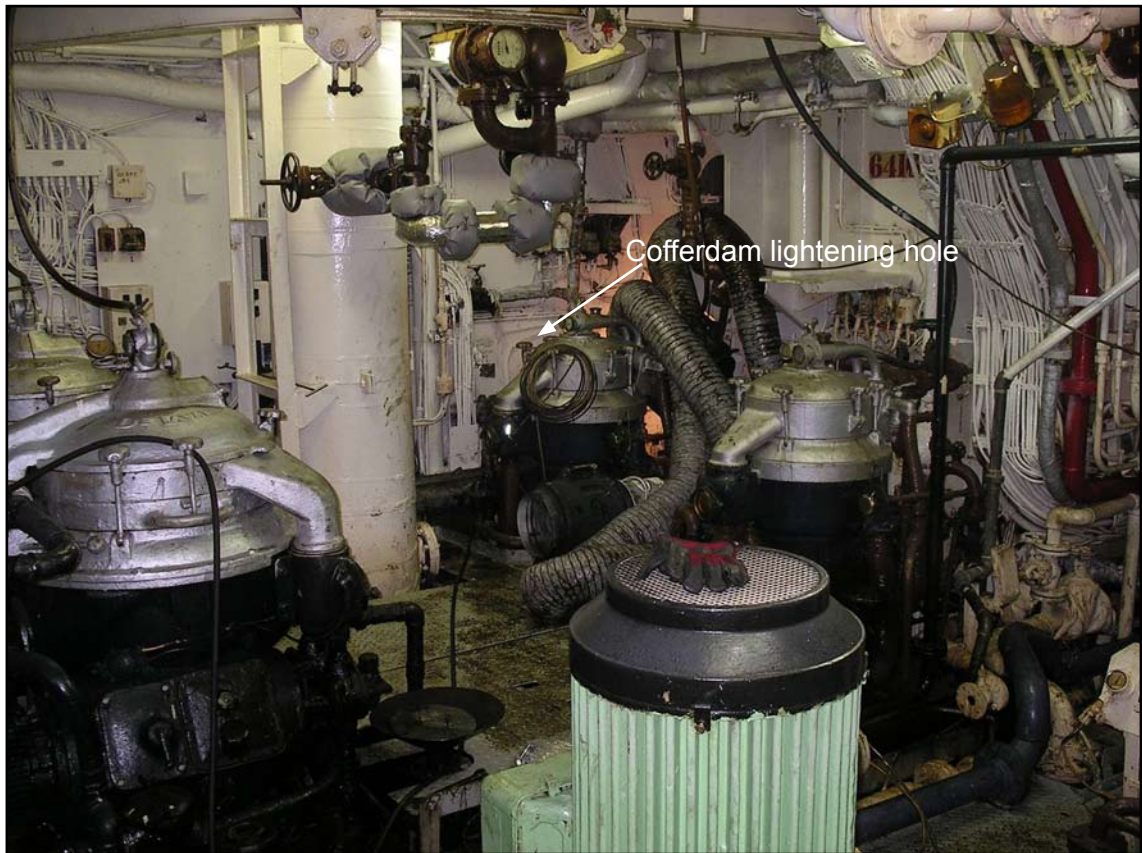
Figure 2

At about 1410, the bosun located the second bosun in the purifier room (**Figure 2**) and told him of the requirement to determine whether No 4 port outer double bottom tank contained fresh or salt water. The second bosun said he would

The purifier room

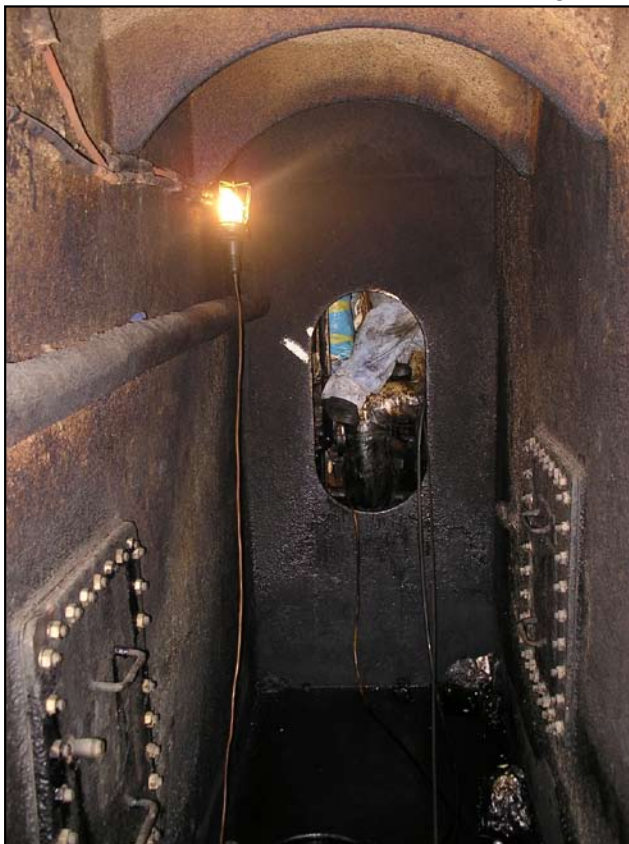
Figure 4

The motorman slid down into the cofferdam and looked down into the tank (**Figures 4, 5, and 6**). He saw the second bosun was unconscious at the foot of the ladder. He was lying face up, with one of his legs passing between two of the ladder’s lower rungs (**Figure 7**). The motorman immediately alerted the bosun, who ordered him to get out of the cofferdam. The bosun and the motorman then went to the engine control room from where the bosun informed the officer of the watch (OOW) on the bridge, by telephone, that the second bosun was unconscious in No 4 port outer tank.

Entrance to the cofferdam (view from cofferdam)

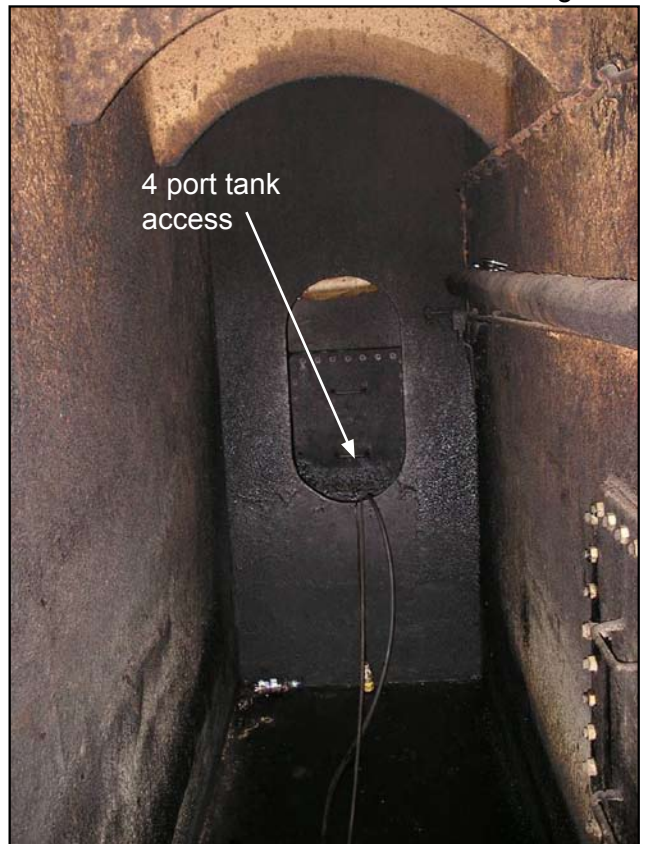
Figure 5

Cofferdam with tank access

The manhole was at the far end of a 5 metre open cofferdam (**Figure 5**) which was accessed through a lightening hole from the purifier room (**Figures 3 and 4**). The cofferdam was situated between two heated fuel oil service tanks and

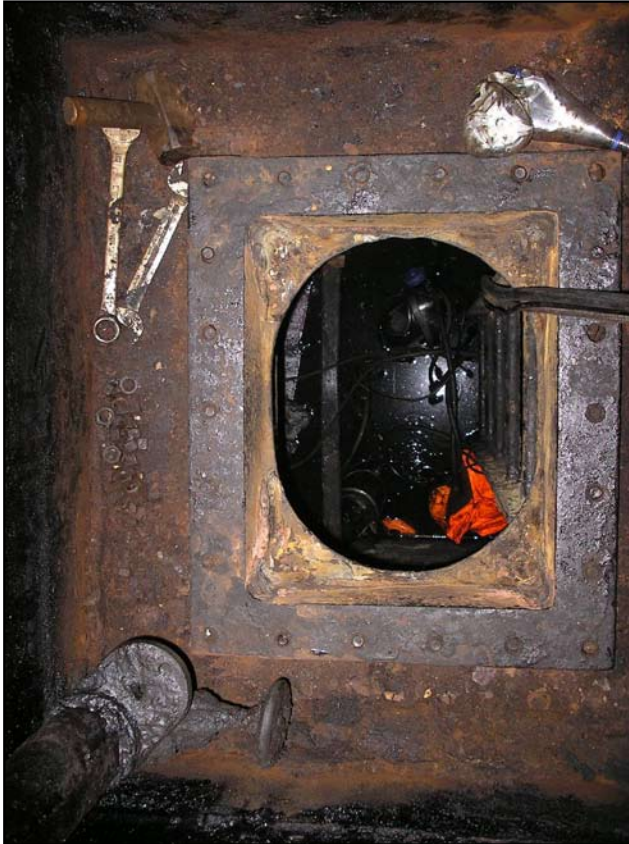
Figure 6

No.4 port outer double bottom tank manhole

Access into the tank was through a single tank top manhole fitted with a steel cover secured by 22 nuts and bolts. The manhole access was oval shaped, but the steel cover was rectangular with dimensions of 800mm x 600mm (**Figure 6**). Following the accident, the manhole cover gasket was found lying in the tank bottom under the discarded breathing apparatus and airlines used during the rescue.

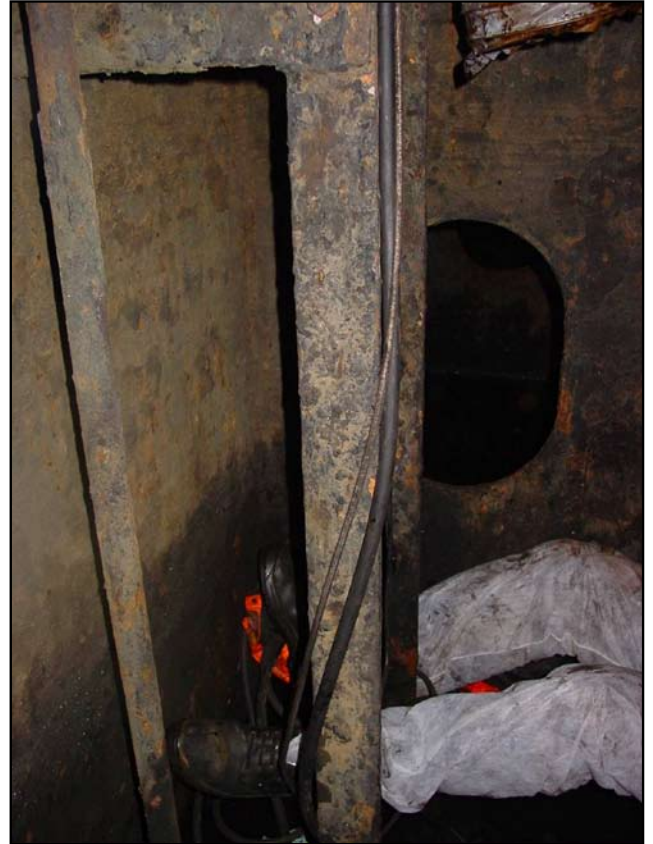
Figure 7

Reconstruction of the position of the second bosun
