MARINE INVESTIGATION REPORT
M09W0193

STRIKING

BULK CARRIER *PETERSFIELD*
DOUGLAS CHANNEL, BRITISH COLUMBIA
25 SEPTEMBER 2009

Report Number M09W0193

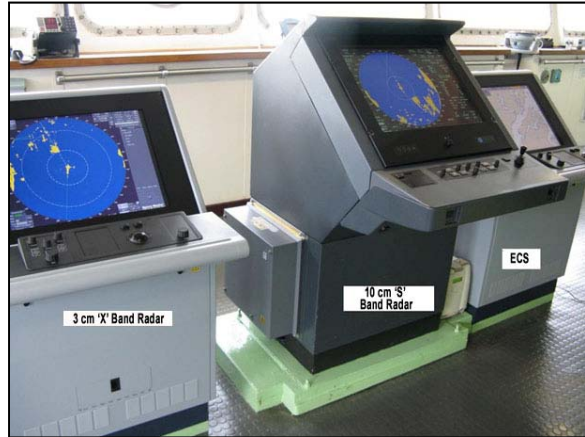
Photo 3. 3 cm radar, 10 cm radar and ECS.

At 2048:48,⁷ the 10 cm radar lost its heading input from the gyro compass and the OOW realigned it,⁸ returning it to normal function. A similar event occurred again at 2054:18 and at 2058:33. Each time the heading was re-aligned.

At 2156:49 and again at 2208:18, the 10 cm radar lost its heading input from the gyro compass. In both instances, the OOW realigned the radar heading.

At 2240:34, with the vessel still on a steady course, the image on the 10 cm radar screen began to rotate randomly and the visual compass alarm appeared. Moments later, the pilot stepped outside onto the port bridge wing in order to use his portable VHF to obtain weather information.¹⁰ Meanwhile, the OOW informed the master of the jumping radar and following a brief discussion, the master left the bridge. At this moment the vessel's heading had started swinging to starboard unobserved and had changed from approximately 218° G to 231° G.

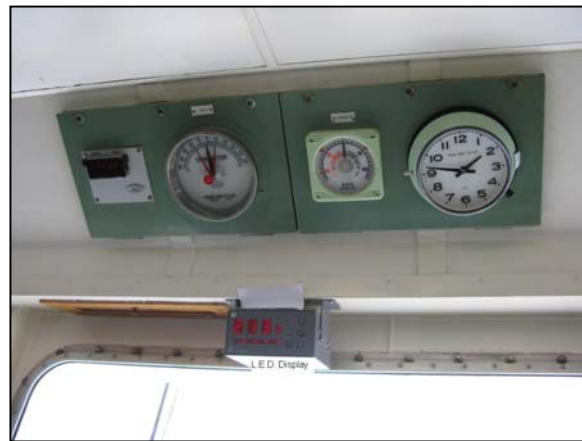
Photo 4. LED analogue repeater and rudder angle indicator.

The pilot then noticed a flashing white light abeam on the starboard side ¹⁴ and he was also able to distinguish the tops of the mountains ahead of the vessel. He immediately ordered the OOW to call the master and requested that a searchlight be turned on. The pilot ordered hard-a-port at 2244:05. Once the vessel started swinging to port, both the LED repeater and the gyro repeater in the steering stand reflected the port swing. However, they were no longer properly aligned with the gyro compass.

Since the vessel's analogue repeaters froze at the same moment, and since the quartermaster relied on these instruments as reference, there would have been no indication from the

repeaters that further helm action was required. Thus, it is most likely that a small routine helm correction to starboard was made and subsequently maintained, resulting in the vessel continuing to turn to starboard.²¹ It is uncertain why the quartermaster maintained the starboard helm, but there are 2 possibilities: either he did not observe the rudder angle indicator, or he observed it and disregarded it because there was no heading change.

In this occurrence, whatever caused the malfunction of the heading feed to the 10 cm radar also likely affected the functioning of the LED analogue repeater and the steering stand repeater used by the quartermaster. This contributed to the vessel deviating from its intended course. Furthermore, a situation was created where some components displayed inaccurate information while others remained accurate. This caused confusion, as the pilot was uncertain which components to trust, adding to the time necessary to determine the vessel's true position and heading.

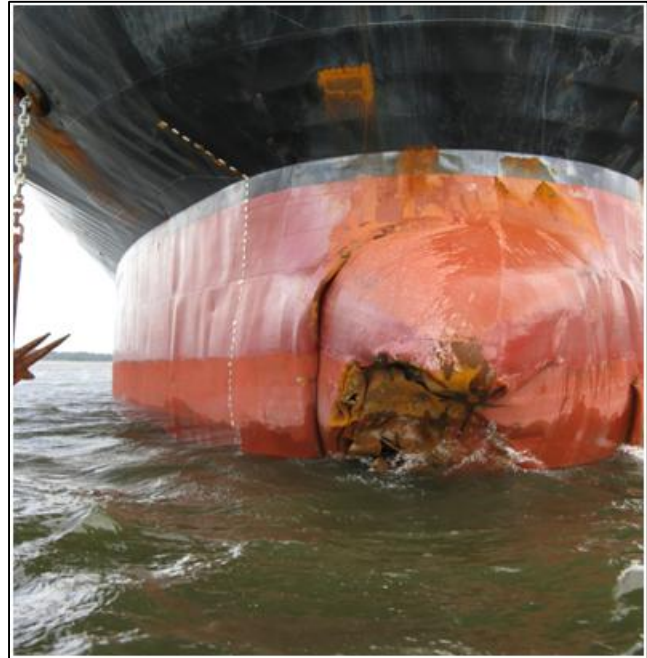
Photo 5. Damage to the bulbous bow.

An underwater inspection¹⁷ revealed that the vessel was holed in the forepeak and that the bulbous bow was pushed in between frames 227 and 238, from the 8 m draft mark to a depth of 6 m below and predominantly on the starboard side.

Most of the floors, stringers, frames and brackets were found buckled, deformed or ruptured from frames 220-238 in the forepeak tank. Buckling of frames was also observed on the collision bulkhead. The maintenance room deck above the forepeak was deformed and ruptured at 3 locations.

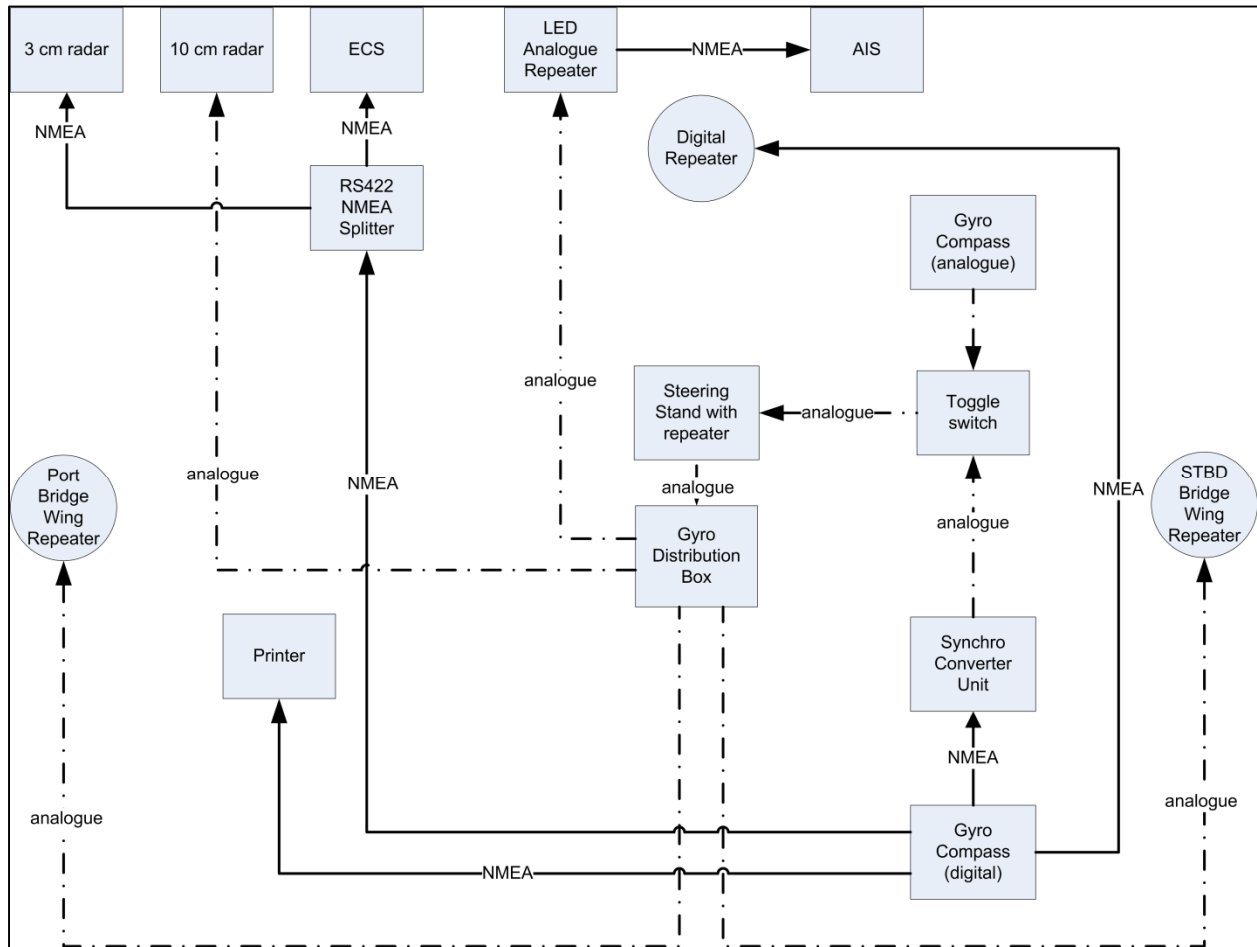
Figure 2. Schematic of the gyro compass signal distribution, as of 23 September 2009.

In April 2009, the 3 cm radar and the ECS were replaced by new radar and ECS units. The synchro converter unit was set to provide a digital heading signal to this newly-installed equipment, however, it continued to provide an analogue heading feed to the older 10 cm radar and 4 of the 5 repeaters.

On 23 September in Kitimat, a service technician again boarded the vessel to address the malfunction with the heading markers. An NMEA heading feed from the digital gyro was fed through a splitter box directly to the ECS and to the 3 cm radar, thereby bypassing the synchro unit. The technician tested the gyro system with its repeaters and heading feeds to the navigation equipment. They were found to be in good working order.

Following the occurrence, a service technician in Kitimat tested the gyro system and observed that the synchro converter unit overheated and that the internal cooling fan was not functioning properly. Later, after the fan had been serviced, the vessel made its transit to Vancouver without any reported problems. In Vancouver, another service technician tested the system for overheating by disconnecting the internal fan and also observed problems with the unit. It should be noted, however, that the conditions of these tests imposed a load on the synchro converter unit that was more strenuous than normal service conditions. As such, the results of these tests, although suggestive of overheating, were not conclusive.

Nonetheless, during the occurrence voyage, there was a malfunction in the heading feed to the 10 cm radar that originated from the synchro converter unit. This malfunction coincided with the 'hanging up' of both the LED repeater and the steering stand repeater. There are 3 likely sources for this malfunction:

- Overheating due to an old repeater becoming stuck;
- An internal malfunction with the converter unit; or
- Loose connections within the synchro converter unit housing, gyro distribution box, or steering stand.

- 8 out of 11 similar synchro converter units in use by their fleet were replaced;
- A gyro-GPS compass alarm which is visible from the helm position will be installed on board 25 vessels per year over a 3 year period; and
- Various navigational procedures have been developed or updated regarding the setup of ECS/ECDIS alarms and passage planning.

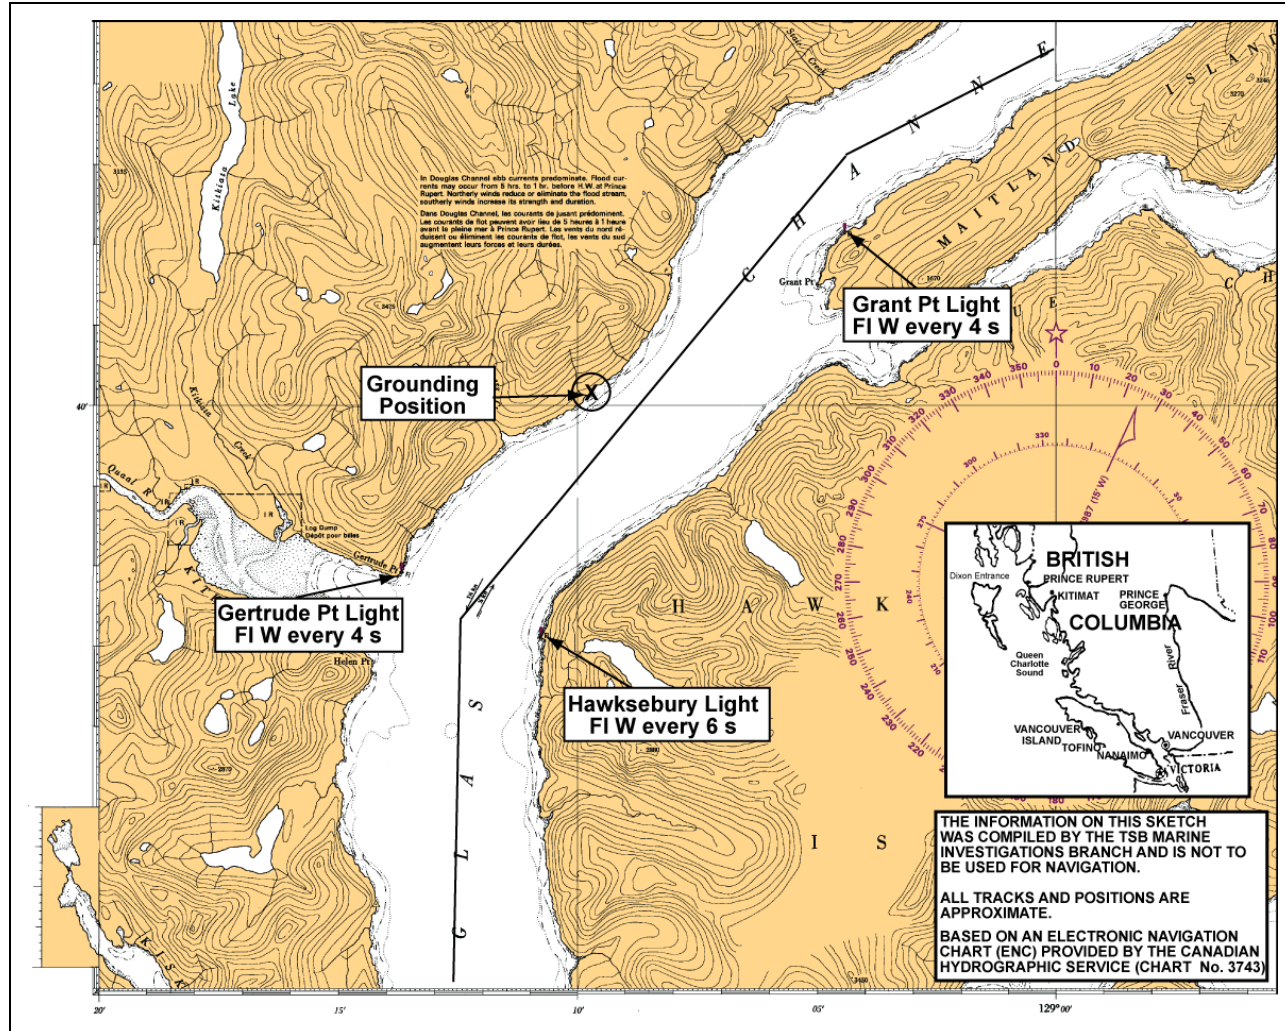
Appendix A – Area of the Occurrence

Having been called by the OOW, the master returned to the bridge when at 2244:46 the pilot ordered full astern. The swing to starboard was arrested at 316° G, but the vessel could not avoid striking the shoreline at approximately 2245:25 in position 53°40.6' N, 129° 08.8' W (see Appendix A).

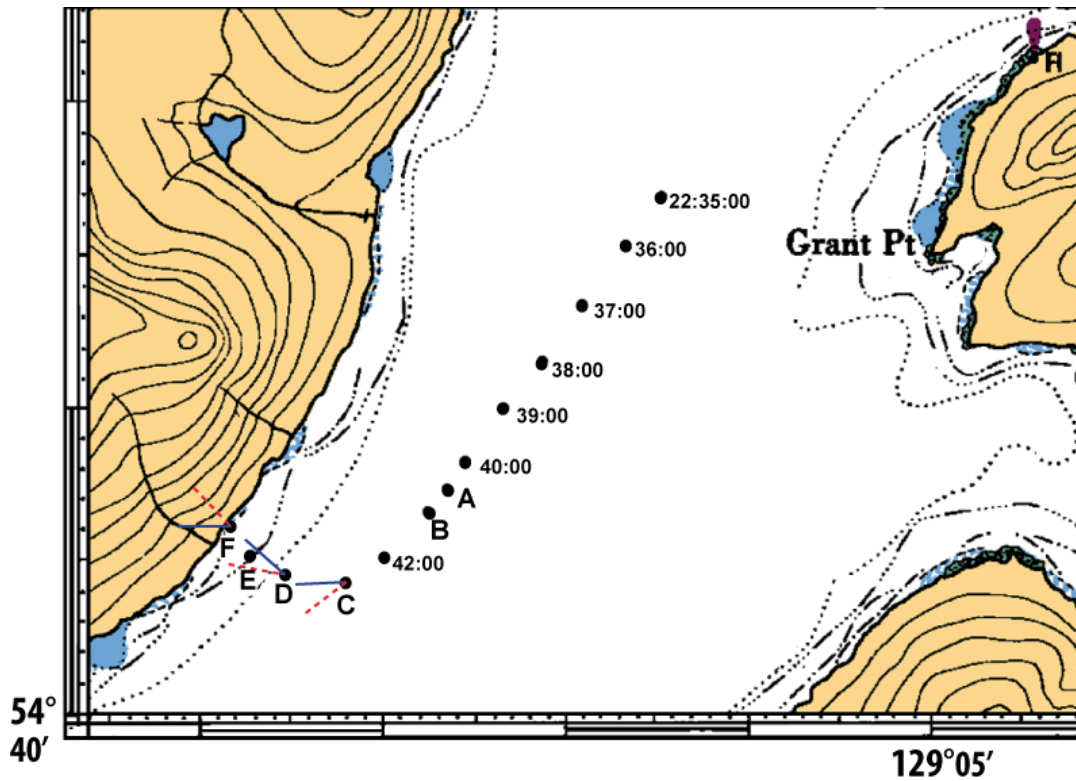
Positions of *Petersfield* 10 minutes prior to striking

As a result, the vessel's swing to starboard went unnoticed for a period of 2 minutes and 15 seconds until the pilot was alerted by visual cues from navigational aids onshore and a change in apparent wind. At this time, the vessel's rate of turn had increased to almost 40 degrees per minute to starboard, the heading had changed by over 50 degrees, the distance from shore had decreased to approximately 0.4 nm (see Appendix B) and the vessel was standing into danger.

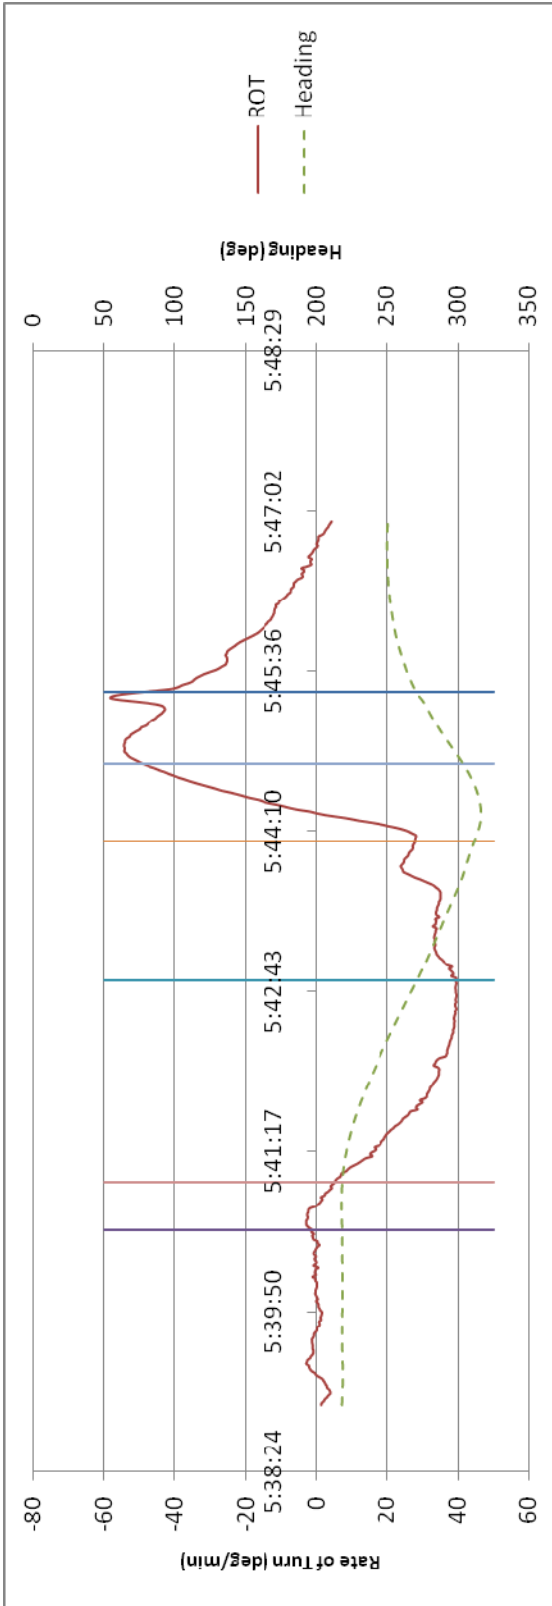
Appendix C – S-VDR Data

The application of starboard helm was examined through a detailed analysis of the S-VDR data. By plotting the vessel's heading and rate of turn against time (see Appendix C) it can be seen that, when the 10 cm radar started experiencing problems, the vessel's rate of turn was to port. In order for the quartermaster to maintain the vessel's desired heading, a small routine helm correction to starboard was necessary.

Nevertheless, S-VDR data indicates that the starboard rate of turn continued until shortly after the pilot re-entered the bridge, as illustrated in Appendix C (between points C and D). It is likely that the quartermaster, having been alerted of a problem, initiated corrective action to port at that time. However, when the pilot ordered hard to port (75 seconds after entering the bridge) the vessel was just over 0.2 nm from shore. Travelling at 12 knots on a heading of 312° G, the vessel had progressed to a point where striking the shore could not be avoided. The vessel had commenced swinging to port when the starboard bow struck the shore at an angle of 30 to 45 degrees relative to the ship's heading, at approximately 10 knots.
