Report on the investigation of  
the catastrophic failure of a capacitor  
in the aft harmonic filter room on board  
***RMS Queen Mary 2***  
while approaching Barcelona  
23 September 2010

At 0425 on 23 September 2010, as *RMS Queen Mary 2 (QM2)* was approaching Barcelona, an explosion occurred in the vessel's aft main switchboard room. Within a few seconds, all four propulsion motors shut down, and the vessel blacked out shortly afterwards. Fortunately, the vessel was clear of navigational hazards and drifted in open sea.

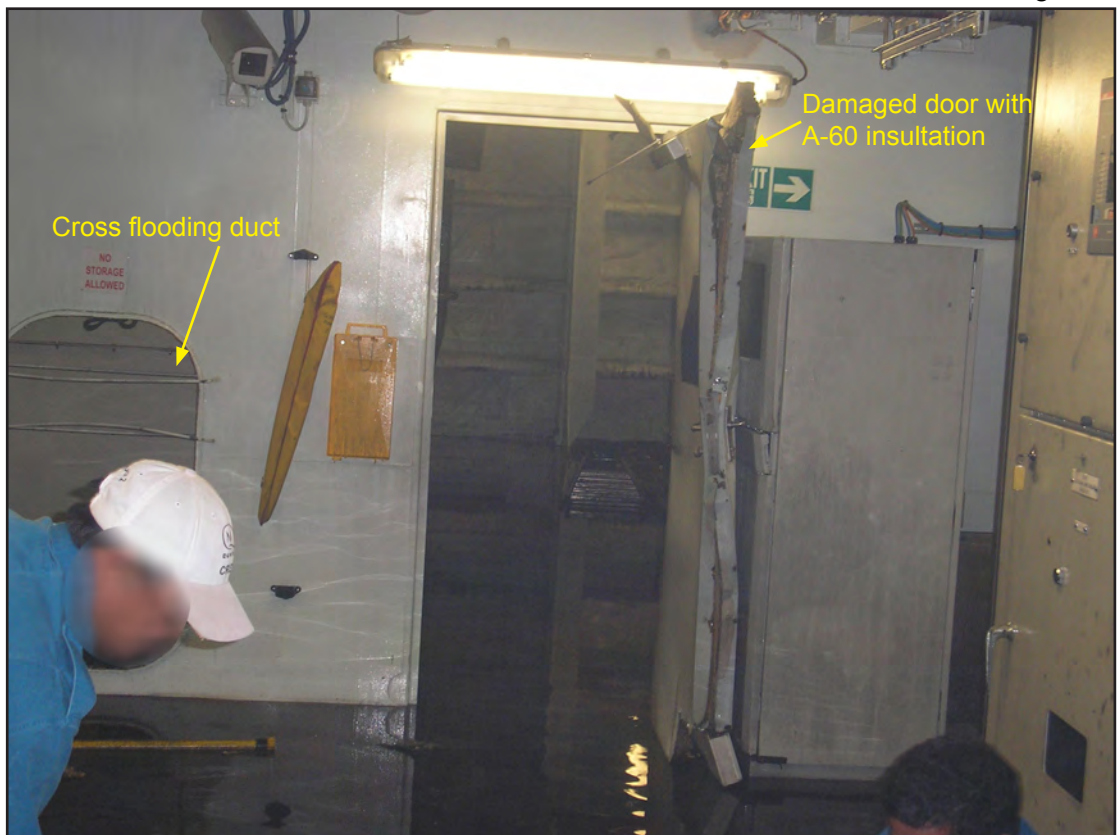
Figure 6

By 0439, the second electro-technical officer and a third engineer, both wearing breathing apparatus and carrying carbon dioxide portable fire extinguishers and a thermal imaging camera, were ready to carry out an inspection of the scene. They entered the aft MSB room and made their way into the HF room, stopping just after entering the doorway (**Figure 4**). They confirmed that the space was filled with thick black smoke; but there was no fire and, using their thermal imaging cameras, they did not detect any hot spots. Two *Hi-Fog* glass bulbs (**Figure 5**), one in the aft HF room and another in the aft MSB room had ruptured and there was approximately 10mm of water on the decks of both compartments (**Figure 6**).

Water in the aft harmonic filter and main switchboard rooms

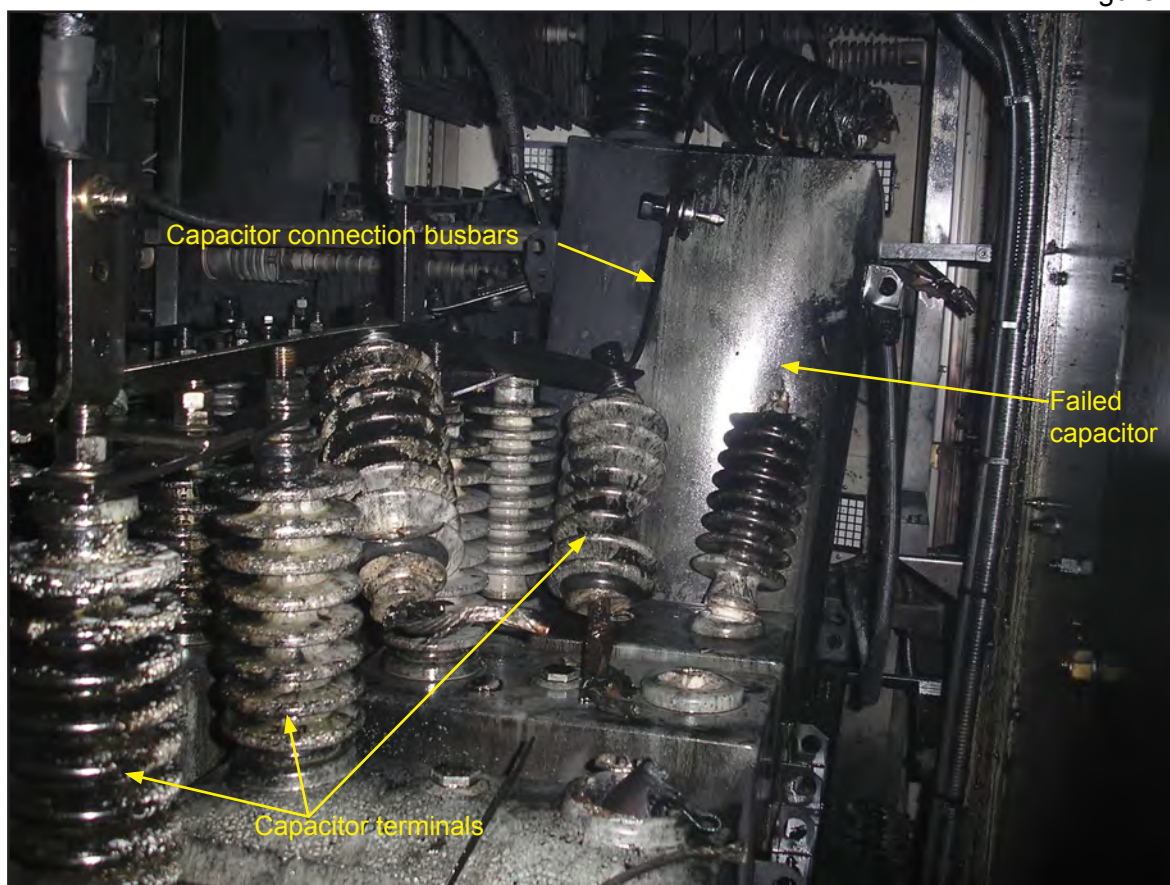
Figure 7

The explosion was triggered by deterioration in the capacitors in the aft HF. Internal arcing between the capacitor plates developed, which vaporised the dielectric medium causing the internal pressure to increase, until it caused the capacitor casing to rupture. Dielectric fluid vapour sprayed out, igniting and creating the likely conditions for an arc-flash to occur between the 11000 volt bus bars that fed power to the aft HF.

The damage in the aft HF room was extensive. Most of the occupants of the six crew cabins located directly above the aft HF room heard the noise of the blast and described the sound as a 'loud bang'. There was no damage inside their cabins. Panels on either sides of the rank 11.3 cubicle were badly distorted and covered with soot. Panels for the rank 4 cubicle were also bulged out. The floor and deckhead were covered with soot and dielectric oil was found all over the rank 11.3 HF section, including the area under the capacitors and on the inside of the top panel of the enclosure. One capacitor was found to have lifted up around 60cm from its normal position. Its bottom cover had bent outwards and blown out at its welded joint. It had wrenched itself free from its foundation bolts, breaking the connection to the capacitor elements inside. All the capacitors fitted in the same row as the failed one had suffered damage on their terminals. The casing of another capacitor was found to have bulged severely (**Figure 7** and **Figure 8**).

Failed capacitor

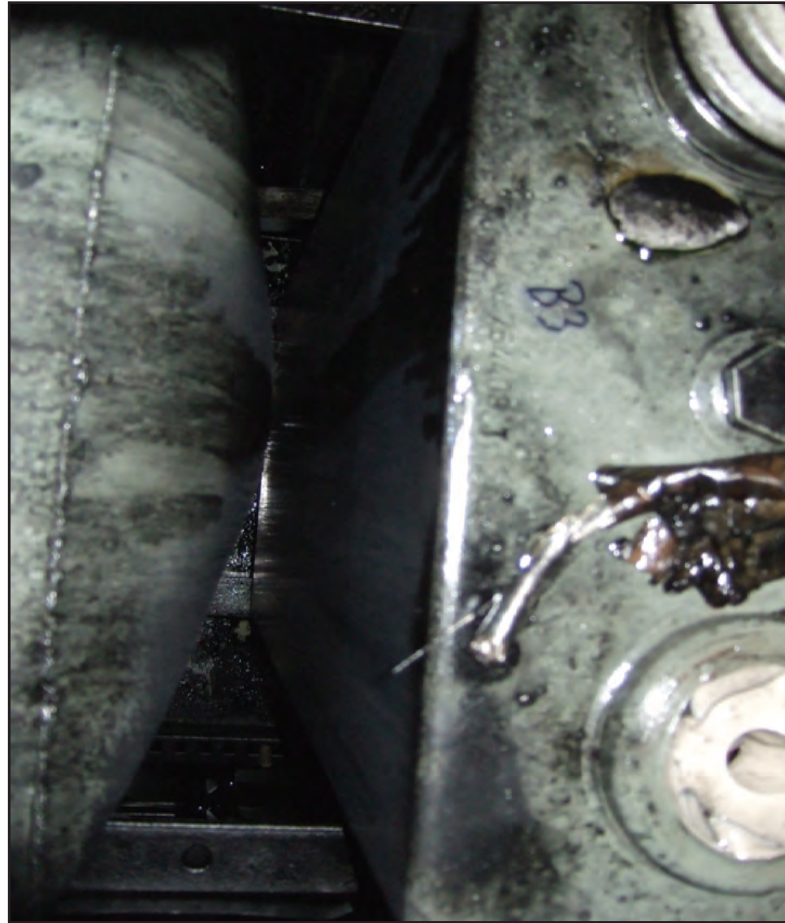
Figure 8

Top view of bulged capacitor

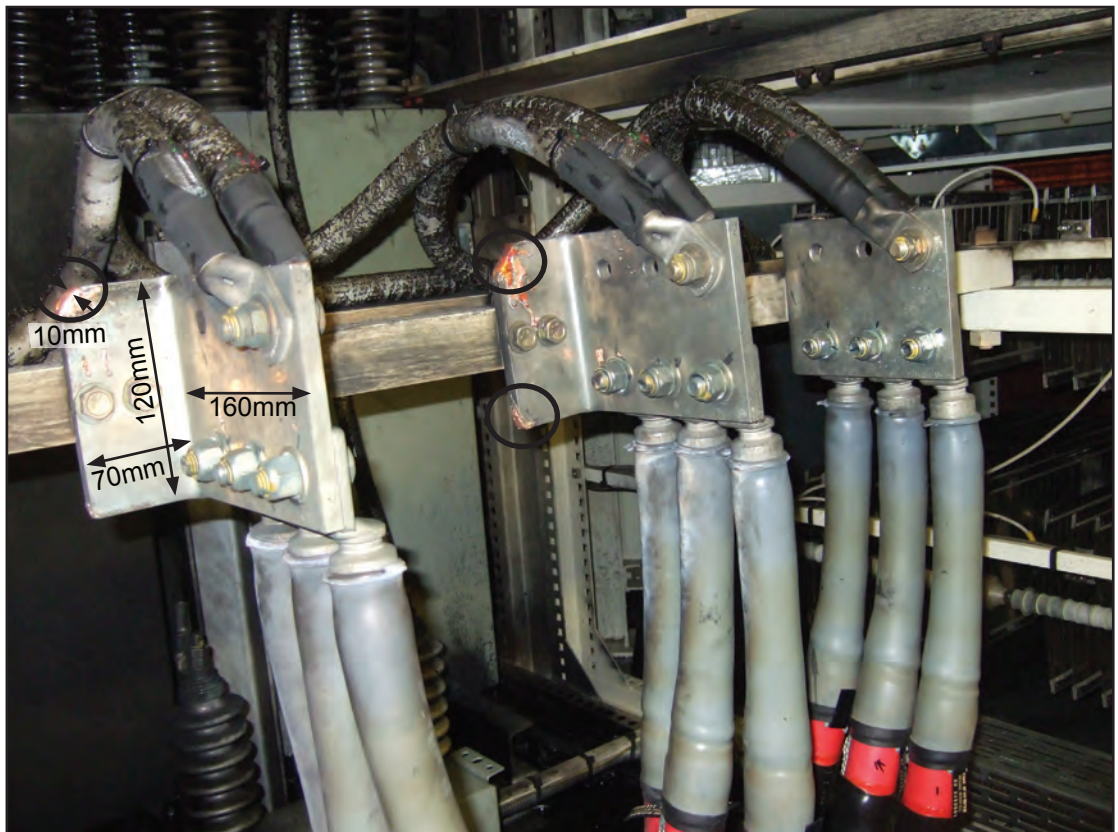
Figure 9

The 'A-60' rated steel door to the compartment was found forced out through its frame and the adjoining steel door for the MSB room was also buckled and split. A steel door at the inboard entrance to the aft MSB room and located approximately 20m away from the site of the explosion was forced off its hinges. The stiffeners on the bulkhead of the compartment were buckled and the steel cover plate on the cross-flooding duct between the HF and MSB rooms was blown out into the MSB room. The polythene covering on a fire extinguisher, which was located approximately 2m away from the failed capacitor, was found singed. The corners of all three high voltage bus bars that fed into the aft HF had been melted (**Figure 9**).

Evidence of arcing on the harmonic filter bus bars

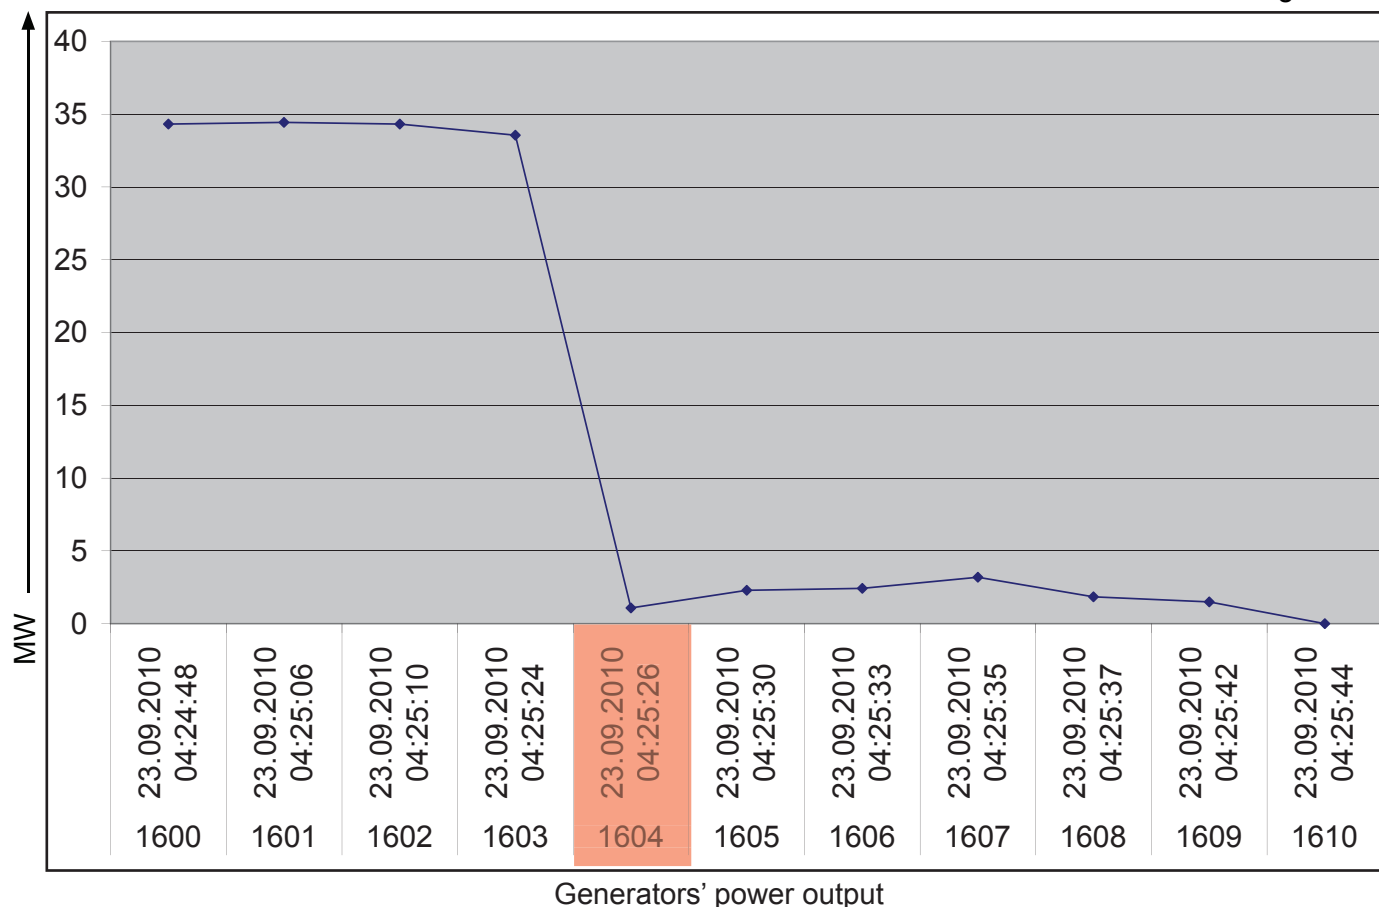
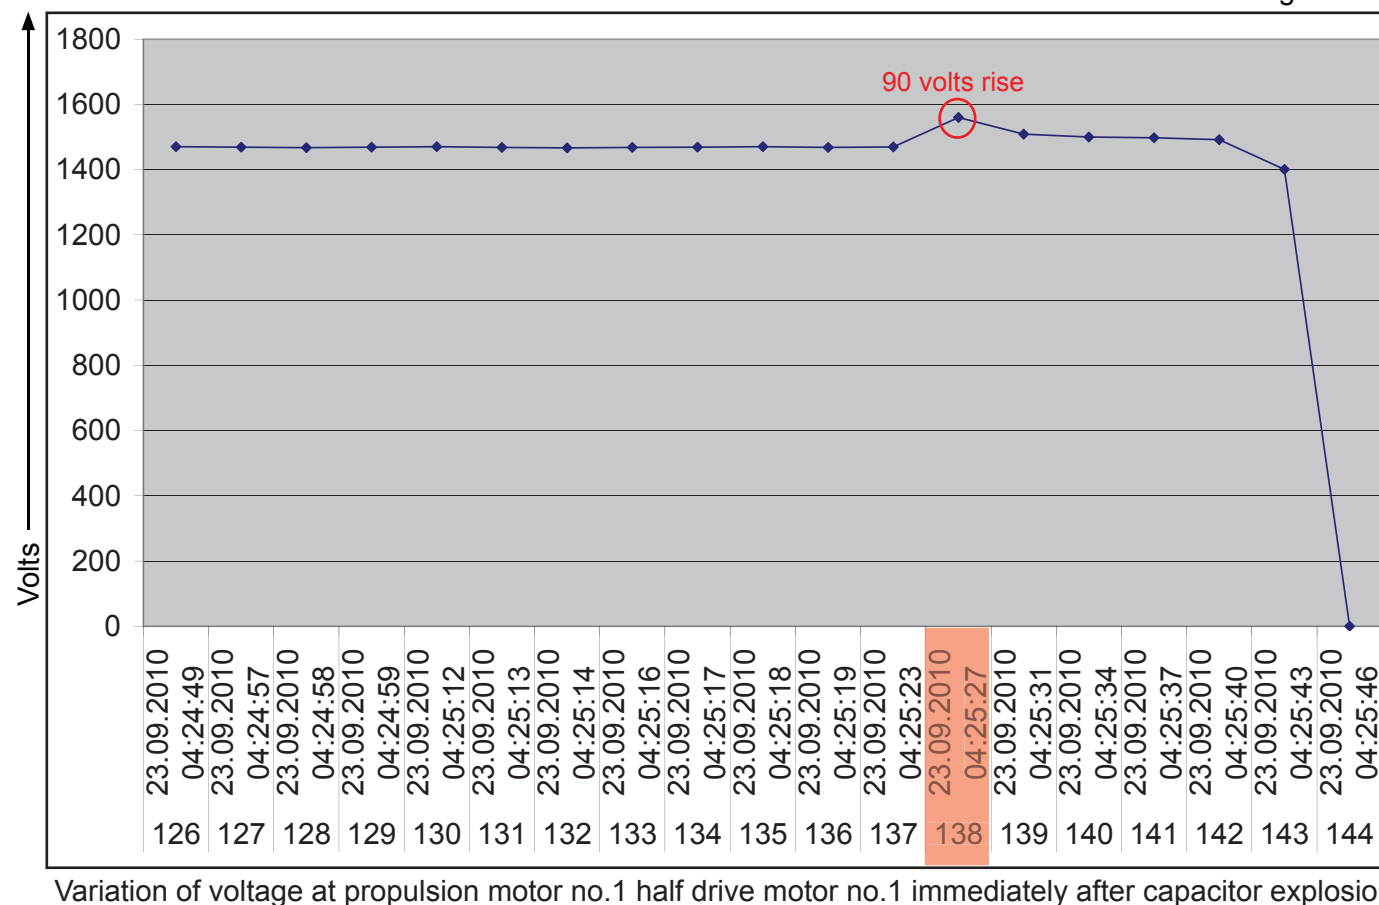
Figure 11a

Variation of voltage at propulsion motor no.1 half drive motor no.1 immediately after capacitor explosion

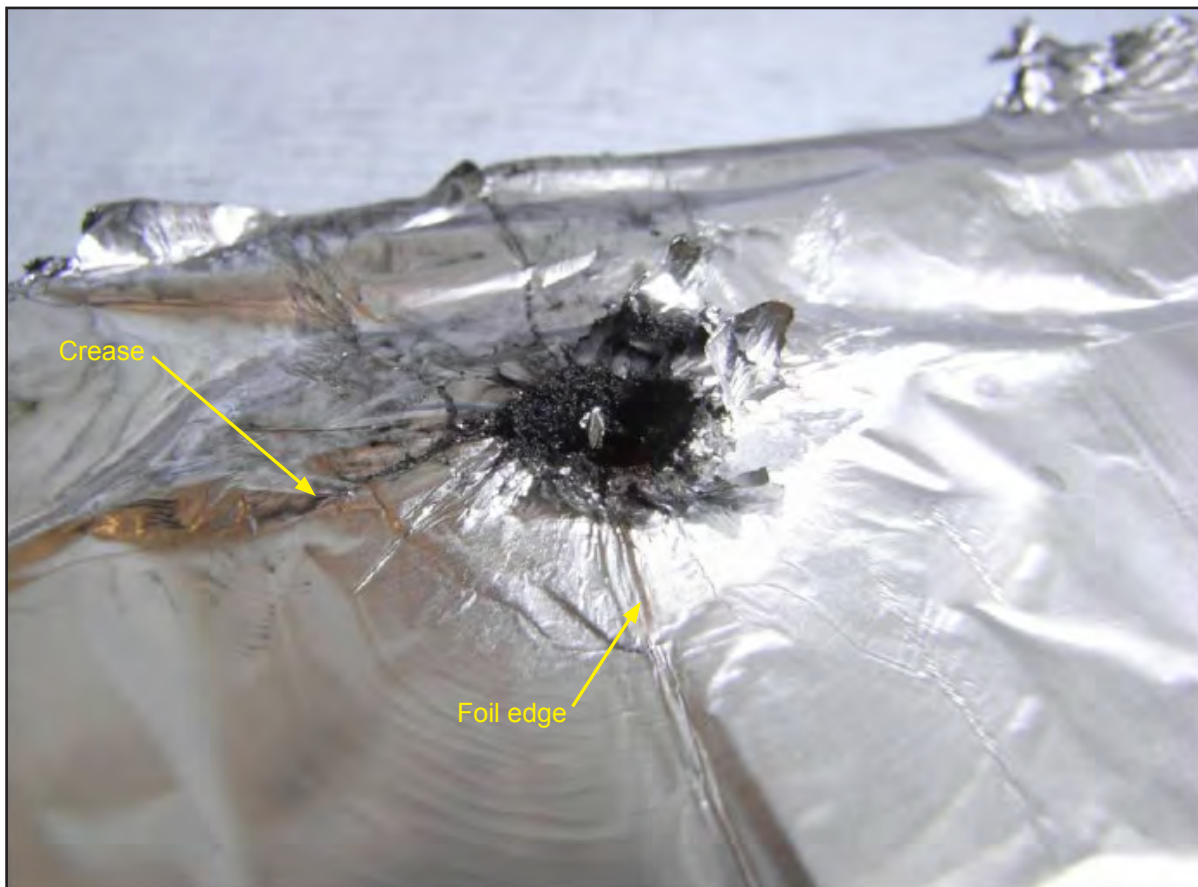
Figure 17

Crease on capacitor element

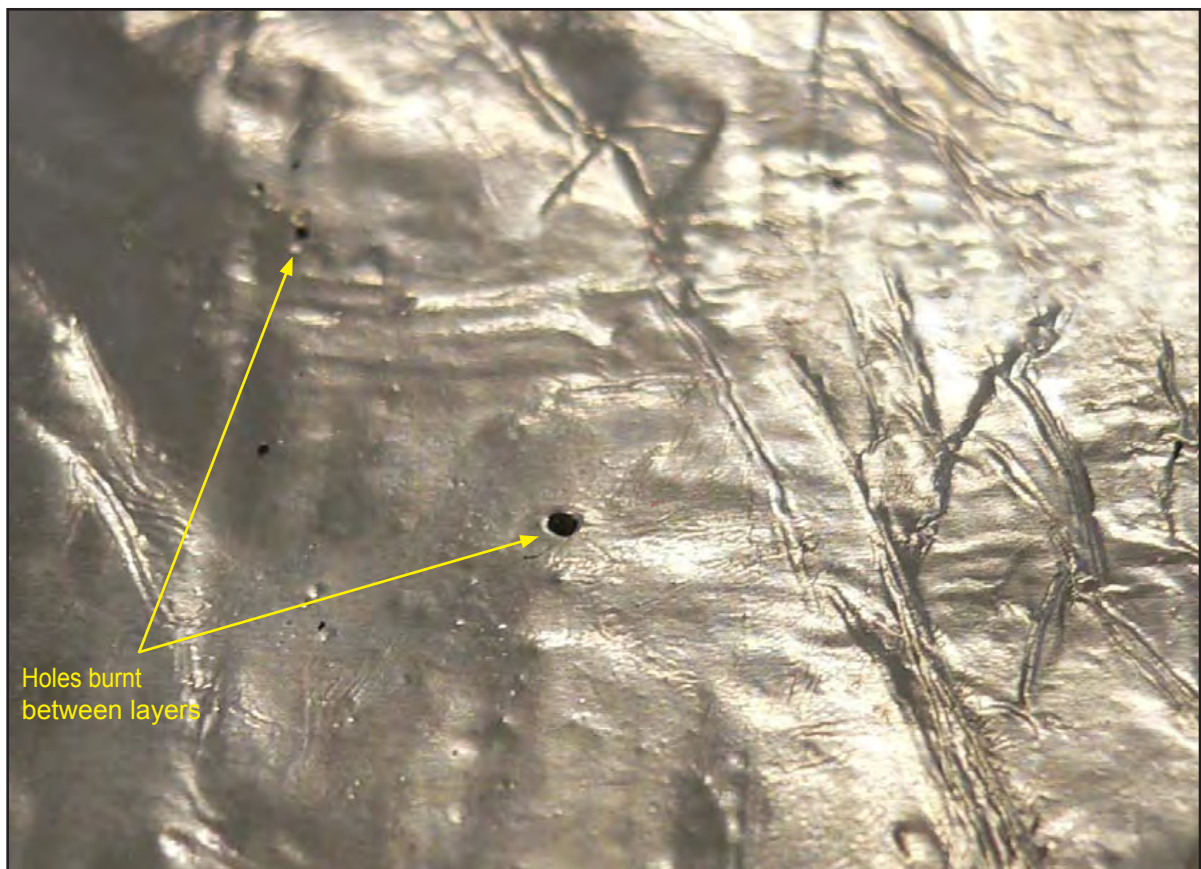
Figure 18

An element from the bulged capacitor was inspected and very small round holes, the largest of which was approximately 0.5mm diameter, were found between two layers (**Figure 18**). With reference to these holes, the report stated:

*'This type of damage is typically associated with transient overvoltage. However, it is not possible to say, from the physical evidence whether or not the transient over voltage was generated by disturbances [in the supply] or as a result of the prior failure of other elements in the capacitor.'*

Holes in capacitor element from bulged capacitor

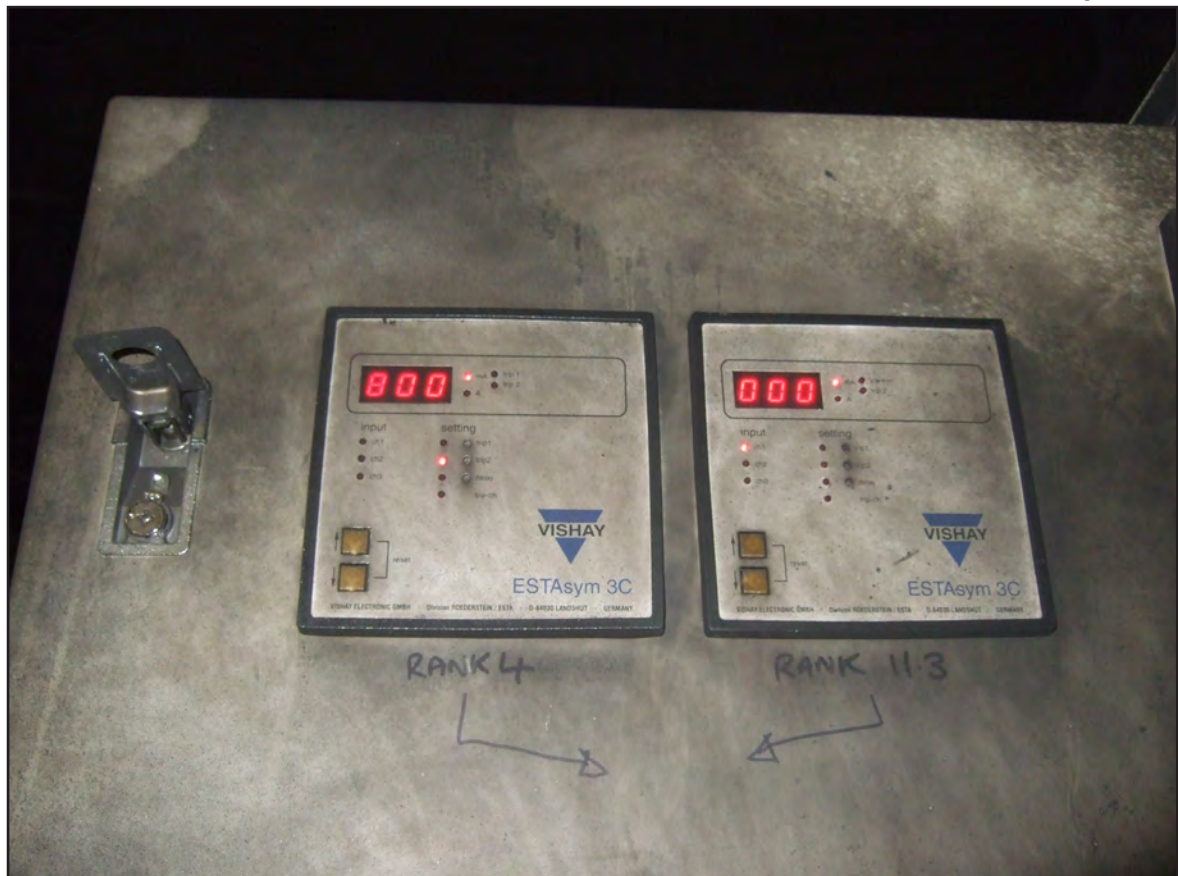
Figure 21

Immediately after the accident, the imbalance detection unit for rank 4 of the aft HF indicated 800mA and the equivalent unit on rank 11.3 (where the failure took place) showed '000' (**Figure 21**). Cooling water leakage and cooling air alarms were also provided for each rank. These alarms did not activate during the accident. An overload alarm was also provided but it was not possible to determine from the alarm records if this activated during the accident.

Current imbalance indicators in the aft harmonic filter room

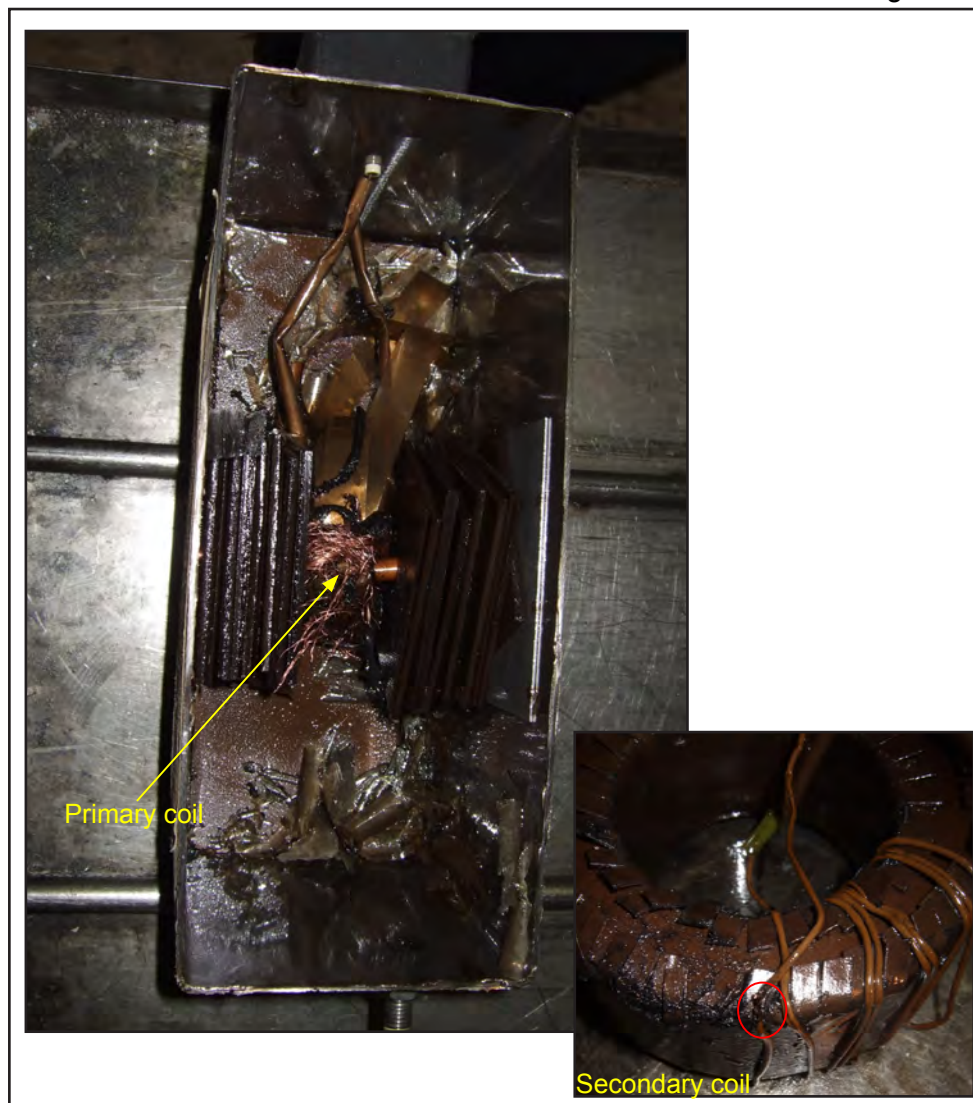
Figure 22

The casing of the imbalance current transformer was cut open by Vishay and witnessed by representatives from MAIB and Converteam. The transformer oil was very dark in appearance and contained visible solid debris. The primary winding was found severely damaged, with most of its insulation missing. The copper wire in the secondary winding was broken at one place and held together by damaged insulation. The wire had flattened and insulation broken where it had been wound around the edges of the transformer's iron core (**Figure 22**). The complete report is at **Annex E**.

Current transformer for the imbalance detection system with its casing cut open (inset: secondary coil)
