MARINE ACCIDENT REPORT

December 2013

EMMA MÆRSK

Flooding of engine room on 1 February 2013

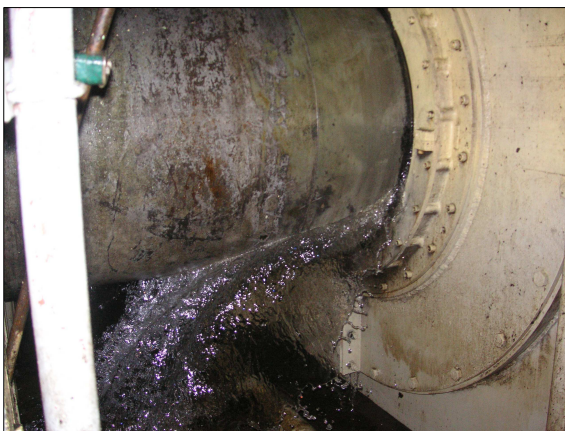
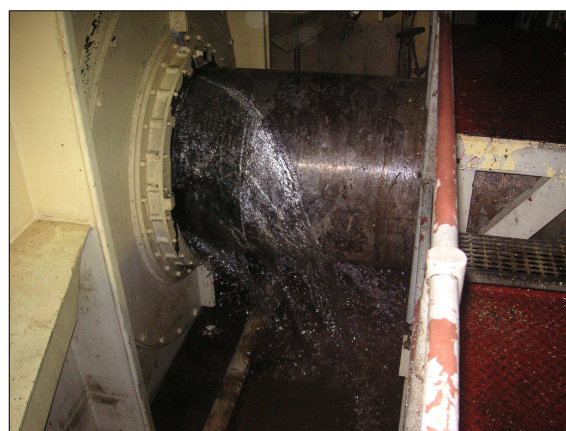
Figures 13 and 14: Ingress of water from the shaft tunnel to the engine room at the propeller shaft sealing when, at the repair yard, water in the engine room is being discharged and the propeller shaft tunnel is still flooded.

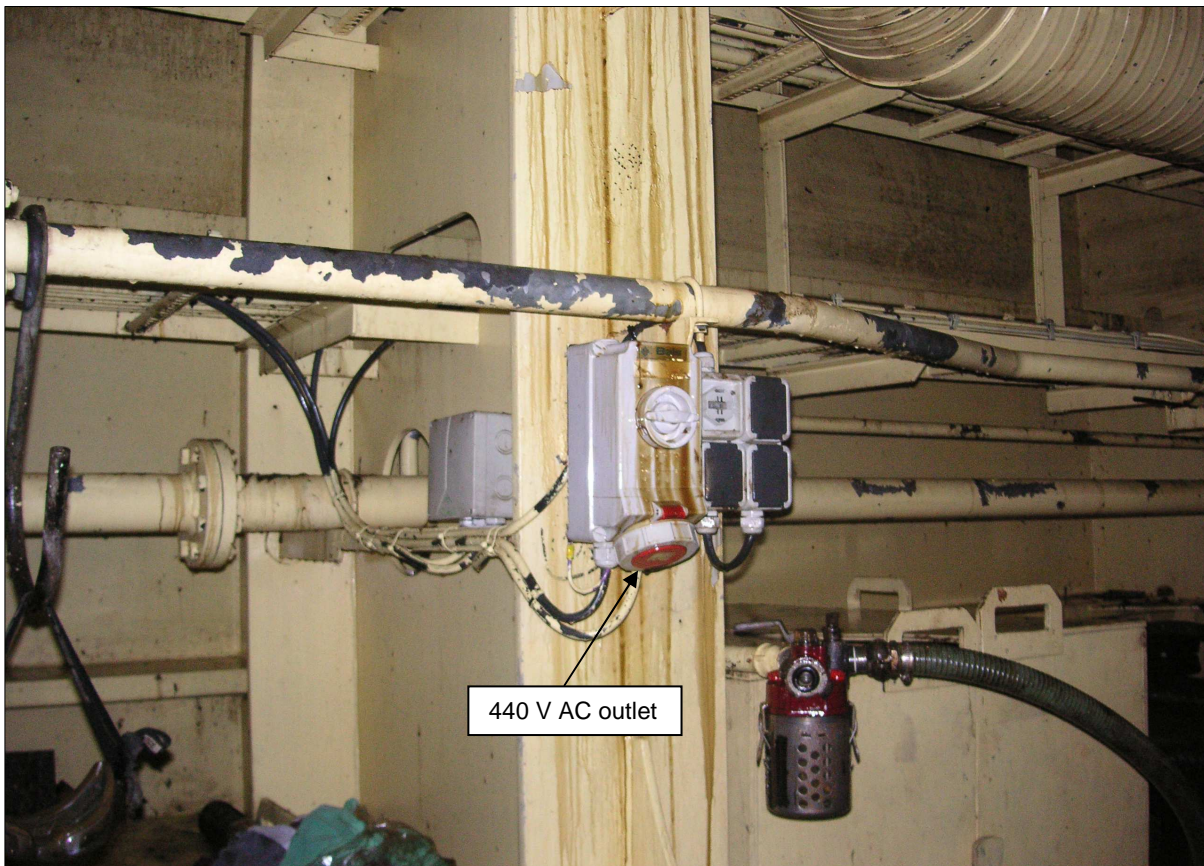
At about 2205 hours, a 3rd engineer, who was standing at the aft part of the main engine watching the situation develop, became aware that water unexpectedly began flowing from a 440 volt AC outlet at the port side of the engine room some five or six metres from the watertight bulkhead (figure 15 below).

Figure 15: 440 volt AC outlet from which seawater began flowing out
Source: DMAIB

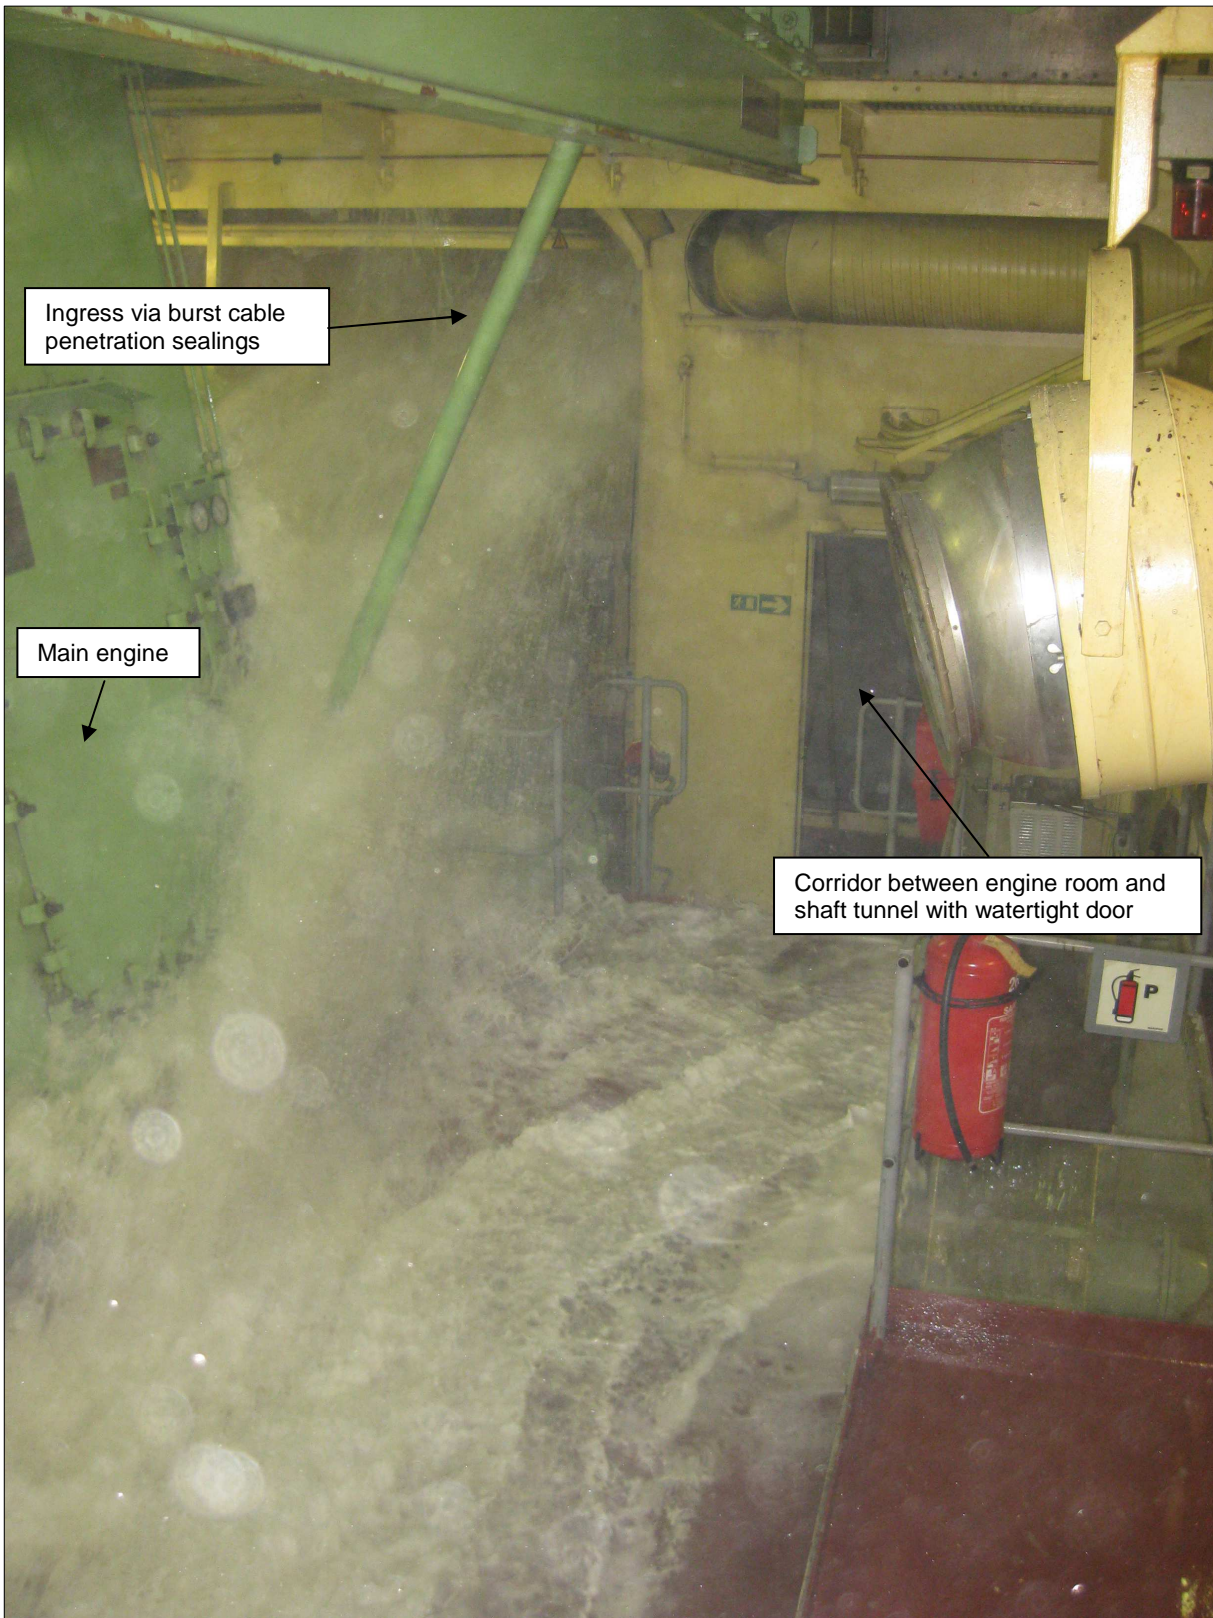
As the 3rd engineer investigated this unexpected scenario, he heard a sudden blast and saw one of four cable penetration sealings in the watertight bulkhead give way to the water pressure followed by a massive ingress of seawater. A few moments later, the other three cable penetration sealings also failed which resulted in an even larger ingress of water into the engine room.

Figure 17: Seawater ingress from propeller shaft tunnel into the main engine room via burst cable penetration sealings in the watertight bulkhead, viewed from the port side of the engine room
Source: Maersk Line

When the four high voltage cable penetration sealings collapsed, the ship’s draught was about 16 metres. The high voltage cable penetrations in the watertight bulkhead were situated about seven metres above the ship’s basis line. Thus, the cable penetrations collapsed at a hydrostatic water pressure corresponding to the maximum water column of appr. nine metres equal to appr. 0.9 bar.

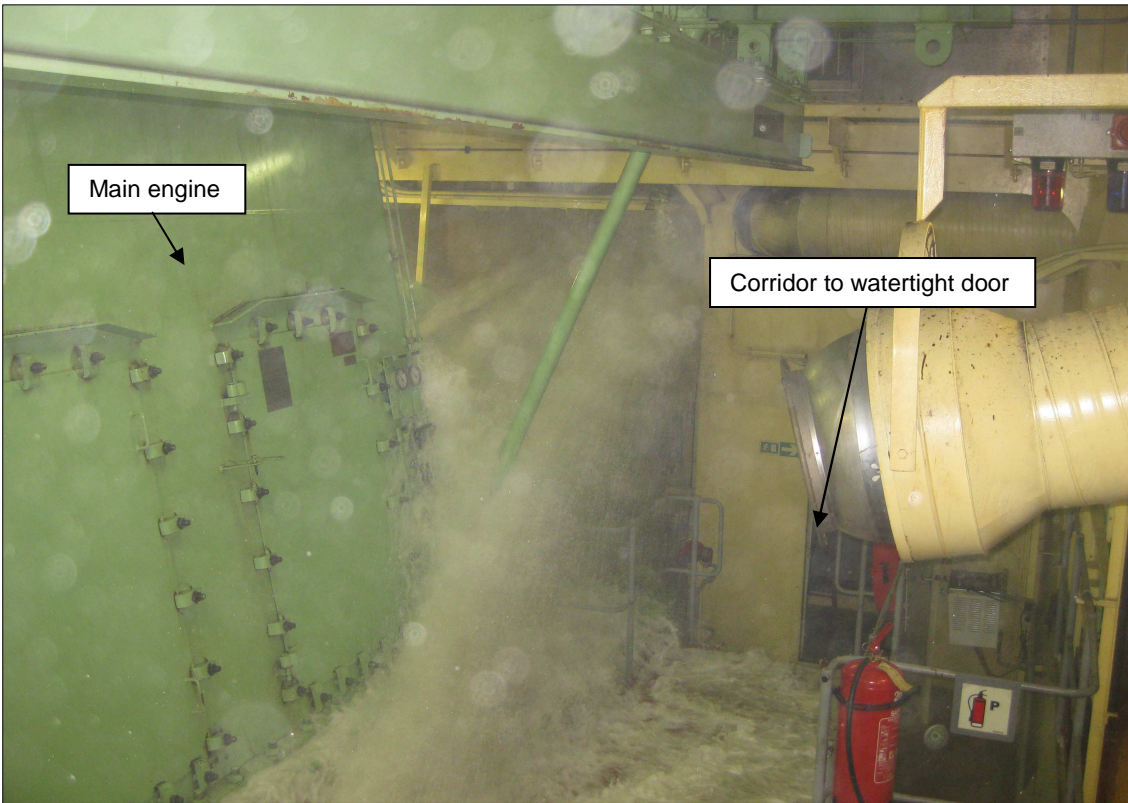
Figure 18: Seawater ingress from propeller shaft tunnel into the main engine room via burst cable penetration sealings in the watertight bulkhead, viewed from the port side of the engine room
 Source: Maersk Line

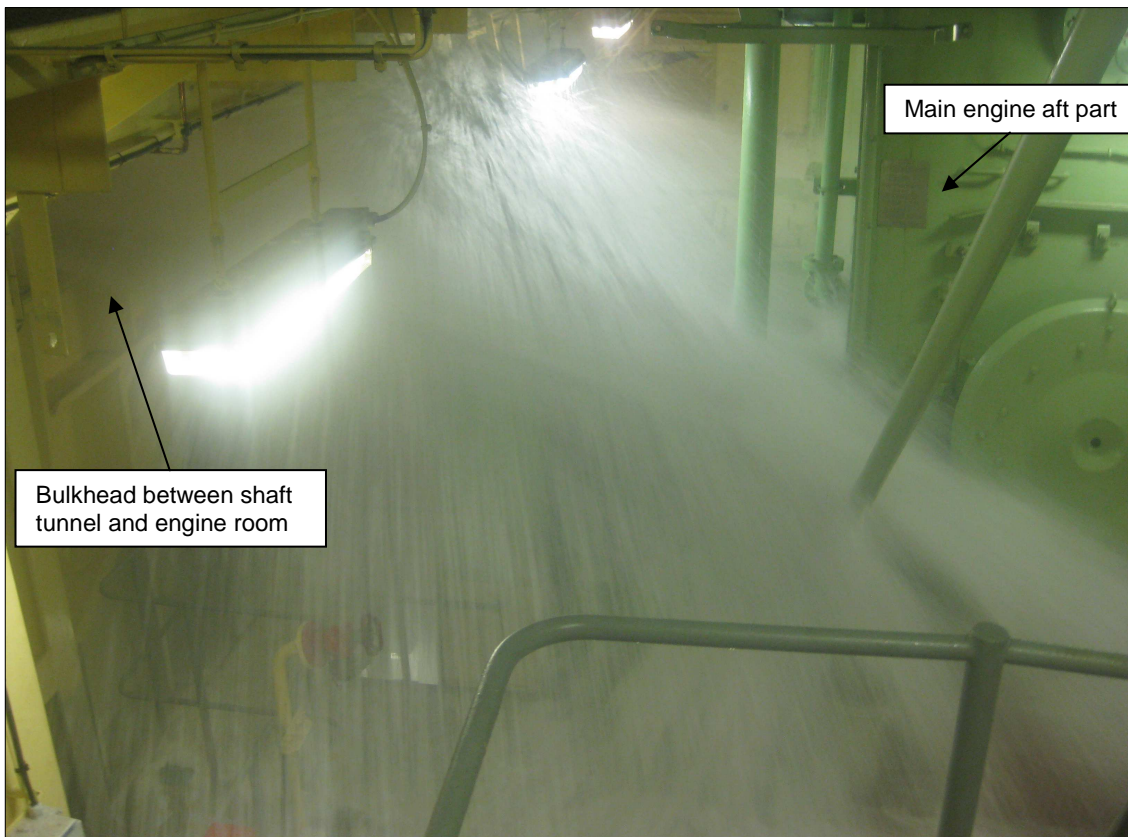
Figure 19: Seawater ingress from propeller shaft tunnel into the main engine room via burst cable penetration sealings in the watertight bulkhead, viewed from the starboard side of the engine room
 Source: Maersk Line

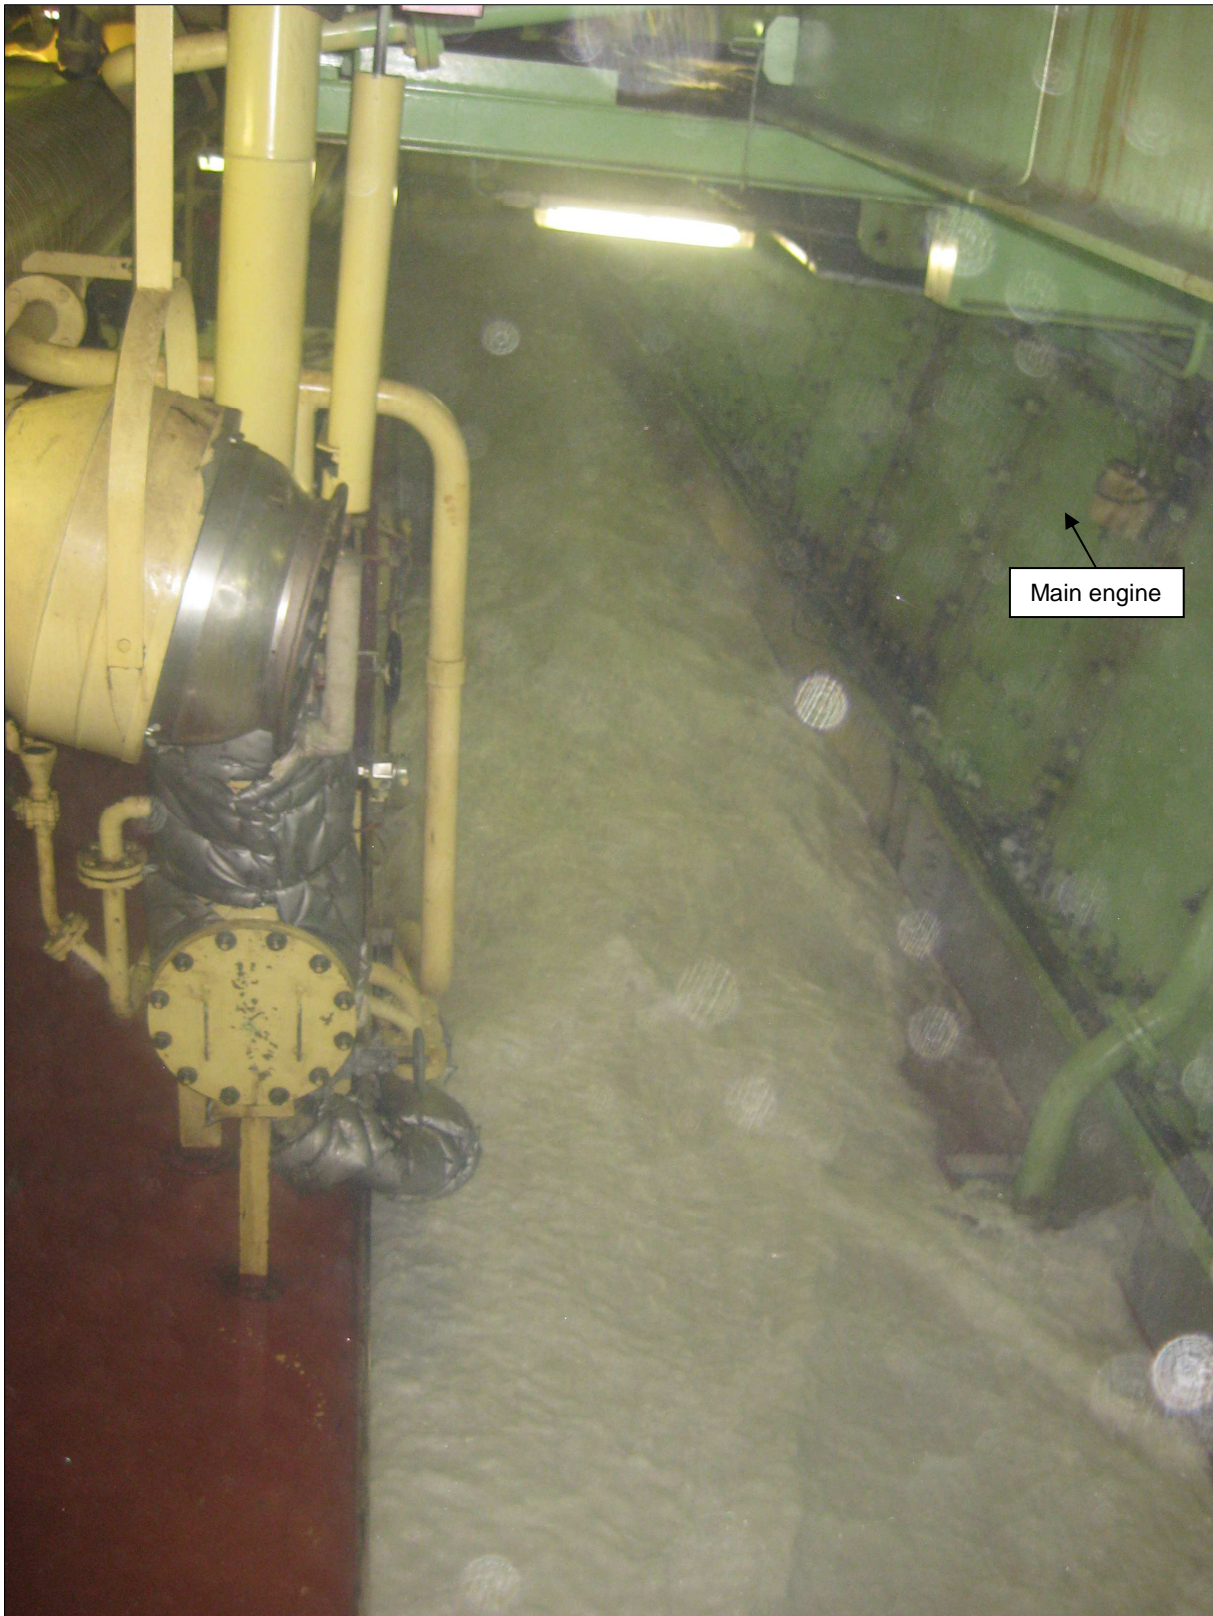
Figure 20: Engine room getting flooded, viewed forward from the aft of the engine room port side
Source: Maersk Line

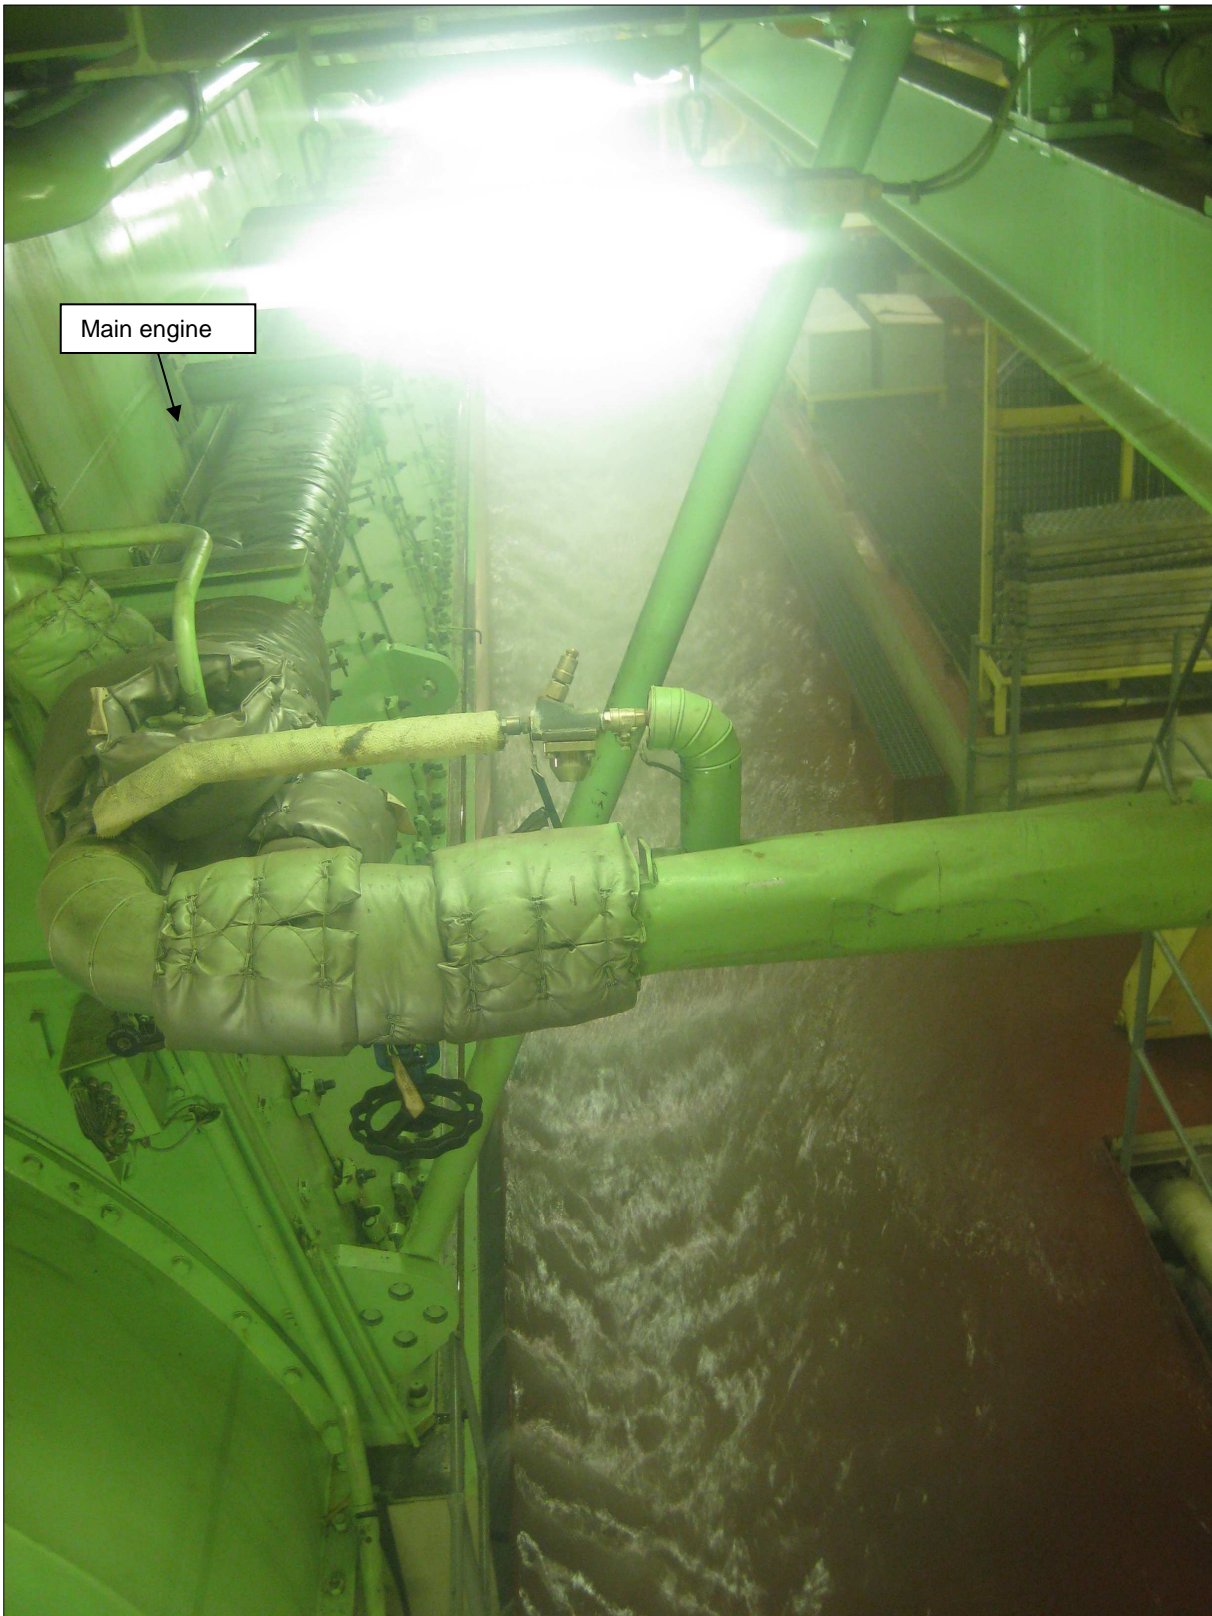
Figure 21: Engine room getting flooded
Source: Maersk Line

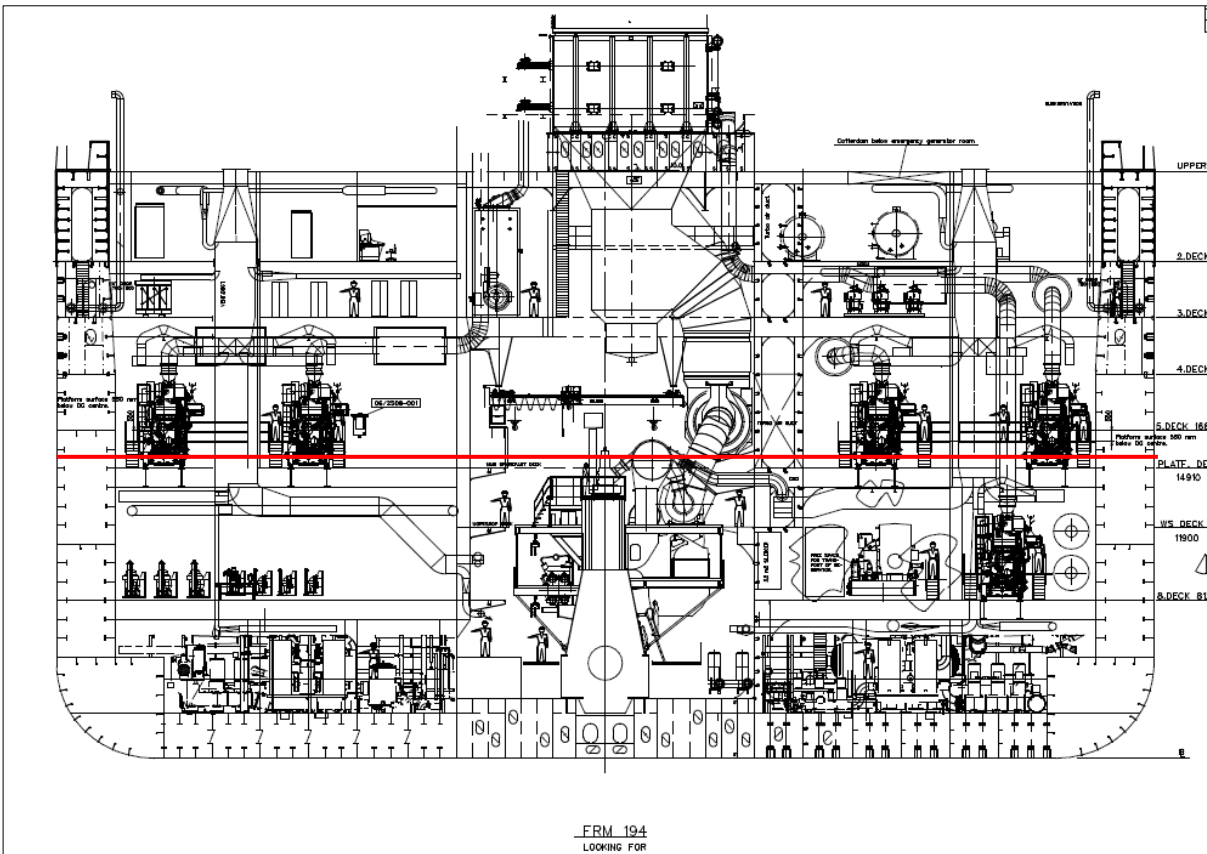
Figure 22: Transverse section of the engine room with a red line indicating the maximum water level
 Source: Maersk Line

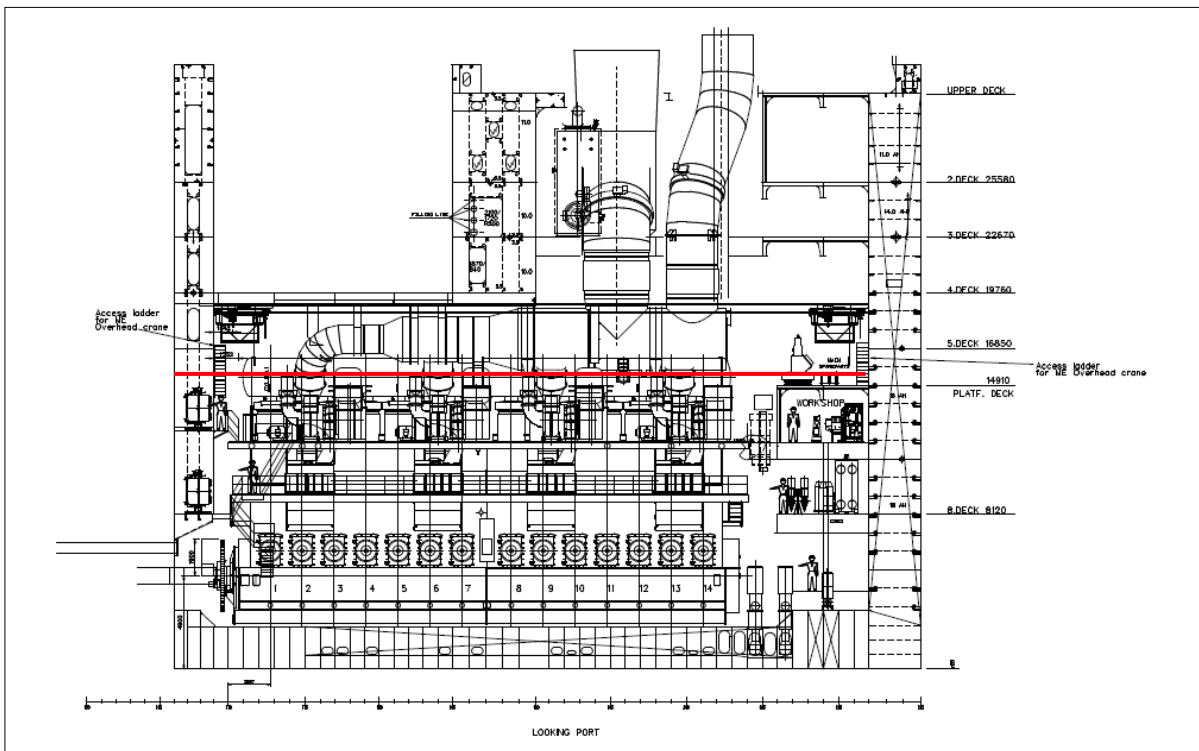
Figure 23: Longitudinal section of the engine room with a red line indicating the maximum water level
 Source: Maersk Line

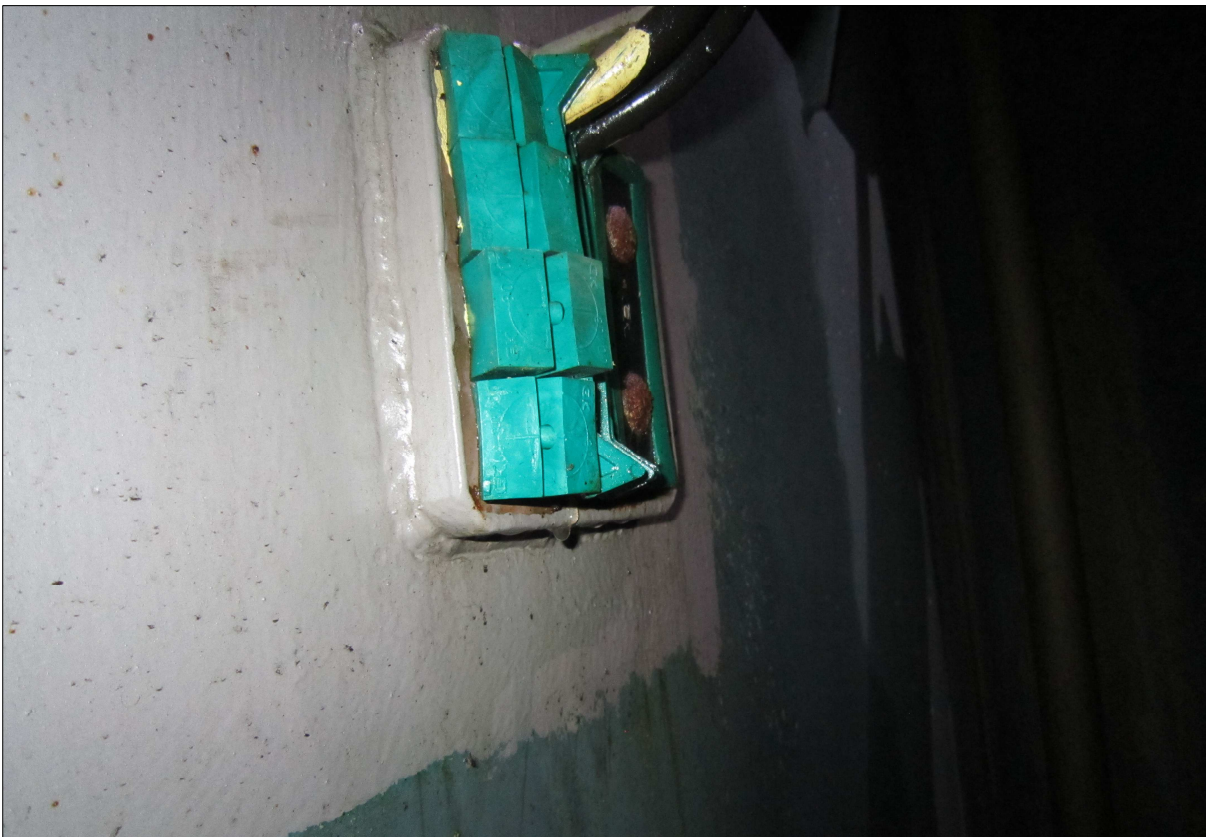
During the attempt to get the ship safely into the Suez Canal Container Terminal, appr. 0.35 metres of water was sounded in cargo hold No. 21. It was found that this ingress had occurred through a cable penetration in the transverse bulkhead at frame 53 between the cargo hold and the emergency exit from the aft part of the shaft tunnel (figure 24 below). The collapse of this cable penetration, which at a later investigation was found to have been improperly installed or re-installed and consequently presented a risk of flooding the cargo hold, was soon countered by the crew by putting a wooden bar jammed with wedges (figure 25 on page 25).

The cable penetration in question was situated in the emergency exit shaft at a height so that the damage waterline corresponded to a hydrostatic pressure of appr. 0.5 bar.

*Figure 24: Cable penetration in bulkhead between emergency exit and cargo hold during collapse
Source: Maersk Line*

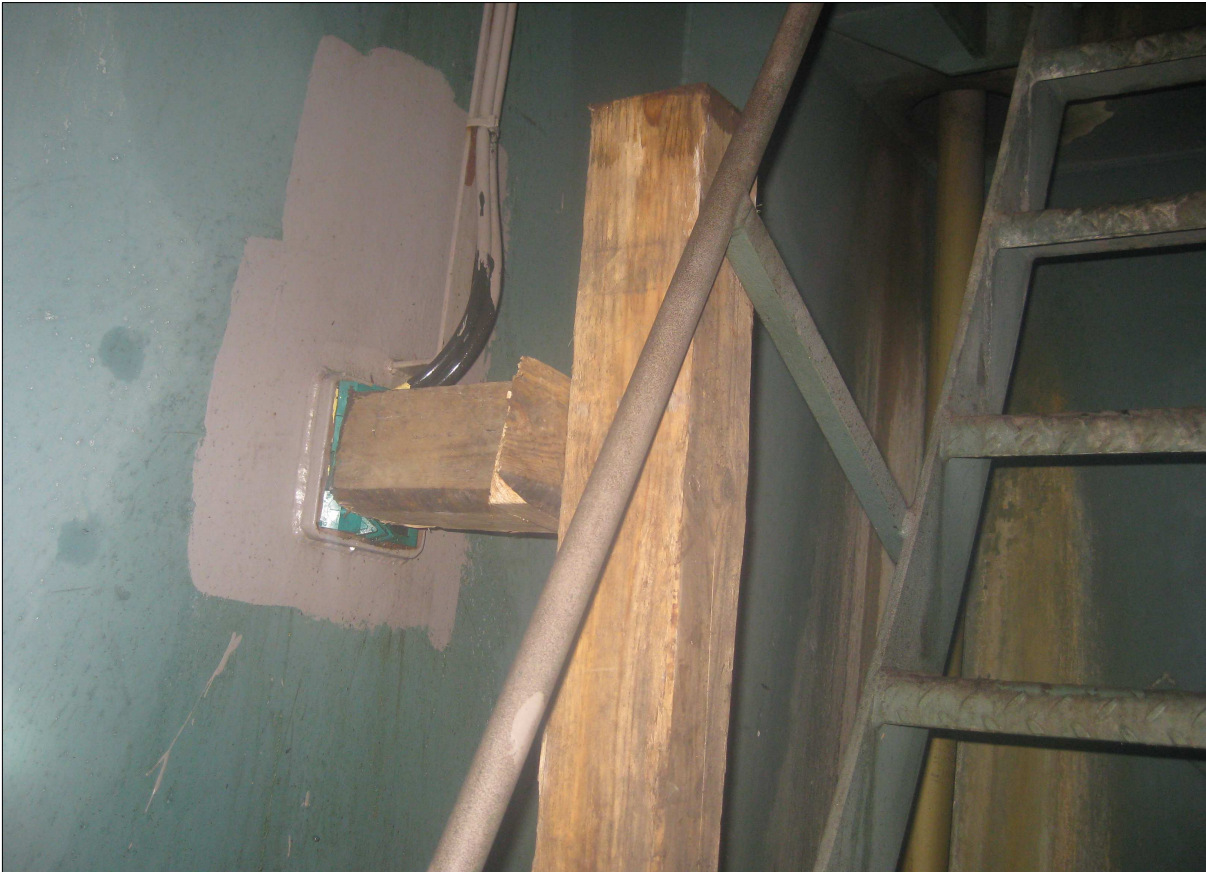
Figure 25: Temporary repair of cable penetration in bulkhead between emergency exit and cargo hold
Source: Maersk Line

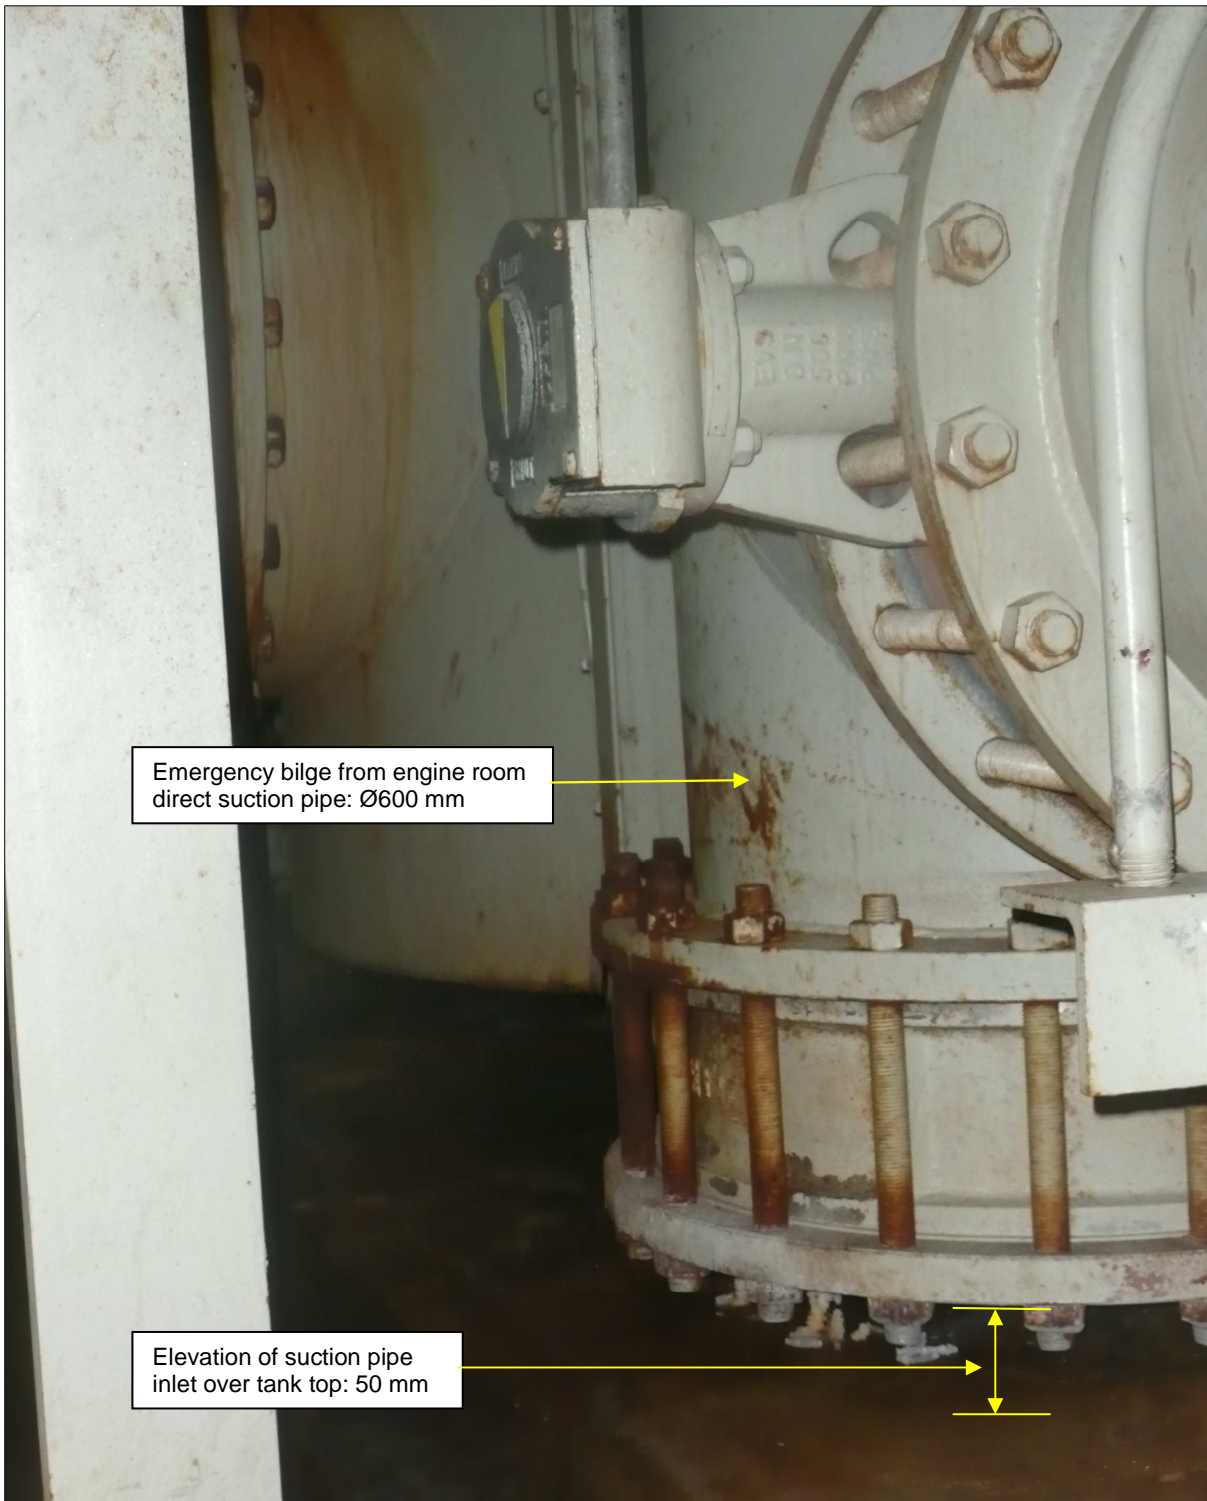
The emergency bilge suction pipe has a 600 mm internal diameter. It was situated just below the pump 50 mm above the tank top and had no strainer (figure 26 below). The area made up by this elevation (50 mm) multiplied by the pipe circumference is only one third of the internal area of the inlet pipe. Therefore the flow to the pump was reduced to an unknown proportion of what would be the case with an inlet area under the suction pipe equally large as the pipe itself.

Figure 26: Emergency direct suction from engine room by largest seawater pump of a sister ship
Source: DMAIB

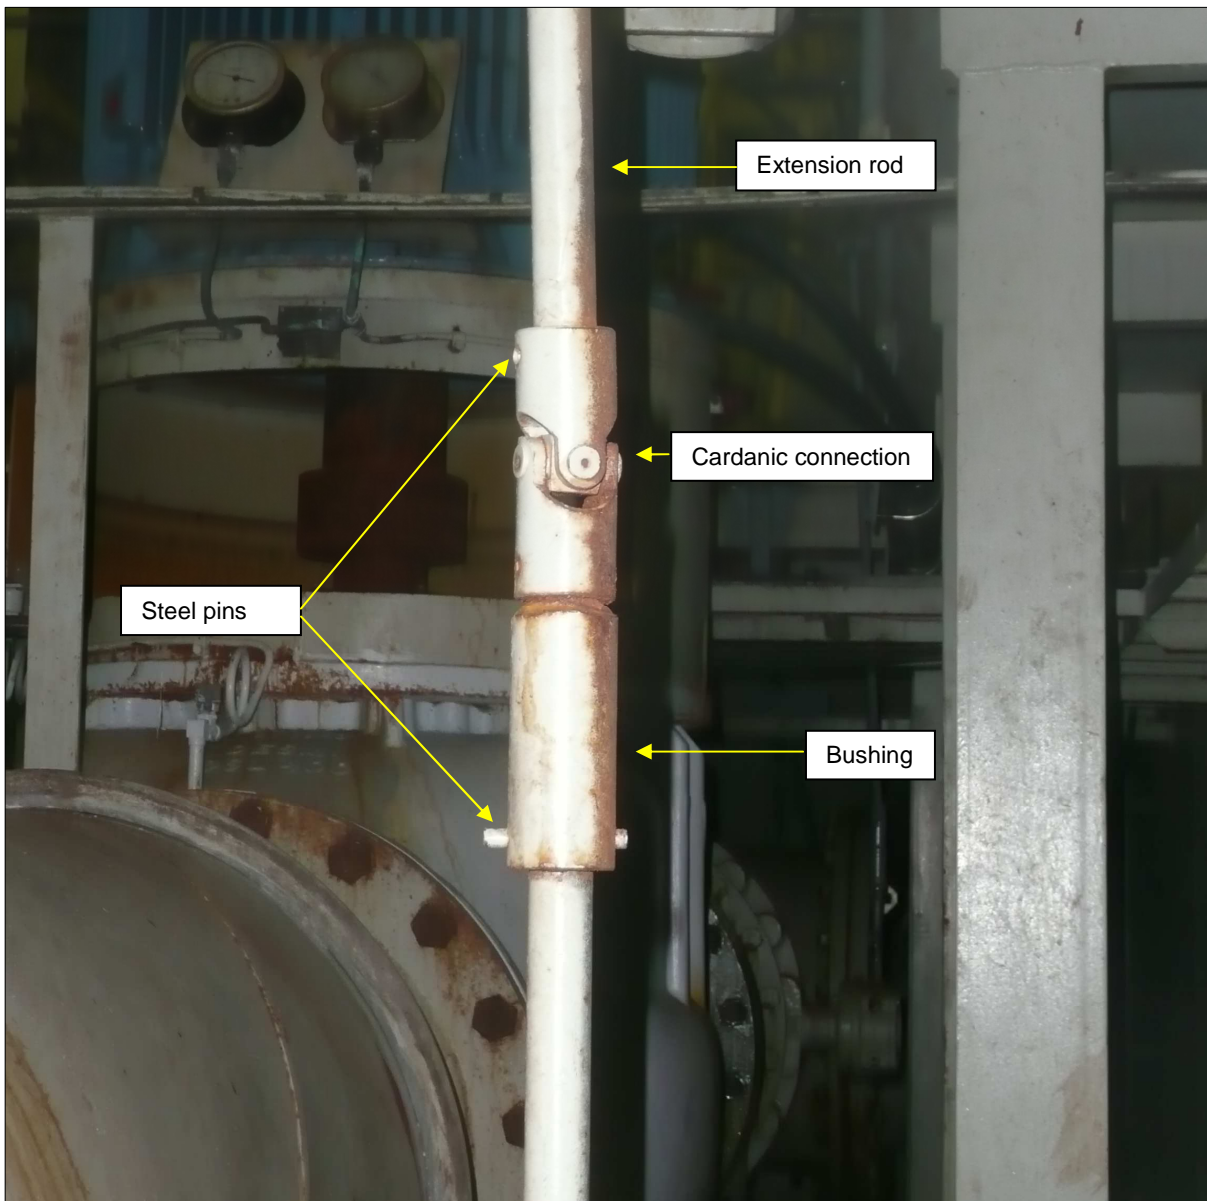
When operating the handwheel, a steel pin broke and the handwheel could not be used. The engineer then crawled under the floor plates and used a wrench to open the valve while standing on the tank top in water to the knees.

Figure 27: Extension rod with a cardanic connection fitted with a bushing and steel pins, in a sister ship and of the same type and principles as in EMMA MÆRSK
Source: DMAIB

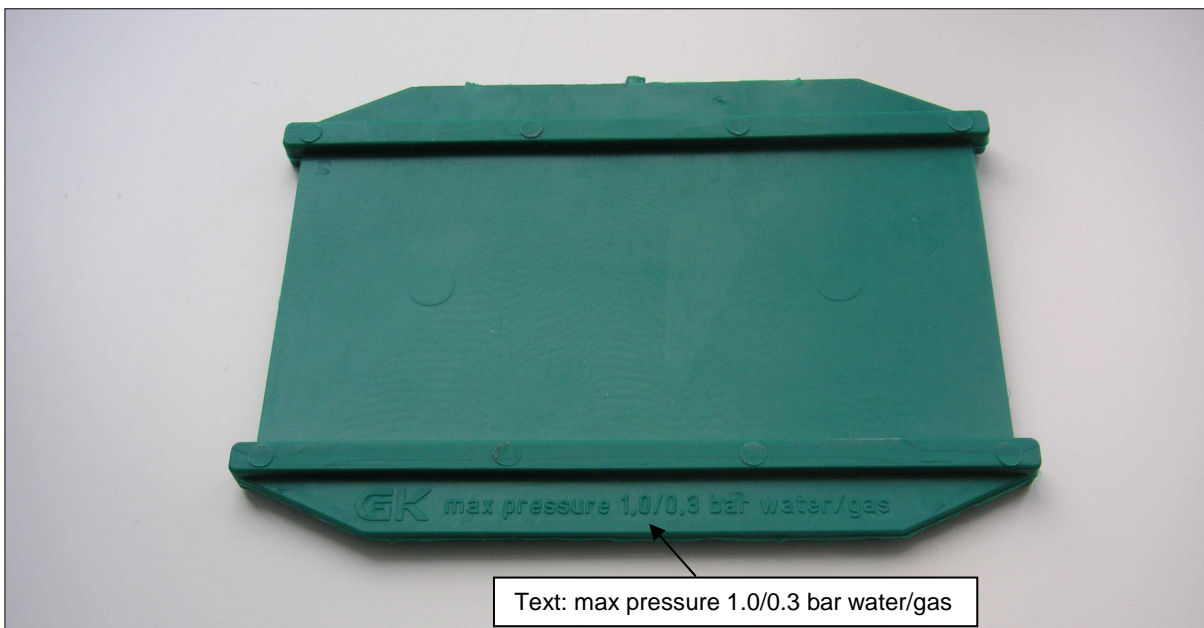
The stay plates are made of plastic material (elastomer), galvanized steel or stainless steel (figures 34 and 36 on page 33). It should be noted that the plastic stay plates mounted in EMMA MÆRSK were not marked with any maximum pressure.

Cable penetrations with plastic stay plates had been approved by class in fire rated class "A" bulkheads and decks in accordance with test results, but had not been approved in watertight bulkheads and decks.

Figure 34: Stay plate of plastic (elastomer) for "GK Packing System"
Source: DMAIB

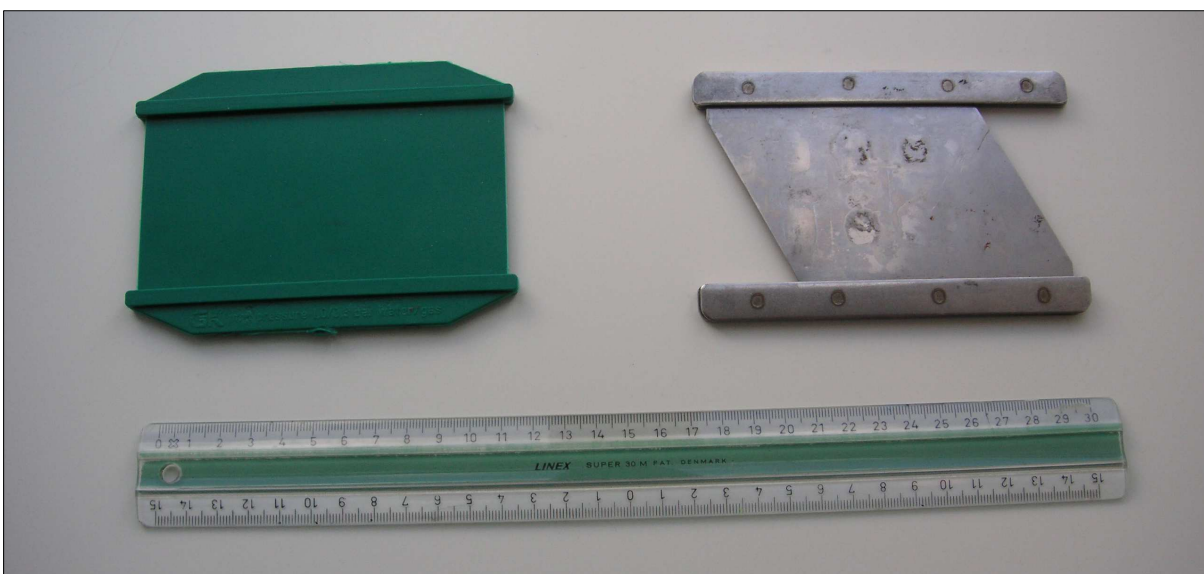
Figure 35: Stay plates of plastic (elastomer) and stainless steel for "GK Packing System"
Source: DMAIB

Cable penetrations were primarily fitted with plastic stay plates instead of stainless steel plates because they were easier to install and were less costly. The four high-voltage cable penetrations located above the propeller shaft in the watertight bulkhead at frame 166 were all fitted with stay plates of plastic. Another cable penetration located in the same bulkhead and below the floor plates was fitted with a stay plate of stainless steel.

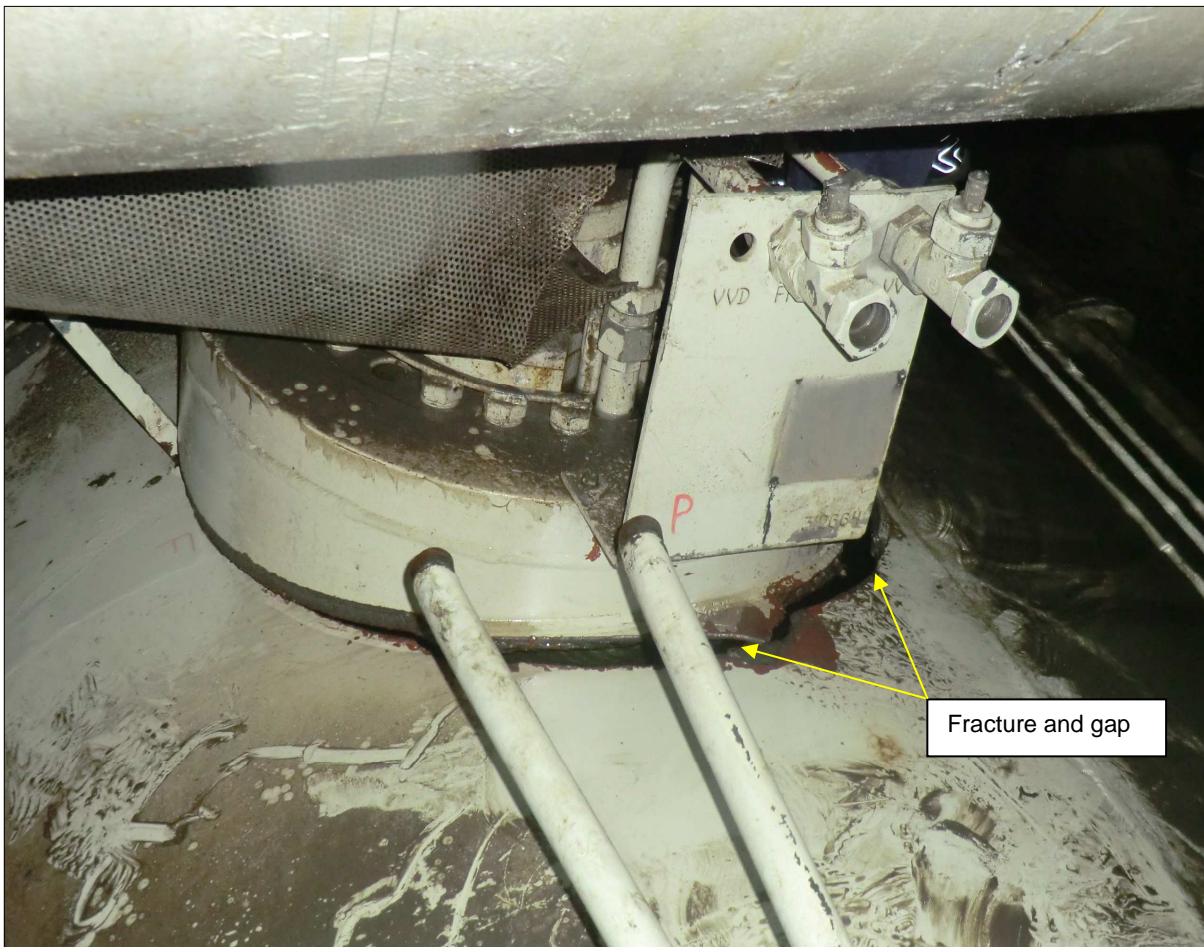
Figure 41: Breakage at the flange neck to the transverse stern thruster tunnel
Source: Maersk Line

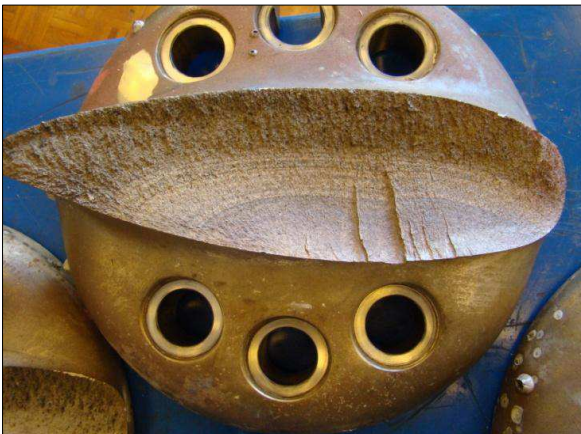
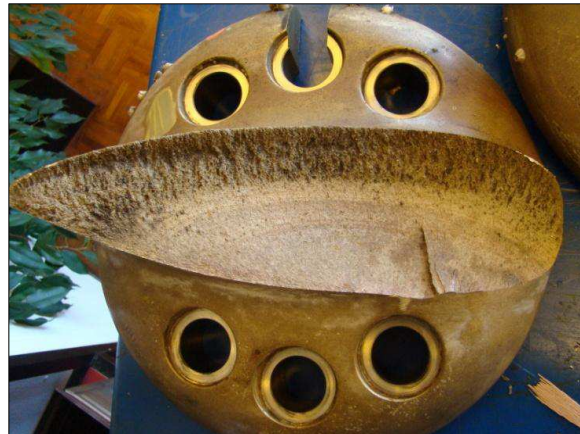
Figures 42 and 43: Fractured surfaces from the forward stern thruster’s blade bases no. 2 and no. 3
Source: FORCE Technology

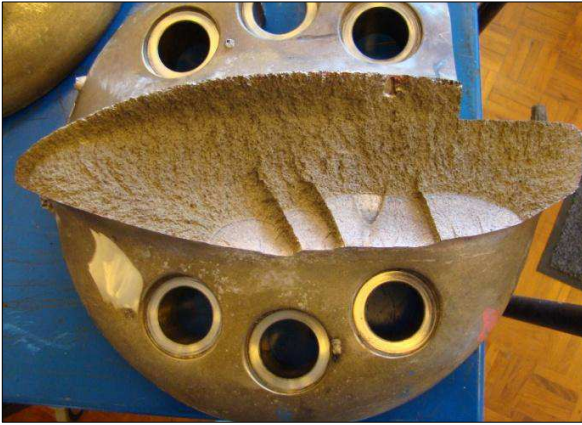
Figure 44: Fractured surface from the forward stern thruster blade base no. 4
Source: FORCE Technology

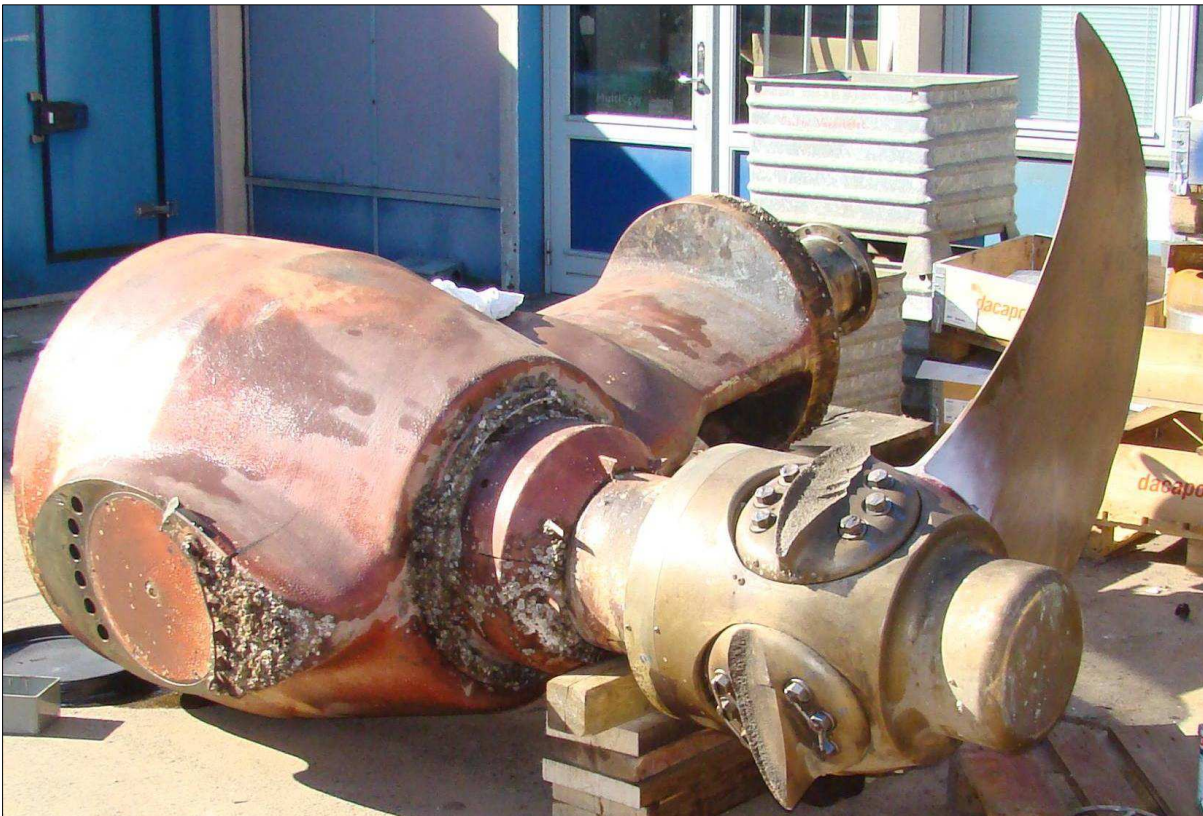
Figure 45: The damaged forward stern thruster before dismantling
Source: FORCE Technology

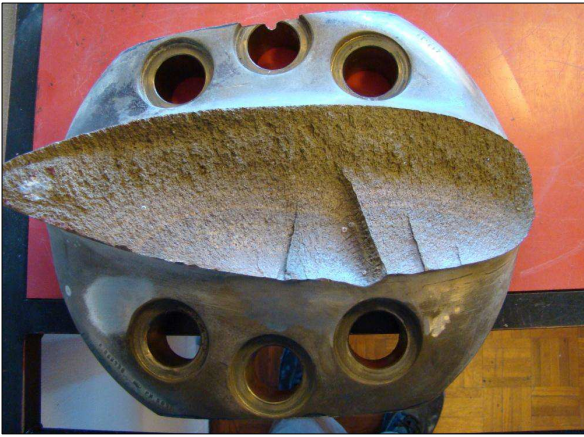
The fractured surface from the base of the broken propeller blade of the aft stern thruster (figure 46 on page 42) had the same pattern of fatigue and had basically the same hardness and chemical composition as those broken off the forward stern thruster. There was no repair welding, and no material defects in crack starts.

Figure 46: Fractured surface from the aft stern thruster blade base that was replaced by a new one in October 2012
