MARINE ACCIDENT REPORT

December 2013

EMMA MÆRSK

Flooding of engine room on 1 February 2013

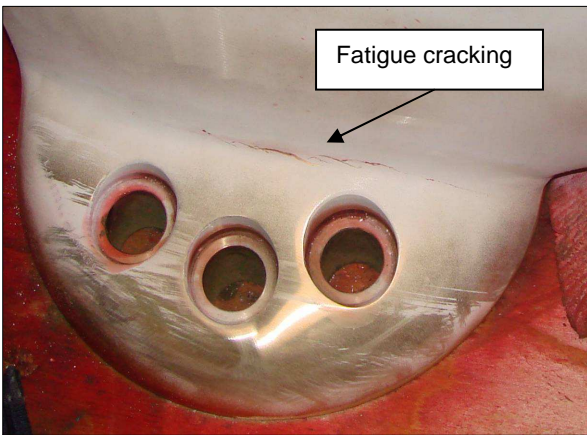
It was found that the three remaining original blades had cracked in way of the transition between the propeller blade and base. All cracks had occurred on the same side, i.e. the side pointing away from the thruster drive. Thus, all eight original propeller blades from the stern thrusters of EMMA MÆRSK had experienced fatigue cracking. All fatigue cracking had the same pattern and appeared at the same area of the propeller blades (figures 47 and 48 below and figure 59 on page 43).

Figure 47: Crack indication on front side of blade 1 on the aft stern thruster

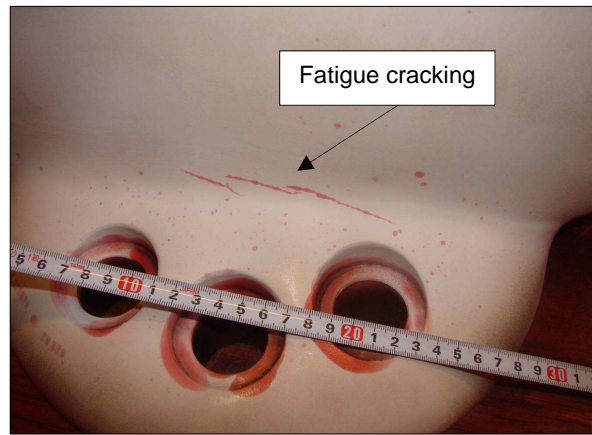
Figure 48: Crack indication on front side of blade 3 on the aft stern thruster

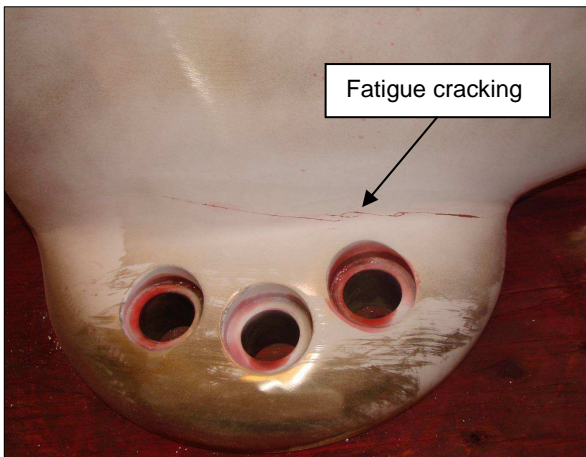
Figure 49: Crack indication on front side of blade 4 on the aft stern thruster
Source: Force Technology

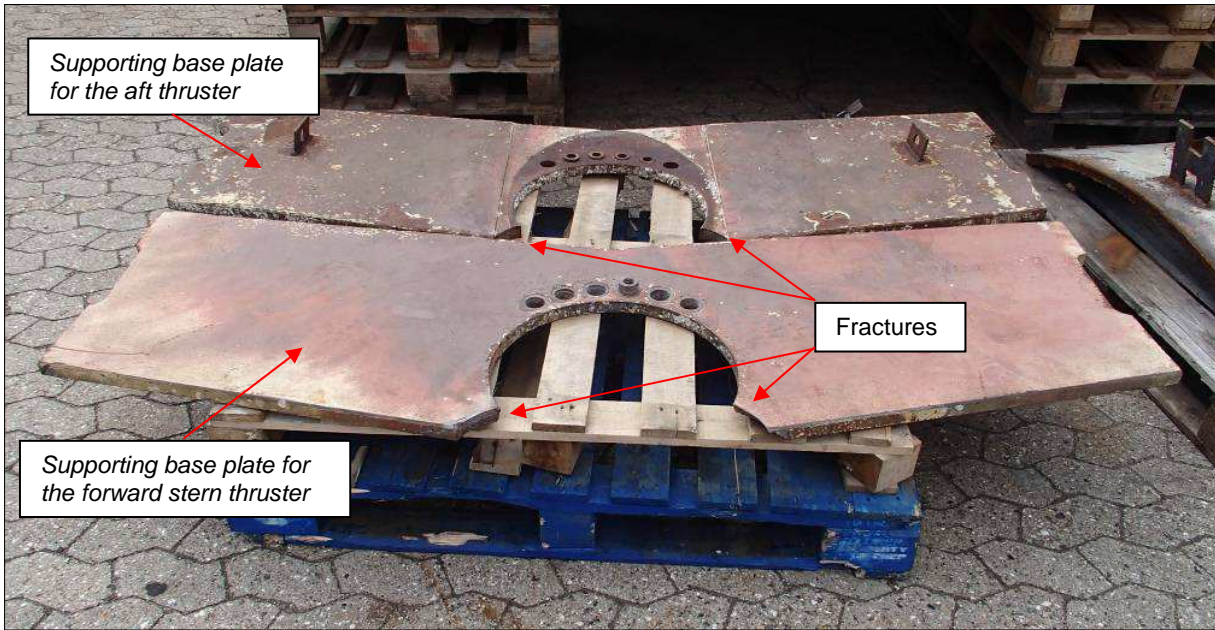
Figure 51: Broken supporting base plates for the forward and the aft stern thruster
Source: Force Technology

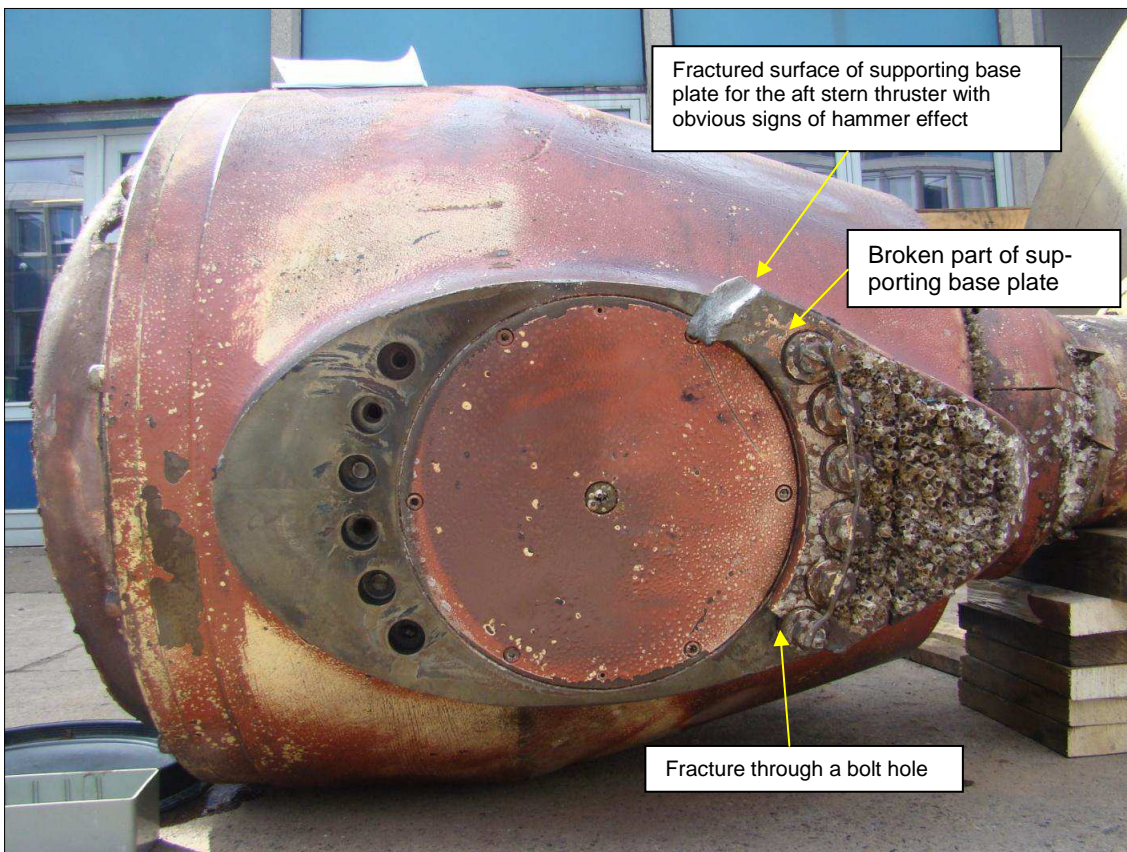
Figure 52: Bottom side of the damaged forward stern thruster with the broken part of the supporting base plate
Source: Maersk Line

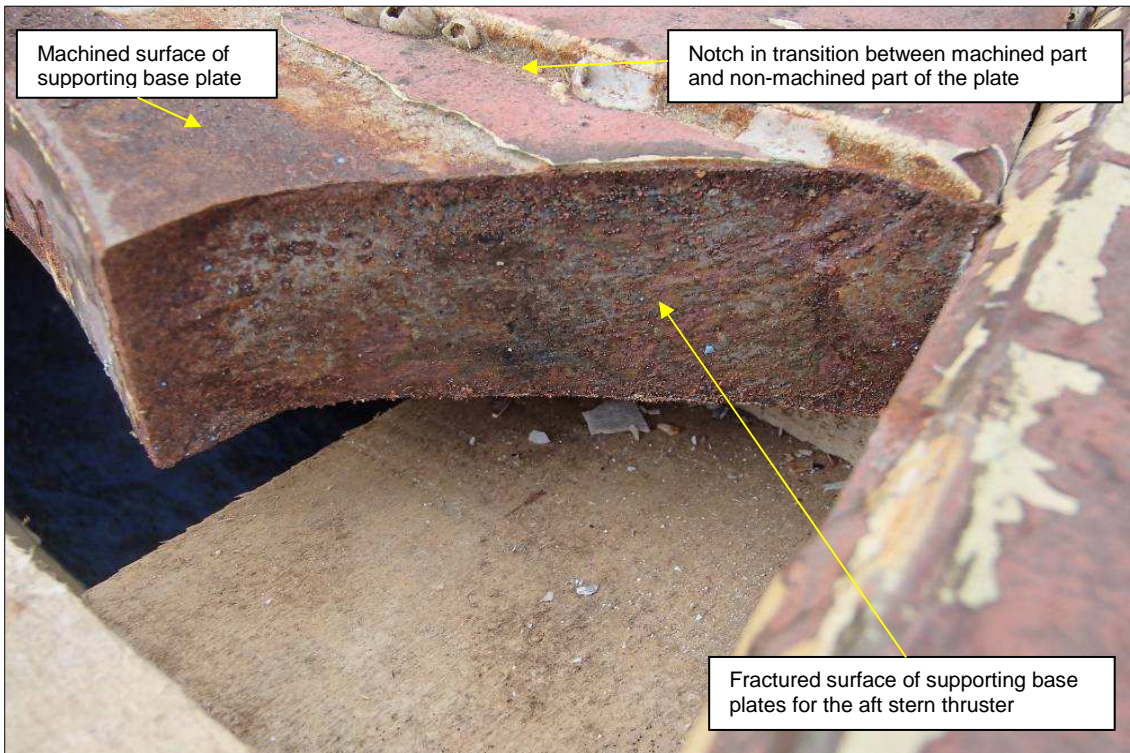
Figure 53: Fracture of supporting base plate for the aft stern thruster
Source: Force Technology

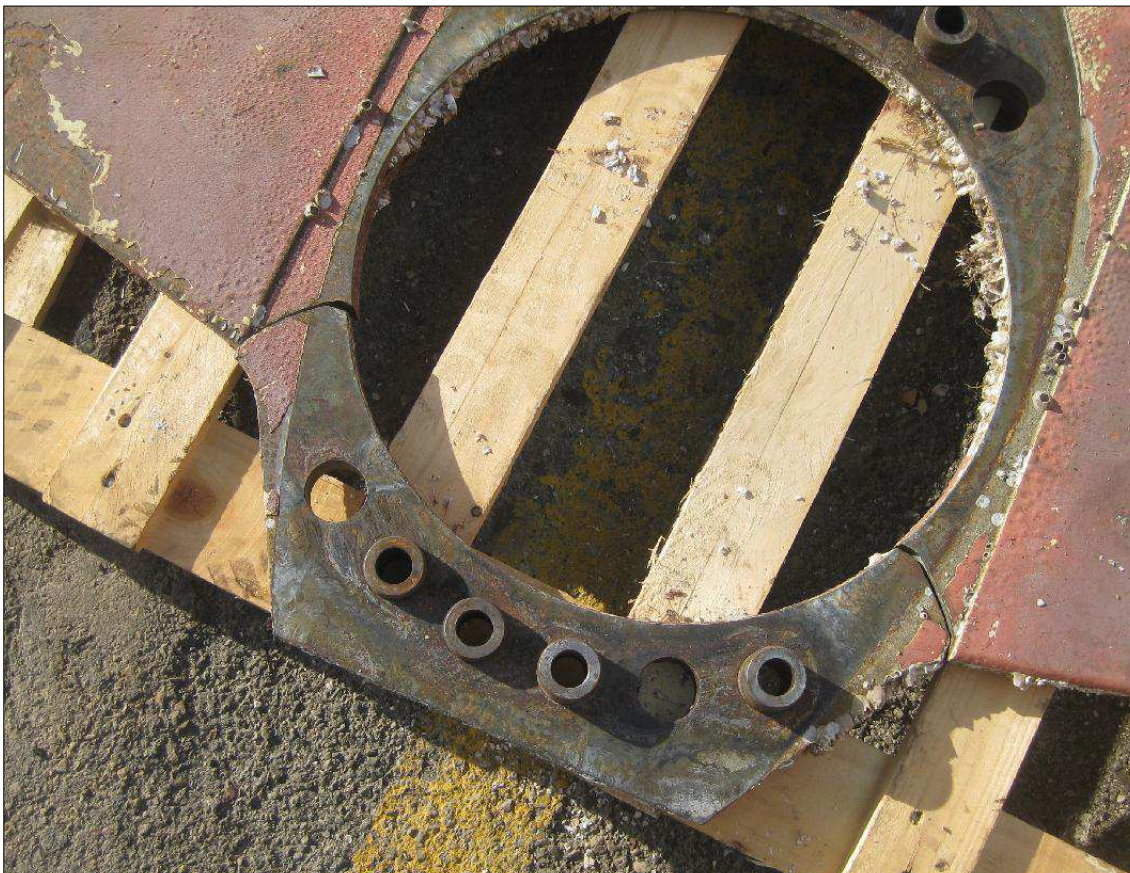
Figure 54: Fracture of supporting base plate for the aft stern thruster
Source: BANDAK Engineering/Rolls Royce Marine

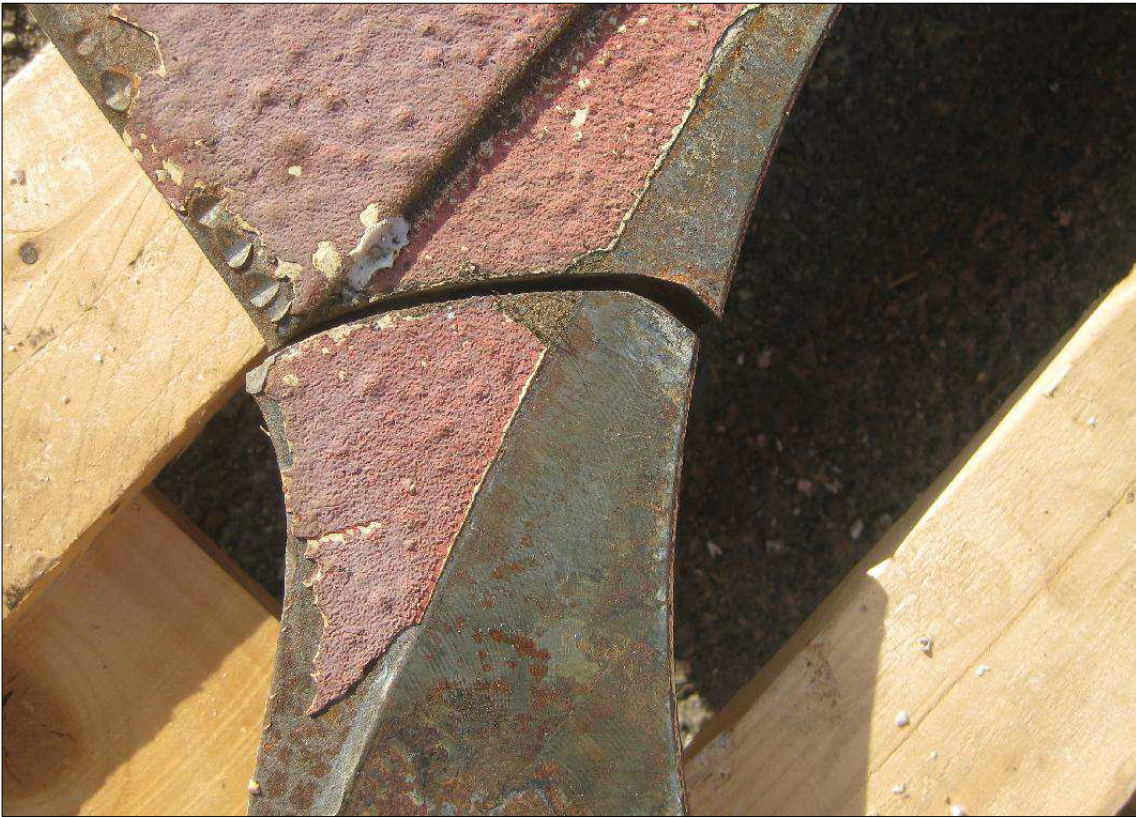
Figure 55: Fracture of supporting base plate for the aft stern thruster
Source: BANDAK Engineering/Rolls Royce Marine
