MARINE ACCIDENT REPORT

December 2013

EMMA MÆRSK

Flooding of engine room on 1 February 2013

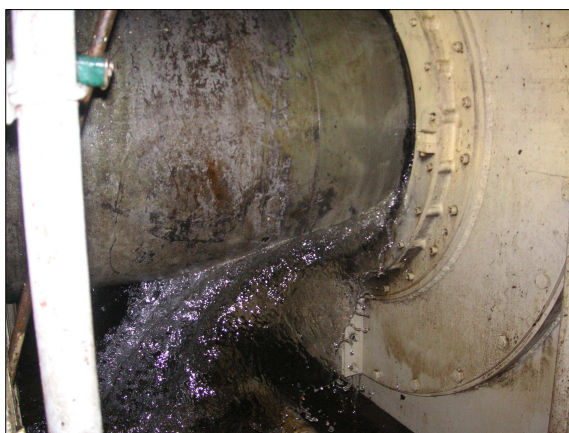
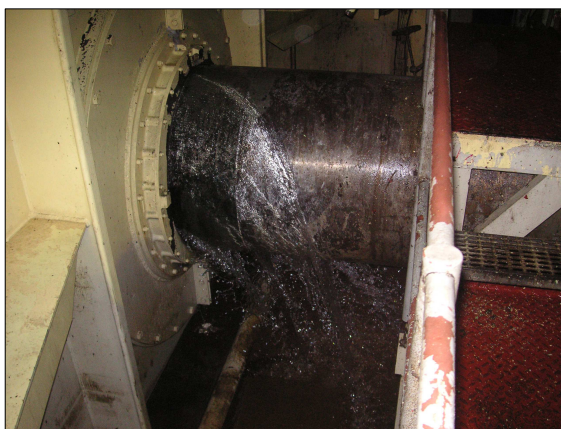
Figures 13 and 14: Ingress of water from the shaft tunnel to the engine room at the propeller shaft sealing when, at the repair yard, water in the engine room is being discharged and the propeller shaft tunnel is still flooded.

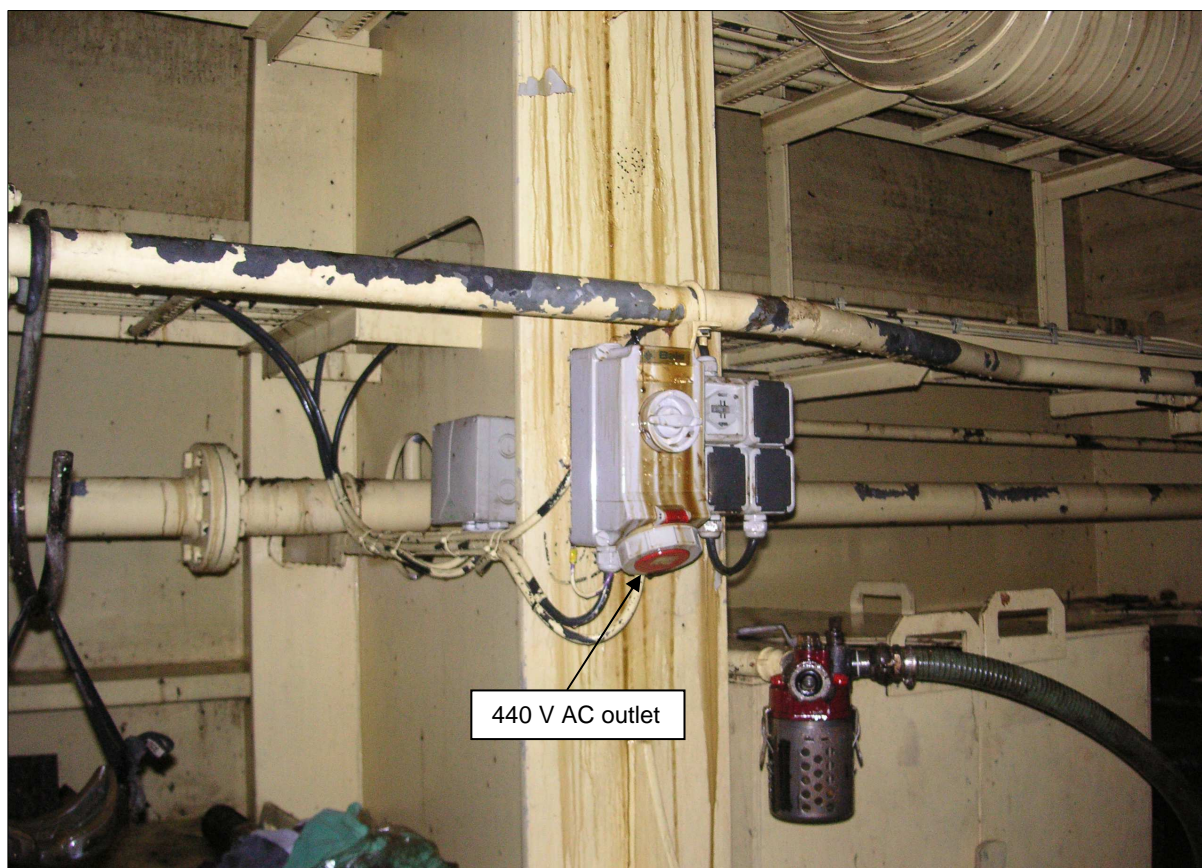
At about 2205 hours, a 3rd engineer, who was standing at the aft part of the main engine watching the situation develop, became aware that water unexpectedly began flowing from a 440 volt AC outlet at the port side of the engine room some five or six metres from the watertight bulkhead (figure 15 below).

Figure 15: 440 volt AC outlet from which seawater began flowing out
Source: DMAIB

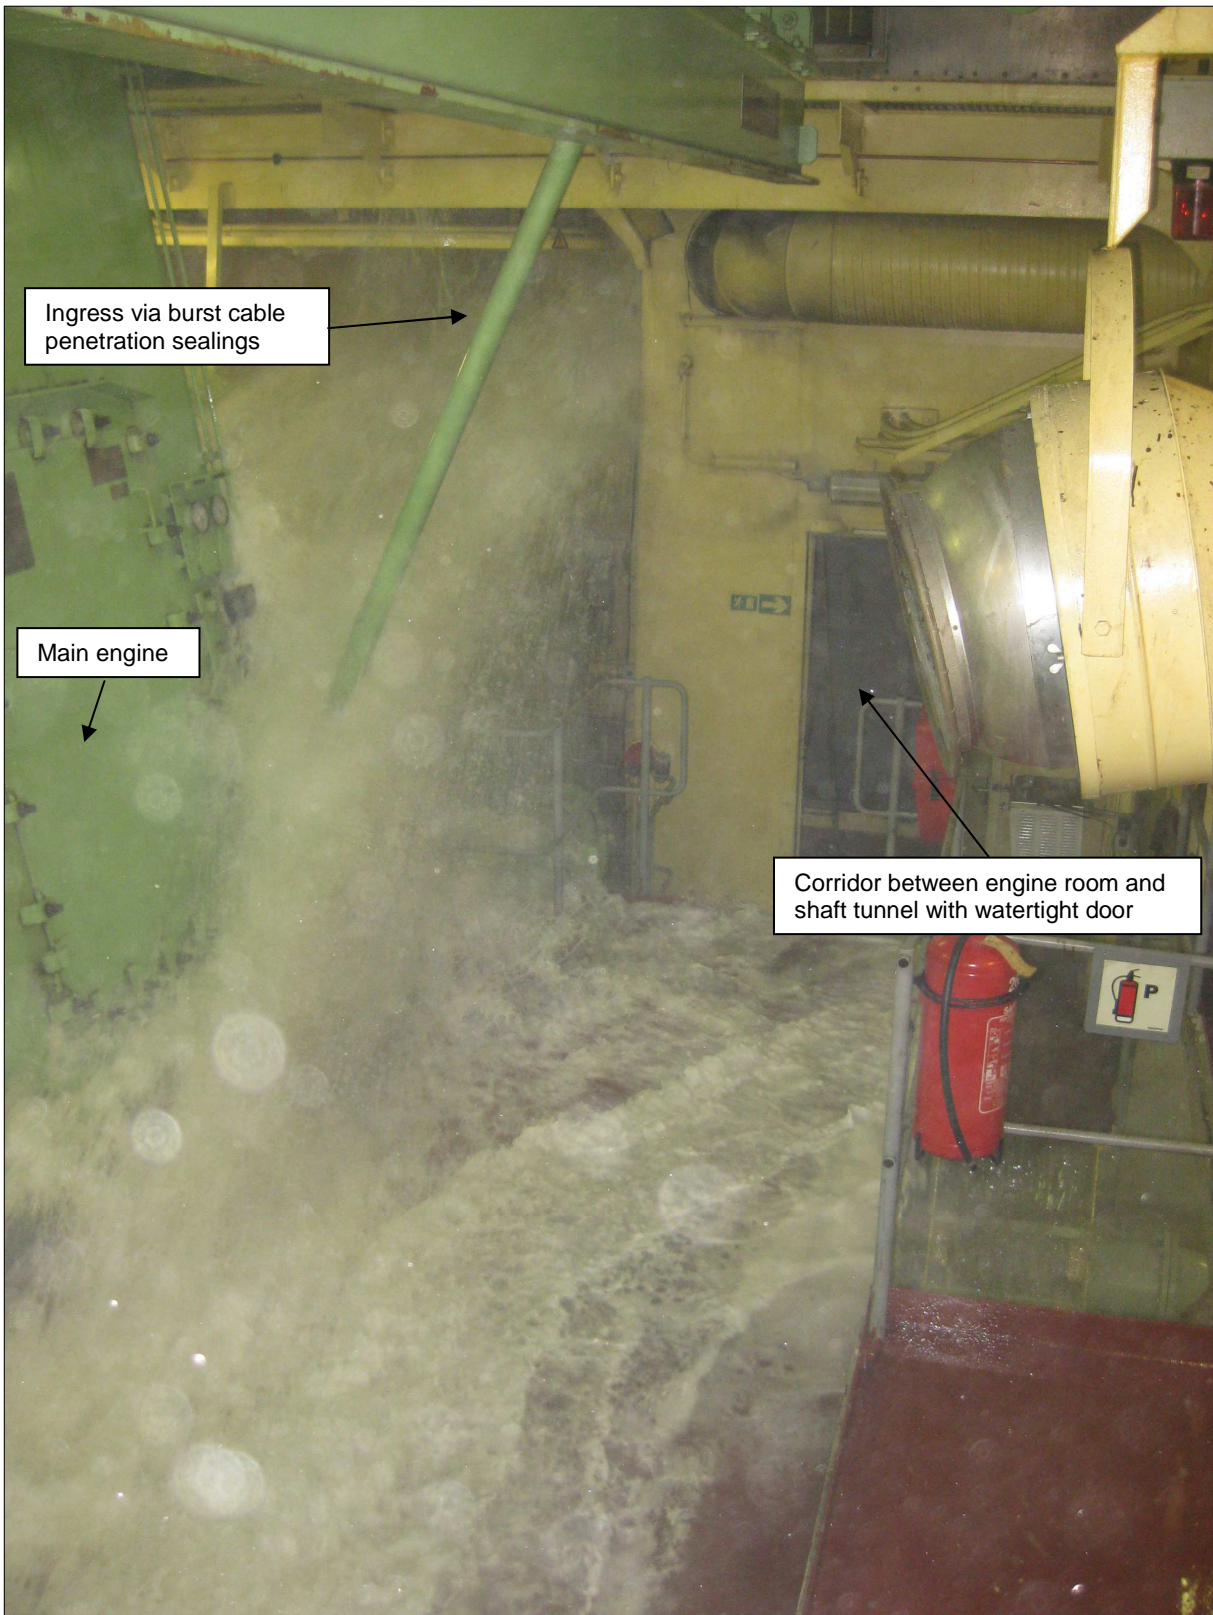
As the 3rd engineer investigated this unexpected scenario, he heard a sudden blast and saw one of four cable penetration sealings in the watertight bulkhead give way to the water pressure followed by a massive ingress of seawater. A few moments later, the other three cable penetration sealings also failed which resulted in an even larger ingress of water into the engine room.

Figure 17: Seawater ingress from propeller shaft tunnel into the main engine room via burst cable penetration sealings in the watertight bulkhead, viewed from the port side of the engine room
Source: Maersk Line

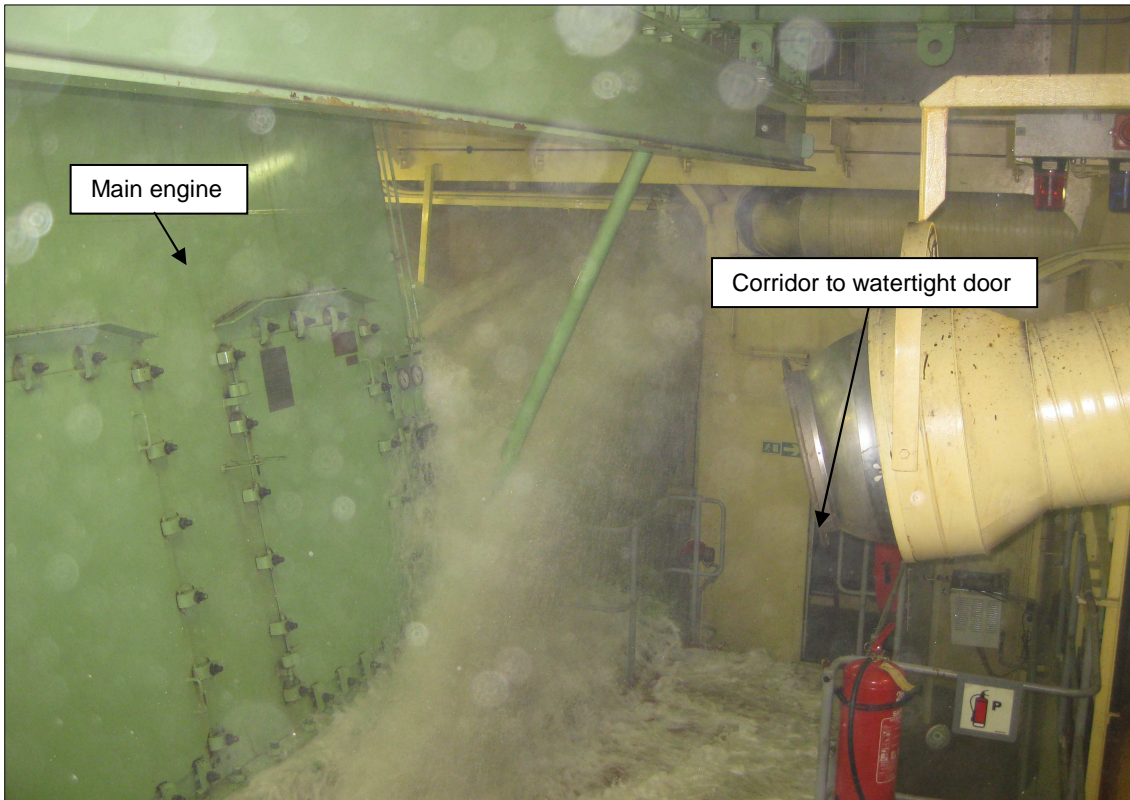
Figure 18: Seawater ingress from propeller shaft tunnel into the main engine room via burst cable penetration sealings in the watertight bulkhead, viewed from the port side of the engine room
 Source: Maersk Line

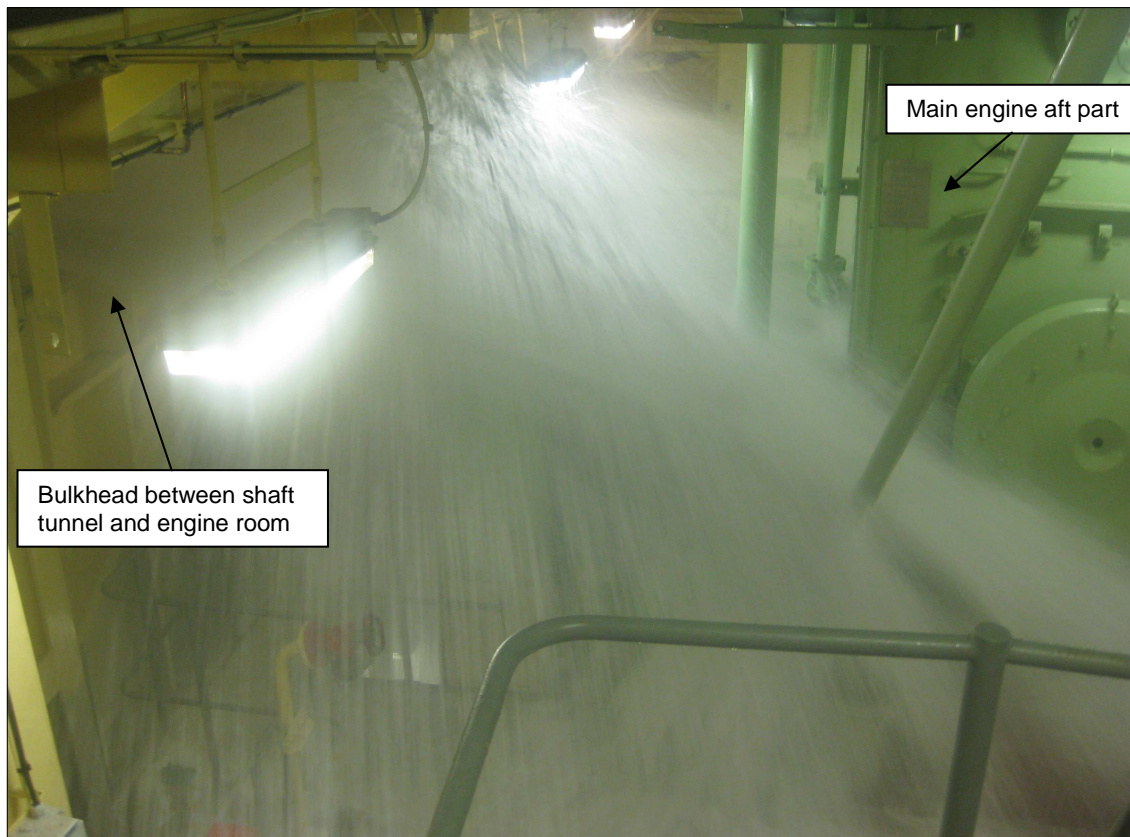
Figure 19: Seawater ingress from propeller shaft tunnel into the main engine room via burst cable penetration sealings in the watertight bulkhead, viewed from the starboard side of the engine room
 Source: Maersk Line

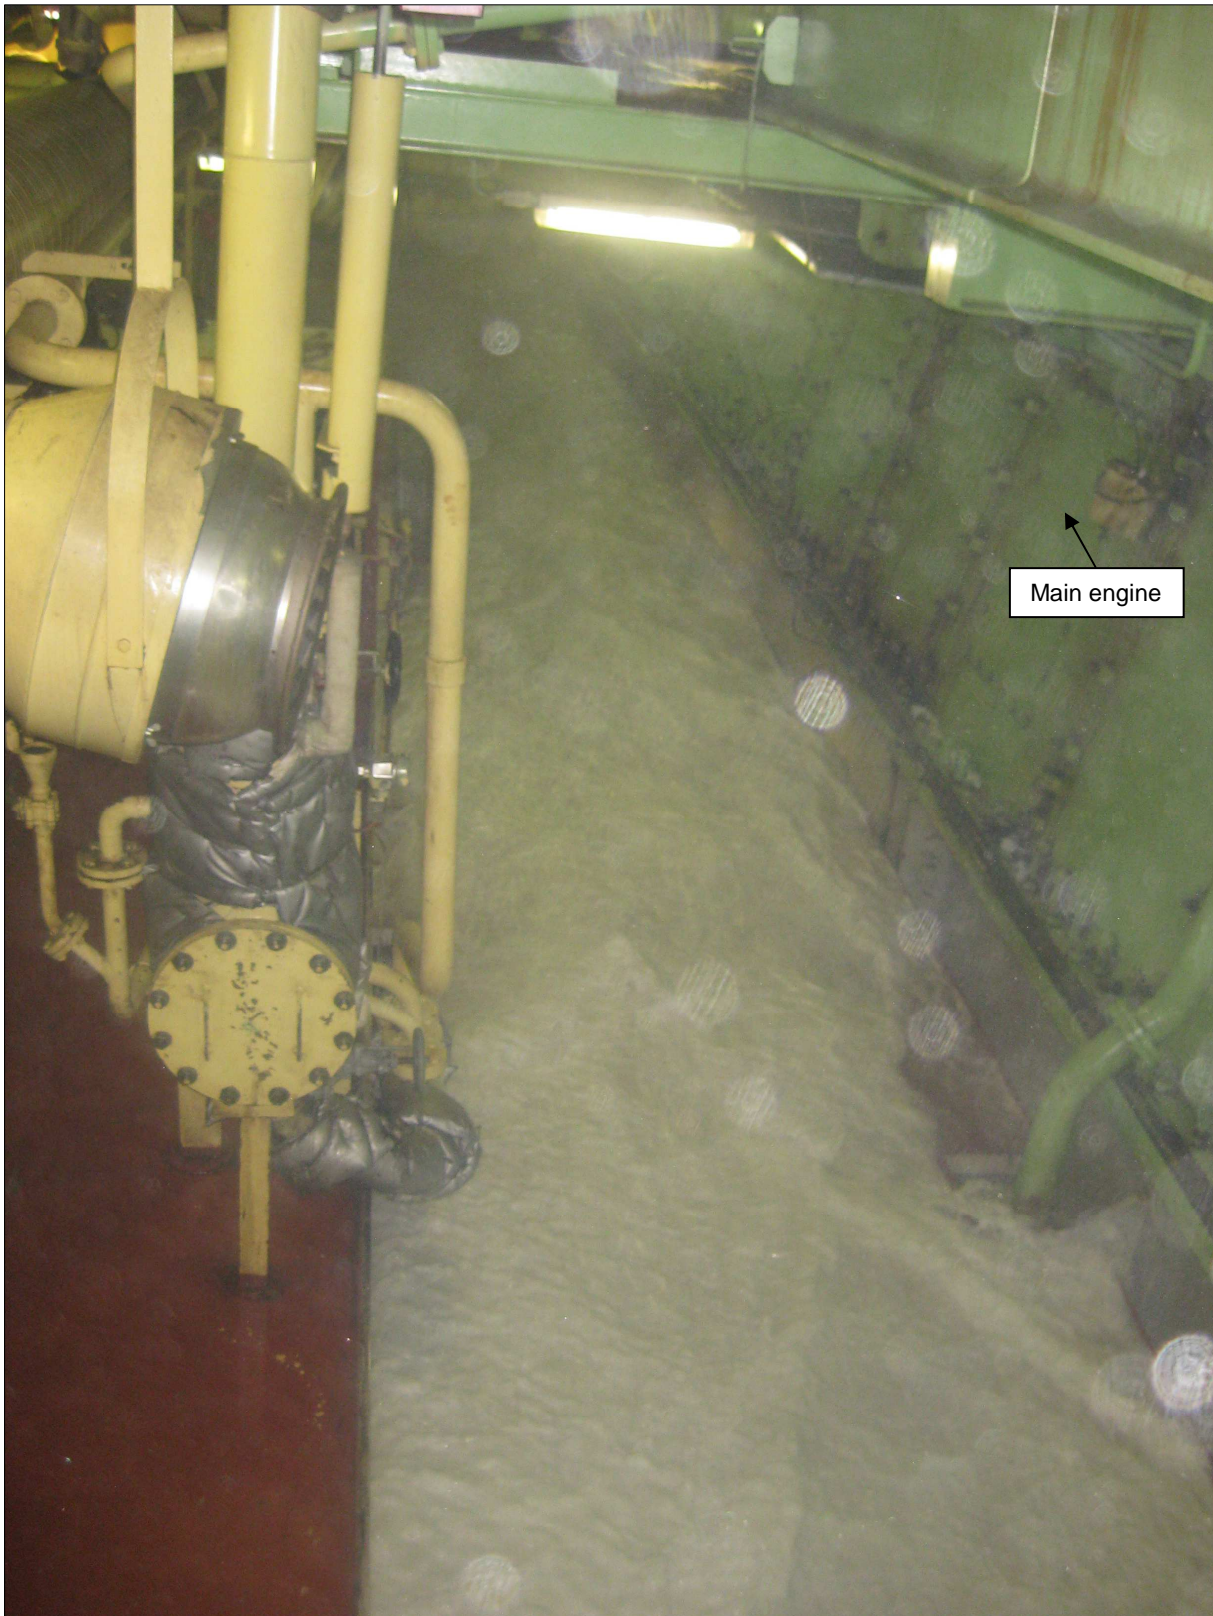
Figure 20: Engine room getting flooded, viewed forward from the aft of the engine room port side
Source: Maersk Line

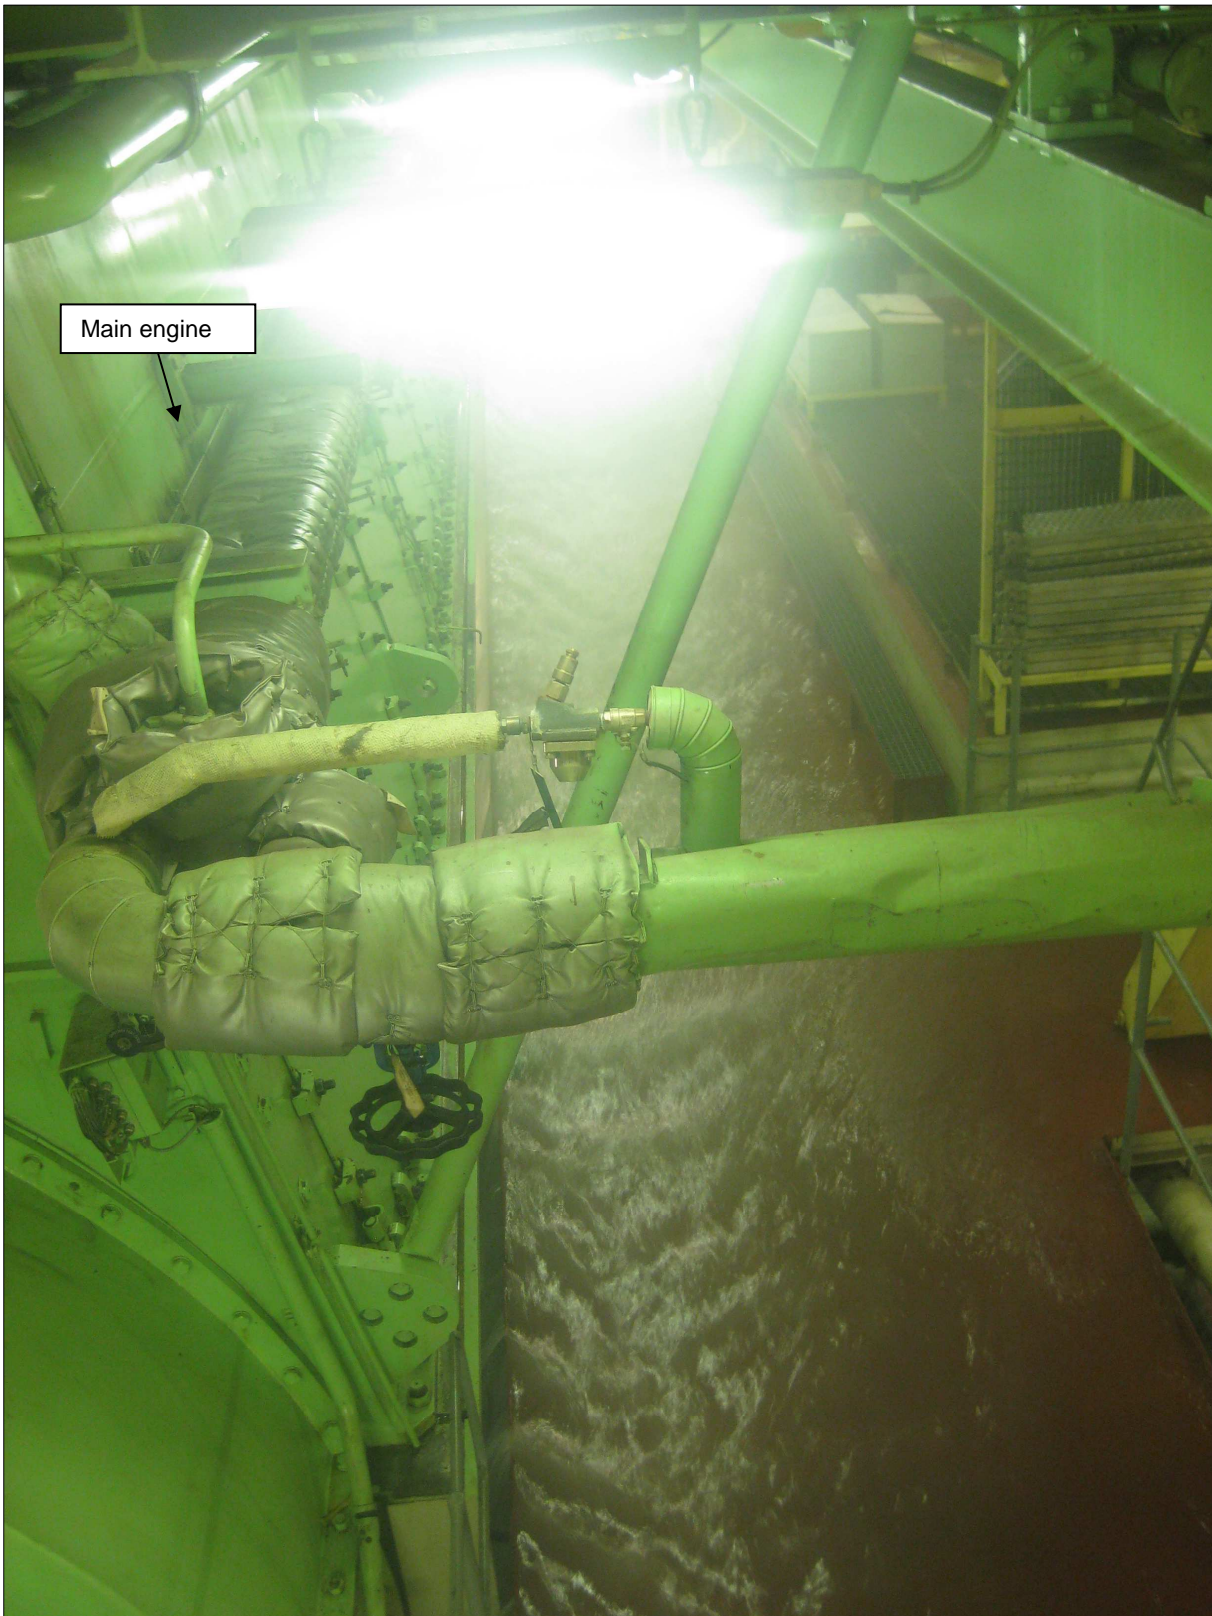
Figure 21: Engine room getting flooded
Source: Maersk Line

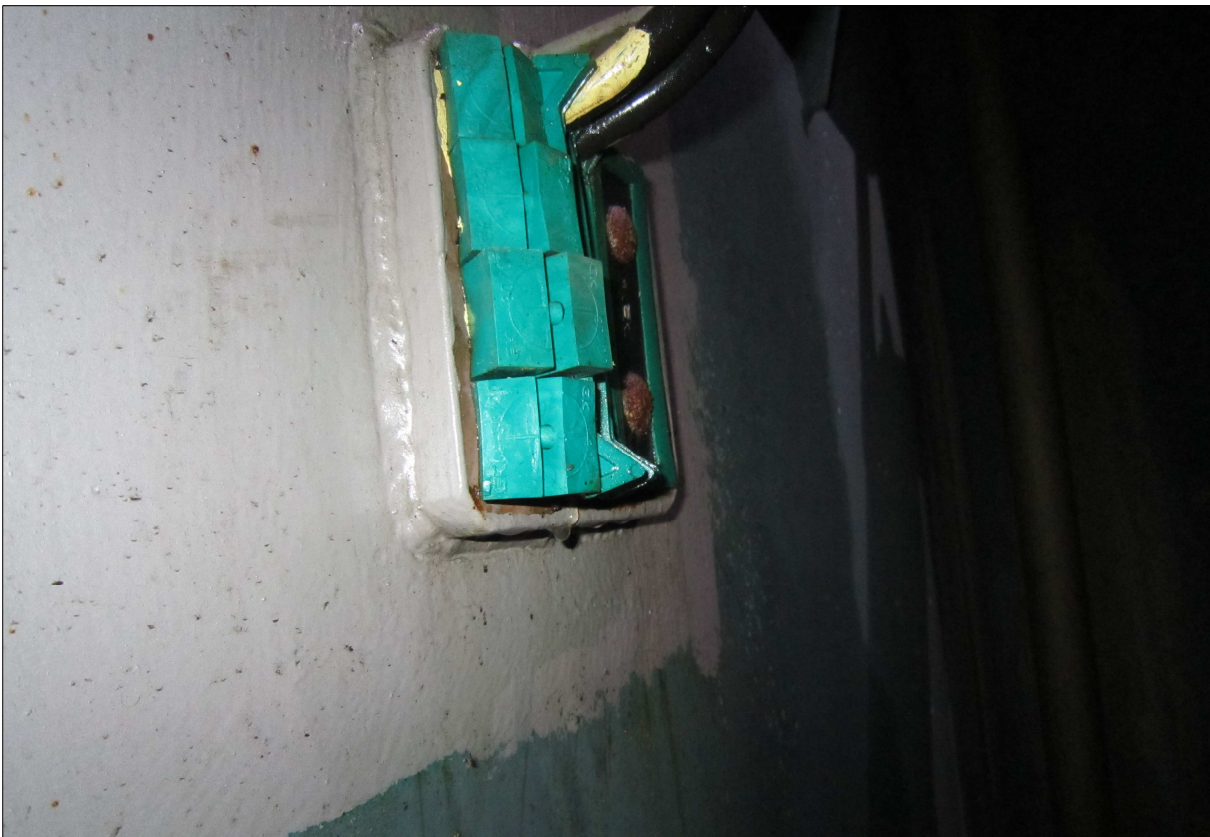
The cable penetration in question was situated in the emergency exit shaft at a height so that the damage waterline corresponded to a hydrostatic pressure of appr. 0.5 bar.

*Figure 24: Cable penetration in bulkhead between emergency exit and cargo hold during collapse
Source: Maersk Line*

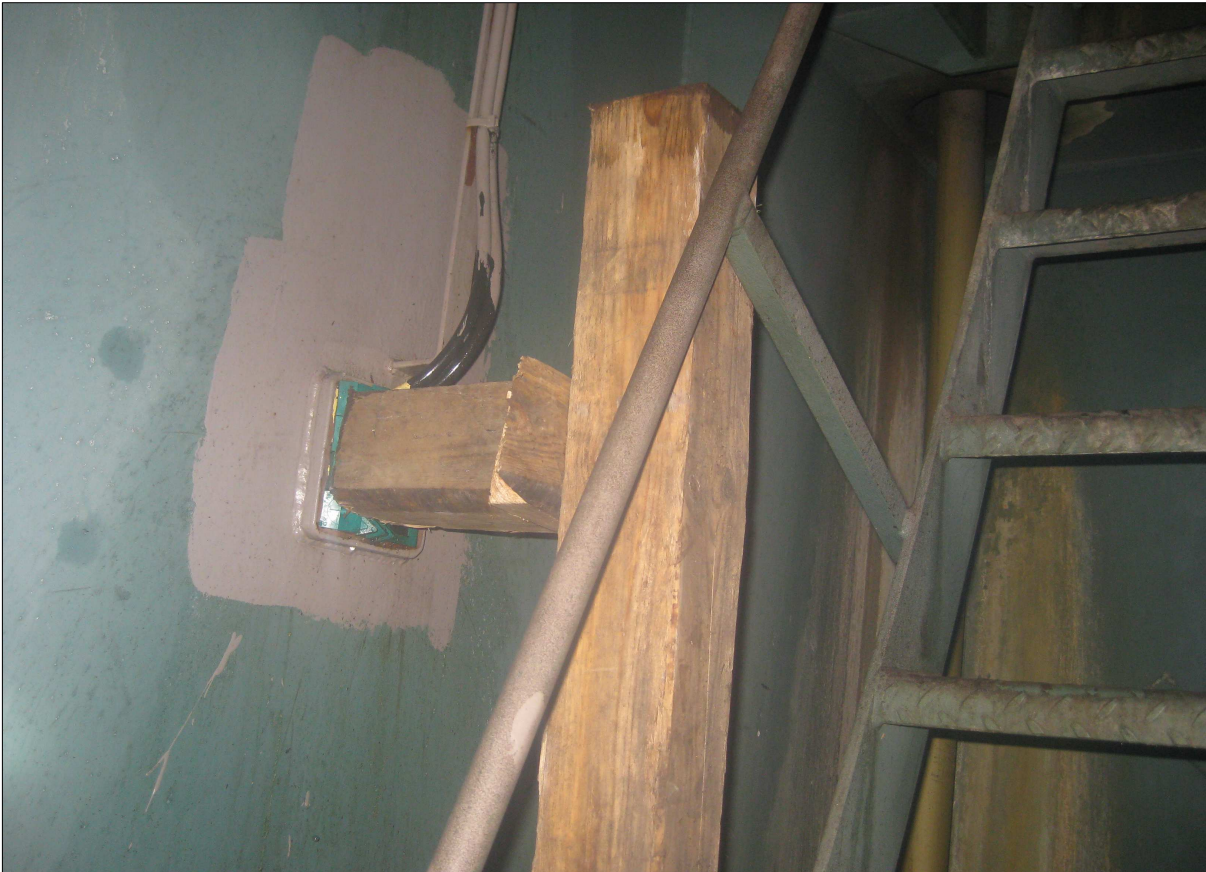
Figure 25: Temporary repair of cable penetration in bulkhead between emergency exit and cargo hold
Source: Maersk Line

During the attempt to get the ship safely into the Suez Canal Container Terminal, appr. 0.35 metres of water was sounded in cargo hold No. 21. It was found that this ingress had occurred through a cable penetration in the transverse bulkhead at frame 53 between the cargo hold and the emergency exit from the aft part of the shaft tunnel (figure 24 below). The collapse of this cable penetration, which at a later investigation was found to have been improperly installed or re-installed and consequently presented a risk of flooding the cargo hold, was soon countered by the crew by putting a wooden bar jammed with wedges (figure 25 on page 25).

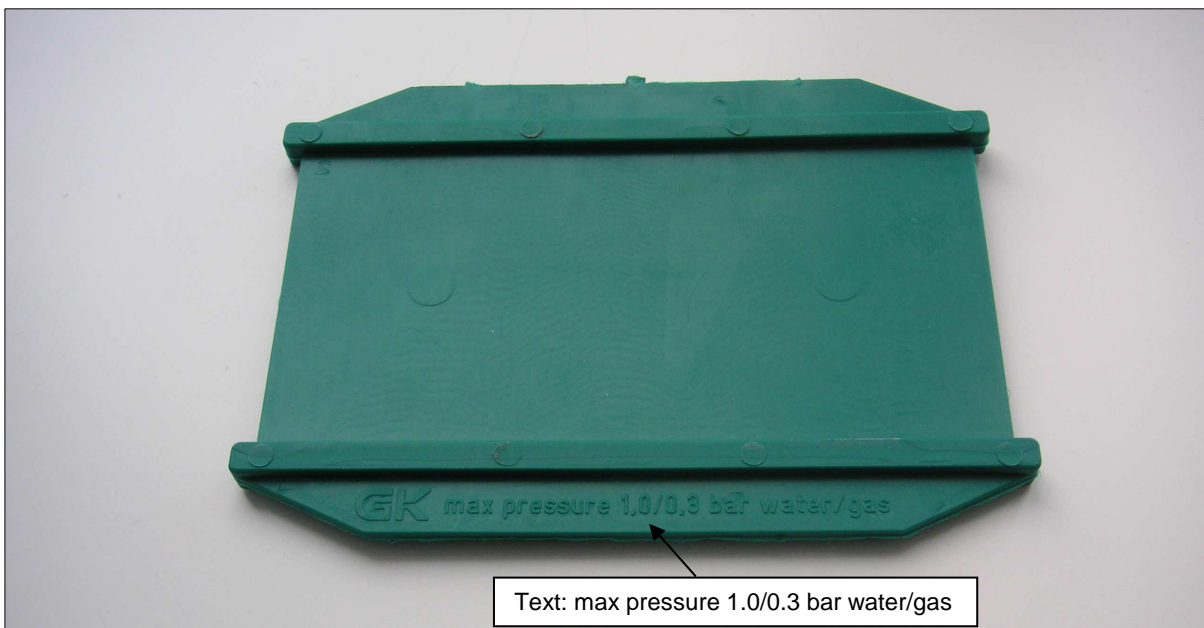
The stay plates are made of plastic material (elastomer), galvanized steel or stainless steel (figures 34 and 36 on page 33). It should be noted that the plastic stay plates mounted in EMMA MÆRSK were not marked with any maximum pressure.

Cable penetrations with plastic stay plates had been approved by class in fire rated class "A" bulkheads and decks in accordance with test results, but had not been approved in watertight bulkheads and decks.

Figure 34: Stay plate of plastic (elastomer) for "GK Packing System"
Source: DMAIB

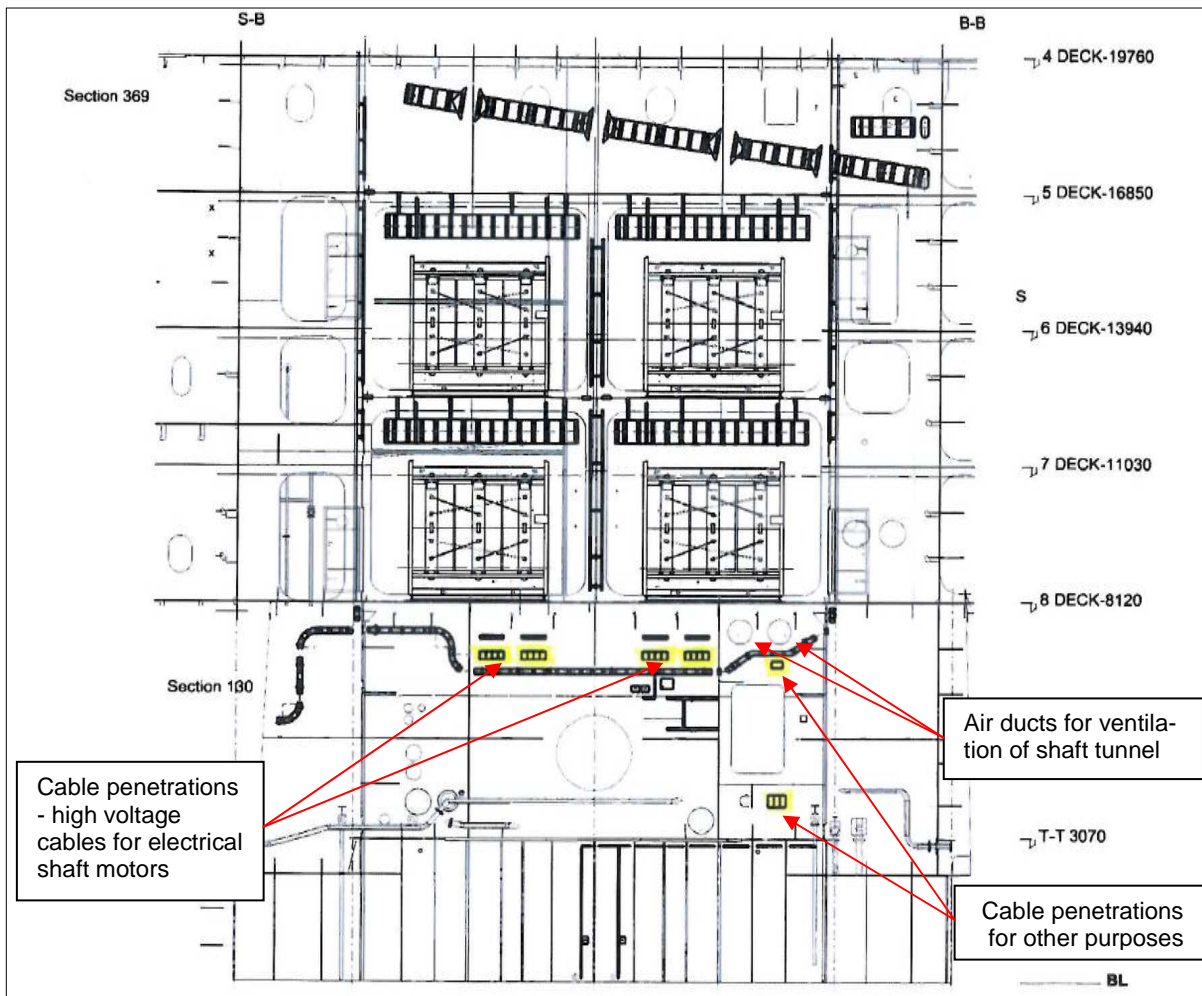
When the four high voltage cable penetration sealings collapsed, the ship’s draught was about 16 metres. The high voltage cable penetrations in the watertight bulkhead were situated about seven metres above the ship’s basis line. Thus, the cable penetrations collapsed at a hydrostatic water pressure corresponding to the maximum water column of appr. nine metres equal to appr. 0.9 bar.

Figure 36: Detail of watertight bulkhead at frame No. 166 transverse section viewed from forward
Source: The ship’s damage stability booklet

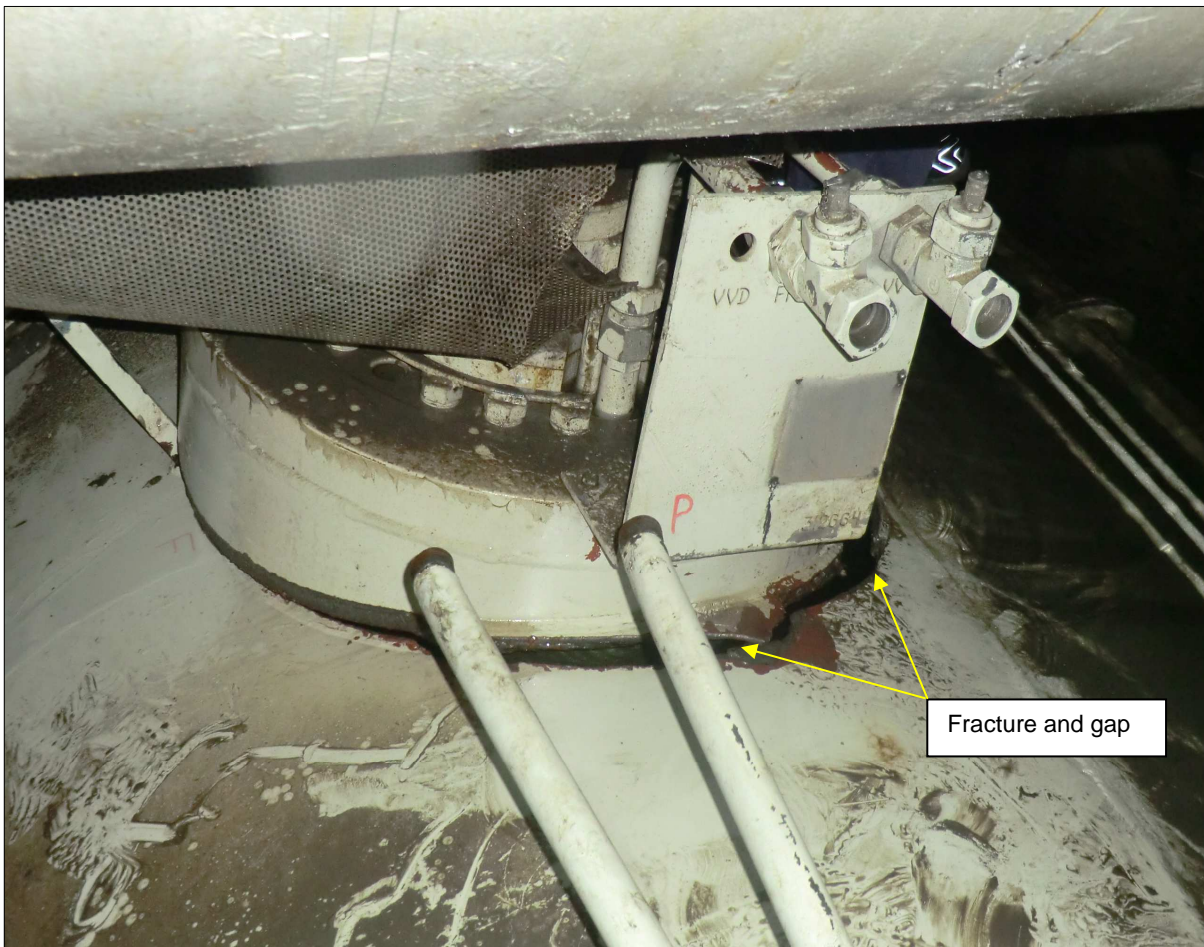
Figure 41: Breakage at the flange neck to the transverse stern thruster tunnel
Source: Maersk Line

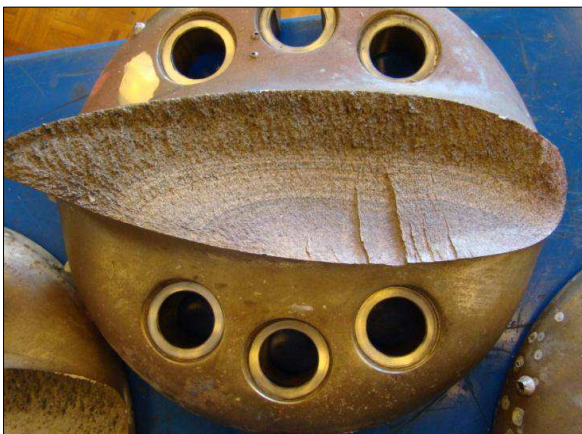
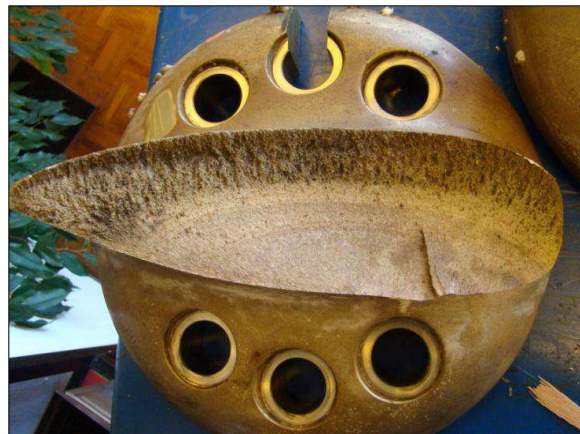
Figures 42 and 43: Fractured surfaces from the forward stern thruster’s blade bases no. 2 and no. 3
Source: FORCE Technology

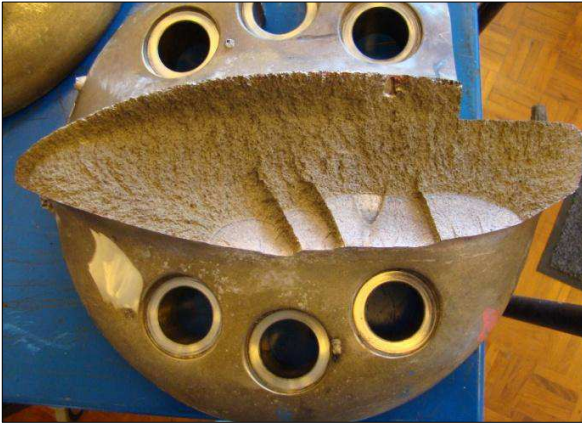
Figure 44: Fractured surface from the forward stern thruster blade base no. 4
Source: FORCE Technology

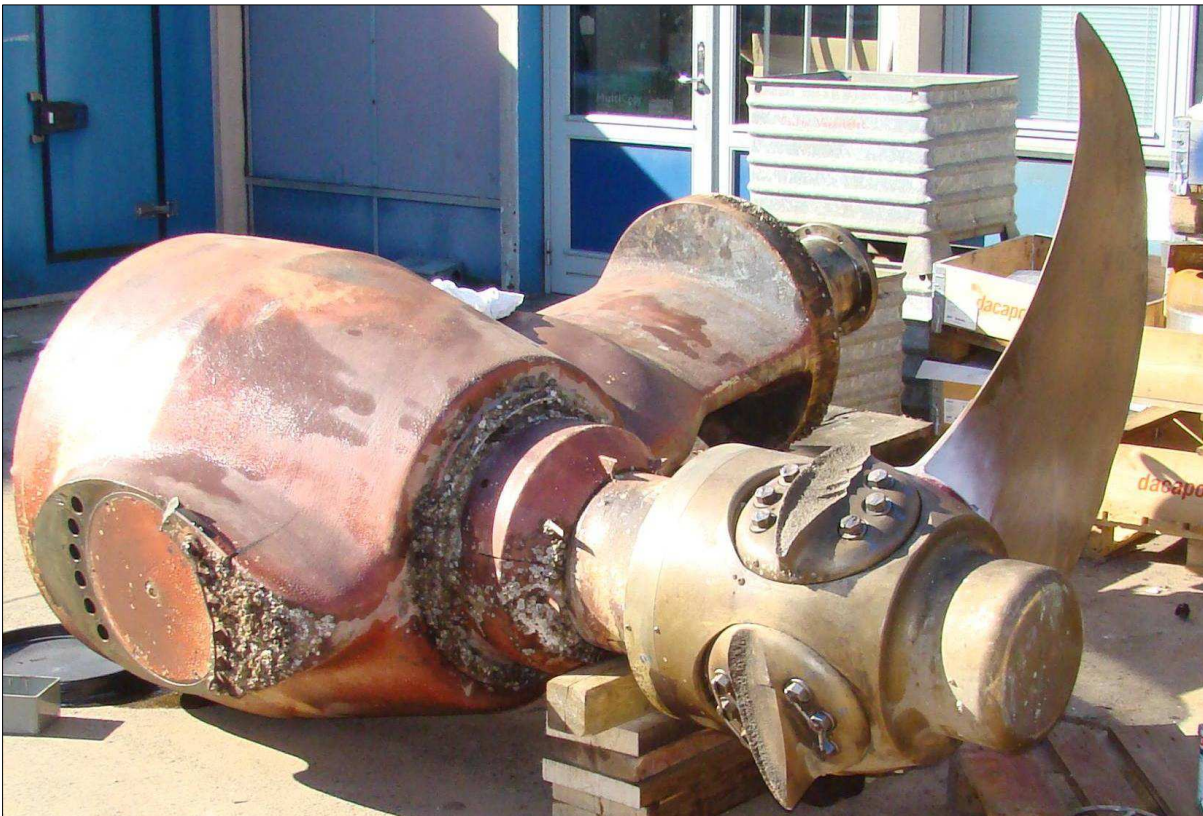
Figure 45: The damaged forward stern thruster before dismantling
Source: FORCE Technology

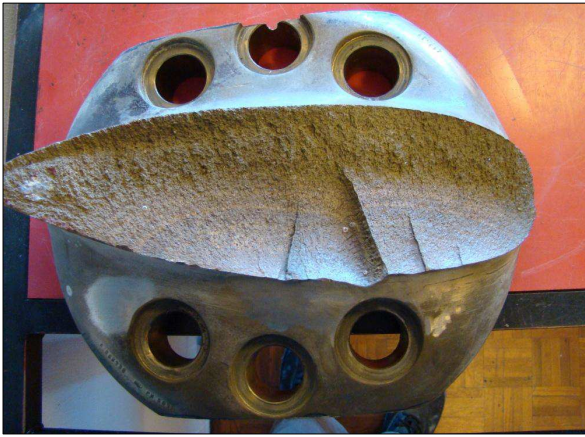
The fractured surface from the base of the broken propeller blade of the aft stern thruster (figure 46 on page 42) had the same pattern of fatigue and had basically the same hardness and chemical composition as those broken off the forward stern thruster. There was no repair welding, and no material defects in crack starts.

Figure 46: Fractured surface from the aft stern thruster blade base that was replaced by a new one in October 2012

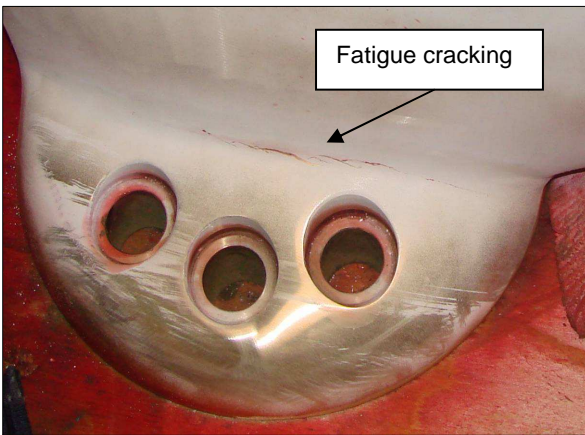
It was found that the three remaining original blades had cracked in way of the transition between the propeller blade and base. All cracks had occurred on the same side, i.e. the side pointing away from the thruster drive. Thus, all eight original propeller blades from the stern thrusters of EMMA MÆRSK had experienced fatigue cracking. All fatigue cracking had the same pattern and appeared at the same area of the propeller blades (figures 47 and 48 below and figure 59 on page 43).

Figure 47: Crack indication on front side of blade 1 on the aft stern thruster

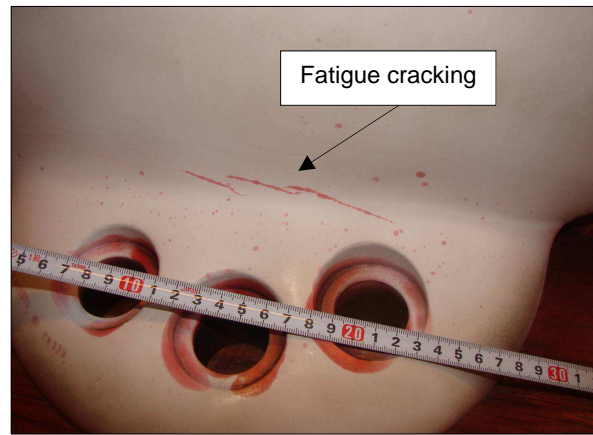
Figure 48: Crack indication on front side of blade 3 on the aft stern thruster

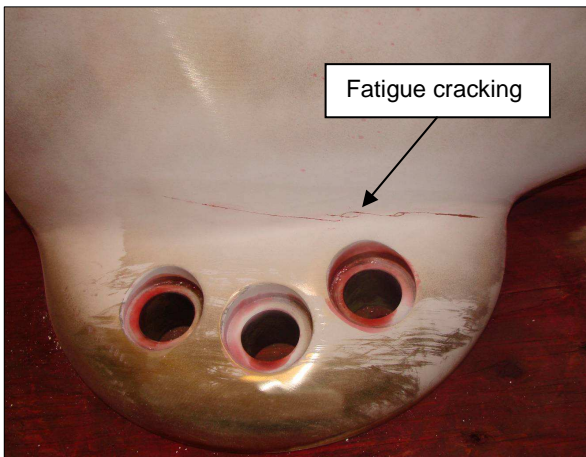
Figure 49: Crack indication on front side of blade 4 on the aft stern thruster
Source: Force Technology

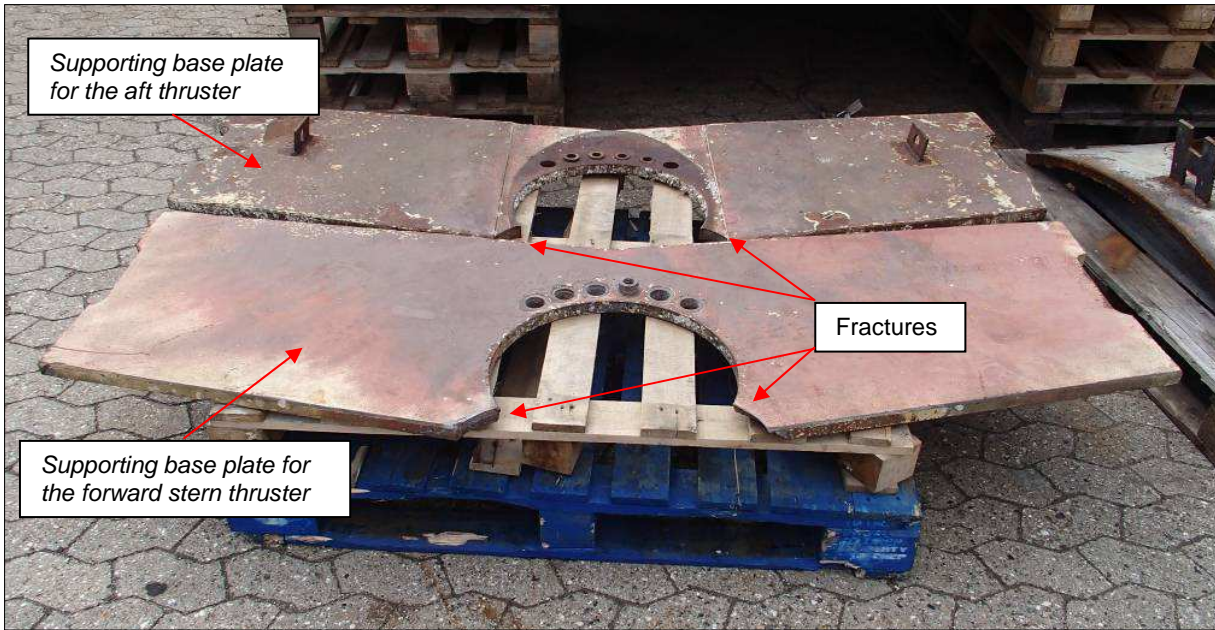
Figure 51: Broken supporting base plates for the forward and the aft stern thruster
 Source: Force Technology

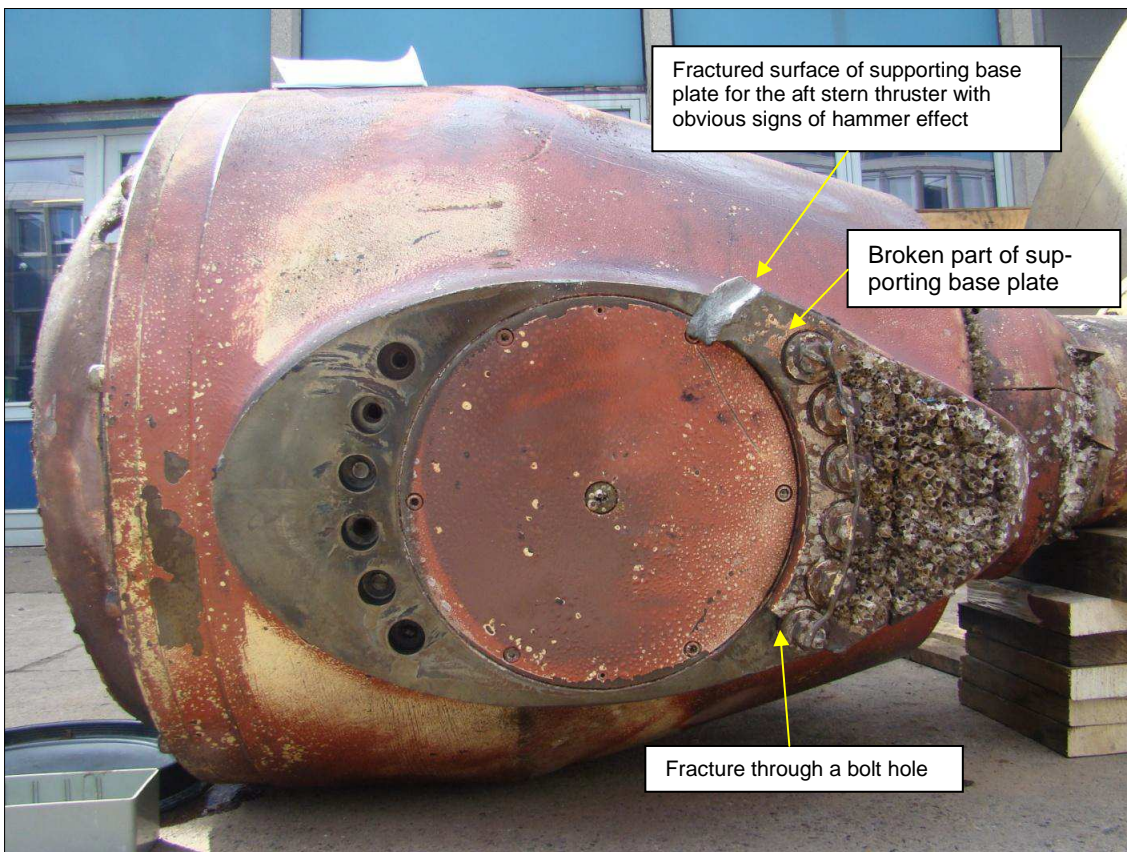
Figure 52: Bottom side of the damaged forward stern thruster with the broken part of the supporting base plate
 Source: Maersk Line

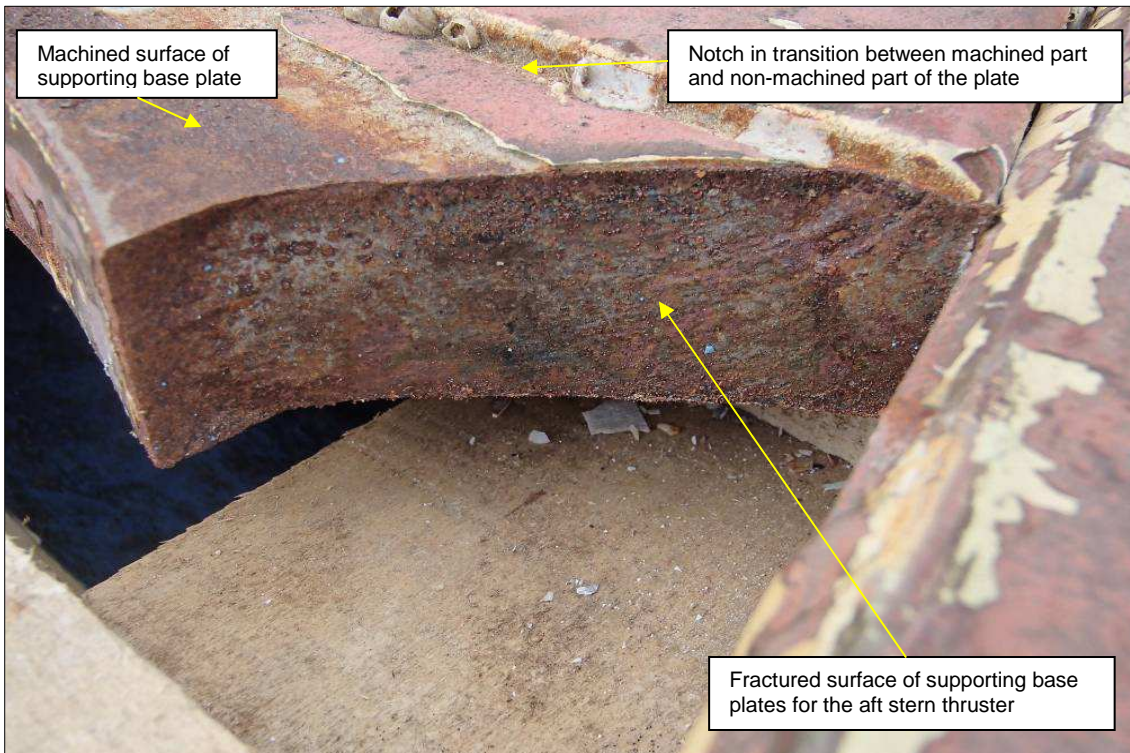
Figure 53: Fracture of supporting base plate for the aft stern thruster
 Source: Force Technology

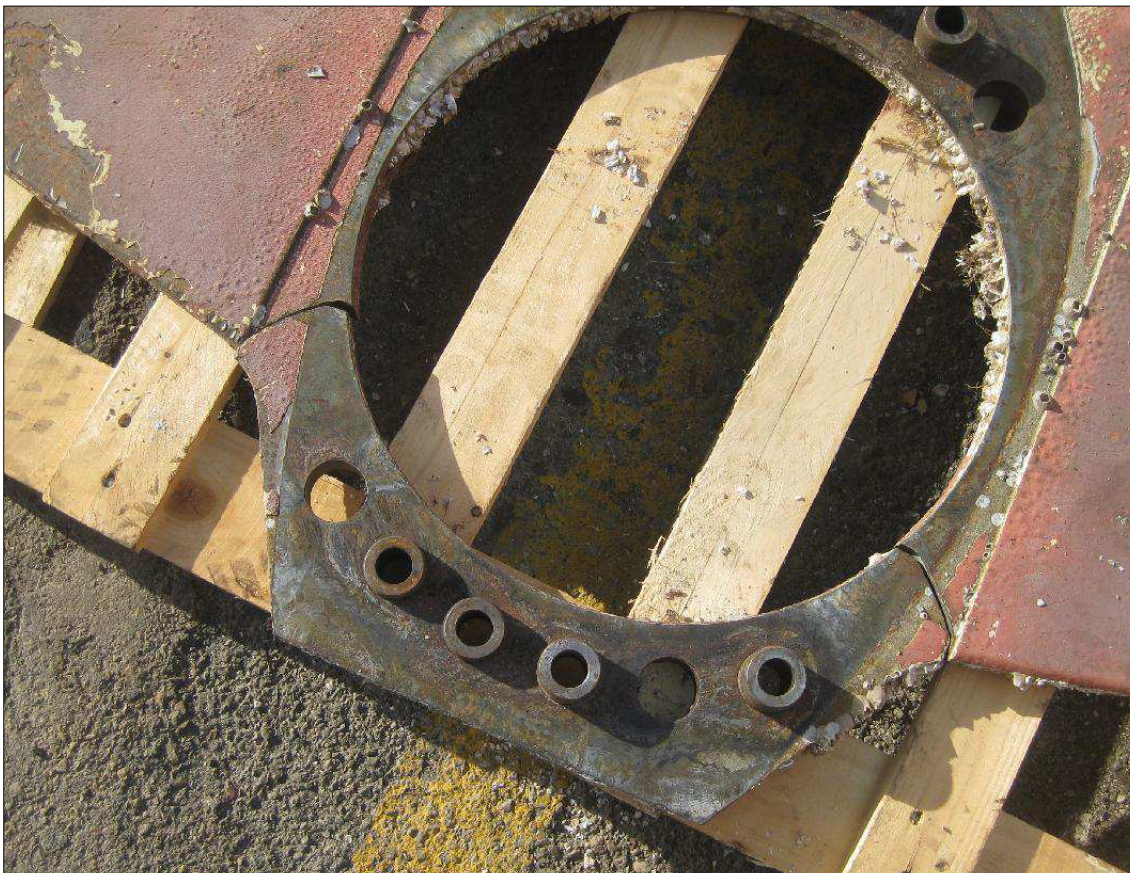
Figure 54: Fracture of supporting base plate for the aft stern thruster
 Source: BANDAK Engineering/Rolls Royce Marine
