MARINE ACCIDENT REPORT

December 2013

EMMA MÆRSK

Flooding of engine room on 1 February 2013

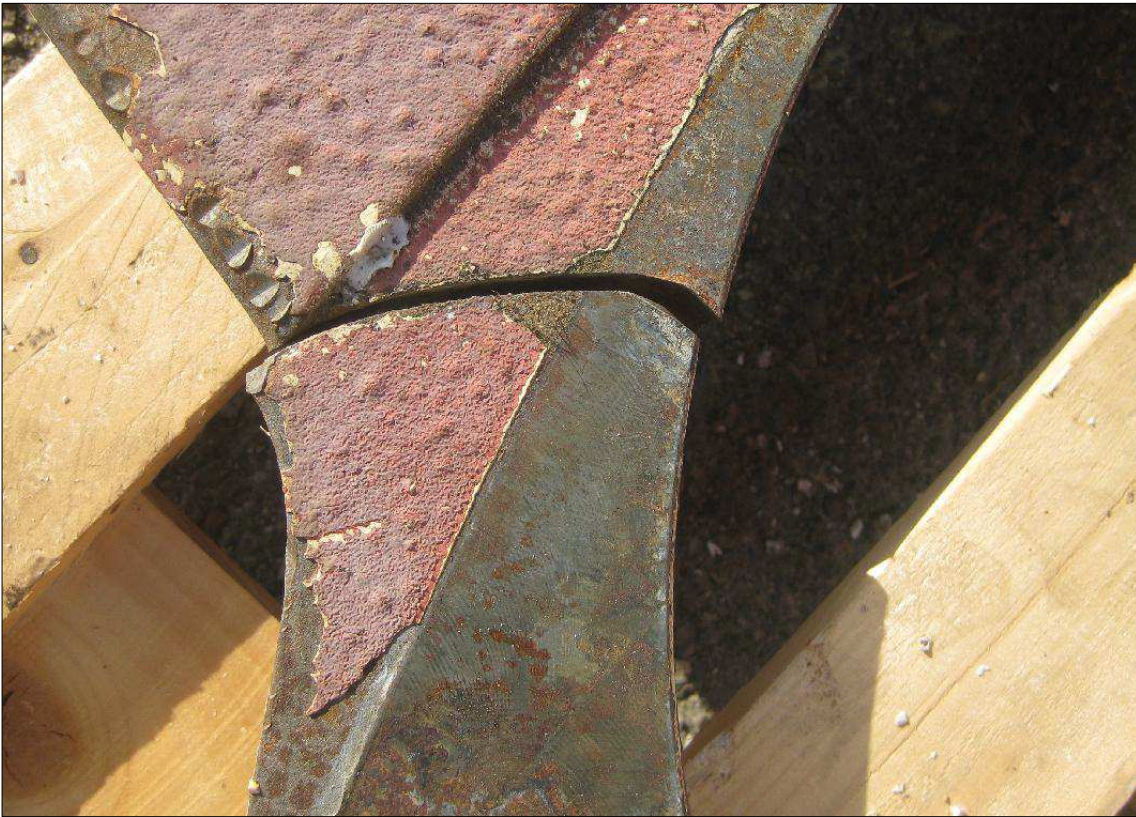
Figure 55: Fracture of supporting base plate for the aft stern thruster
Source: BANDAK Engineering/Rolls Royce Marine
