MARINE INVESTIGATION REPORT
M13N0014

CAPSIZING OF TOW AND ACCIDENTAL DEATH
TUG *WESTERN TUGGER* AND BARGE *ARCTIC LIFT I*
33 NAUTICAL MILES SOUTHWEST OF BURGEO,
NEWFOUNDLAND AND LABRADOR
10 MAY 2013

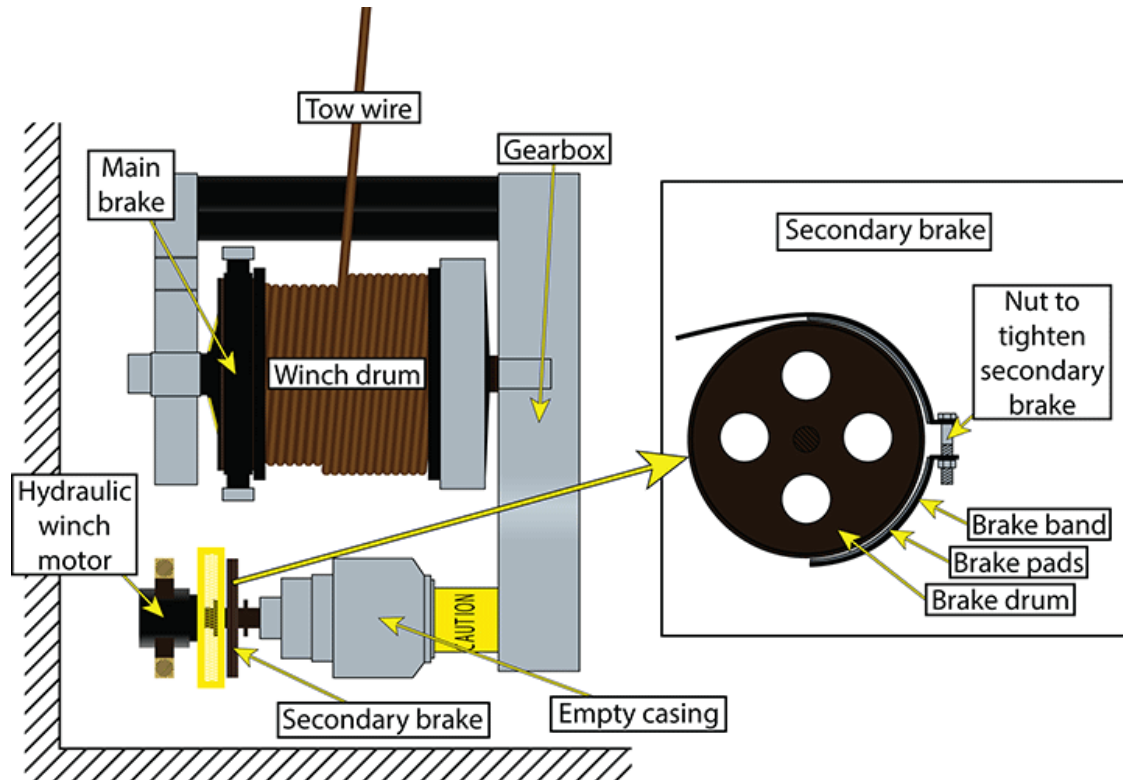
Figure 1. Simplified diagram of the towing winch, showing the locations of the 2 brakes and the nut used to tighten the secondary brake.

The tug had an emergency tow release that was intended to allow an operator located in the wheelhouse to immediately release both air brakes; however, this function was overridden by the nut-and-bolt assembly on the secondary brake.

On the *Western Tugger*, the main brake was unable to keep the winch drum from slipping while towing, even with the on-board practice of keeping the drum clutched in to the motor. For this reason, a secondary brake, which consisted of a brake drum on the drive shaft, had been

installed.⁵ However, these 2 brakes combined were still unable to keep the winch drum from slipping, so the on-board practice was to manually tighten the nut-and-bolt assembly on the brake band of the secondary brake in order to stop the winch drum from slipping.

The remote release on the *Western Tugger* was unable to function as intended because of the nut-and-bolt assembly on the secondary brake drum. The installation of a nut-and-bolt assembly required a crew member to enter the winch room and manually loosen the nut before the winch drum would pay out the tow wire, rendering the emergency tow release ineffective. This practice introduced a hazard to operations, which was not identified or mitigated.

The vessel operator is repairing the vessel's towing winch, which will not incorporate a second brake.

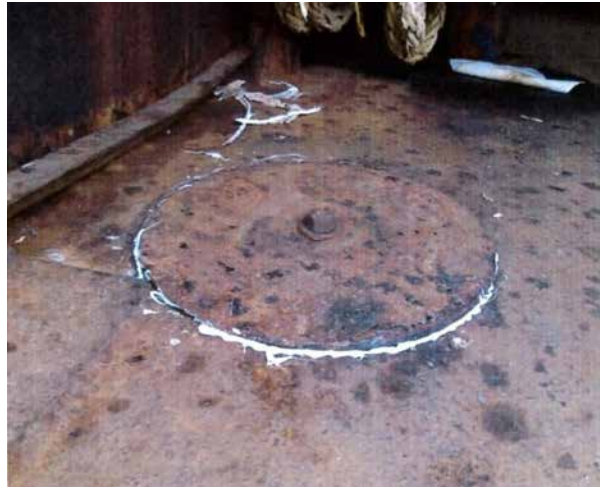
Prior to loading the cargo for this voyage, the barge owner visually inspected the seals on the hatches. A bead of silicon was applied around selected hatch covers where the previously applied sealant had deteriorated (Photo 3).

Photo 3. Silicon sealant on 1 of the 26 hatch covers
