# UNITED STATES COAST GUARD

## **MODU KULLUK**

**ON DECEMBER 31, 2012**

**REPORT OF INVESTIGATION INTO THE CIRCUMSTANCES SURROUNDING THE  
GROUNDING OF THE MOBILE OFFSHORE DRILLING UNIT (MODU) KULLUK ON  
THE EASTERN COAST OF SITKALIDAK ISLAND, ALASKA  
ON DECEMBER 31, 2012**

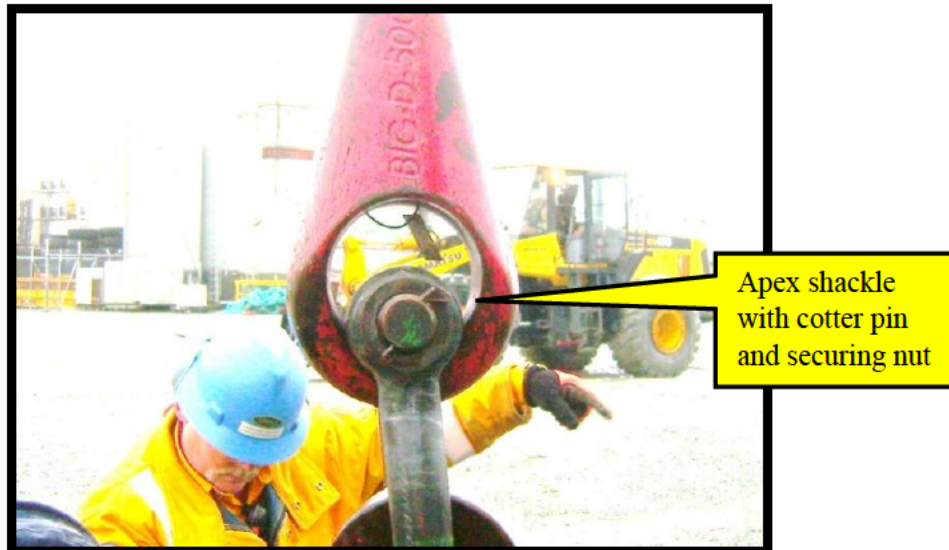
inspection. Additionally, the cotter pin was not removed or replaced.<sup>51</sup> It is assumed that this is the same cotter pin that was installed for the July 2012 tow at the beginning of the season. Figure 13 shows a photo provided by the warranty surveyor that shows the “apex” shackle and cotter pin.

**Figure 13:** OSI Terminal workers hoist the tow plate and pennant wire. The photo shows the 120 ton shackle (original photo brightness adjusted) with the cotter key. The shackle (described as apex shackle) connects the tow plate to the 100' tow pennant socket. (Photo courtesy of GL Noble Denton, Mr. █████)

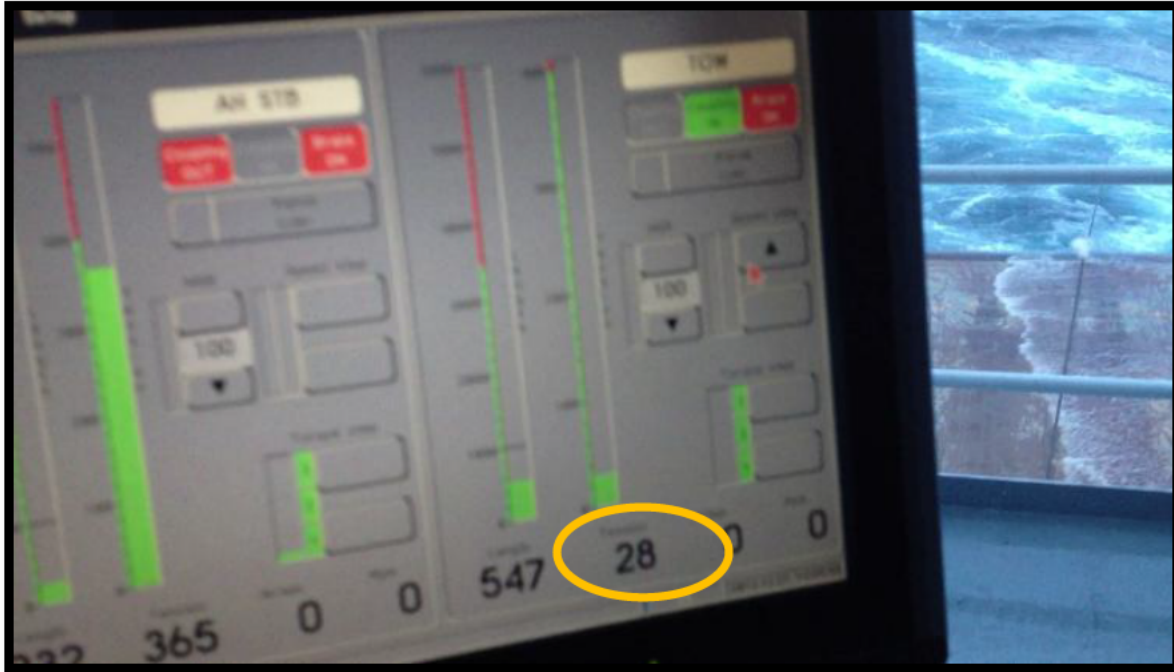
**Figure 18:** Screen capture from video showing tension reading of 28 tons on main tow drum. (Cell phone video screen capture provided by Mr. [REDACTED] AIVIQ Mate)

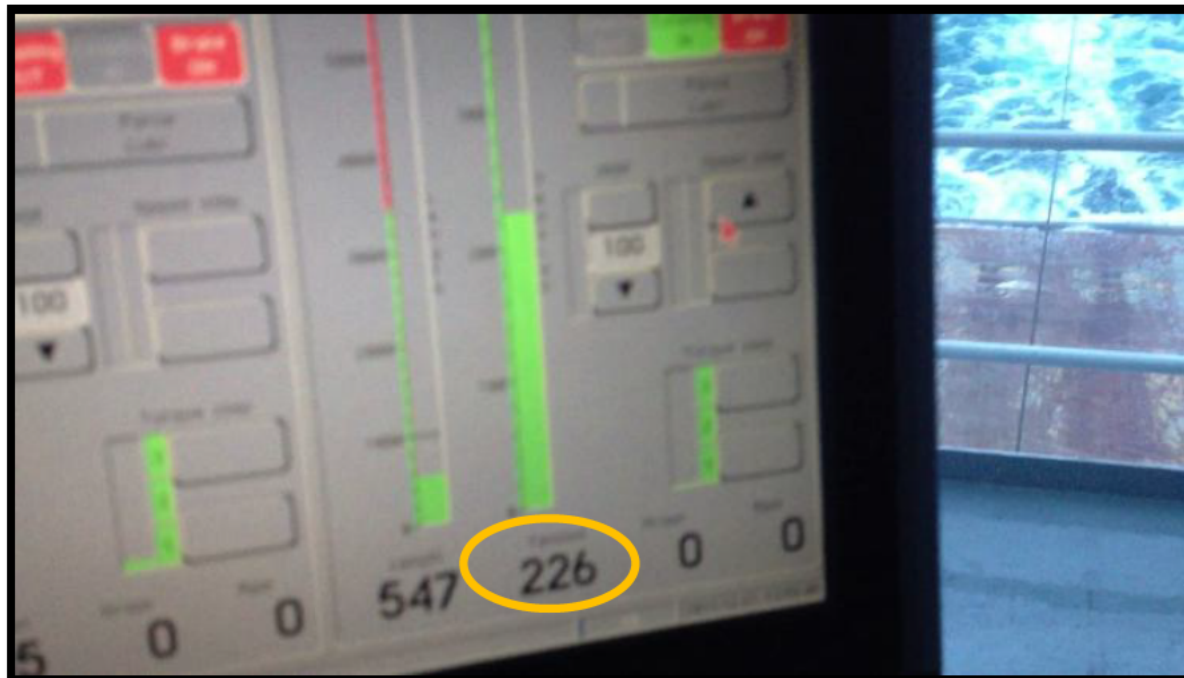
**Figure 19:** Screen capture from video showing tension reading of 226 tons on main tow drum. (Cell phone video screen capture provided by Mr. [REDACTED] AIVIQ Mate)

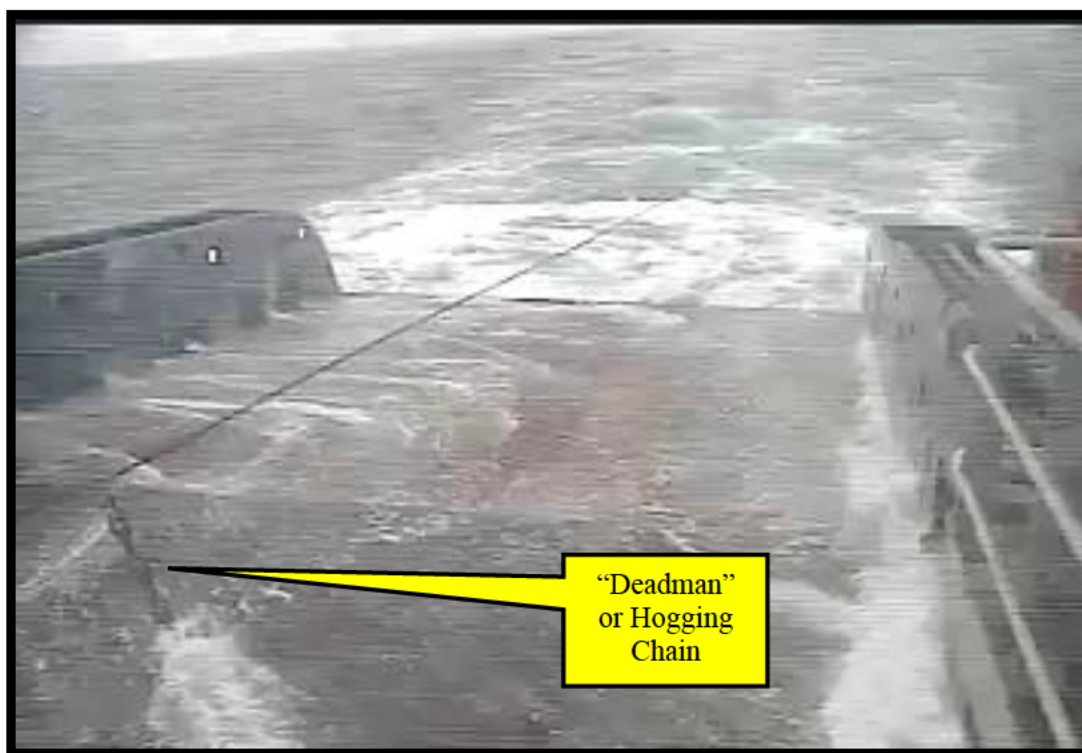
**Figure 20:** Screen capture of towline moments before failure of the shackle on the morning of December 27, 2012 (From AIVIQ CCTV recording and provided by ECO)

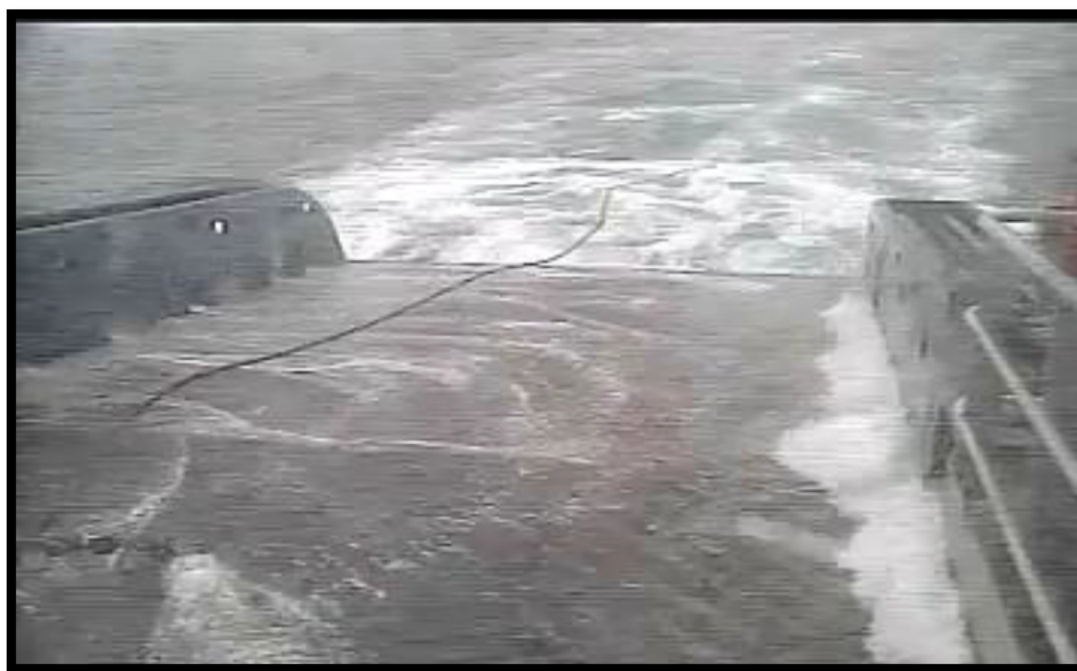
At approximately 1135, the towing operation experienced a failure of the towing shackle. The KULLUK was reported adrift at 56° 15' N and 152° 24' W. Examination of the towing equipment revealed a 120 ton shackle that connected the AIVIQ pennant wire to the triangular towing plate was missing and was not recovered. The SHELL Marine Manager was informed of the towing gear failure. SHELL notified the tug vessel GUARDSMAN and oil spill response vessel NANUQ, both located in Seward, Alaska, to make preparations to get underway. The USCG received notification by VHF radio at 1324 on December 27, and dispatched the USCGC ALEX HALEY<sup>5</sup> on patrol to proceed to assist.

**Figure 21:** Screen capture of towline at moment of shackle failure on the morning of December 27, 2012 (From AIVIQ CCTV recording and provided by ECO)

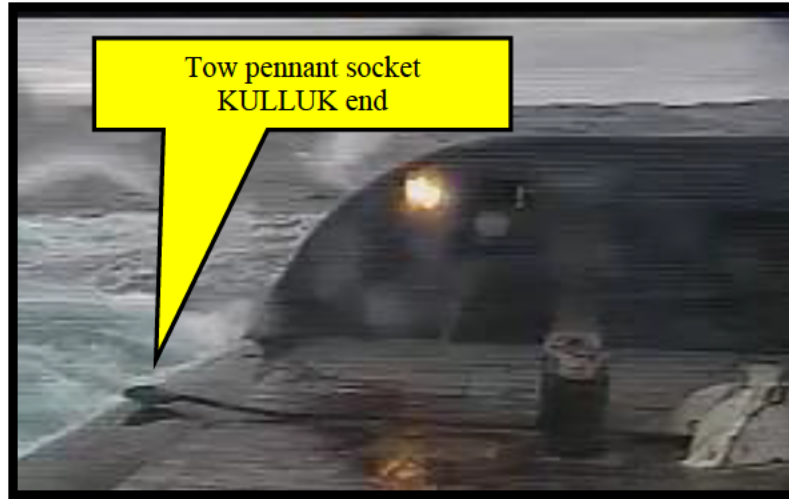
**Figure 22:** Screen capture showing retrieved pennant wire and socket, missing shackle later in the morning of December 27, 2012. (From AIVIQ CCTV recording and provided by ECO)

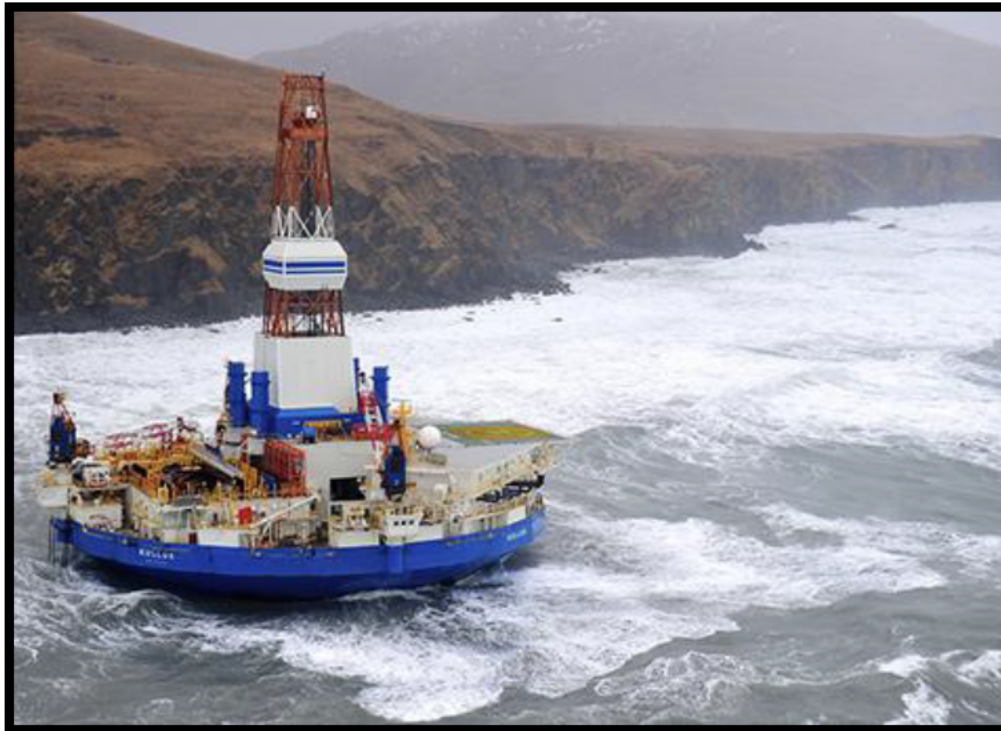
**Figure 44:** KULLUK grounded in Oceans Bay, Alaska. (USCG Photo)

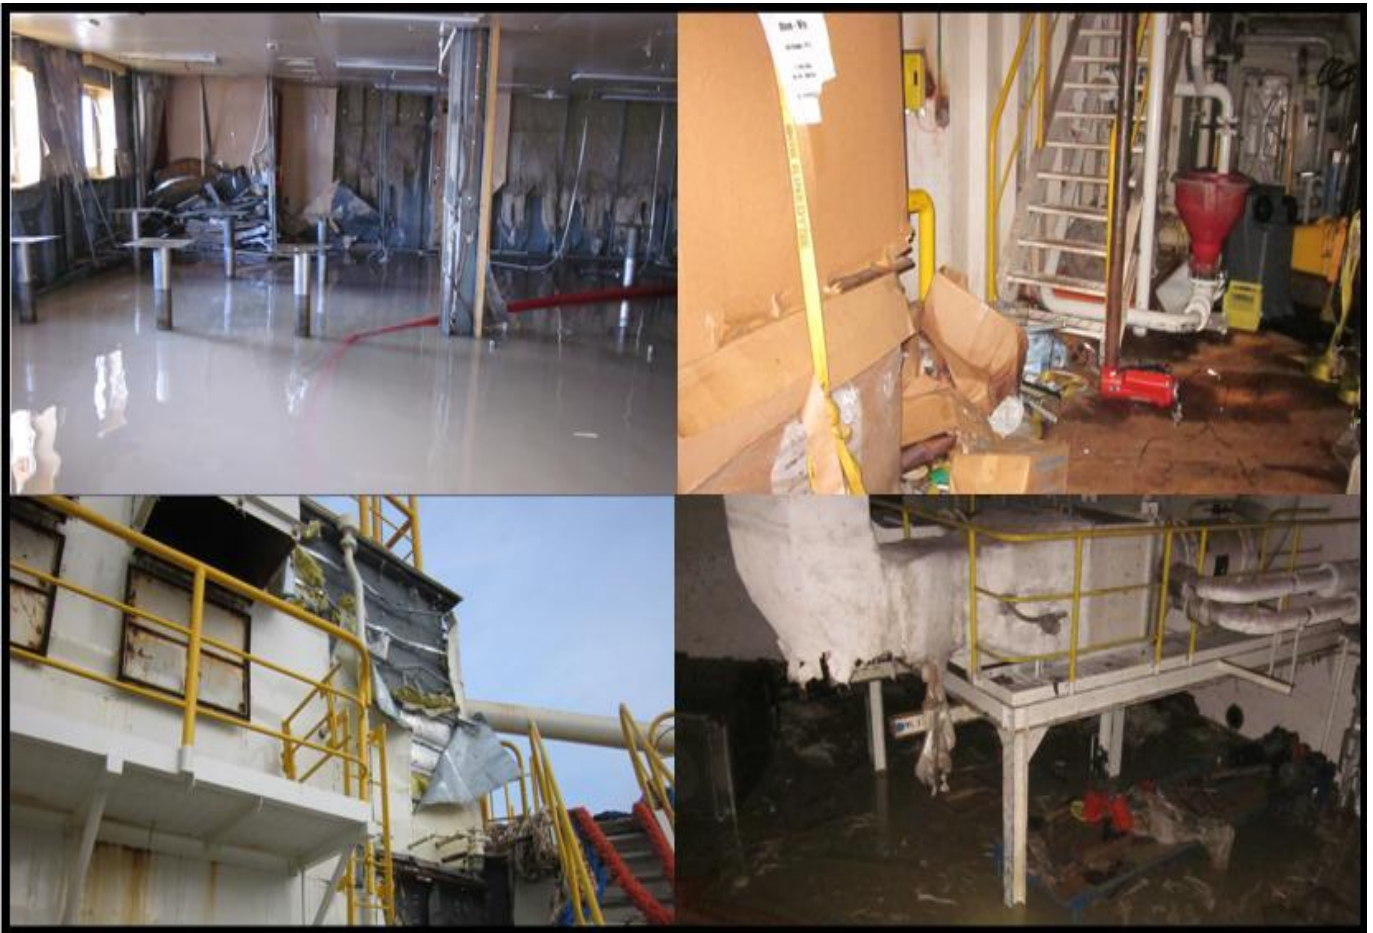
**Figure 45:** Composite photographs showing damage to topside areas of the KULLUK taken by USCG Inspectors after the grounding and prior to refloating. *(USCG Photos)*

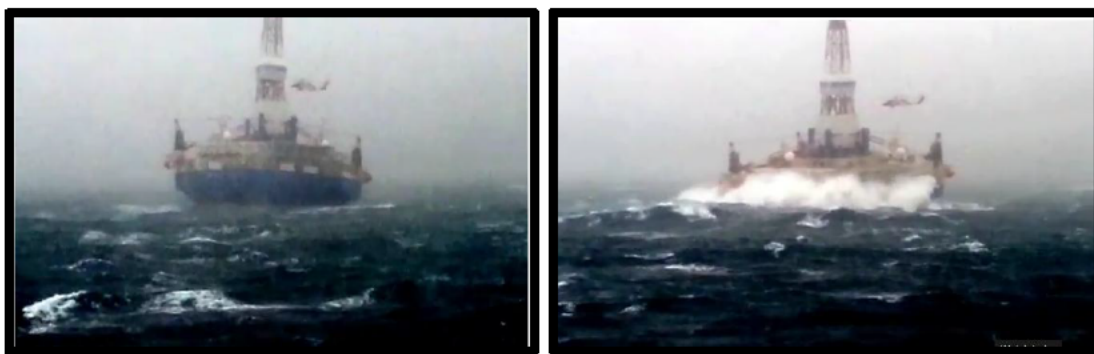
**Figure 48:** Screen captures showing extreme pitching resulting in the KULLUK burying hull into seaway and causing increased towing resistance. (*Taken from YouTube video taken by unknown AIVIQ crewmember during afternoon hours of 31 December with AIVIQ and ALERT towing, video titled “KULLUK rescue 2012 Gulf of Alaska”*)

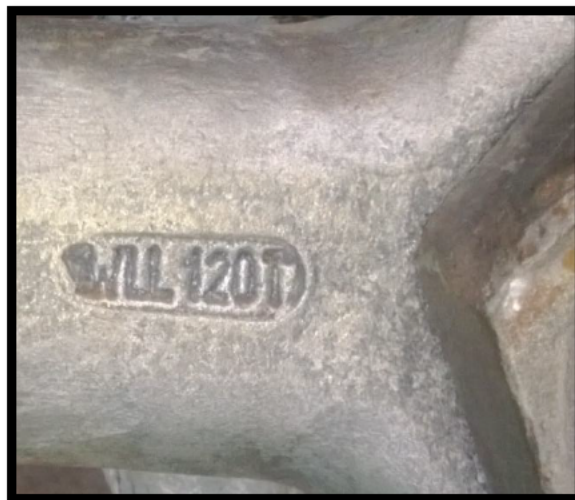
**Figure 55:** Photo of Working Load Limit Stamped on Bow of 120 Van Beest Green Pin® Super Shackle. (USCG Photo)

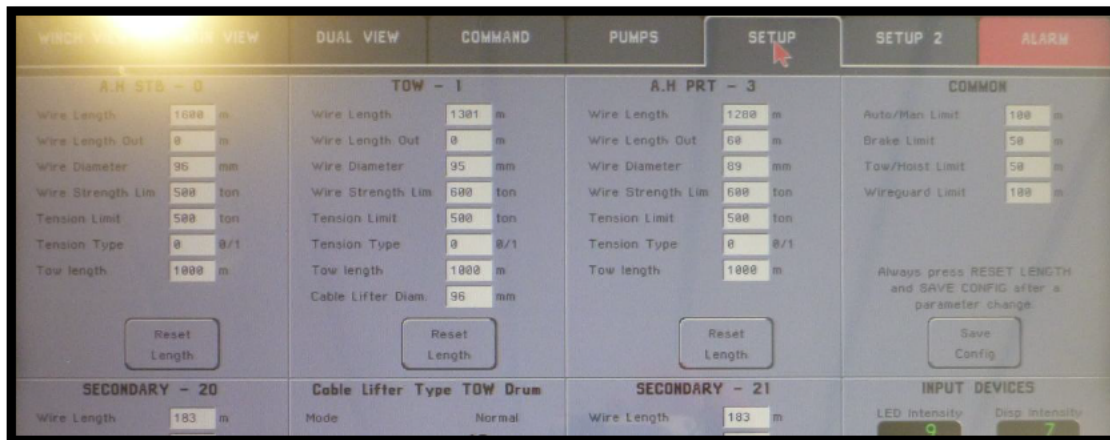
Figure 58: Photo of Towcon Setup screen showing “wire strength limit” for main towing drum is set at 600 tons. (USCG Photo)

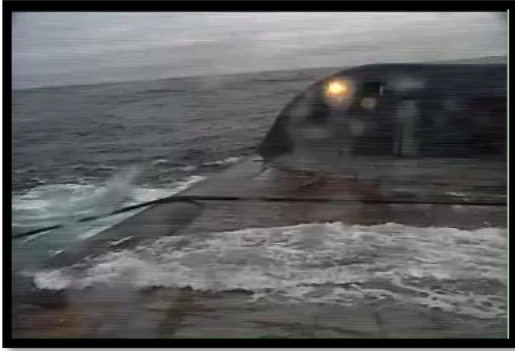
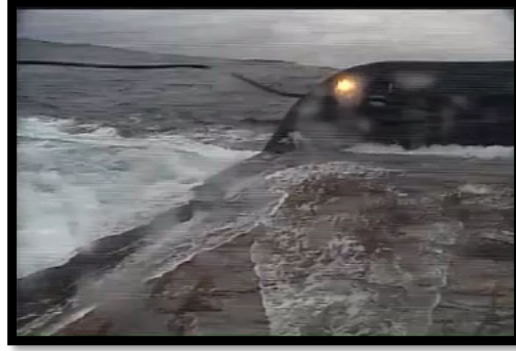
**Figure 64:** Starboard aft CCTV stills showing fluctuations in towline tension. Still on left shows lower tension at 11:32:06. Still on right shows high tension at 11:32:10 at the time of the shackle failure. *AIVIQ CCTV Provided by ECO*

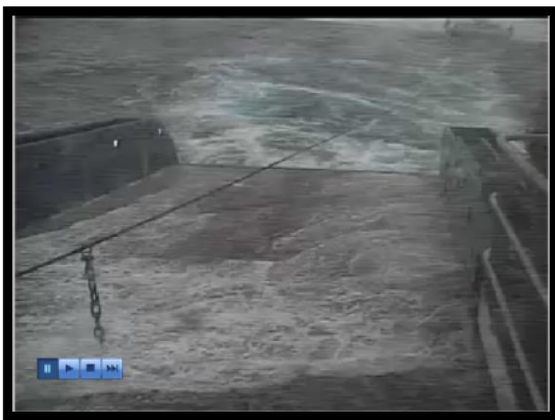
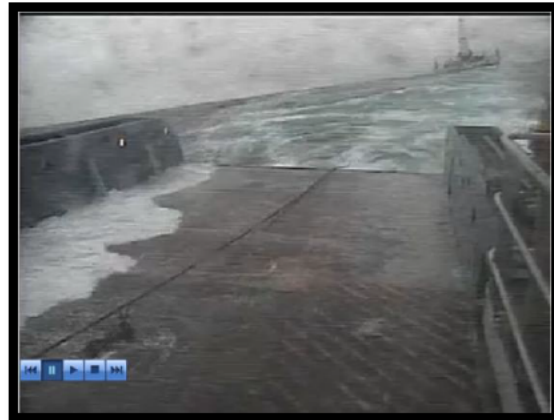
**Figure 65:** Port Forward CCTV stills showing fluctuations in towline tension. Still on left shows high tension at 10:54:48, demonstrated by the stiffness of the hogging chain (bottom right of still) and towline appearing to lead nearly horizontally toward KULLUK. Still on right shows low tension at 10:54:52, a mere 4 seconds later, with a slack Deadman chain and towline on the deck. *(AIVIQ CCTV Provided by ECO)*

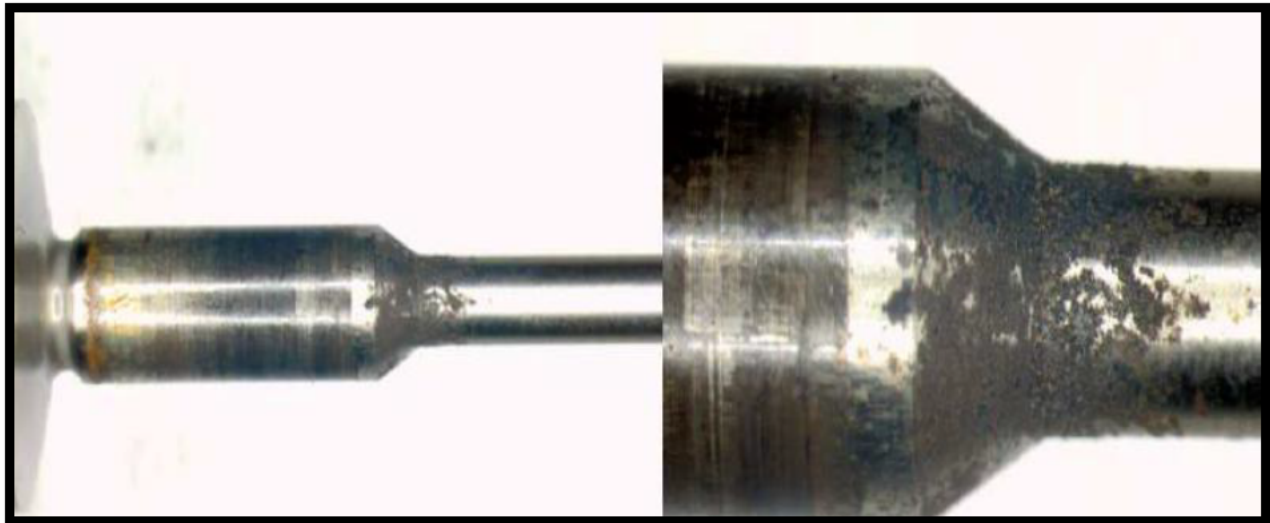
**Figure 68:** Two photos showing significant corrosion of injector check valve. (Provided by Caterpillar)

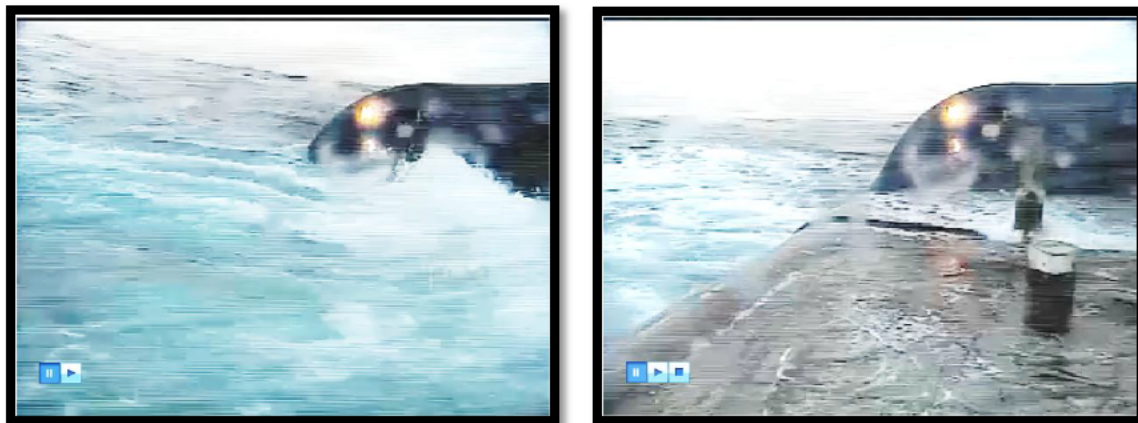
**Figure 70:** (left) Still from Starboard Stern CCTV showing seawater flowing over aft working deck and entering safety deck area at 15:16:47 on December 27. (right) Safety deck area at 15:16:55 after water clears from deck. Port side aft safety deck hatchway is visible. *(AIVIQ CCTV Provided by ECO)*

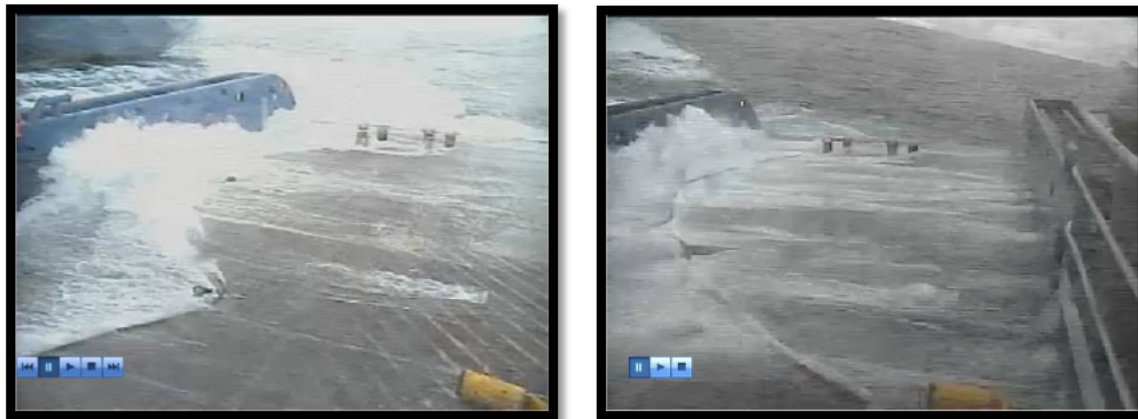
**Figure 71:** (left) Still from Port Forward CCTV showing seawater flowing over aft working deck and entering safety deck area at 14:39:09 on December 27. (right) Similar occurrence at 14:49:19 on December 27. (AIVIQ CCTV Provided by ECO)

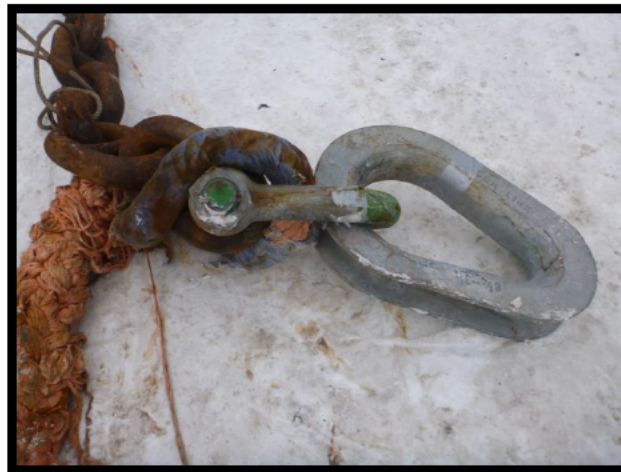
**Figure 75:** Photo of recovered emergency towline (eye on the KULLUK end of the emergency towline) showing missing thimble lashings allowing towline to separate from hard thimble. Blue Cordura® protection is also damaged. (*USCG Photo*)
