MARINE ACCIDENT REPORT

April 2016

CAROLINE MÆRSK

Fire in containers on 26 August 2015

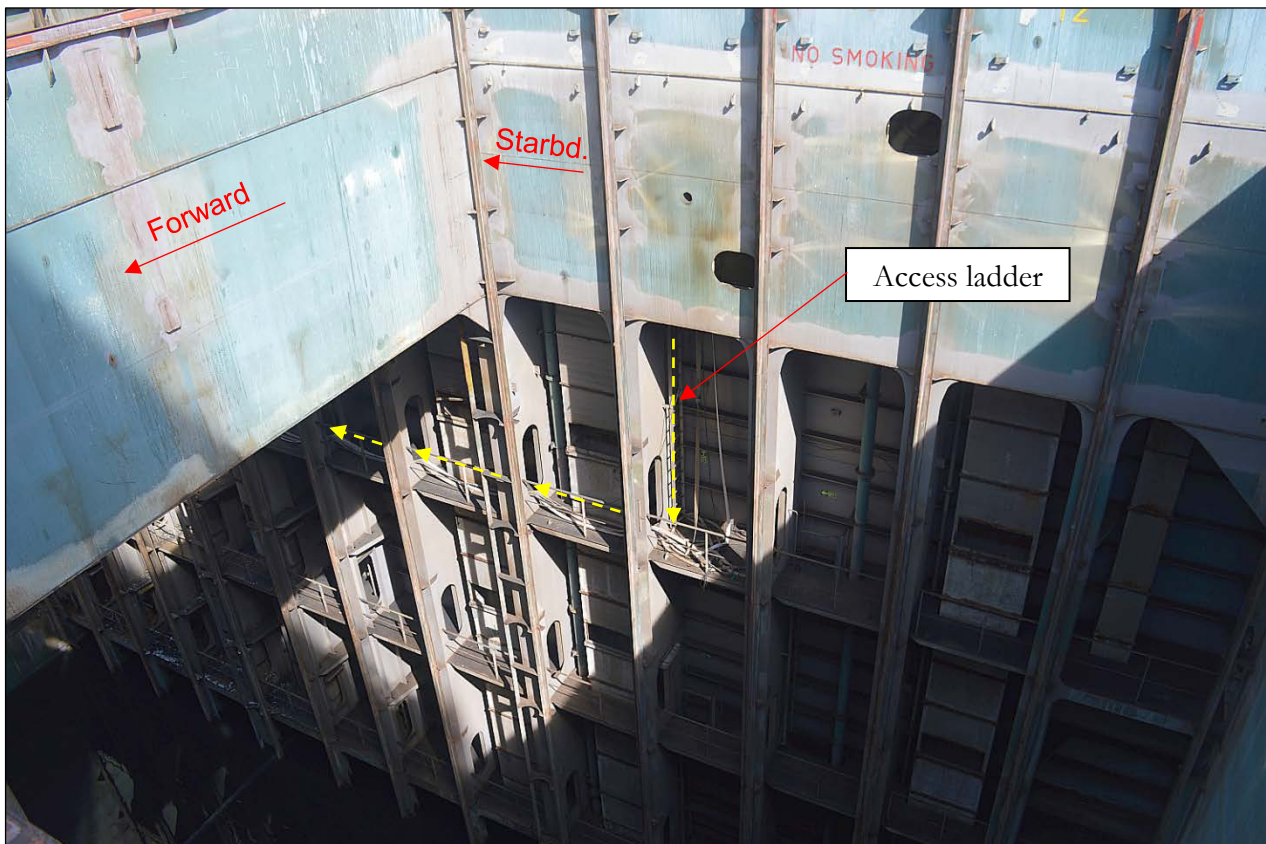
on deck, they first had to descend a 5 metre vertical ladder, then pass through the transverse gallery decks one by one, passing numerous narrow manholes, while searching for the fire (figure 4).

Figure 4: Cargo hold 9, transverse gallery decks, firefighters' access route to fire indicated in yellow
Source: DMAIB

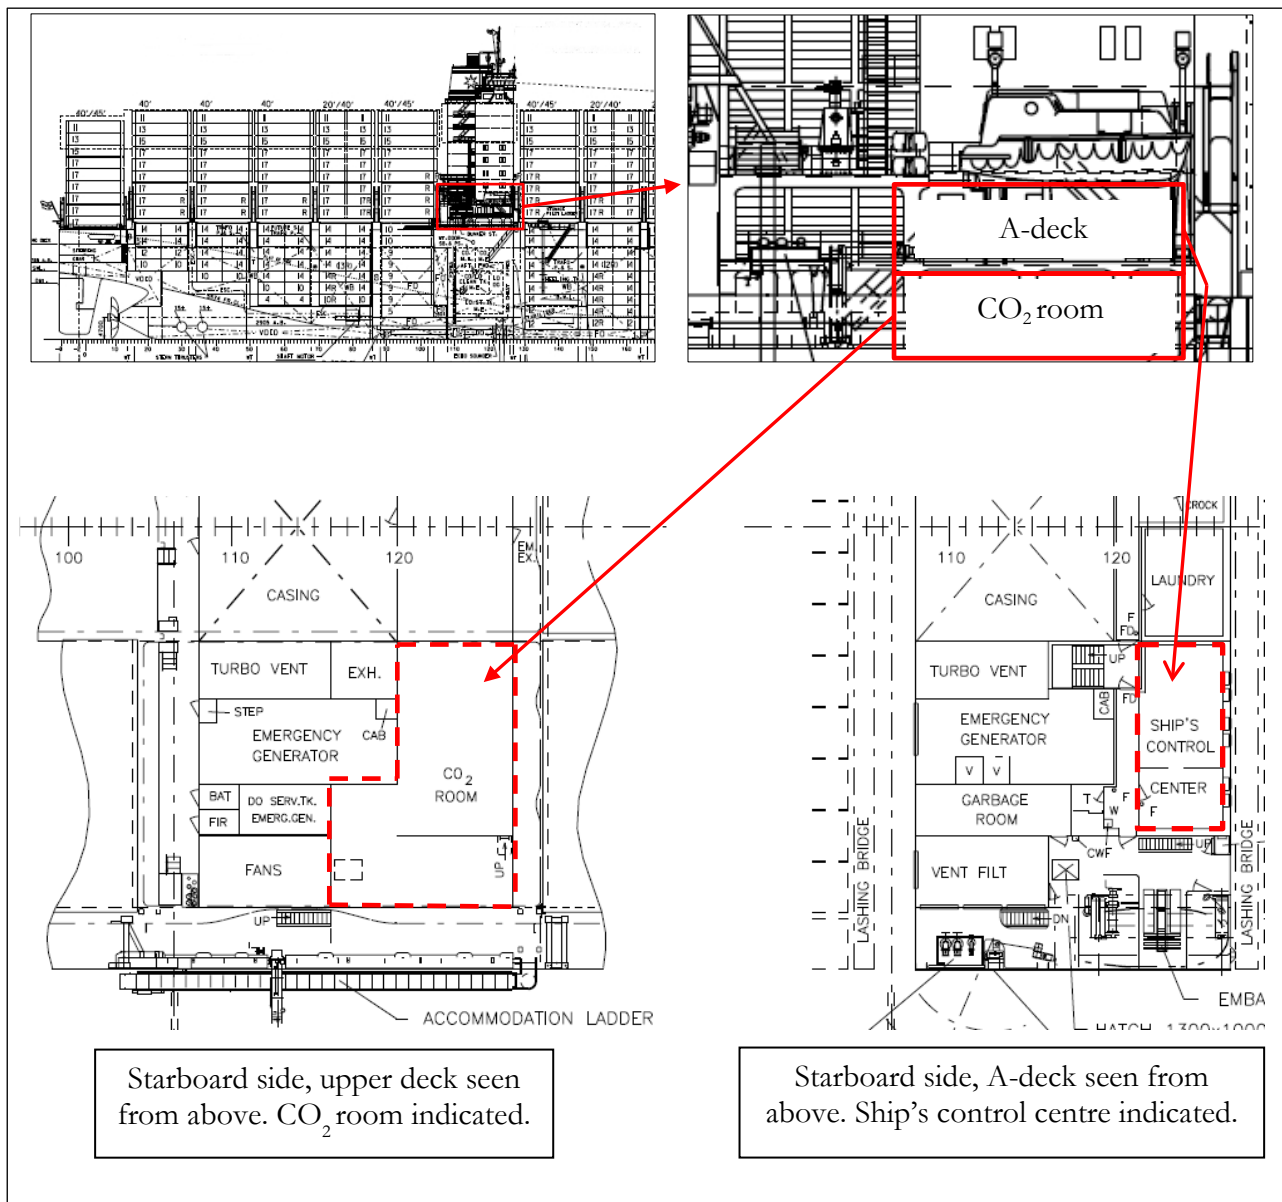
With the information provided by the firefighting teams, the master considered his options and decided to deploy the ship's CO₂ extinguishing system. In preparation for releasing the CO₂, the crew withdrew from the cargo hold area, and the ventilation to the accommodation was switched off. To be safe from any potential leaks from the system into the ship's control centre, the crew mustered on the open deck outside, at the starboard side of the A-deck, above the CO₂-room (figure 5).

Figure 5: Excerpts from general arr. and capacity plan. A-deck and CO₂ room indicated.

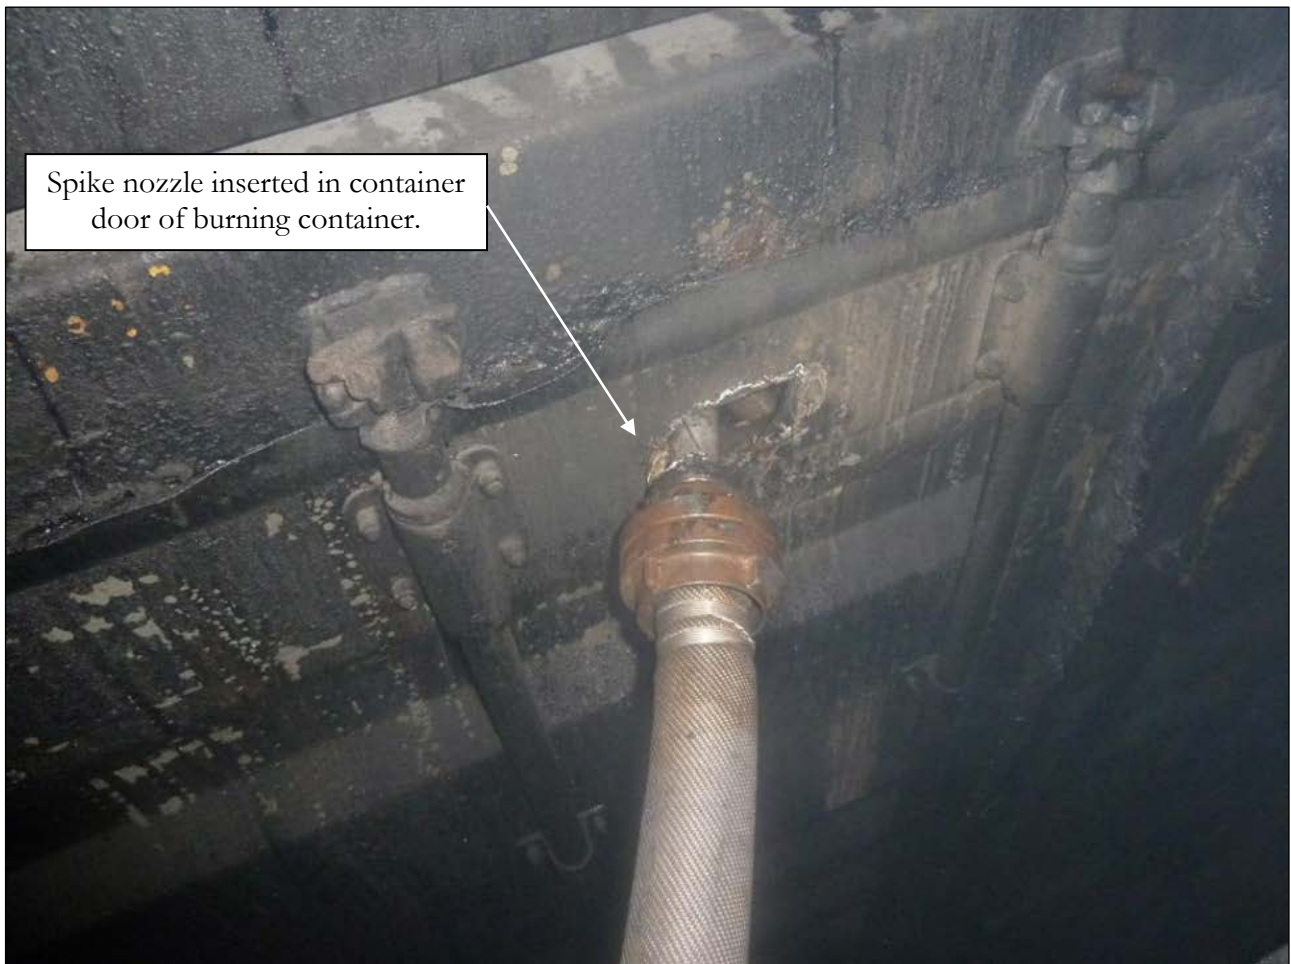
It was decided to close the hold, maintain the cooling, and allow the crew some rest and time to consider alternative approaches. The company crisis team advised the master to make another attempt at placing the spike nozzle in the burning container, this time using an angle grinder. The 2nd officer volunteered for the task. To pre-empt unnecessary difficulties once he was in the hold, the chief engineer instructed the 2nd officer in effective use of the angle grinder by practicing on containers on deck, well away from the constrictions of wearing the firefighter's outfit, and operating in darkness, heat, noise, and a limited amount of time. Just after 0400 on the second day, the 2nd officer had managed to cut a hole, place the spike in the container (figure 6), and turn on the water flow inside it. Soon after, the fire was considered under control.

Figure 6: Burning container with spike nozzle inserted.

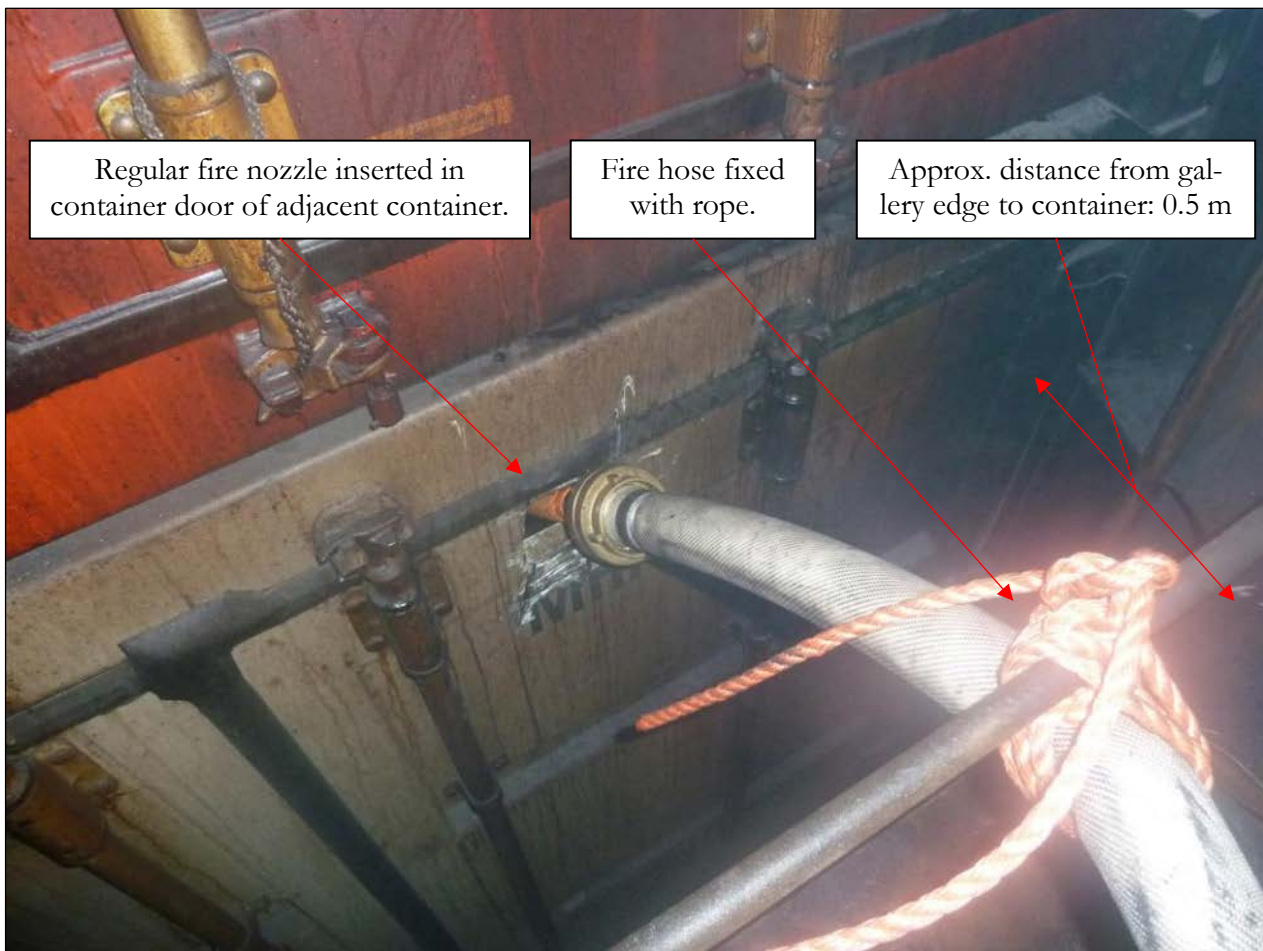
Later in the morning of the second day, smoke and steam in increasing amounts were observed coming from the cargo hold. A firefighting team entered to investigate and evaluate the situation. When they returned, they reported elevated temperatures (65°C as compared to the surrounding temperature of approximately 45°C) in the containers adjacent to the burning one. During the following 12 hours, the situation was kept under observation, and another three teams entered the hold during that period to measure temperatures and check the water level in the hold. Based on these evaluations, it was decided to cut holes in the two adjacent containers and flood them with water as well. Since only one special container spike nozzle was available, the crew instead inserted standard fire nozzles into the two containers (figure 7).

Figure 7: Container with regular fire nozzle mounted.
Source: MÆRSK Line

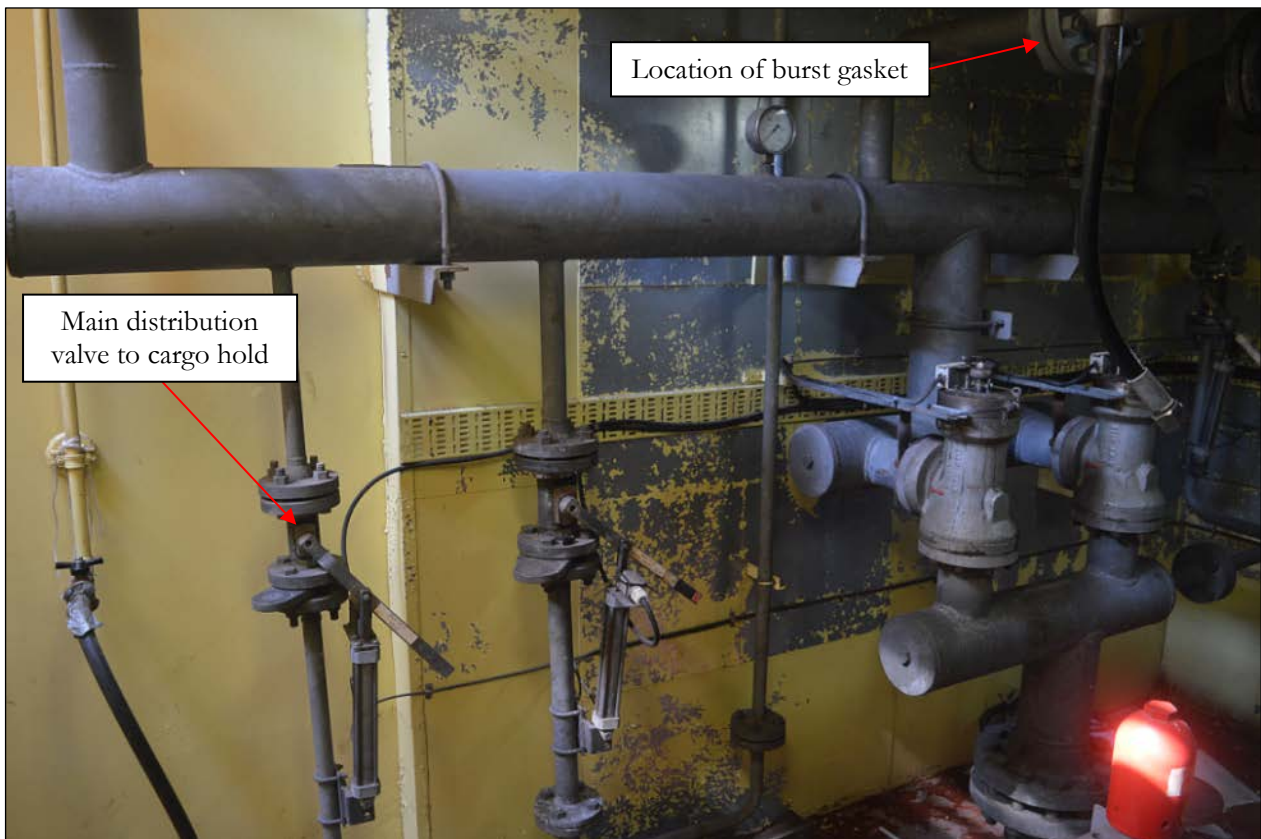
Once inside, he found the room covered in ice from the leaked CO₂, and with paint peeled off by the freezing. He quickly established that there were no defects on the hoses connecting the cylinders, noted that the main distribution valve for the cargo holds was not open, and that a gasket on the main pipeline had burst. He reported to the master that no CO₂ could have reached the cargo hold. He manually opened the main distribution valve to the cargo hold and left the room. The chief engineer then returned to the ship control centre from where he released a second section of CO₂ cylinders, while keeping his hand on the pipes to check that it was in fact flowing to the cargo hold this time. When he went outside to the deck, he also saw that CO₂ was still leaking out of the room. From the bridge, the master confirmed that some CO₂ had likely reached the hold as he could see an effect on the smoke coming from the hold.

On the day of the accident, although operated in accordance with the procedures, the system failed to release CO₂ into the cargo hold. A subsequent third party examination of the CO₂ system indicated that the cause of failure was that the control valve in the fire control station (ship's control centre) release cabinet was not in the fully opened position. This could have led to the venting of CO₂ from the pilot line causing the distribution valve to not open. The examination showed no signs that the burst gasket in the main pipeline had been of a wrong type or mounted incorrectly. It

is likely that the gasket burst as a result of the sudden blast from the released CO₂ building up high pressure due to the stuck valve. Figure 9 below shows the CO₂ room after the accident.

Figure 9: CO₂ room on CAROLINE MÆRSK, main distribution valve indicated
Source: MÆRSK Line/DMAIB

The CO₂ system failed as a main distribution valve did not open, resulting in a near-explosion in the CO₂ room, which presented a serious risk to the crew who had mustered in the area. Another consequence was that very little CO₂ actually reached the cargo hold. At the time of the fire discovery, the crewmembers did not know the source of the fire nor the extent and therefore had no way of knowing the most effective way to fight it, before assessing the situation. As they also did not know the contents of the cargo in the containers, they had no chance of knowing whether releasing CO₂ into a cargo hold would be the most effective approach, or if manual extinguishing would be effective or even possible. For some fire scenarios, such as a smouldering fire inside a container, CO₂ is not a particularly effective method, as the fire will often flare up again when oxygen levels in the hold are restored.

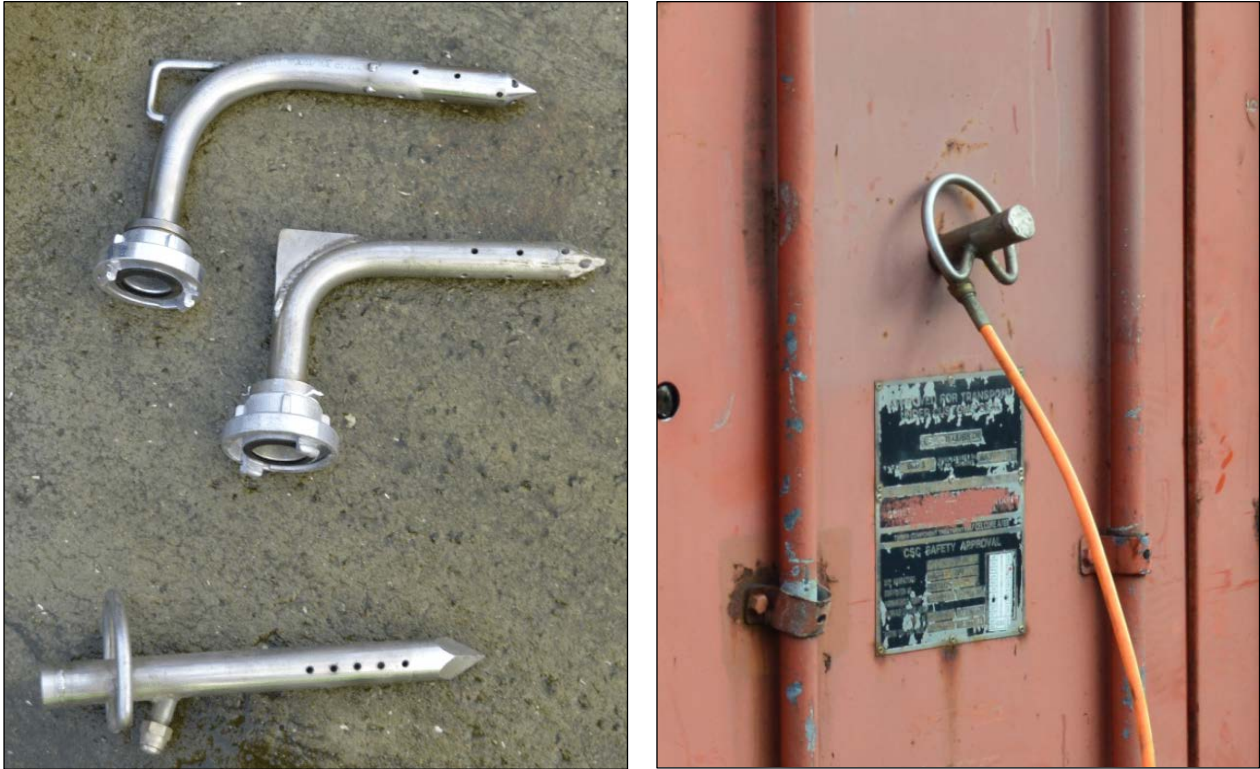
Figure 10: Firefighting spear nozzles – Left: Two water spears, one CO₂ spear. Right: CO₂ spear mounted in container. Source: DMAIB

The spike nozzles supplied by the company's vendor were effective once placed in the container. Hammering the nozzles through the pre-drilled hole required the operator to use both hands and some manual power. Once placed in the container, the nozzles were able to stay mounted in the drilled hole while pressurized.

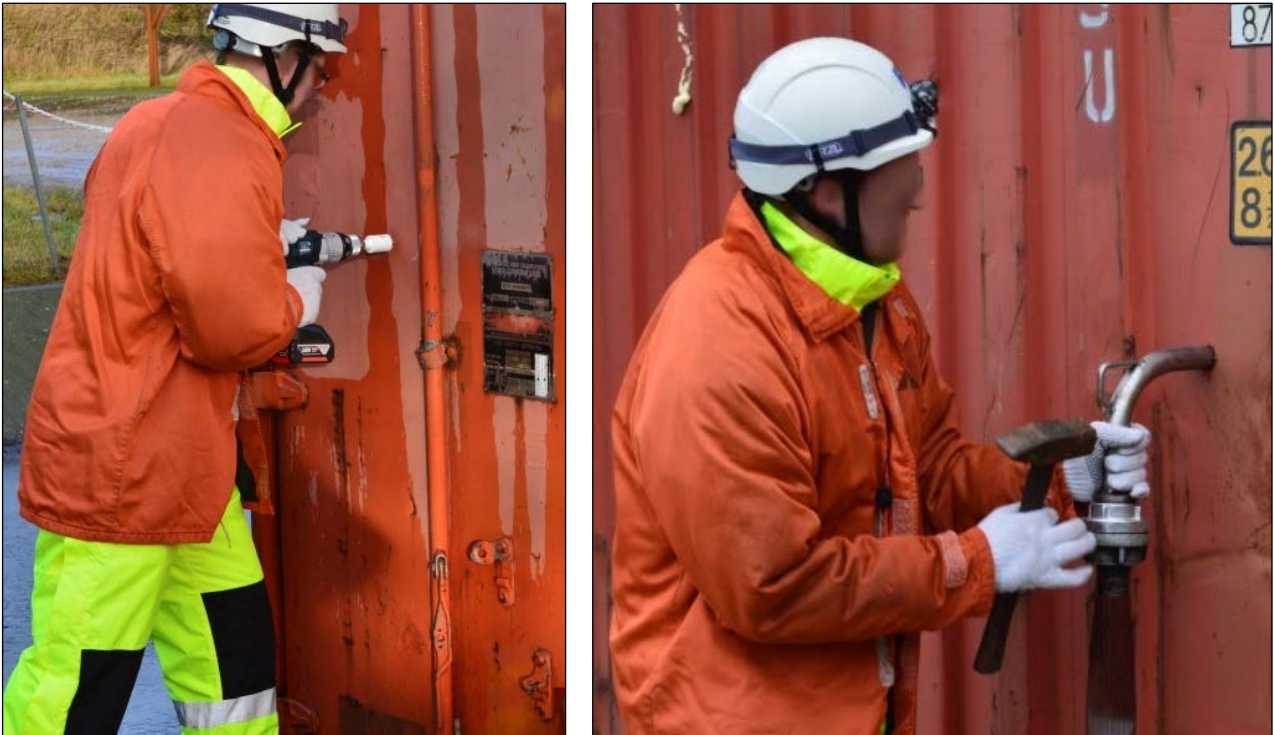
Figure 11: Container firefighting equipment – photos from DMAIB tests
Source: DMAIB

The hole saw bit similar to the one on board CAROLINE MÆRSK could penetrate a standard container door. However, by coincidence the first attempt with the hole saw was made in a location where there was a structural reinforcement on the inside of the door. After one attempt, the hole saw was worn down and not capable of further attempts. During the attempt, the centre bit (pilot drill bit) fell out and had to be refitted.

- The structural features of a container are not visible from the outside, which can lead to problems with identifying the correct drilling location.
- The quality and durability of the drilling equipment. DMAIB is aware of ship crews reporting that the equipment is virtually useless because of its limited power and durability, or due to problems with getting close to the burning containers.
