Fatal accident while manoeuvring *Svitzer Moira* alongside an unmanned tug Royal Portbury Dock, Bristol 29 December 2015

SUMMARY

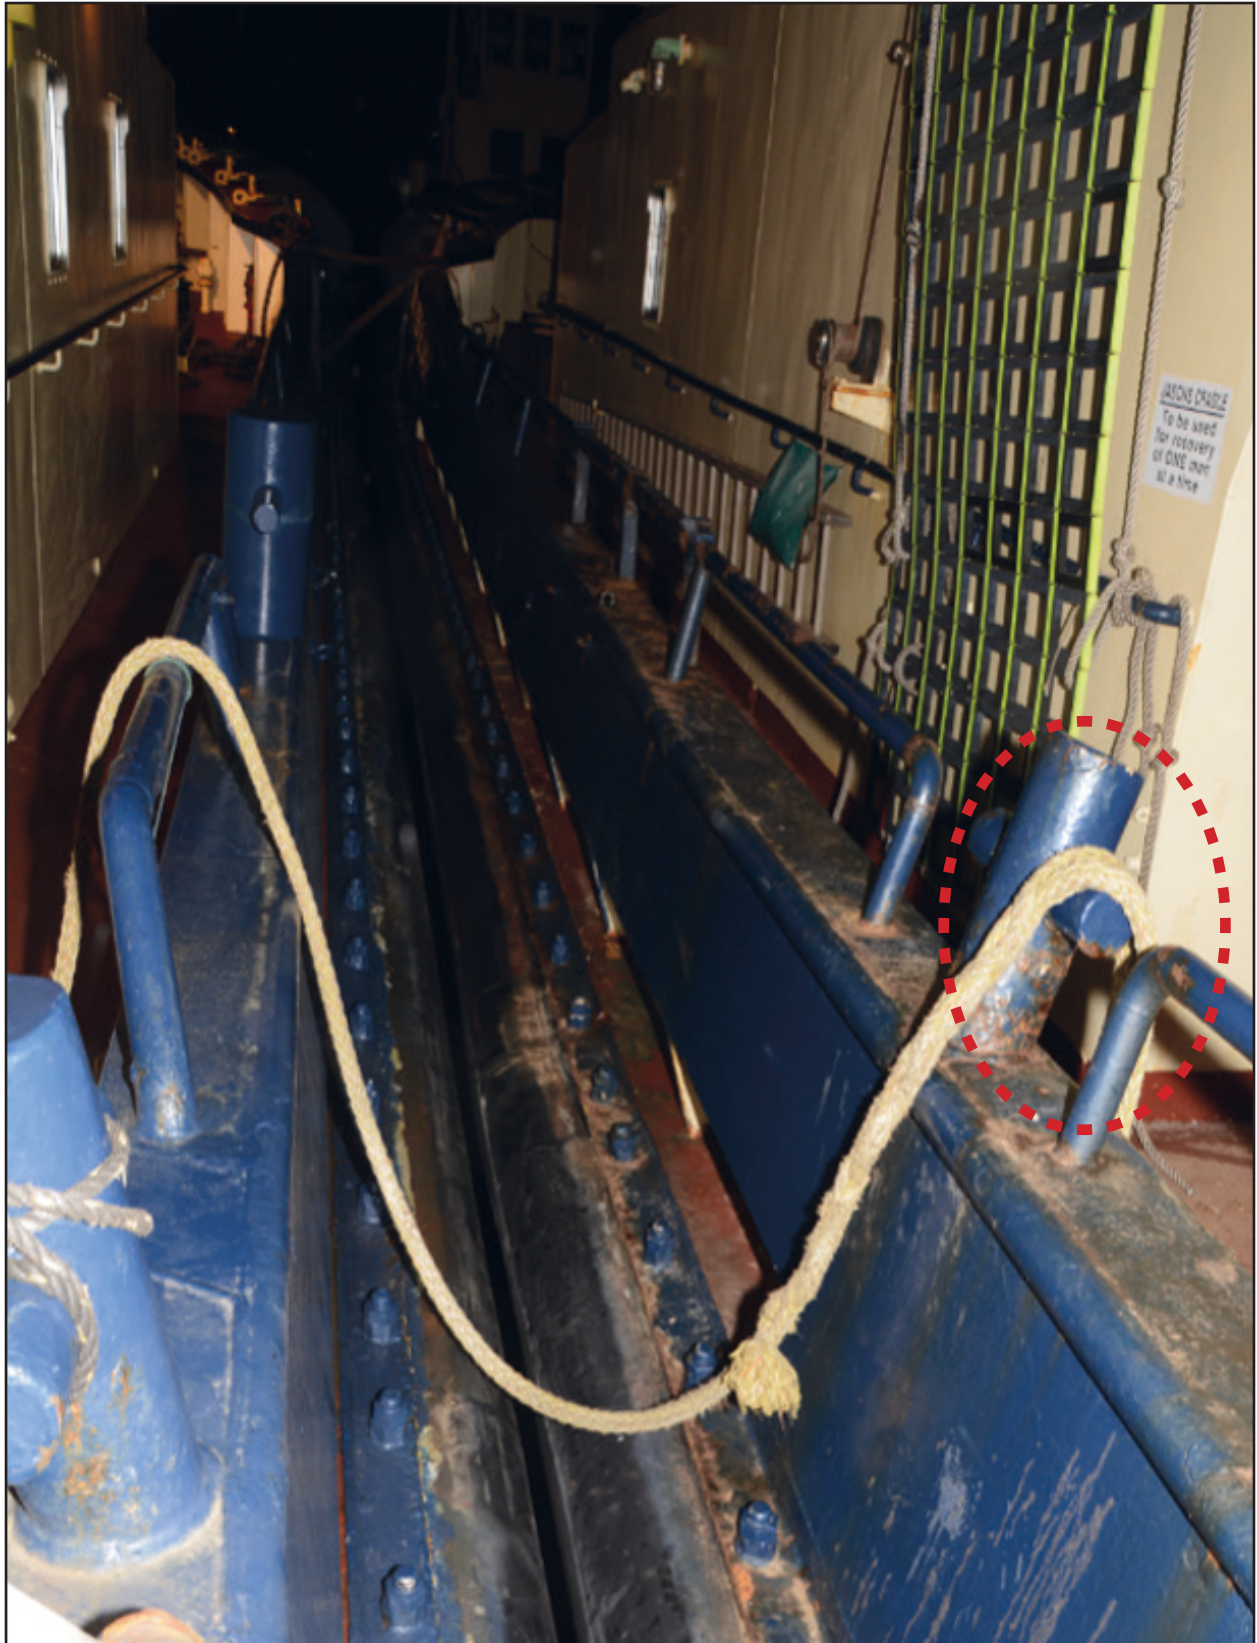
Figure 3: Amidships mooring rope as found following accident (reconstruction)

The engineer was found in the prone position, lying predominantly on top of the fendering between the two tugs. His body was angled such that he was facing *Svitzer Moira* with his head and right arm located between the fendering. Evidence indicates that the vessels remained together once athwartships thrust had been applied. Although the possibility that the vessels moved apart briefly once alongside each other cannot be discounted, that the engineer was found on top of and partially between the fendering suggests that he had passed outside *Svitzer Moira*'s bulwark before *Svitzer Moira* had come fully alongside *Svitzer Ellerby*.

The status of the amidships mooring rope indicates that the engineer had made an attempt to pass the eye of the rope over the corresponding bitts on *Svitzer Ellerby* but was unsuccessful. The open bulwark gate suggests that the engineer had opened it, to transfer to the unmanned tug in order to place the rope correctly over the bitt.

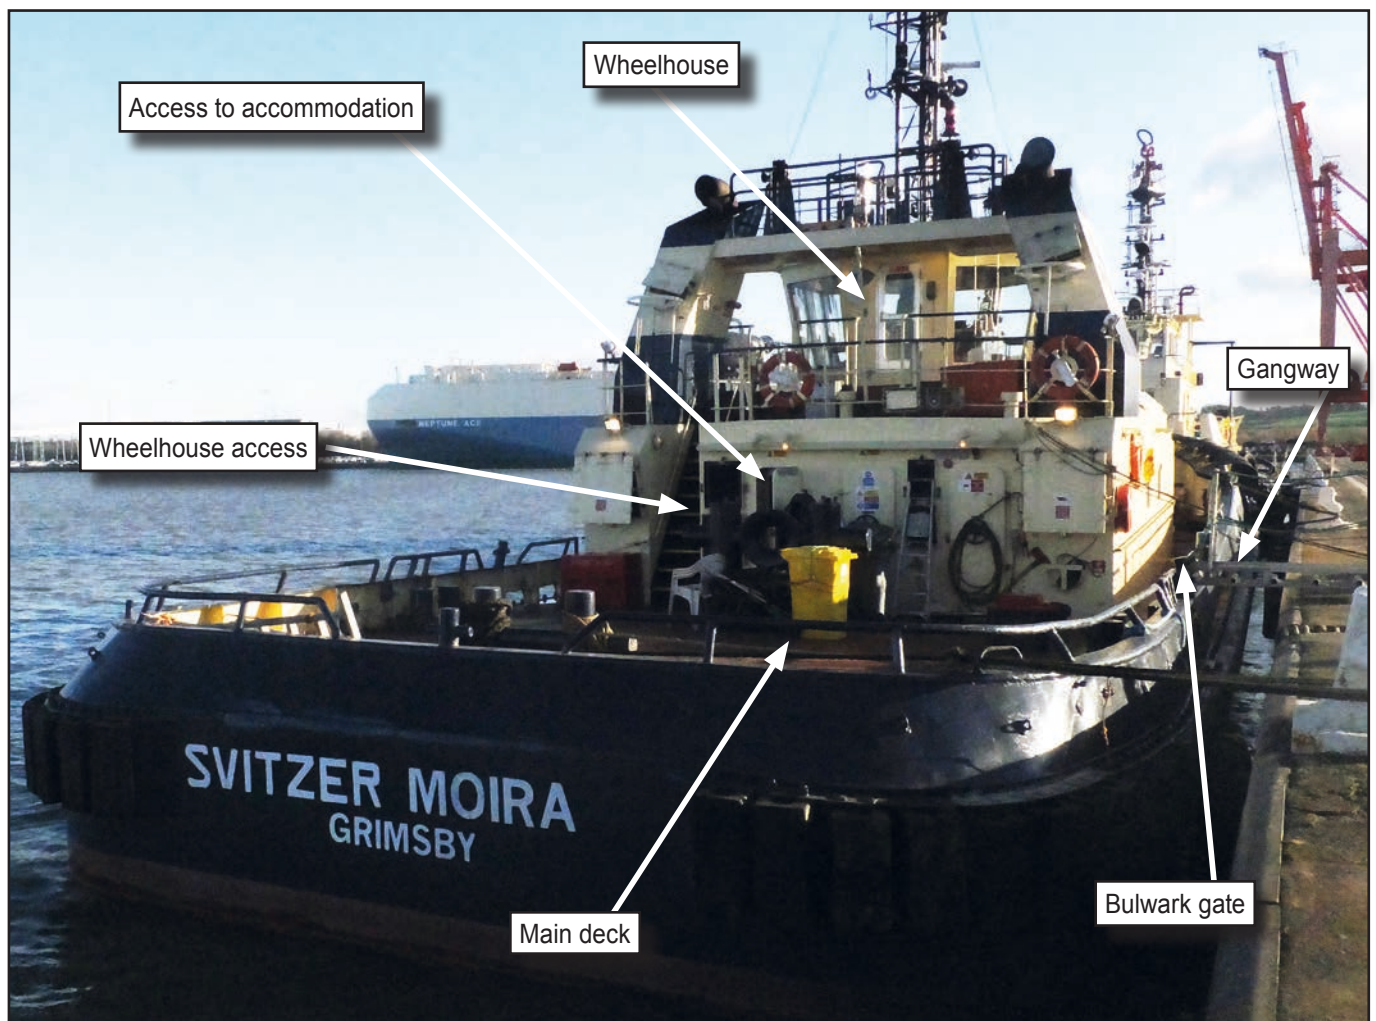
Figure 4: *Svitzer Moira*

On the starboard side of the main deck was a permanently attached gangway with a pivot that enabled it to be raised or lowered as required. A bulwark gate was located aft of the gangway (**Figure 4**).

From within *Svitzer Moira's* wheelhouse visibility of the starboard side of the aft deck was obstructed by the funnels, and the amidships mooring bitt and the bulwark gate could not be seen.
