Paris MoU

on Port State Control

Name:	HUANGHAI DEVELOPER
IMO:	9458444
Flag:	Hong Kong, China
Type:	General Cargo
GT:	20682
Class:	Bureau Veritas
RO:	Bureau Veritas
IMO Company:	Tianjin Xinhai Intl Ship Management
Date keel laid:	17/12/2008
Delivery date:	10/03/2013

MV "HUANGHAI DEVELOPER" IMO: 9458444 flying Hong Kong flag, arrived at Hamburg/Germany on 09/08/2016 for cargo operation, no survey or repair work was planned for the port call.

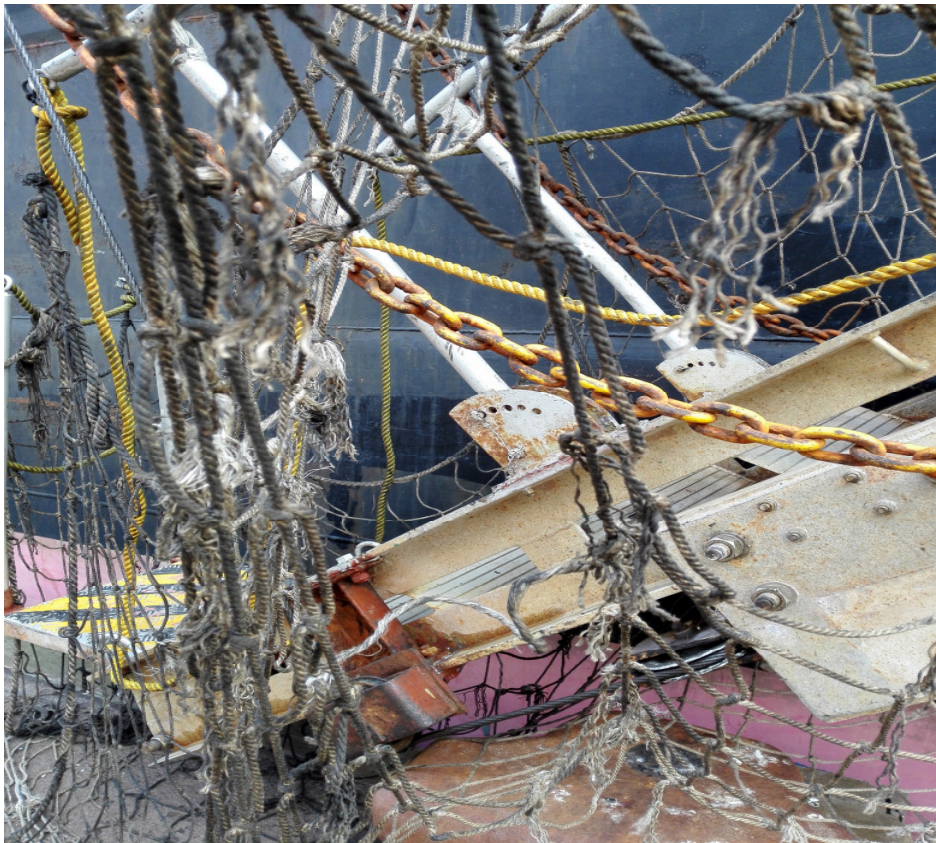
The first deficiency was already recorded when the PSCOs stepped on the gangway. The gangway net was fully worn out, with large gaps, comparable to a patchwork carpet. The picture speaks for itself

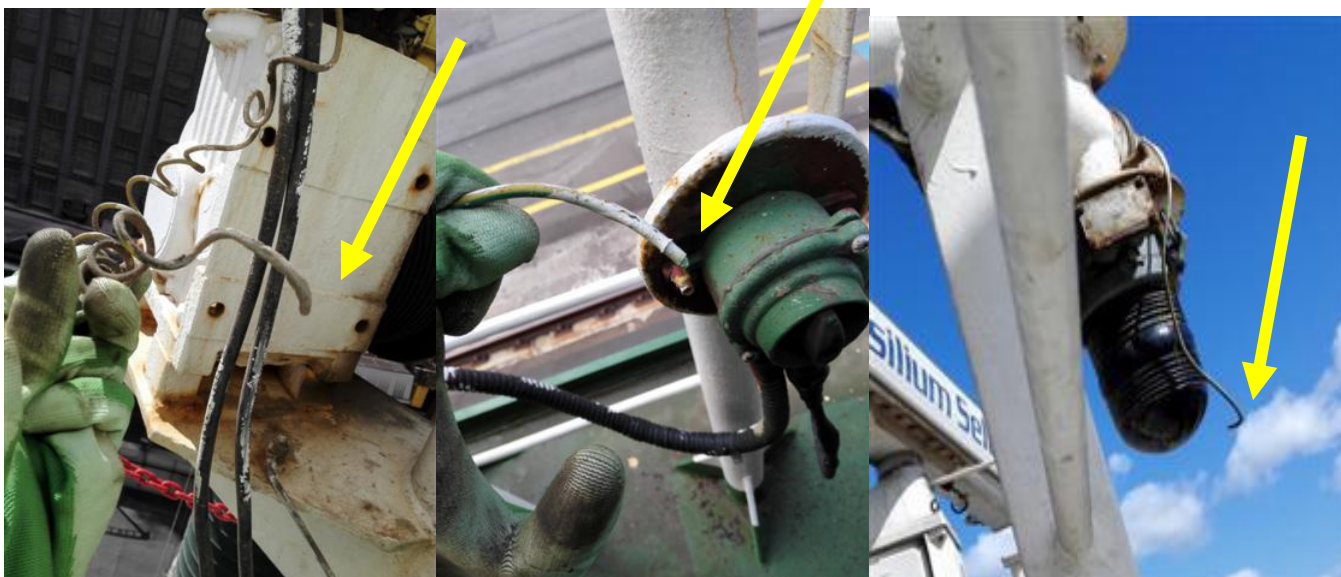
On the way to the ship's office the second deficiency was noted, the protective conductor (earth cable) of the gangway light was rusted away and therefore not connected. Later the PSCOs discovered that this deficiency was found all over the vessel in any possible area. For the sheer amount of damaged conductors this deficiency was noted with "ground for detention".

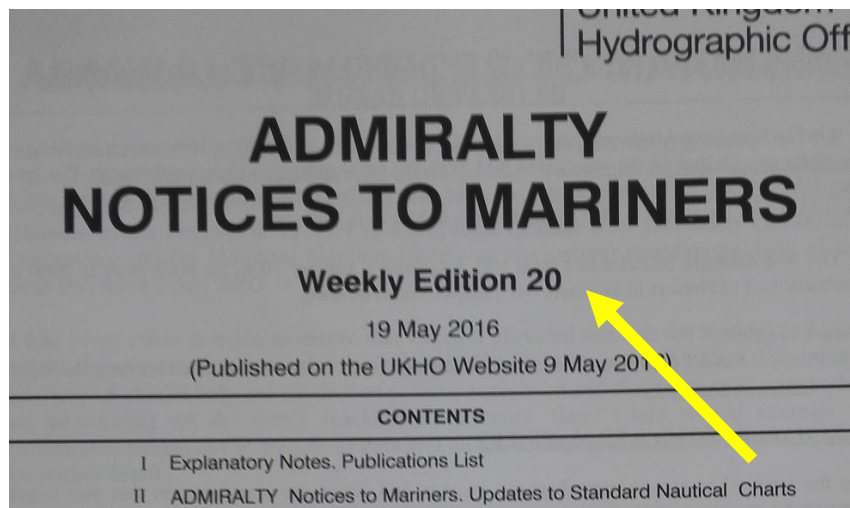
Last NtM available on board was WK 20, the released NtM during the inspection was WK 32. That means that the last 12 (!) weeks no corrections for charts and publications had been done. Additionally, the navigation officer showed a lack of familiarisation with the handling of NtMs, he wasn't able to identify T&P notices on the actual voyage charts. Therefore, the deficiency was marked with ground for detention.

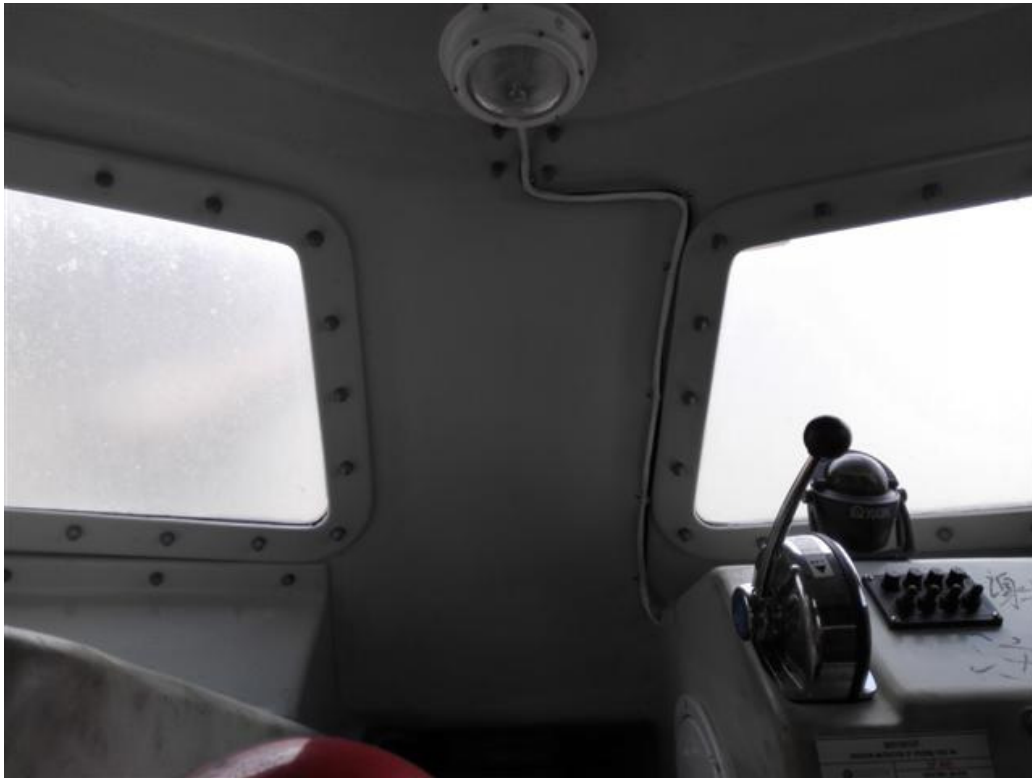
The windows of the free-fall boat, were so dirty that no view from inside to outside was anymore possible.

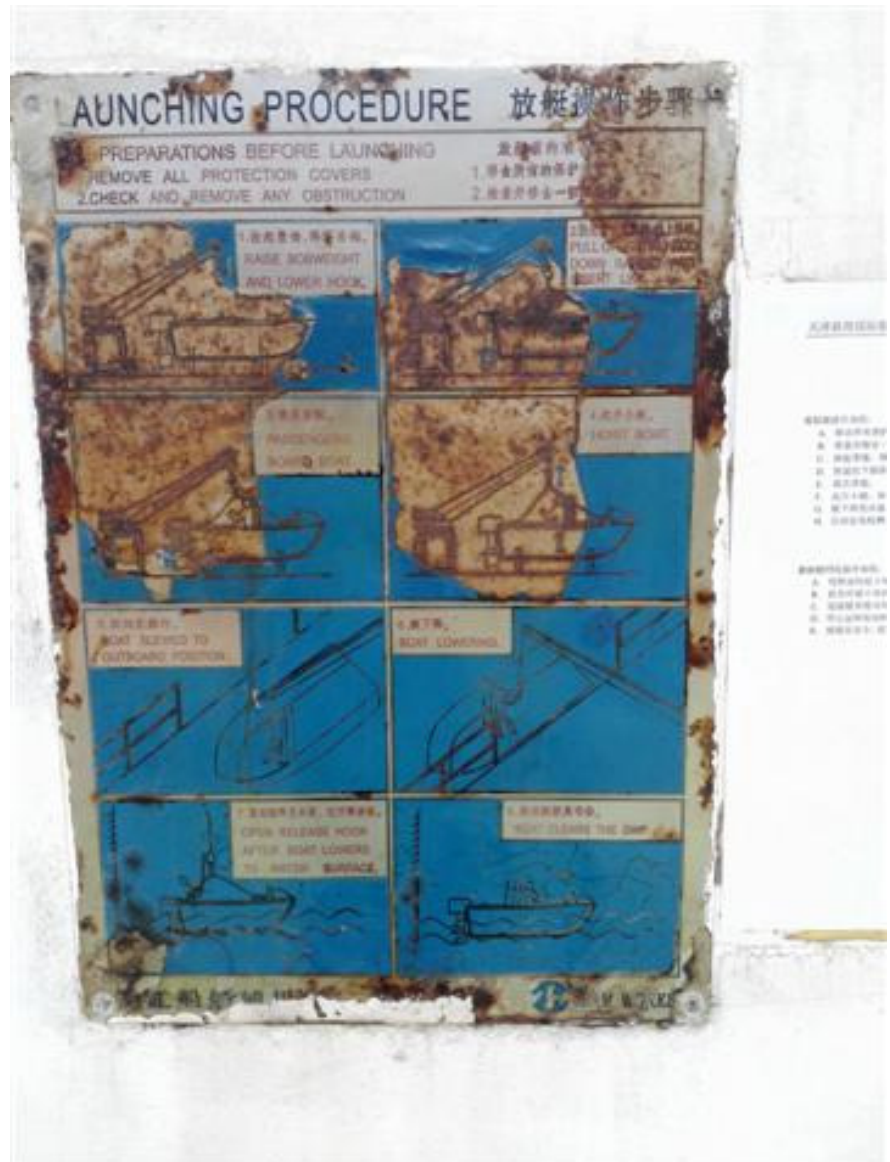
The poster "launching procedures of rescue boat" was so worn out that single steps of the procedures couldn't be identified. Posters for the familiarisation of the crew are a key point for safe operation at sea.

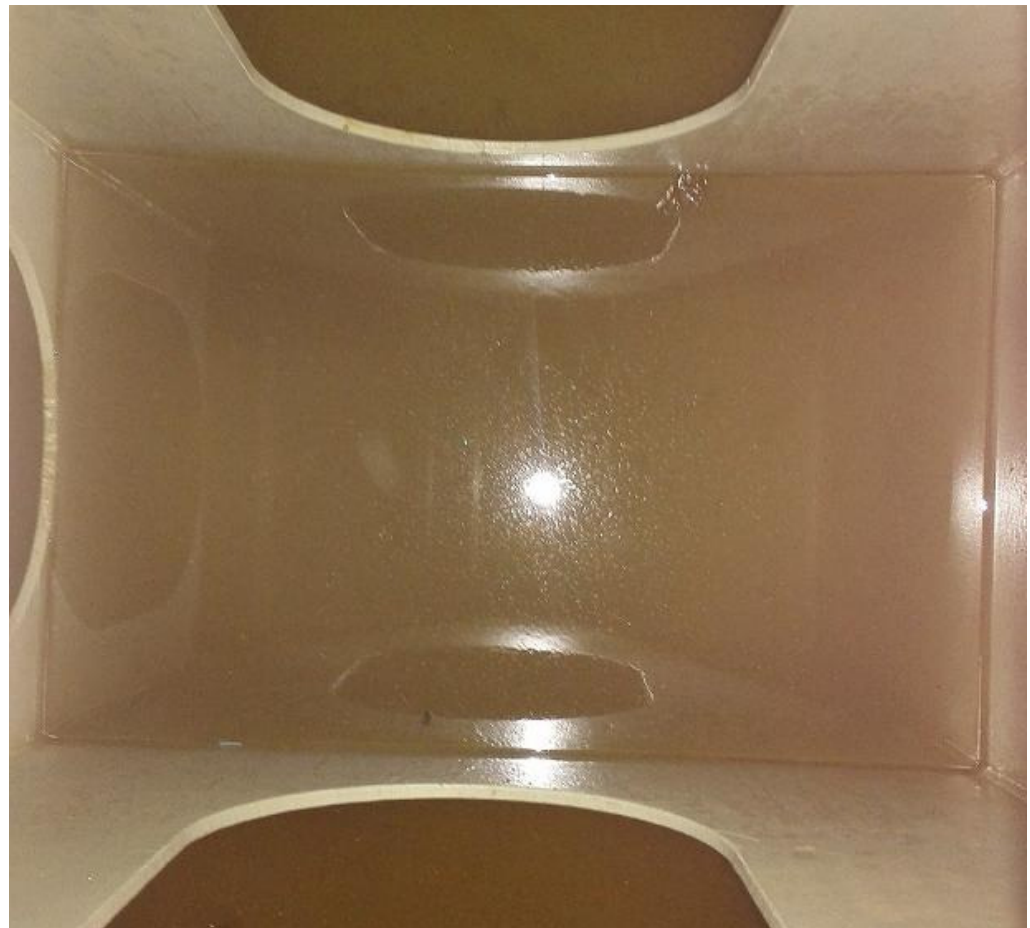
During the inspection of the WATER INGRESS ALARM the EMERGENCY FIRE PUMP ROOM was in alarm. (See pictures below)

An oily water mixture was discovered in the bilge of the emergency fire pump room (about 25cm sounded). According the bilge pumping arrangement a direct discharge to sea was possible. This deficiency was recorded with ground for detention.

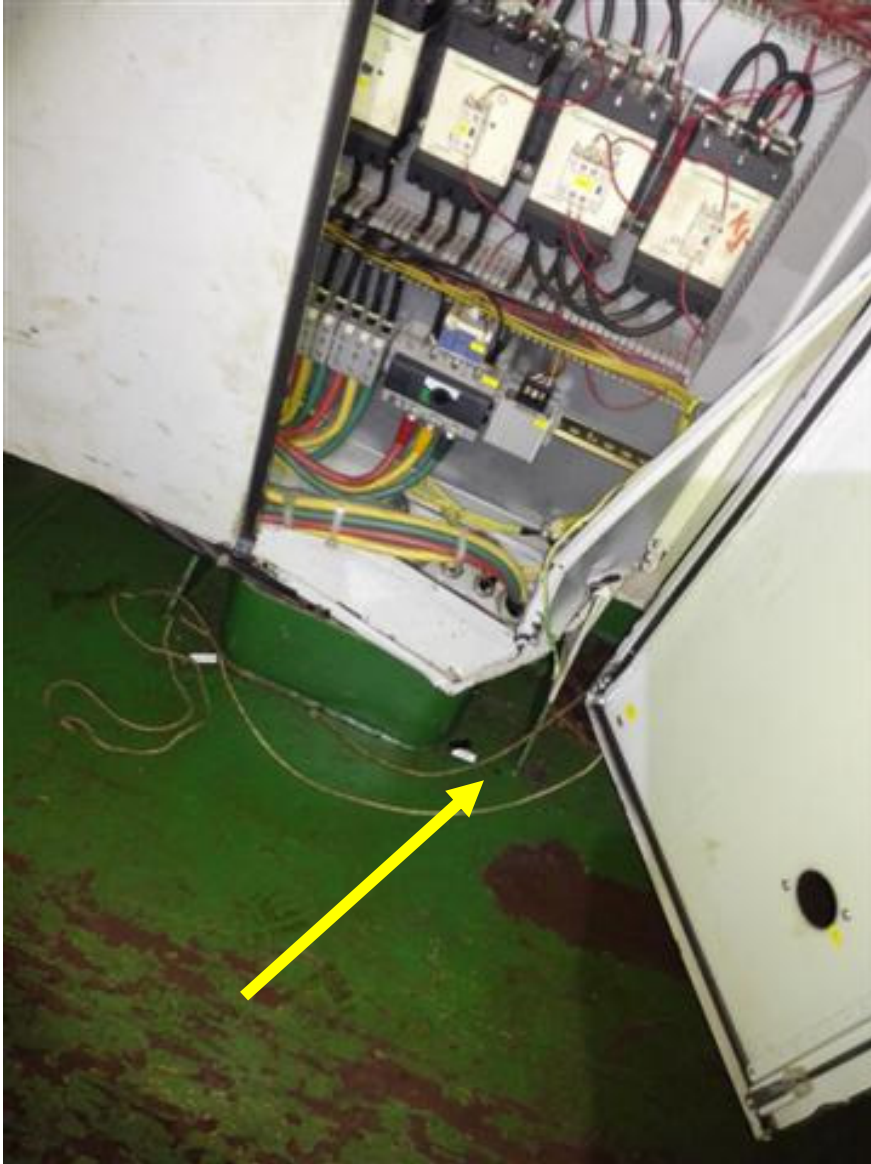
Because of the many unlash drums, both mooring winch control cabinets were heavily damaged. The cabinets were impossible to be closed at all. Crew stated during interview that this had been known for a long time but no spare part orders were forwarded to the company at all. Due to all these facts, this deficiency was recorded with ground for detention.

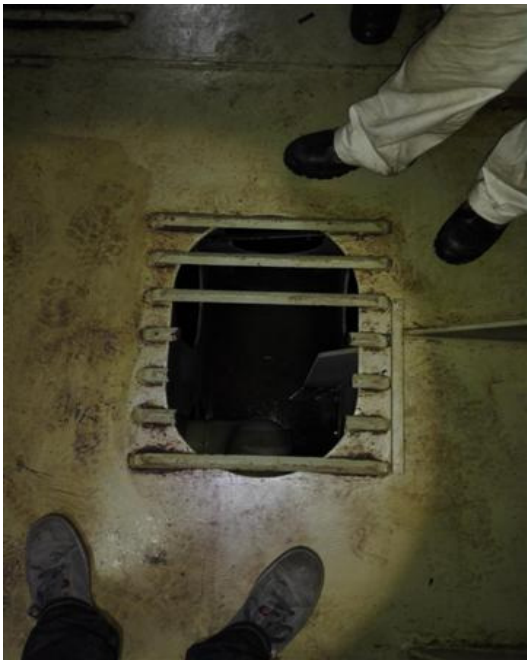
On this picture the fixed steel manhole cover for the bilge is broken. Nobody of the crew could explain why or when this had happened. In this dimly lit area a broken cover like this could lead to serious injuries.

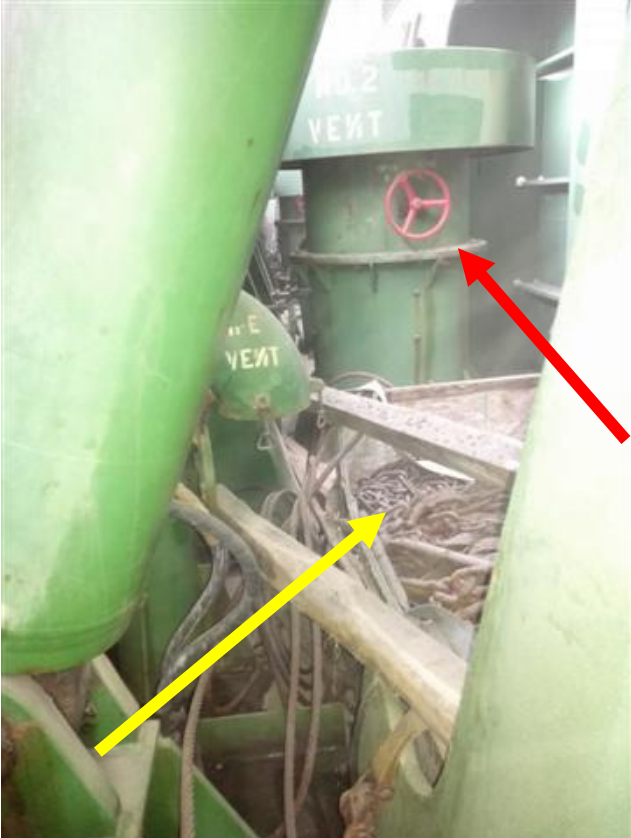
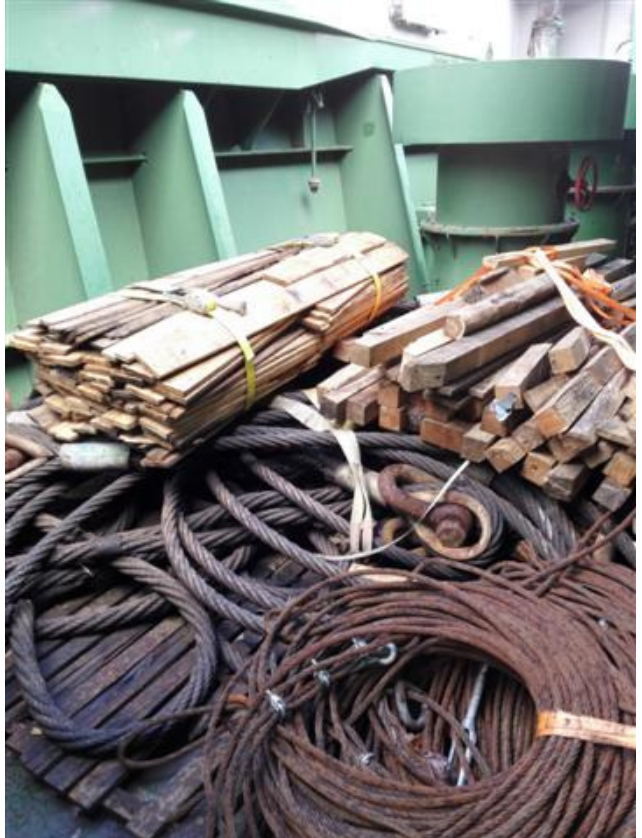
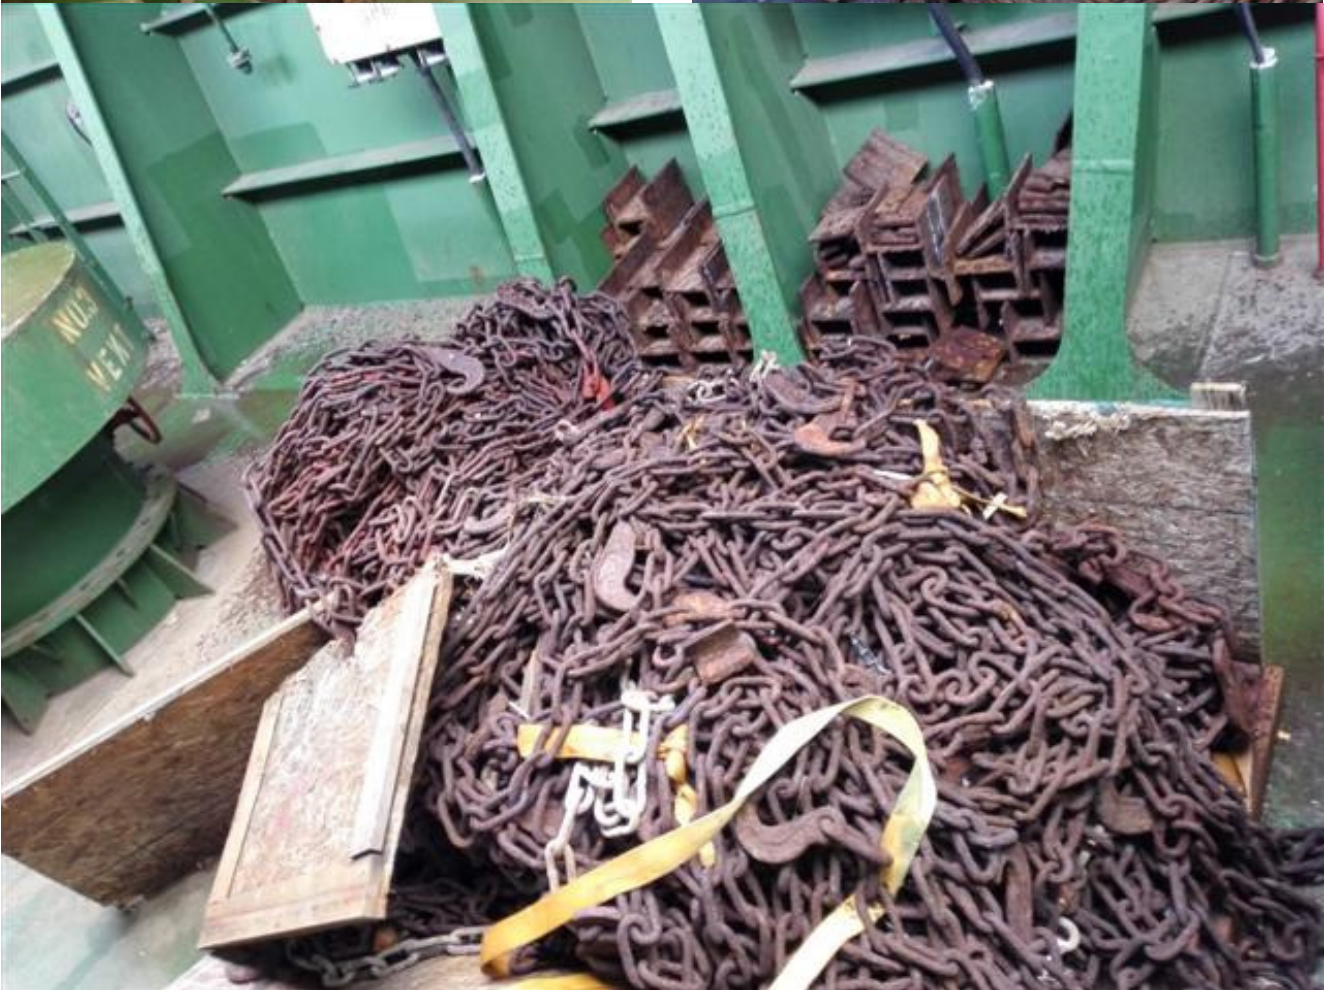
After the inspection of the bosun store, the deck tour continued with an obscure mixture of unlashed deck- and cargo-equipment. Crew confirmed that this equipment remained from previous voyages and had now been "stored" on deck for an unknown time. Ground for detention.

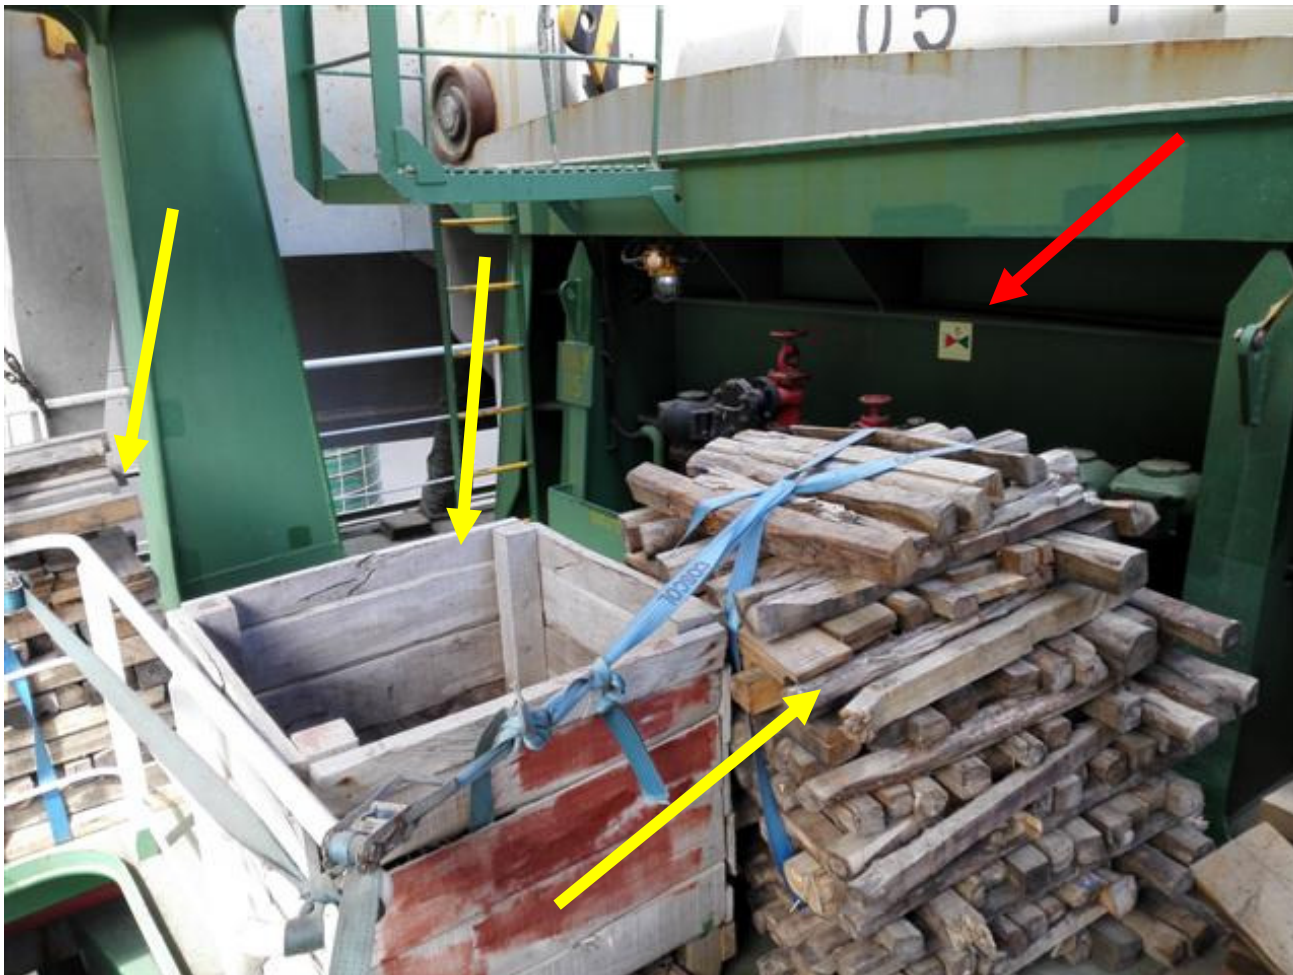
In this picture the fire fighting equipment is totally blocked by dunnage. Hydrants and also fire hose cabinets were not readily accessible at all. This deficiency was recorded with ground for detention.

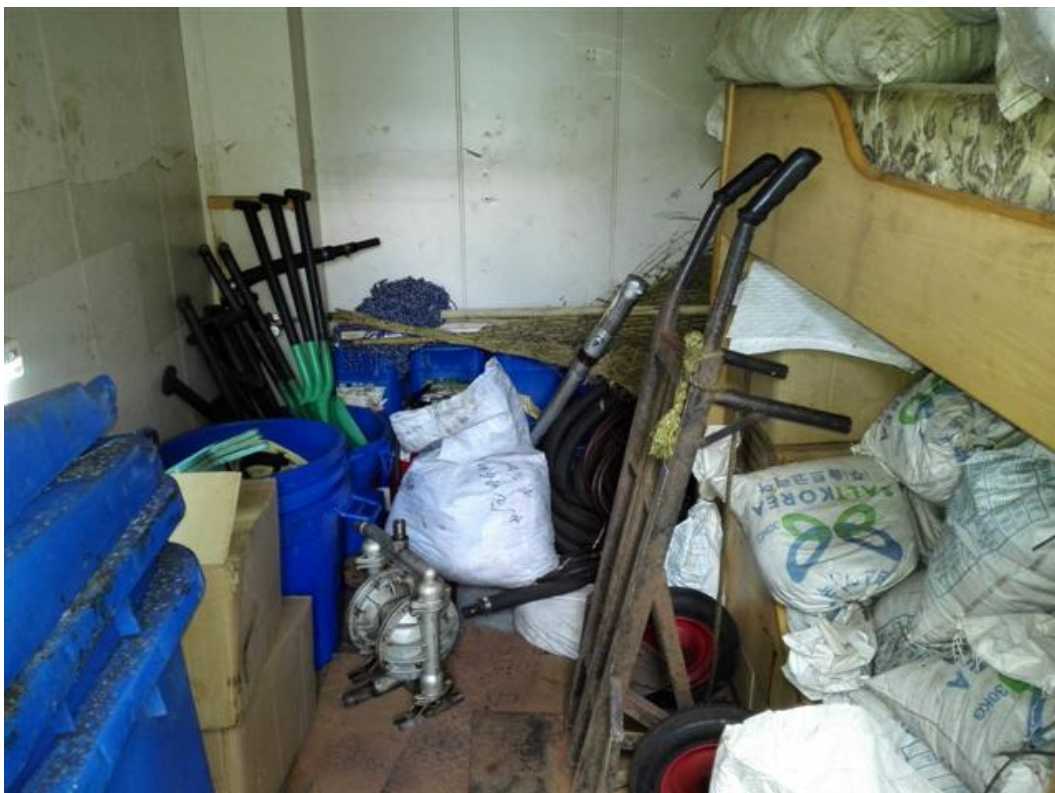
The former Suez crew cabin is used as SOPEP store, still furnished with the bunk beds. Inside the room an unacceptable mess of equipment was discovered. If a quick reaction against an oil spill were necessary, there would be no chance to handle the spill in a professional way.

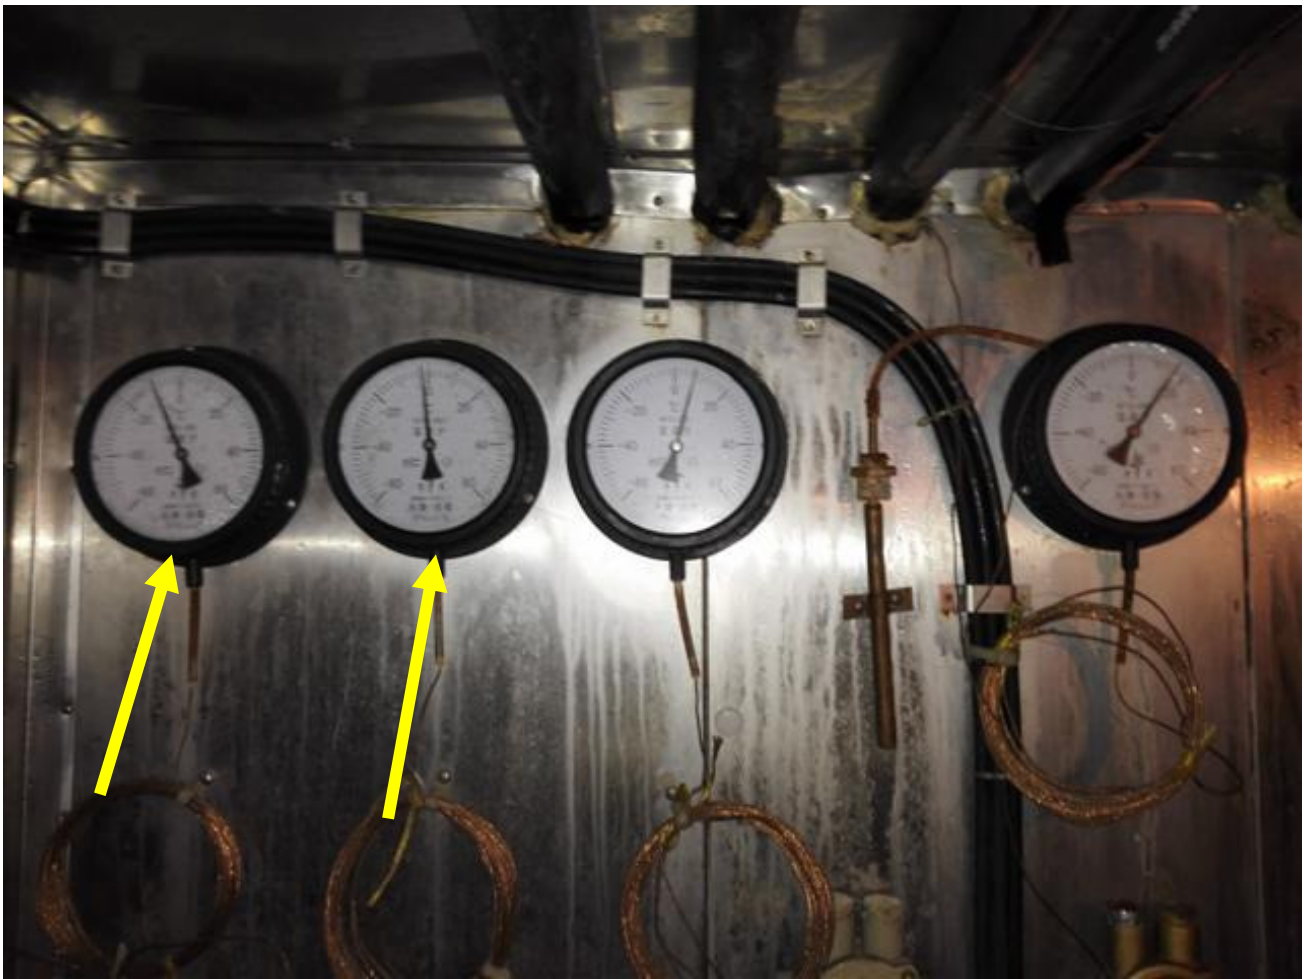
Temperature sensors of freezers fully out of range, resulting in iced meat and rotten food full of mould.

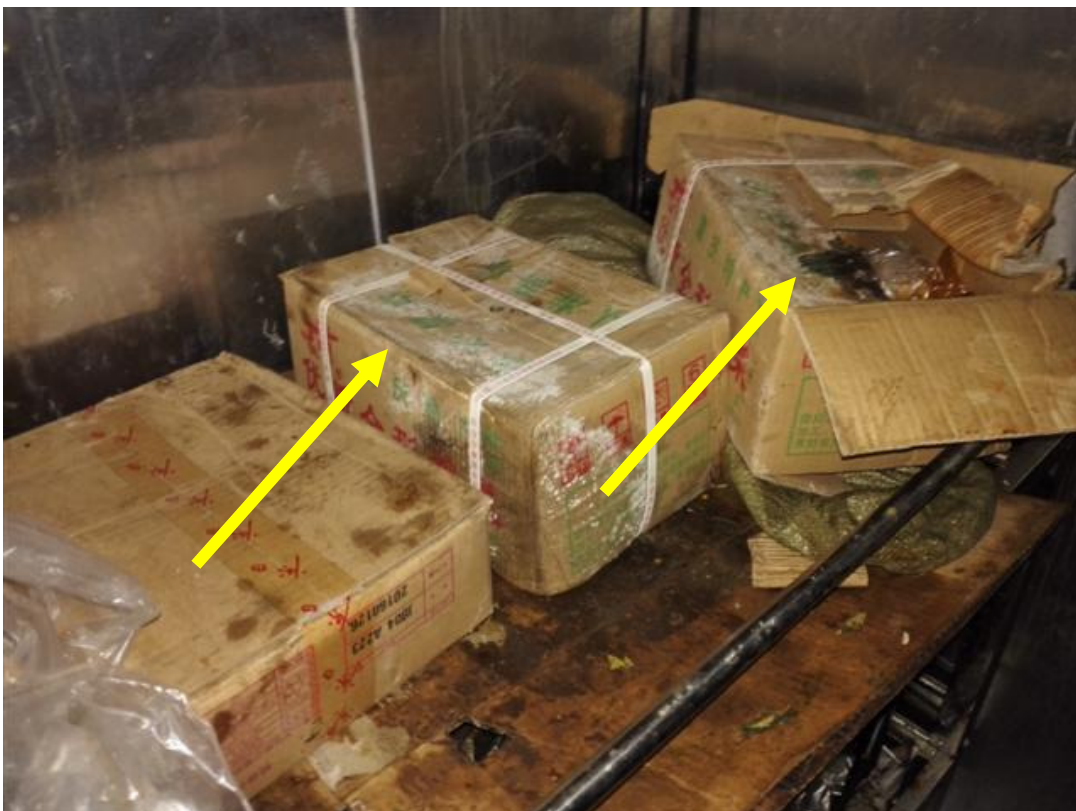
Packed vegetables already fully covered with mould and an awful smell inside all the provision stores.

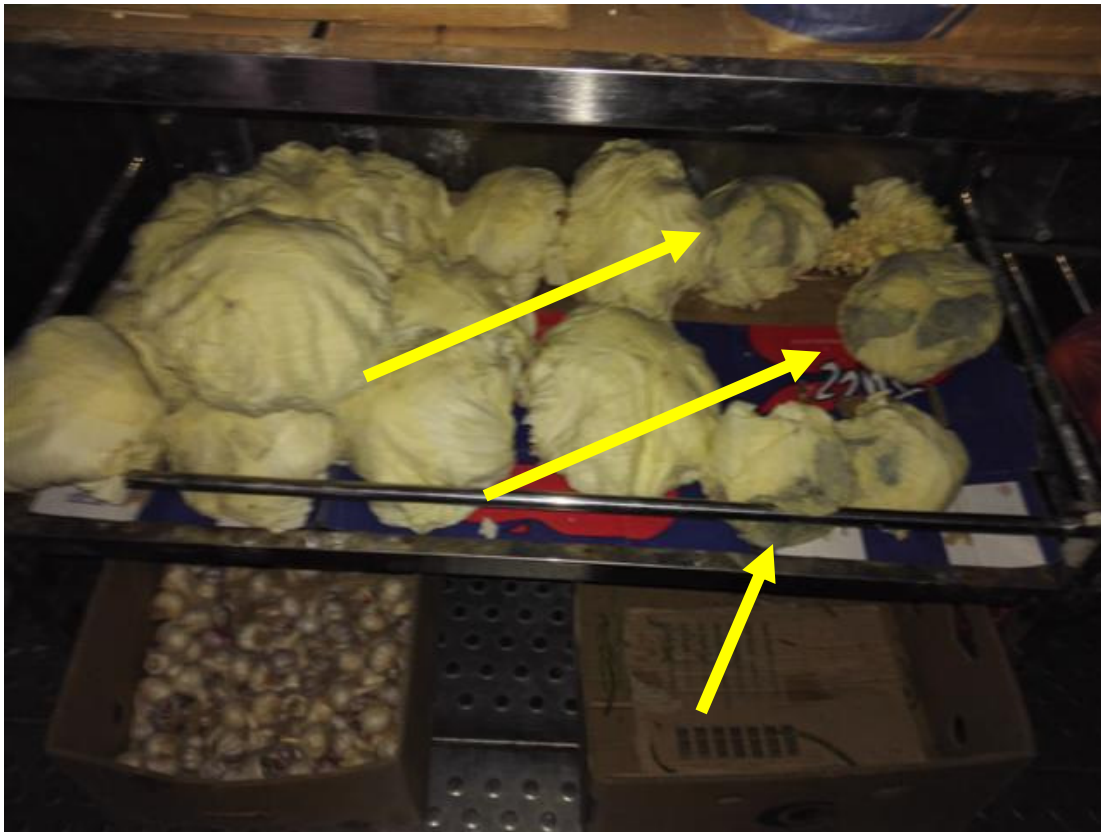
Lettuce heads covered with black mould. This is a high risk of food poisoning for all crew. The mould covered all kinds of vegetables all over the provision store.

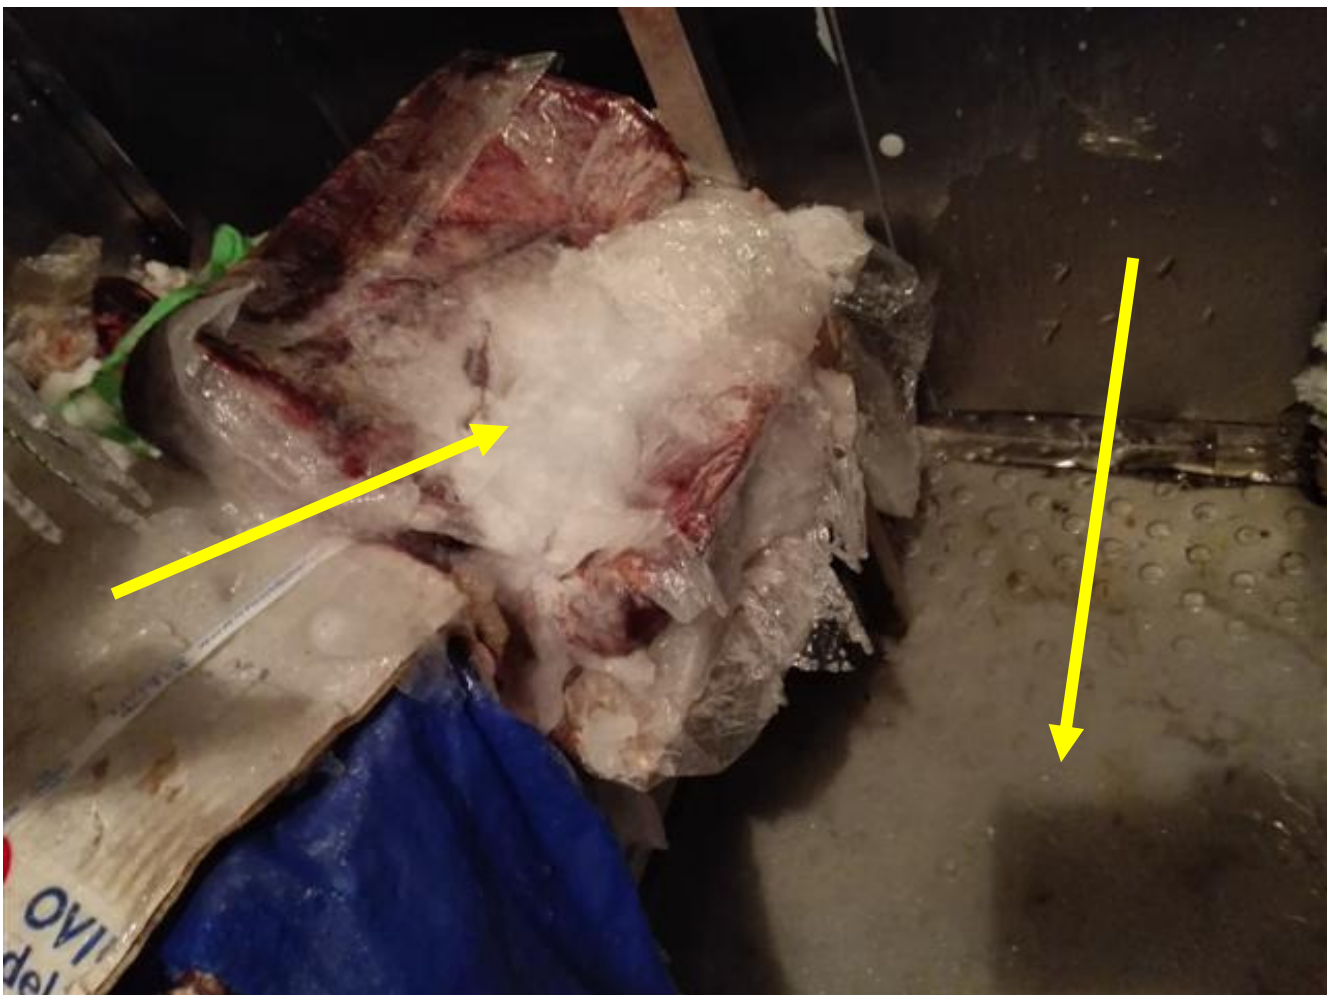
In deep freezer room heavy icing of meat and floor caused by overheating (-10°) and improper gaskets.

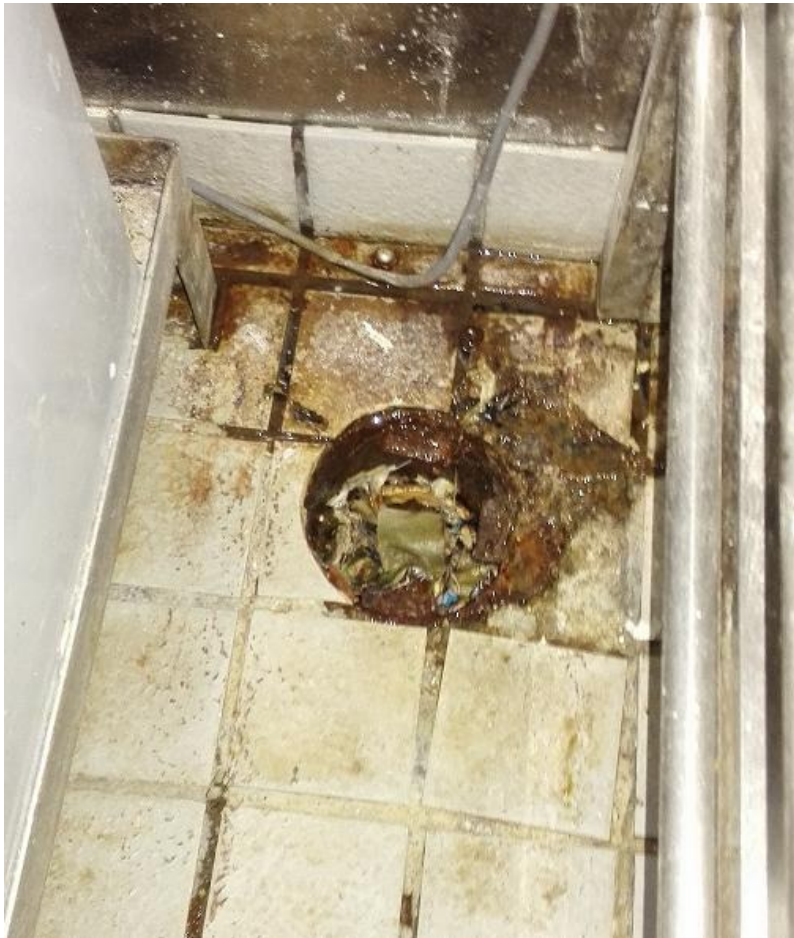
Inside the galley the unhygienic situation continued. Waste, dirt, rotten food and other unknown substances were visible in every corner. The PSCO had the impression, that the galley hadn't been cleaned for months.

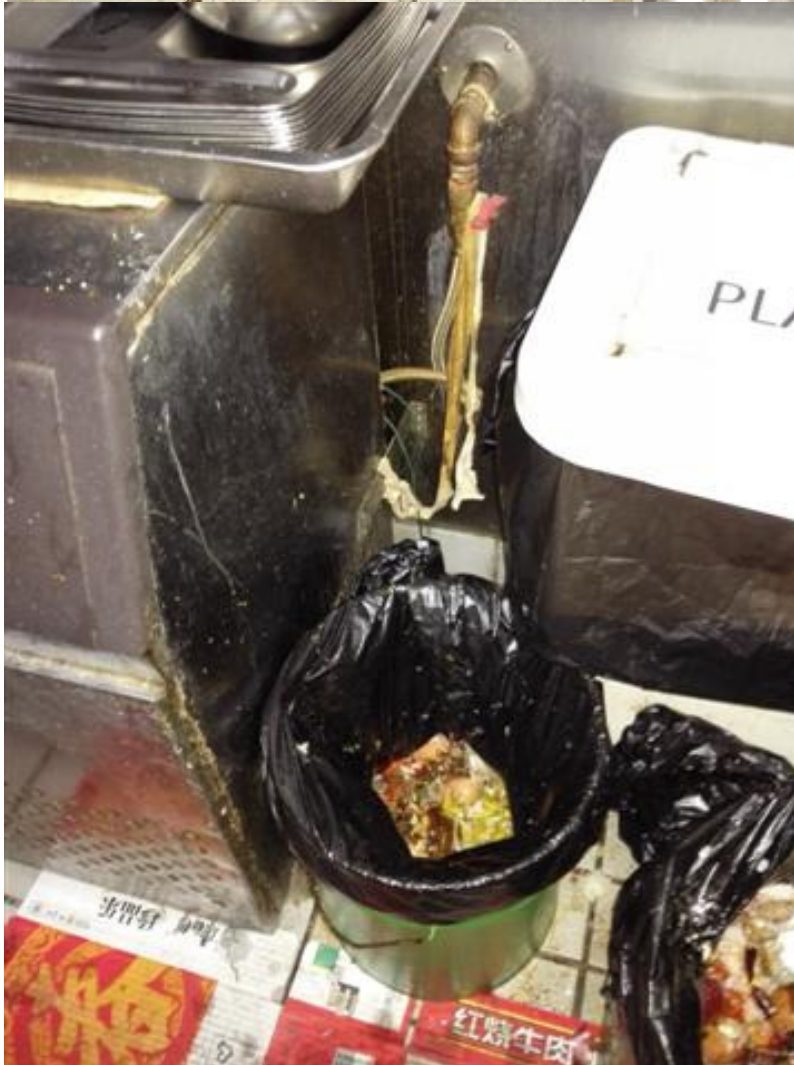
Open waste drums full of old food, walls and floor sticky and a mess of galley equipment was the situation encountered during the first boarding. All these factors combined led to the decision that the absolutely unhygienic situation in galley and provision stores must lead to a deficiency marked with ground for detention.

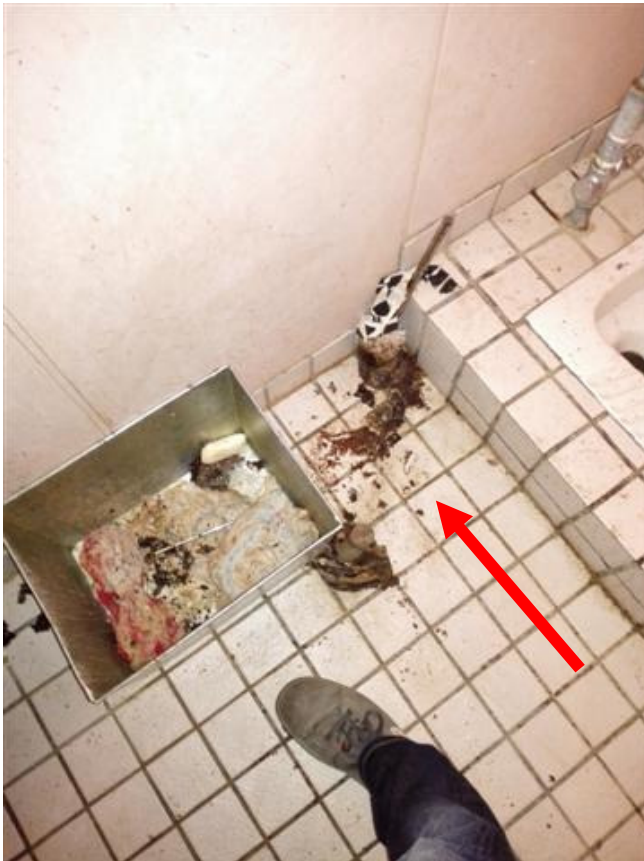
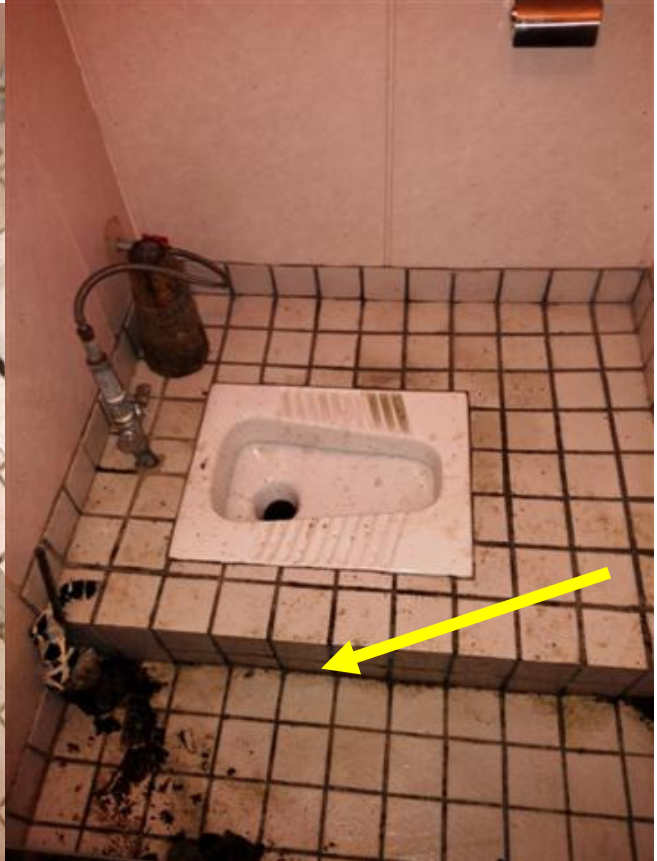
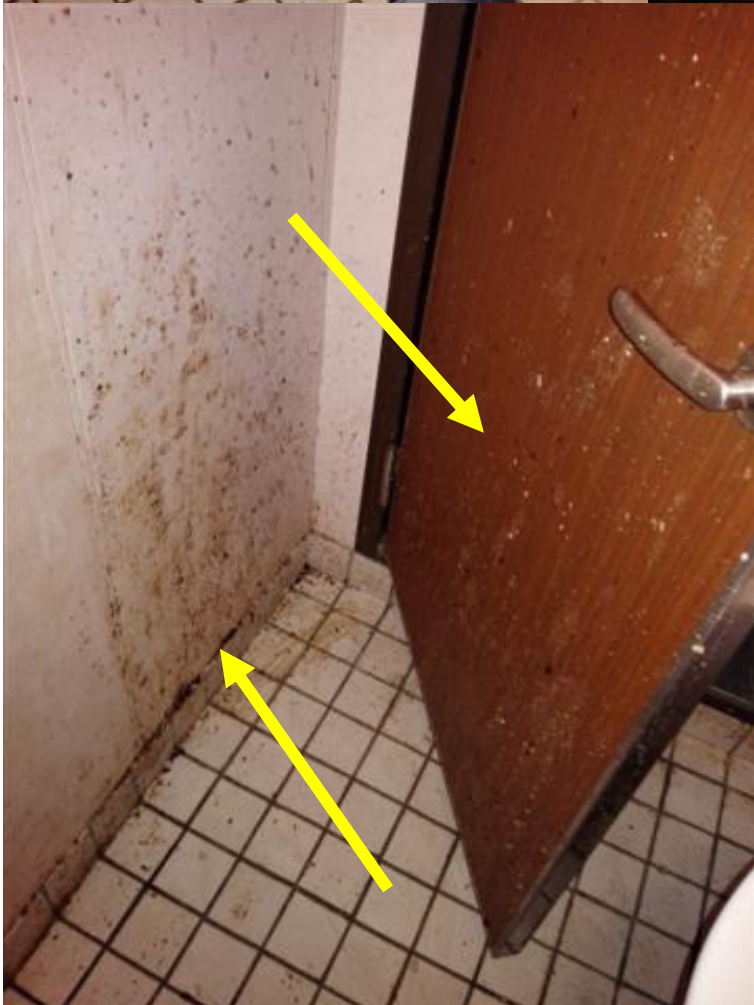
The inspection of the sanitary facilities was the most shocking moment of the PSC, floors and walls were totally contaminated with feces including a disgusting smell. During the whole inspection the PSCOs were under the permanent impression that the crew is fully disinterested and unmotivated. When addressing any of the deficiencies to the crew nobody could explain when or why the specific deficiency occurred. The HUANGHAI DEVELOPER is for sure not the worst ship the PSCOs had ever seen, but she shows what happens to a just 3 years old vessel if the complete ISM system collapses caused by a total lack of maintenance and motivation. At the end of the day, 24 deficiencies were recorded, 11 of them with ground for detention. The vessel was arrested for 3 days before she was allowed to continue her voyage.
