DEPARTMENT OF THE NAVY
OFFICE OF THE CHIEF OF NAVAL OPERATIONS
2000 NAVY PENTAGON
WASHINGTON, DC 20350-2000

Enclosure (1) Report on the Collision between USS FITZGERALD (DDG 62) and Motor Vessel ACX CRYSTAL

Enclosure (2) Report on the Collision between USS JOHN S MCCAIN (DDG 56) and Motor Vessel ALNIC MC

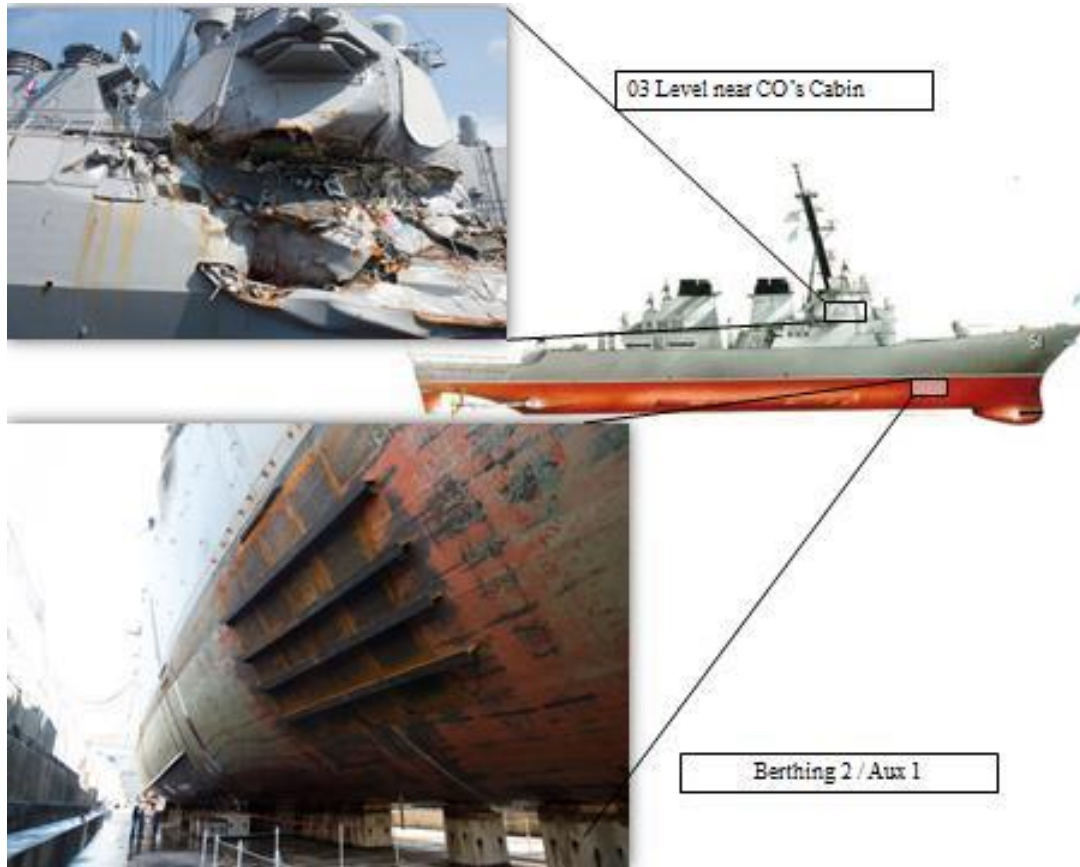
Figure 8 - Starboard side of FITZGERALD

The impact of the top of CRYSTAL's bow above the waterline crushed the false bulkhead (a non-structural steel wall that is the shipboard equivalent of a non-load bearing wall in a house, used to divide a space) and non-watertight door within the Commanding Officer's cabin. The Commanding Officer's cabin is composed of two small rooms: an office area with a desk, table, and couch with seating for several people; and his bedroom. The two rooms are separated by this false bulkhead and door. The outer wall was pushed in and torn open by the impact.

Inset Above: Damage to FITZGERALD above the waterline at the 03 Level near CO's Cabin

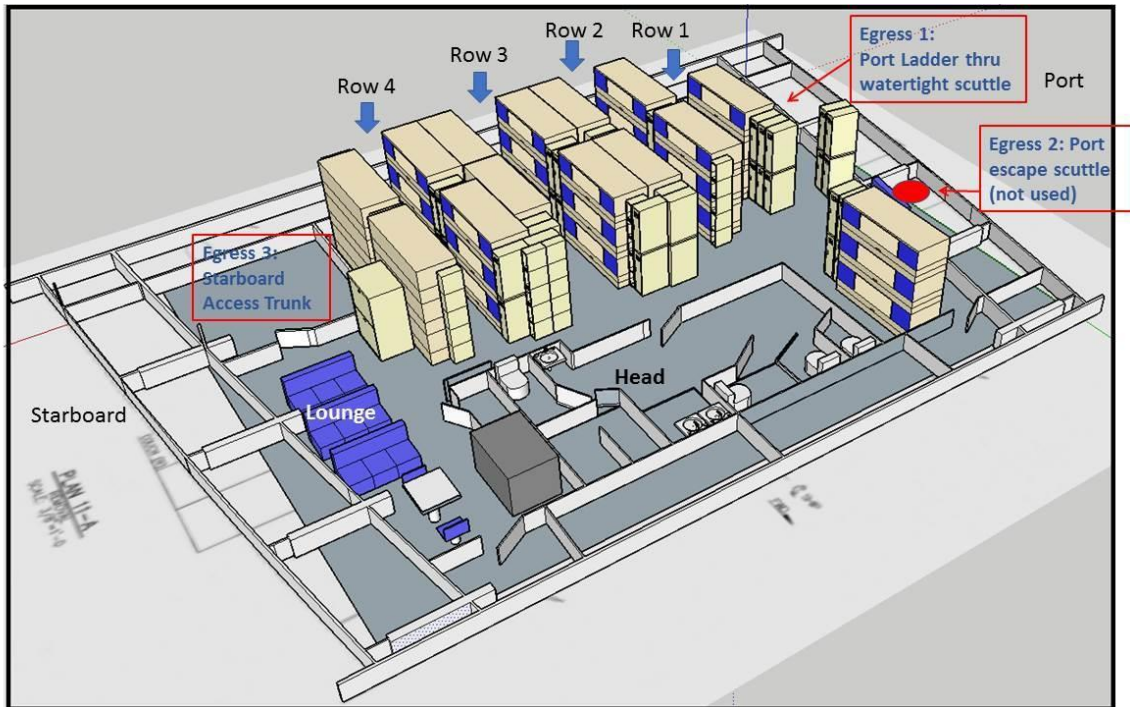
Figure 15 – Berthing 2 Layout of Racks and Lockers (facing aft)

The flooding of Berthing 2 resulted in the deaths of seven FITZGERALD Sailors. The racks of these seven Sailors were located in Rows 3 and 4, the area closest to the starboard access trunk and egress point and directly in the path of the onrushing water, as depicted in Figure 15.

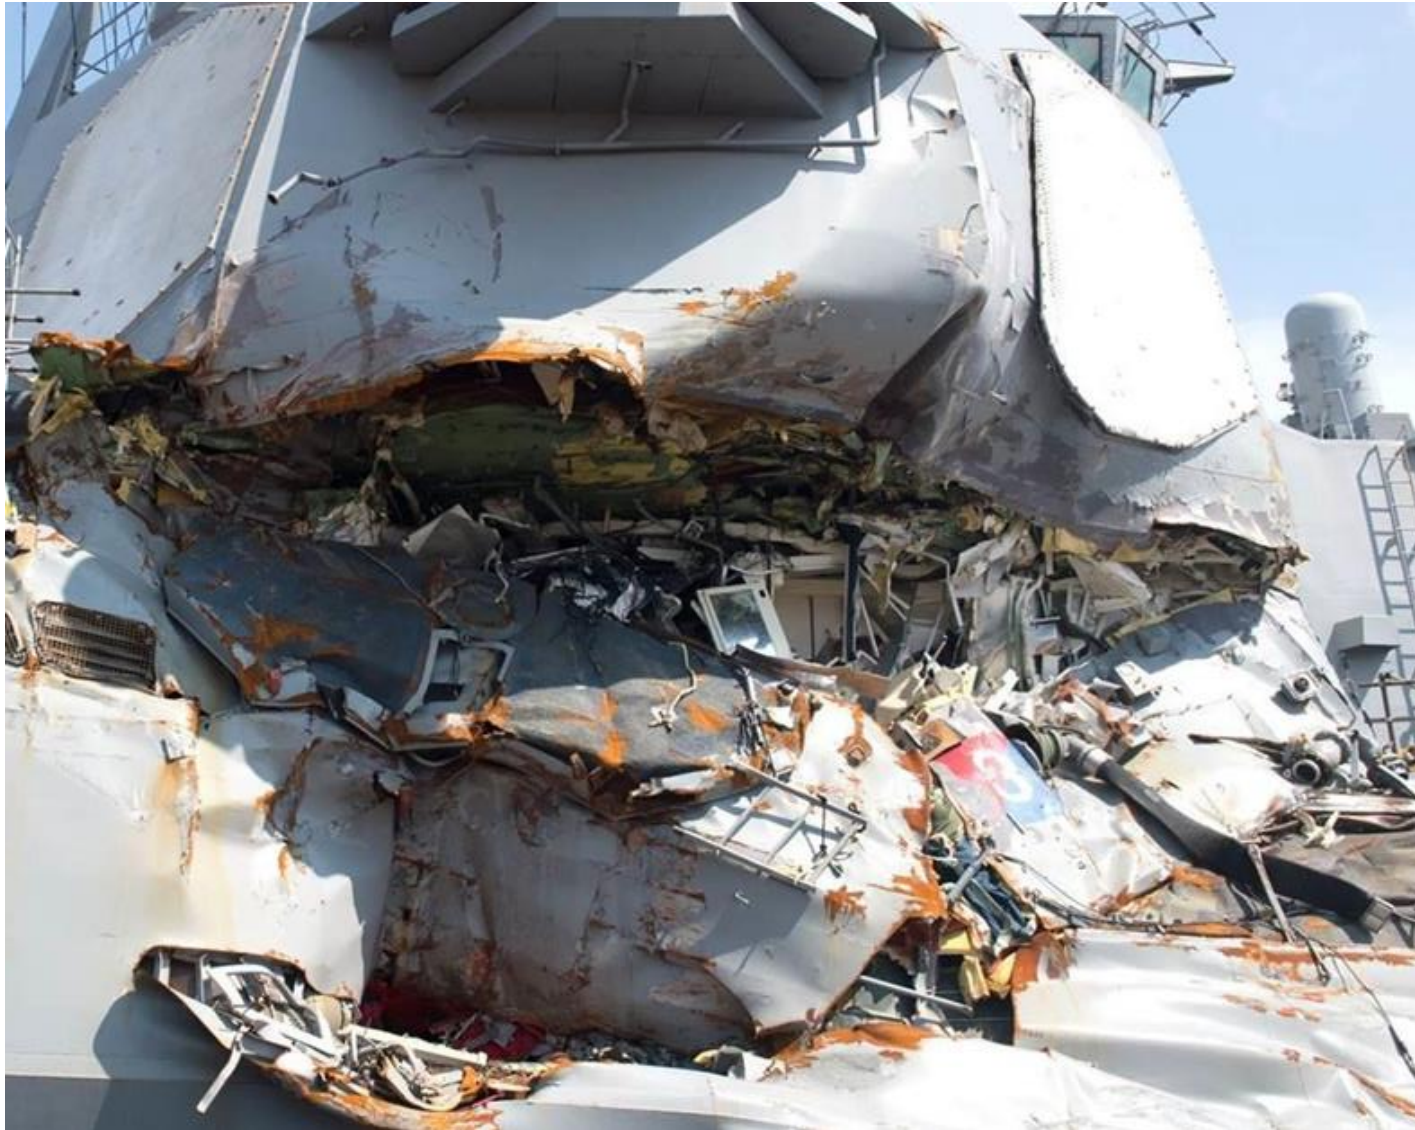
B2: Commanding Officer's Stateroom on FTZ - Interior view

The Commanding Officer was in his cabin at the time of the collision. The CRYSTAL's bow directly struck his cabin, located above the waterline. The impact severely damaged his cabin, trapping him inside. The CO called the bridge requesting assistance.

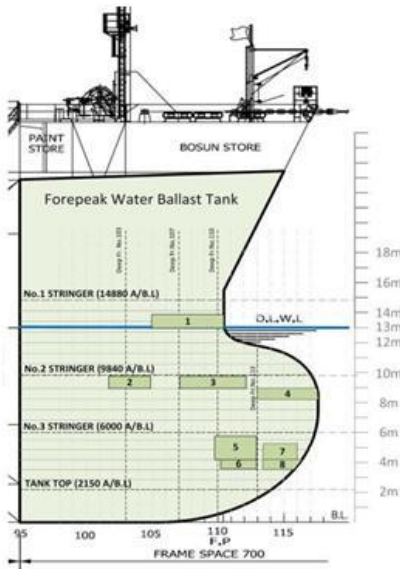
The bulbous bow of ALNIC MC impacted JOHN S MCCAIN on the port (left) aft side. The impact created a 28-foot diameter hole both below and above the waterline of the JOHN S MCCAIN. See Figures 7, 8, and 9.

Figure 8 – Bulbous bow of ALINIC MC and damage to hull from bow to stern

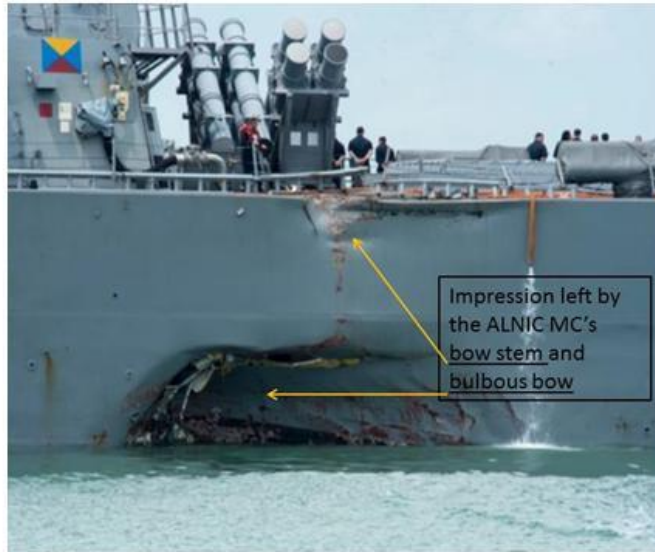
Figure 9 – Point of impact on JOHN S MCCAIN from ALINIC MC

The point of impact was centered on Berthings 3 and 5 as noted in Figure 9. All significant injuries occurred to Sailors that were in Berthing 3 at the time of the impact. All ten of the fallen Sailors were in Berthing 5 at the time of impact.

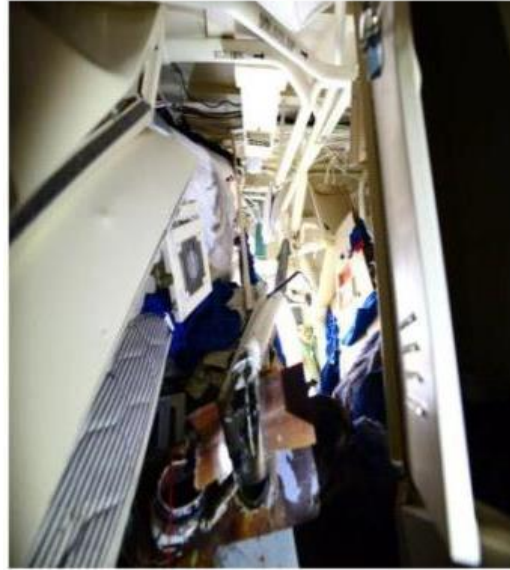
At 0530, the DCA began receiving reports of a ruptured fire main and water and fuel flooding into Berthing 3. The port side of Berthing 3 suffered substantial damage, including a large hole in the bulkhead. See Figure 13. Racks and lockers detached from the walls and were thrown about, leaving jagged metal throughout the space. Cables and debris hung from the ceiling.

Figure 16 – Berthing 3 facing port after collision

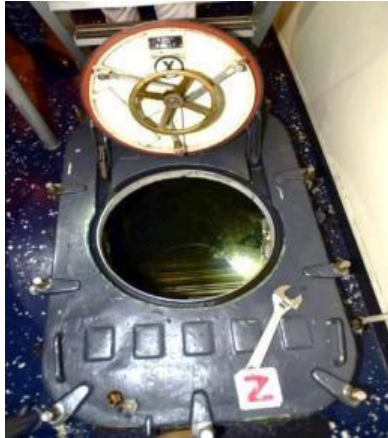
All Sailors in Berthing 4 were able to evacuate. At 0544, Sailors reported 4 inches of water on the deck in Berthing 4. Sailors in Berthing 4 were thrown about their racks by the force of the collision. By 0627, the berthing space was lost. See Figures 16 and 17.

Figure 17—Scuttle and hatch into Berthing 4 showing the space completely flooded

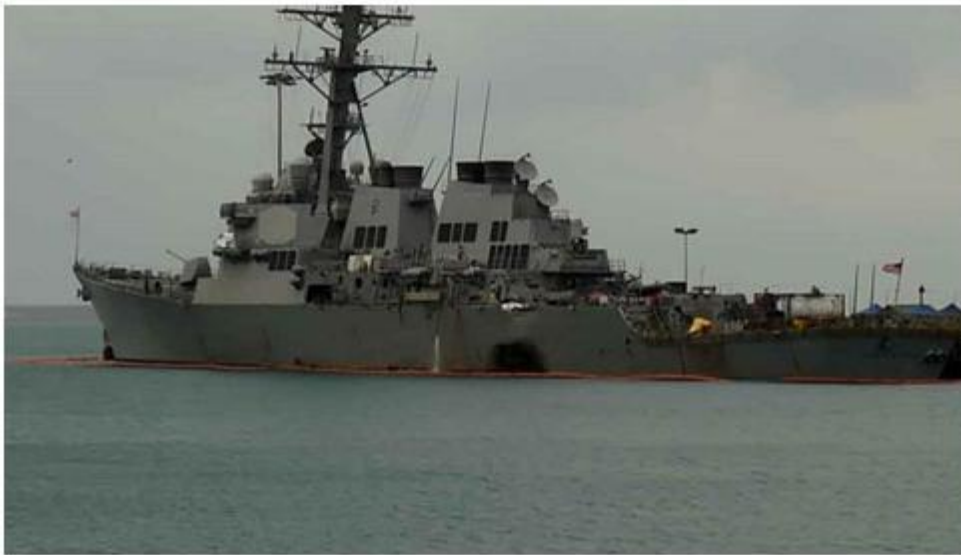
A team of Navy Divers arrived on JOHN S MCCAIN as the ship entered the harbor in Singapore at approximately 1200 on 21 August 2017. They began inspecting the ship to determine how best to proceed with a dive inside the ship. The leader of the dive team inspected Berthing 3 and saw waves breaking into the ship. The divers discovered the hole in the port side of JOHN S MCCAIN that was approximately 28 feet wide. See Figure 18.

Figure 19 – Port side of JOHN S MCCAIN post-collision

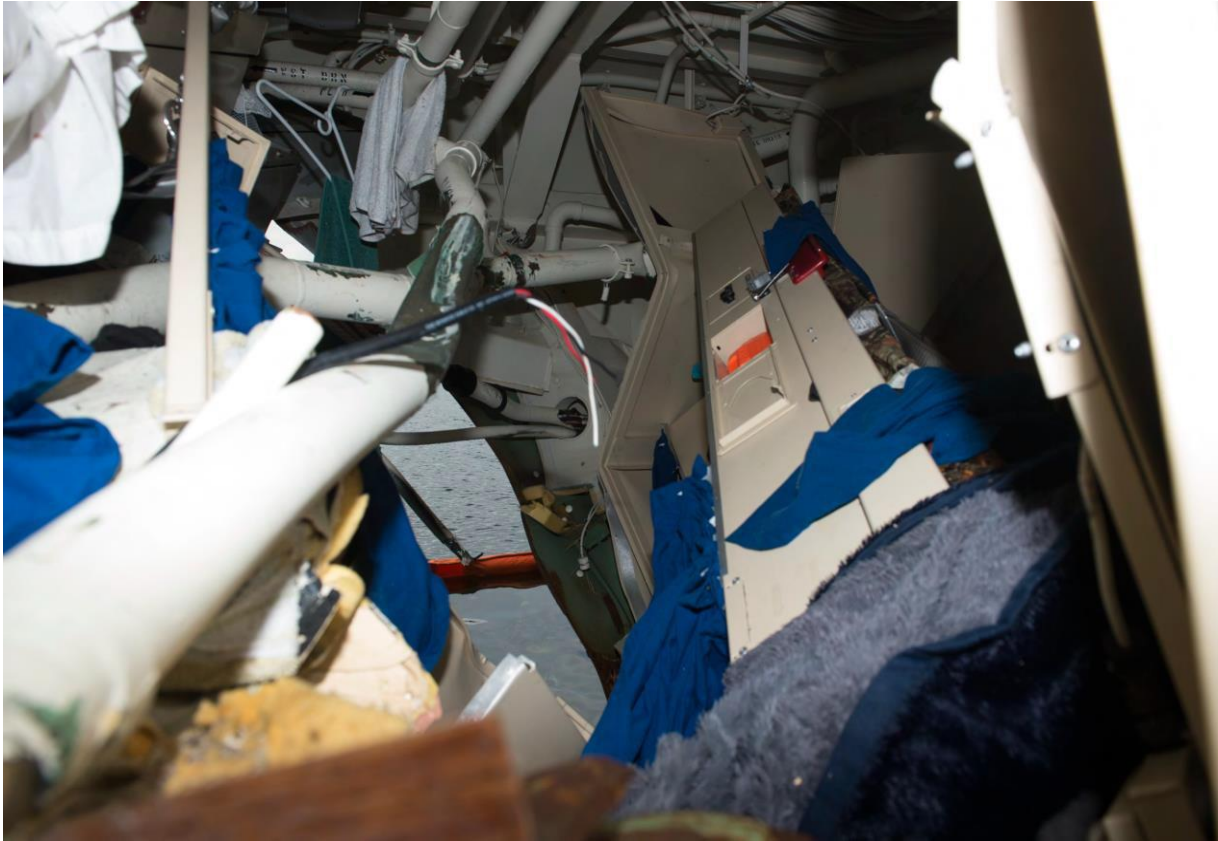
Internal view through Berthing 3 to point of impact; ocean visible

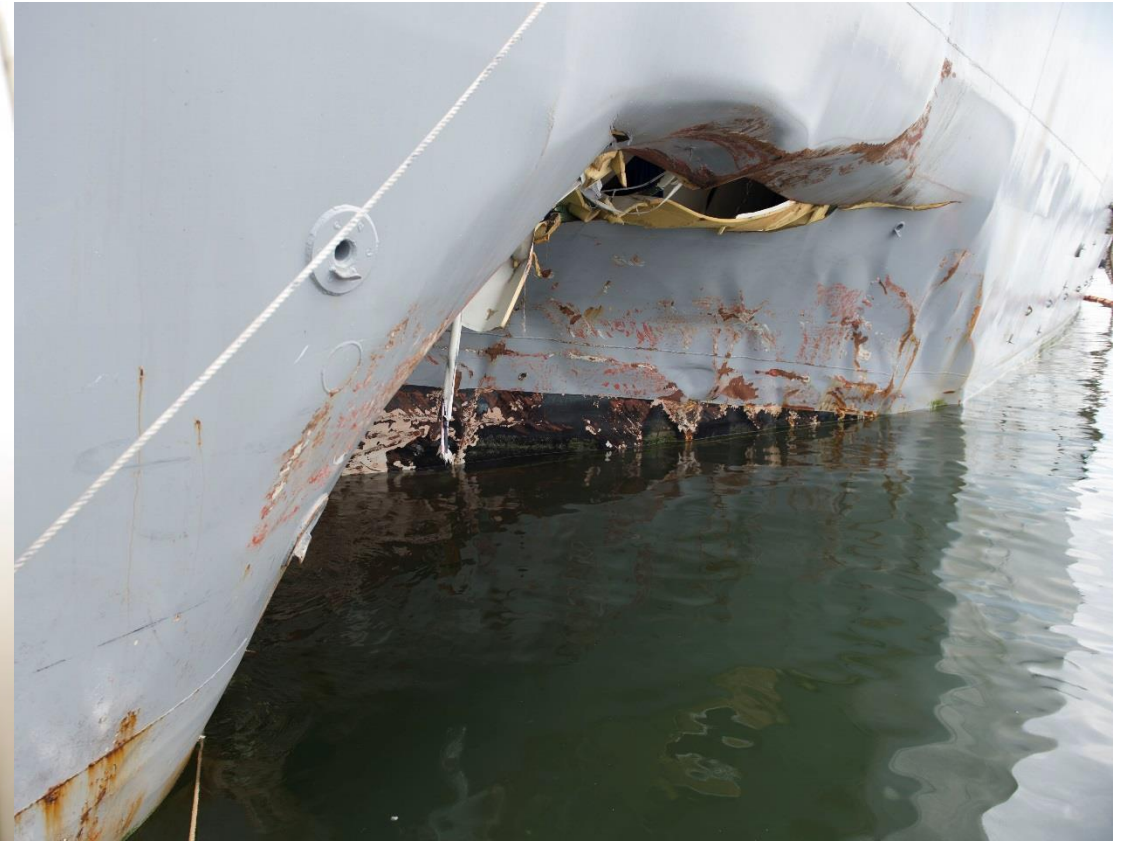
External view of point of impact; rupture in hull of the ship visible

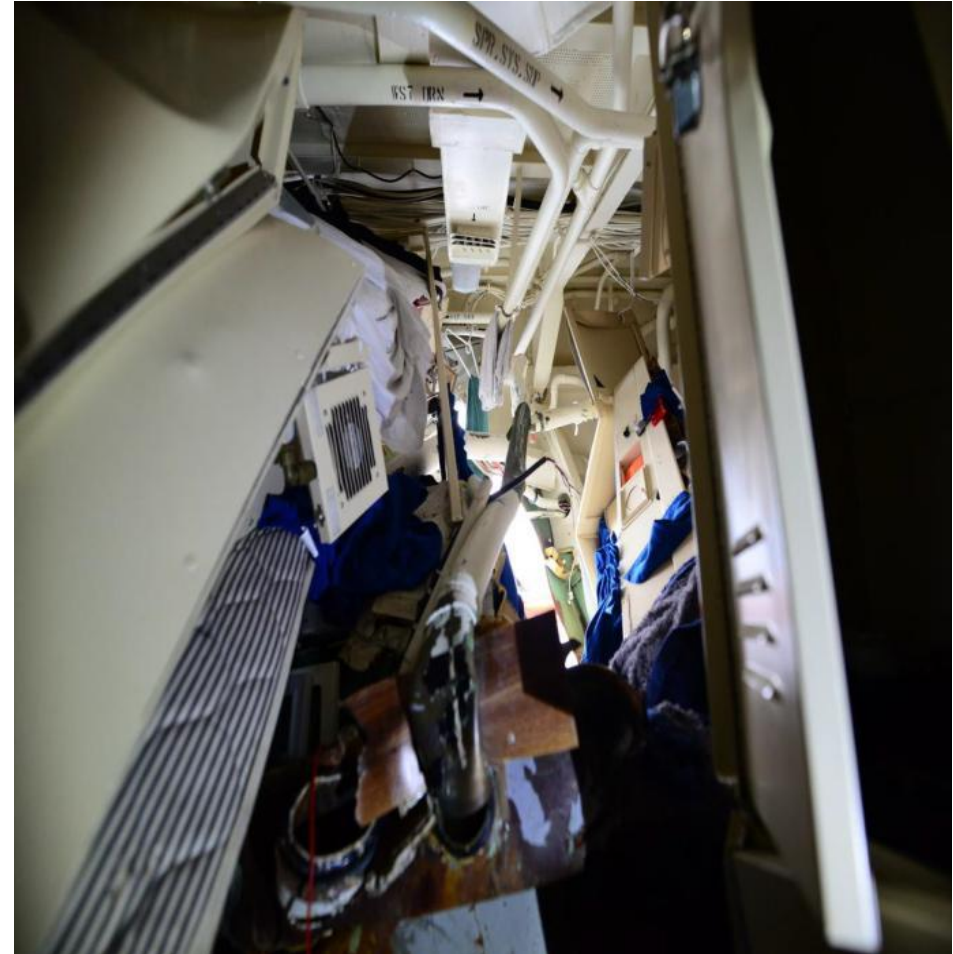
JOHN S MCCAIN, post-collision
