## **INTERIM REPORT 12 NOVEMBER 2019 ON THE INVESTIGATION INTO THE LOSS OF PROPULSION AND NEAR GROUNDING OF VIKING SKY, 23 MARCH 2019**

*The information contained in this interim report is based on investigations to date. Readers are cautioned that there is the possibility new evidence may become available that might alter the circumstances as depicted in this report.*

Accident Investigation Board Norway  
Postboks 213  
2001 Lillestrøm  
Norway  
Phone: + 47 63 89 63 00  
Fax: + 47 63 89 63 01  
<http://www.aibn.no>  
E-mail: [post@aibn.no](mailto:post@aibn.no)

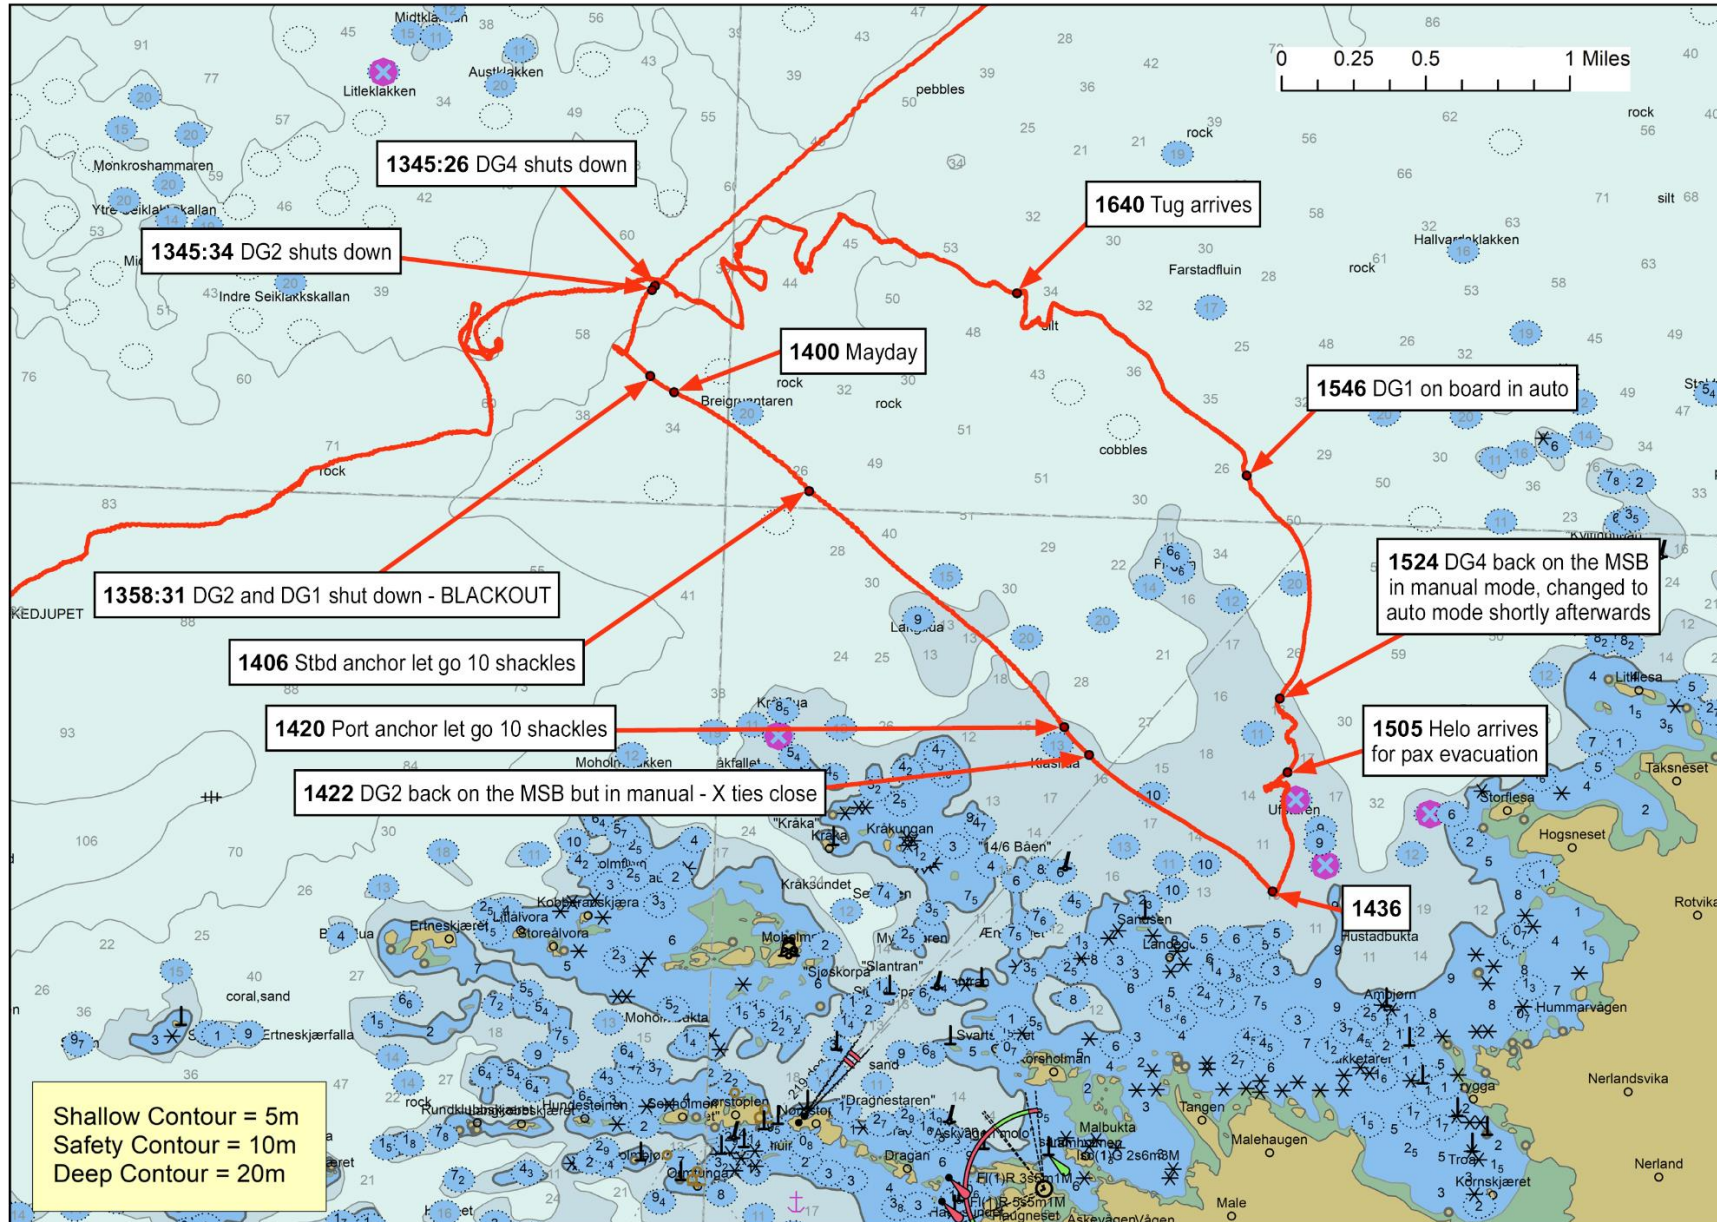
Figure 1: Sequence of events. Source: MAIB

No more alarms were registered until 13:37:04 when DG4 registered an alarm indicating that the DG was shedding load as a result of low lubricating oil pressure. A few seconds later it registered a low lubricating oil pressure alarm. At 13:39:52, DG1 registered a low low lubricating oil sump level alarm. A little over five minutes later, at 13:45:26, DG4 shut down followed by DG2 eight seconds later. DG2 was restarted after approximately 11 minutes, but shut down again along with DG1 at 13:58:31, causing a complete blackout and loss of propulsion.
