MARINE SAFETY INVESTIGATION REPORT

Safety investigation into the serious occupational accident on board the
Maltese registered heavy lift /pipelay vessel

PIONEERING SPIRIT

MARINE SAFETY INVESTIGATION REPORT NO. 02/2021

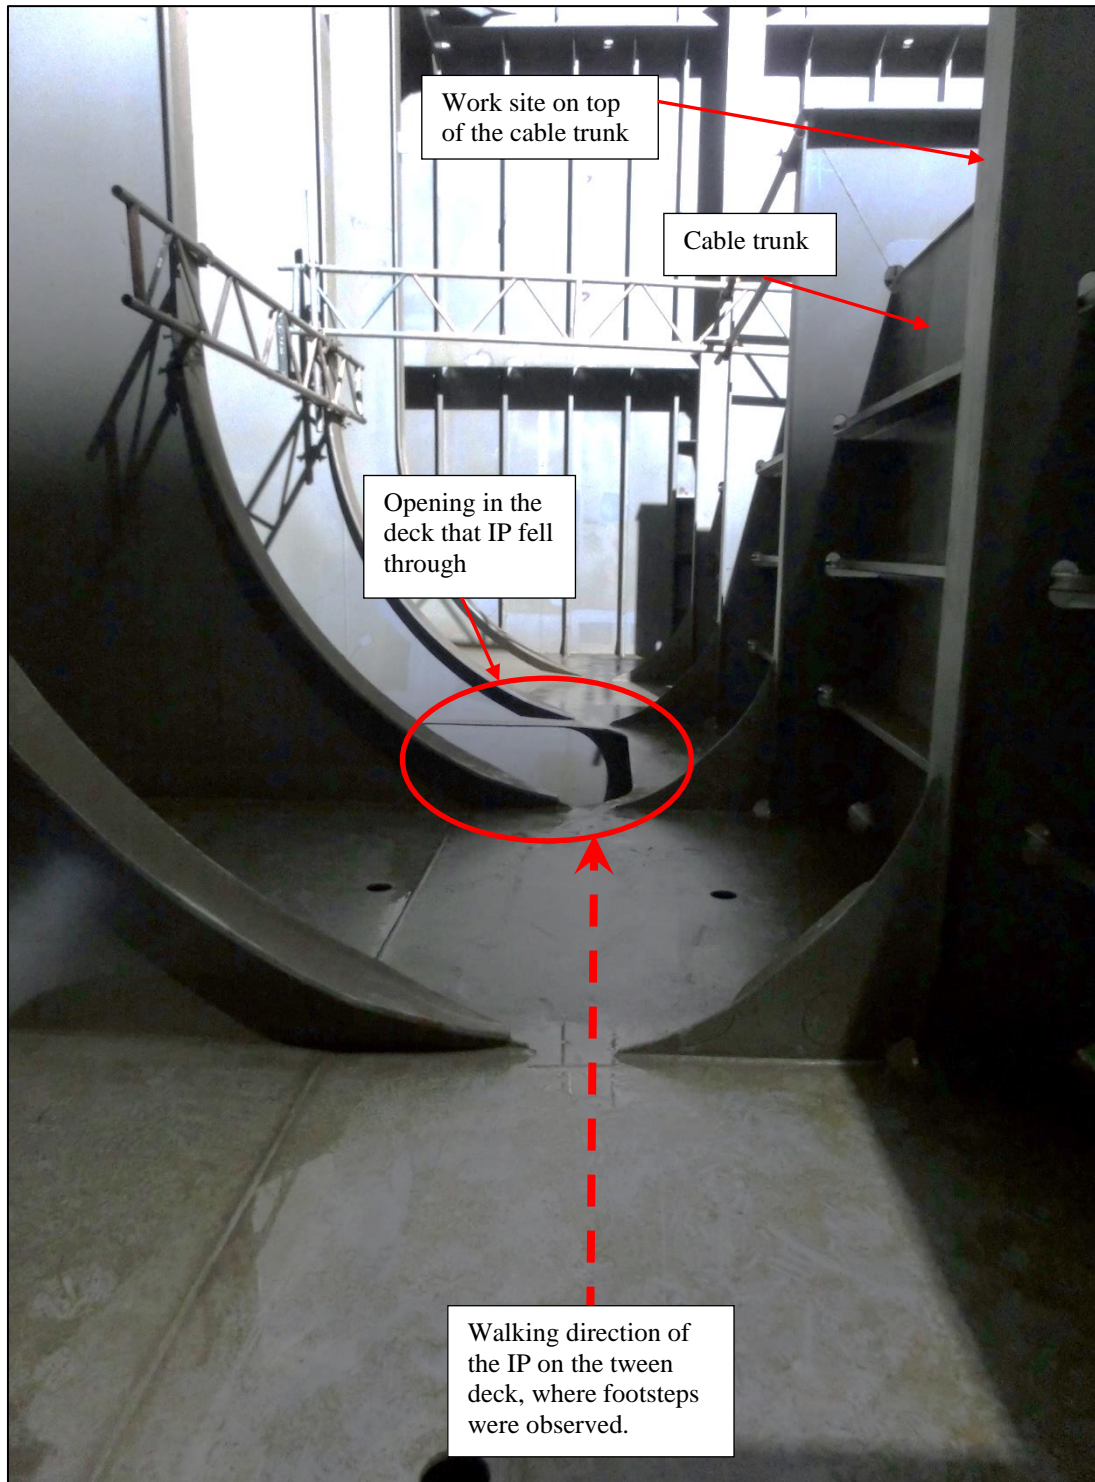
Figure 12: Access ladder passing cable trunk. Lighting conditions are similar to those at the time of the accident

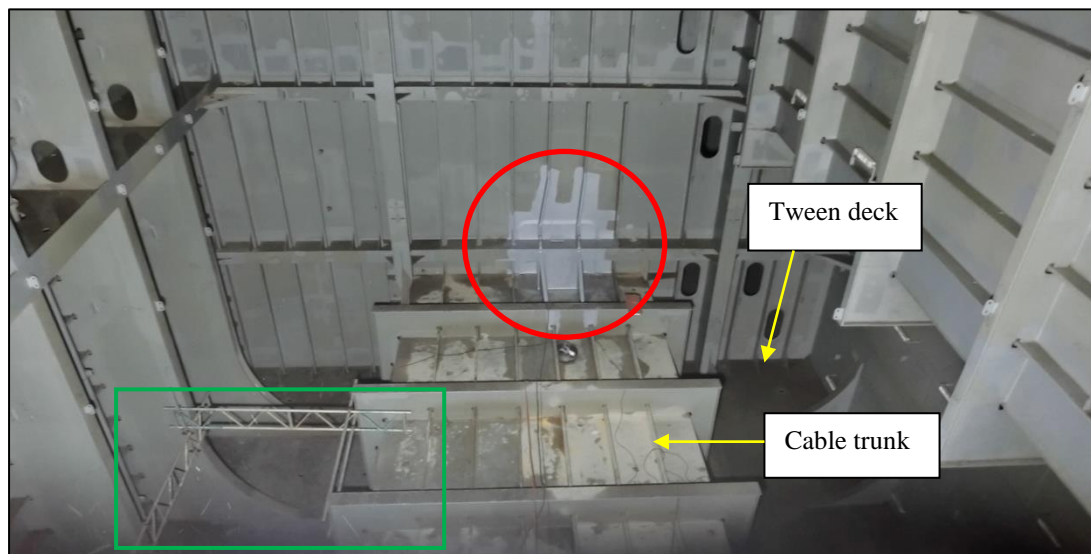
The welding job was to be carried out at the aft bulkhead on top of a large cable trunk, located on the tween deck of the tank structure (Figure 5), which the welder⁶ had stepped on to, from the access ladder. When the IP started lowering the hoses from the welding machine, the welder grabbed and dragged them to the work site. At this time, the two crew members that were inside the tank had visual contact with each other. After that, the welder observed the IP making his way down the second access ladder, and then he turned around, and started to mark where the stiffeners had to be welded on to the sheave-block assembly reinforcement.

Figure 5: View inside of the WBT. Position where stiffeners were to be welded on, marked in red. Scaffolding (marked in green) was rigged during the recovery of the IP

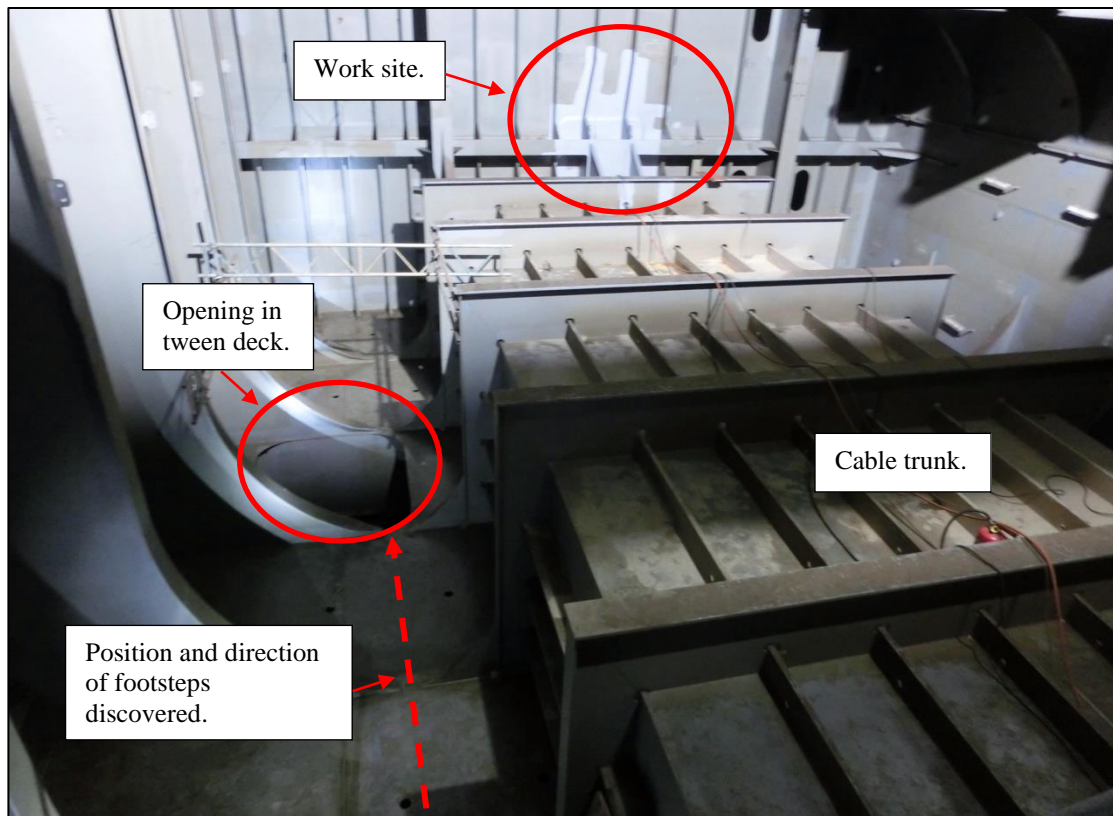
At around 1330, on his way down the ladder, the first welder helper shouted for the IP but received no response. He shouted to the welder that the IP was nowhere to be found on the tween deck below the trunk. When the first welder helper made a turn at the bottom of the access ladder, he observed fresh shoe prints on the otherwise untouched sludge coating on the tank tween deck going aft from the tank access pathway, which was bounded by hand railings. The shoe prints led along the side of the trunk in the direction of the work site (Figure 6).

Figure 6: Most probable route taken by the IP

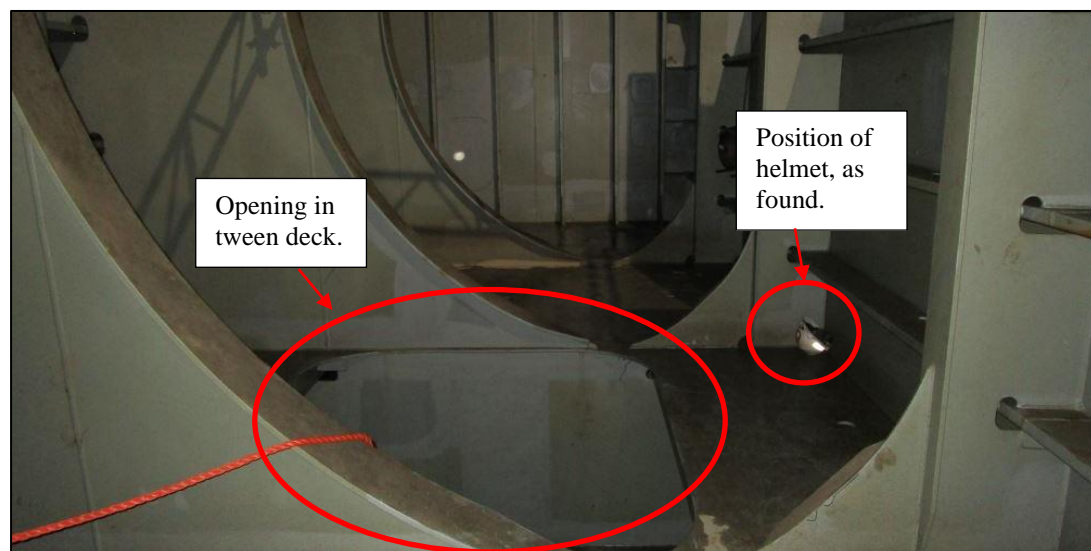
The opening in the deck through which the IP fell, was located about halfway from the guard railed passageway to the aft bulk head of the tank (Figure 12). Neither permanent nor temporary barriers had been fitted specifically around the opening in the deck.

There, the first welder helper discovered a hard hat lying on the deck with the head torch still lit just next to a large opening in the deck leading to the lower level of the WBT (Figure 7).

Figure 7: Accident site
