**NOU (Norwegian Public Reports)**

**2008:8**

# The loss of the “Bourbon Dolphin” on 12 April 2007

Report from a Commission appointed by Royal Decree of 27 April 2007.  
Submitted to the Royal Norwegian Ministry of Justice and the Police on 28 March  
2008

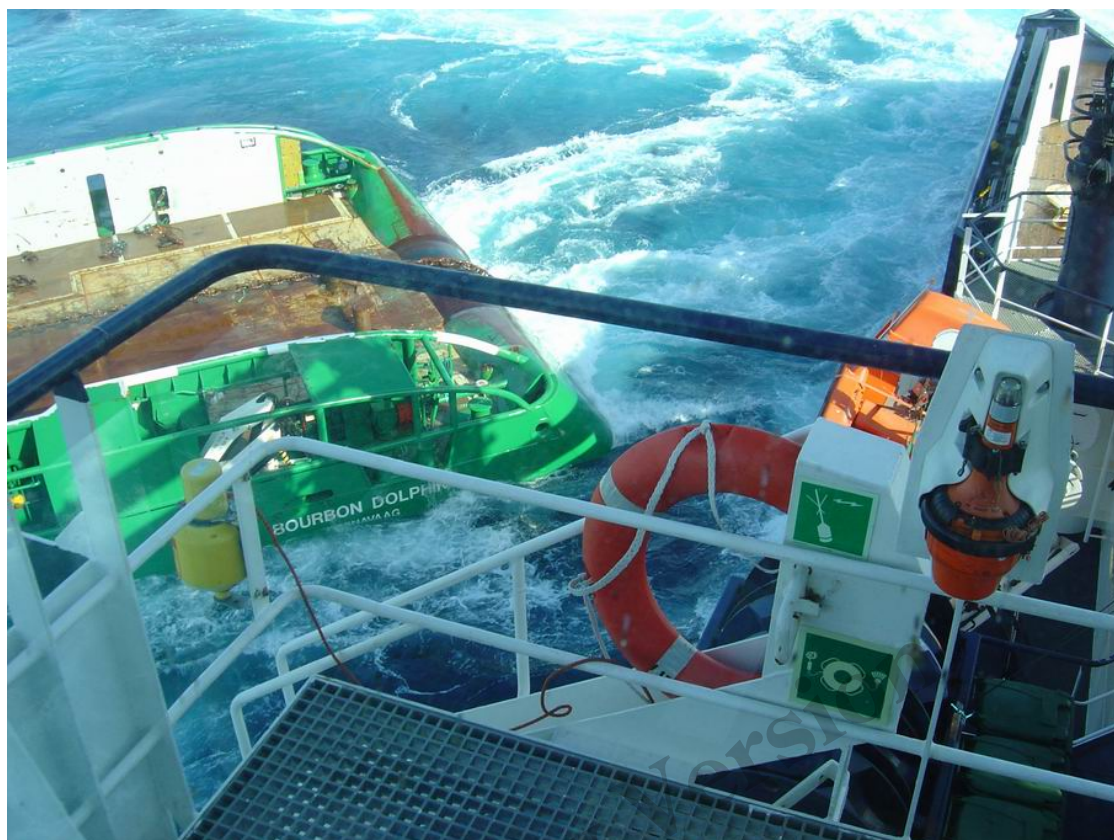
**Figure 9.2 The near-miss**

The grappling operation was not successful. Even if the “Highland Valour” had hold of the chain about 240 aft of the “Bourbon Dolphin”, the operation to get the “Bourbon” Dolphin back into the right position was a failure. The vessels were eventually lying almost sideways-on with their sterns closest. The crews of the “Highland Valour” and the “Bourbon Dolphin” have given detailed testimony about the near-miss that occurred at 16:26. Eyewitnesses estimated the distance between the vessels as a mere few metres, as shown by photographs taken from on board the “Highland Valour”, see Figure 9.2.

First Officer Syversen, who was on the bridge of the “Bourbon Dolphin” with a view astern, said in the maritime inquiry that the “Highland Valour”, when she lost hold of the chain, drifted at high speed towards the “Bourbon Dolphin”, and that a collision appeared unavoidable. In his subsequent testimony before the Commission, he amended this and said that it was probably the “Bourbon Dolphin” that drifted astern when the “Highland Valour” lost the chain.

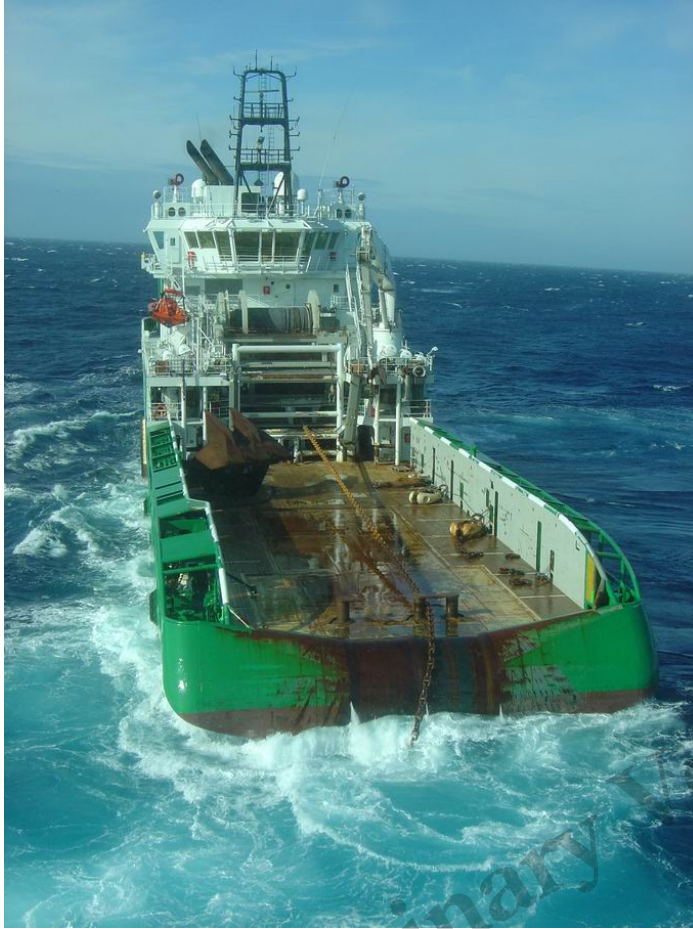
**Figure 9.3 The “Bourbon Dolphin” at 16:31**

The picture taken from the “Highland Valour” at 16:31 shows that the “Bourbon Dolphin” had the chain between the starboard towing-pins. The port inner towing-pin was down, whereas the outer port towing-pin was up.

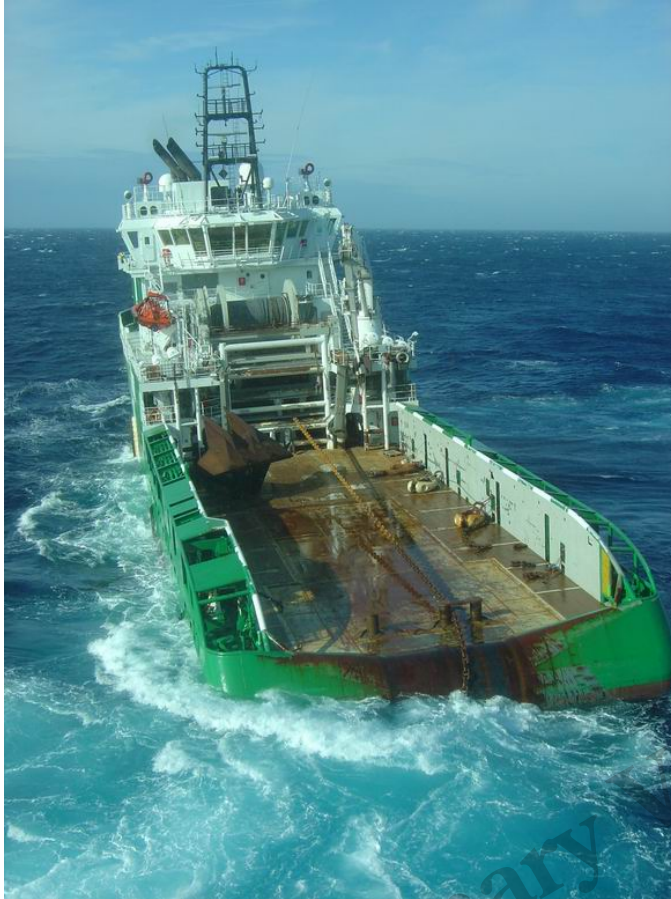
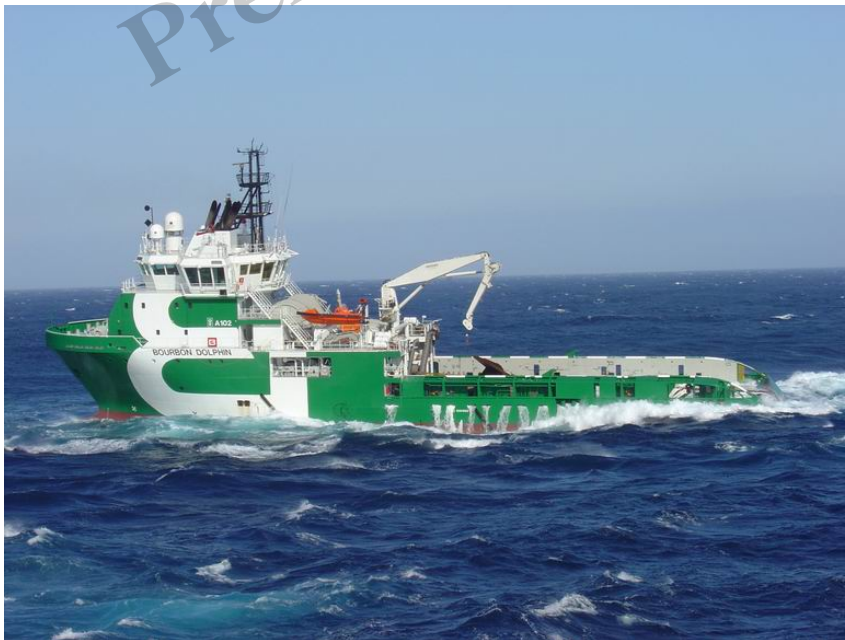
It may be seen from the pictures, and was confirmed in witness questioning, that, prior to the capsizing, the vessel regularly had some seawater on deck. The pictures show it running off the deck and not being shipped; and so it does not need to have had an effect in the capsizing of the vessel.

**Figure 9.6** Picture taken at 16:31. Photo: Sean Dickson

**Figure 9.7** Picture taken at 16:02. Photo: Sean Dickson

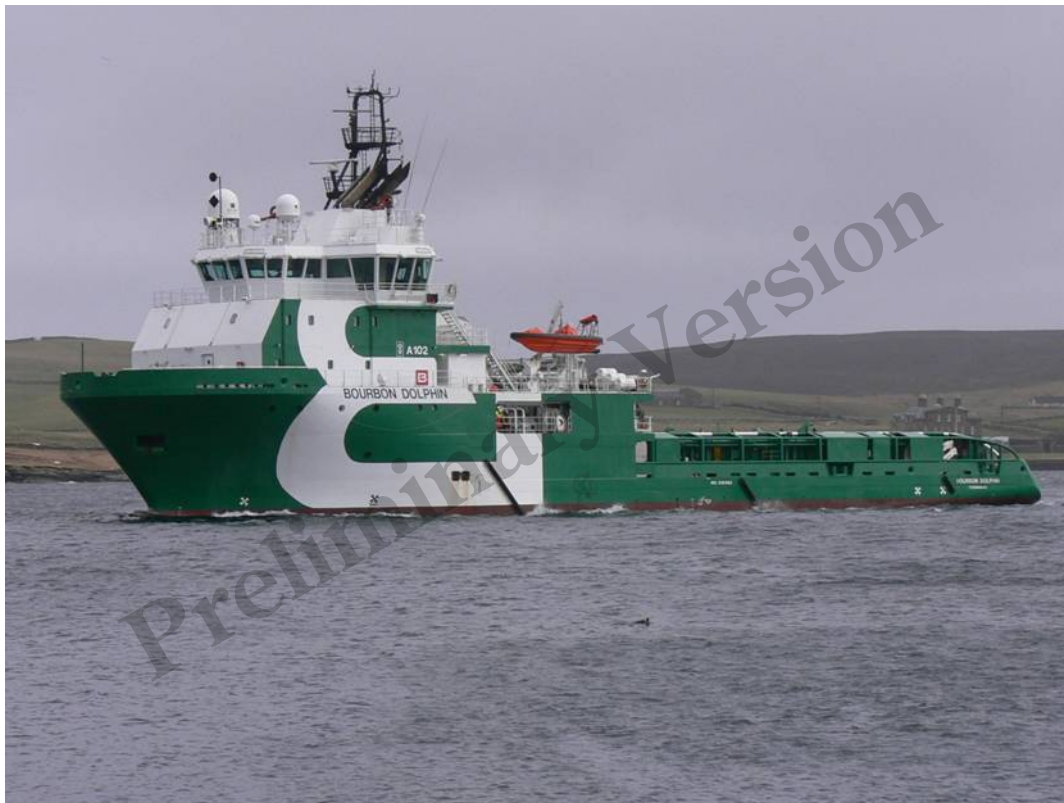
**Figure 9.11 Bourbon Dolphin on arrival at Lerwick at 14:35 on 10 April. Photo downloaded from [www.Shipspotting.com](http://www.Shipspotting.com)**

The vessel was photographed on arrival at Lerwick (see Figure 9.11). From this picture it may be deduced that the vessel had a mean draught of between 5.8 and 5.9 m. This corresponds to a navigational draught of between 6.2 and 6.3 m. It can also be seen from the picture that the vessel has a forward trim of between 0.3 and 0.4 m.

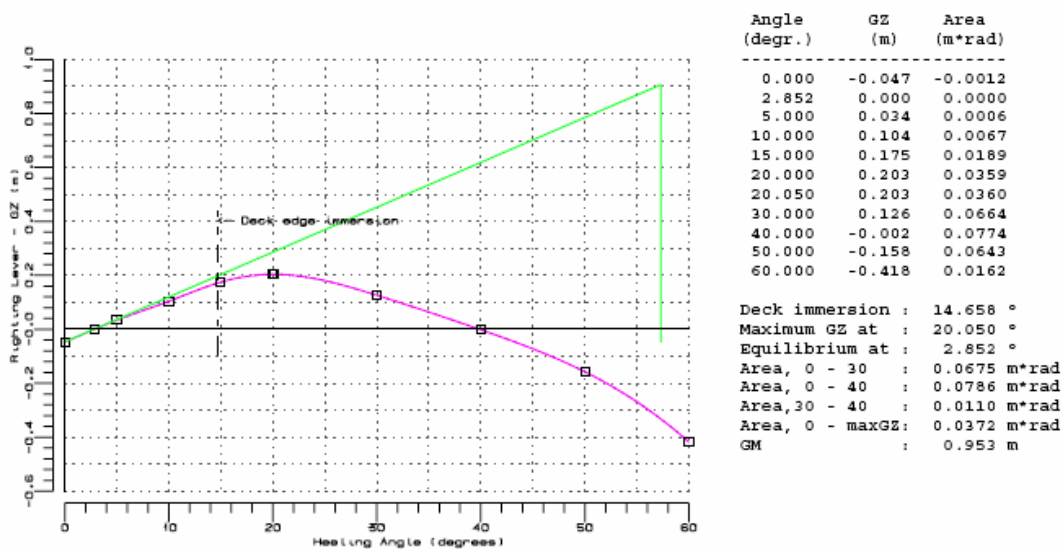
Figure 9.12 Correcting and heeling arms for load condition 2

The results for the condition with an angle of attack of 25° are shown in Annex 1, Section 1.12 (pages 6-10). The correcting arm for this load condition is shown in Figure 9.12.

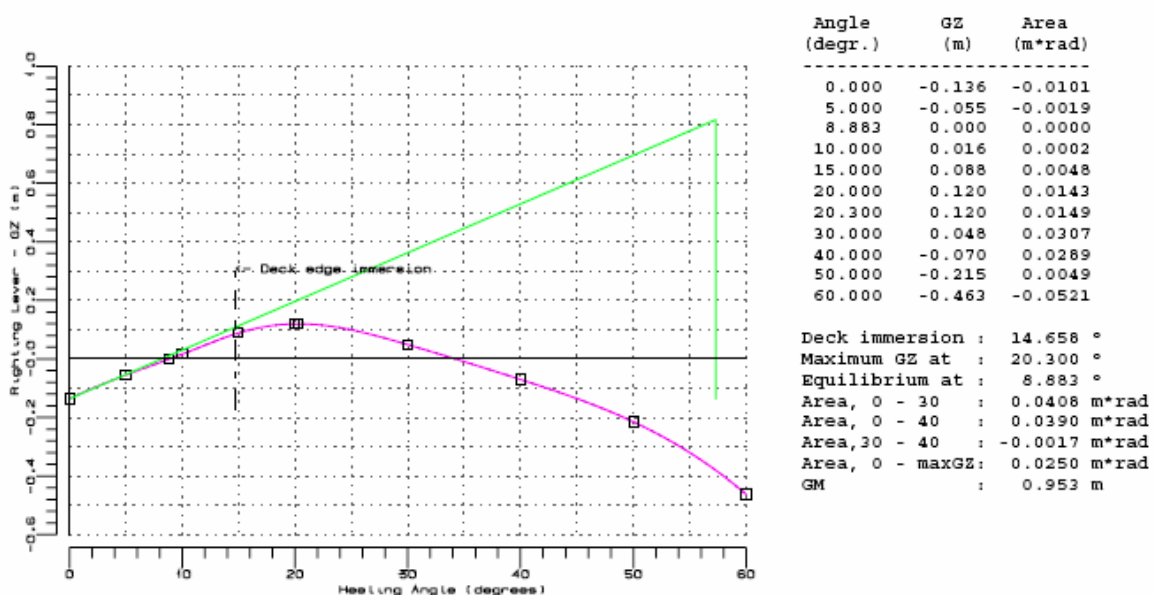
Figure 9.14 Correcting and heeling arms for load condition 3.1 after towing-pin is depressed. 40% angle of attack, 126 tonnes tension

In this situation the vessel has some stability left with a positive reach of the GZ curve to 34°. This is in a situation in which the vessel is stressed with a mean tension. When the pin is depressed the vessel, in consequence of the dynamic conditions, may acquire a list angle of 15 to 20° before she rights herself and acquires a permanent list angle of 7-9°, depending on the anchor-line's angle of attack. For example an angle of attack of 40° gives a permanent list for this condition of about 9°. See Figure 9.14, also Annex 1, Section 1.12 (pages 10-15) for more details.

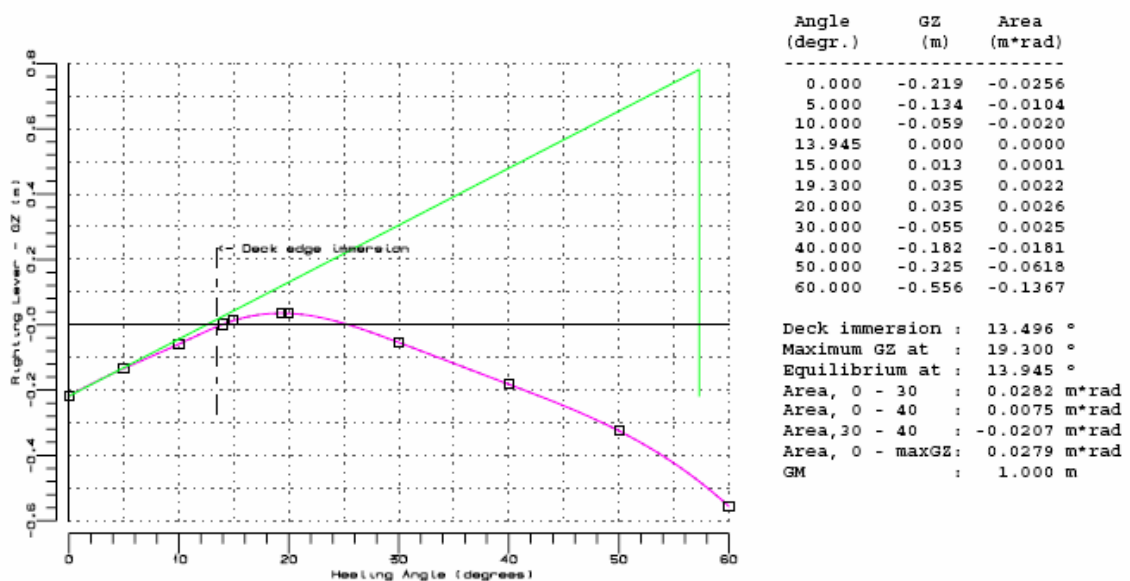
**Figure 9.15 Correcting and heeling arms for load condition 3.1 after towing-pin is depressed, 60° angle of attack, 180 tonnes tension**

On the basis of the calculations for load conditions 3.1 and 3.2, the Commission finds that the capsizing can be explained in terms of a probable load condition for the vessel and forces inflicted by the anchor line. The calculations also show that the roll reduction tank must have been in use during this part of the anchor-handling operation, in conformity with witness observations.

With an angle of attack of 60° and a tension of 180 tonnes, the vessel will acquire a list angle of almost 15°. The calculation in Annex 1 Section 1.12 (pp. 20-24) shows that the vessel's residual stability in this situation is very poor. The difference between the correcting and heeling arms is at maximum 12 mm. The situation is volatile and can end in a capsize at any time, see Figure 9.14.
