**CRANKCASE EXPLOSION  
CASUALTY INVESTIGATION**

**BRITISH VALOUR - OFFSHORE BERMUDA**

**23.03hrs (GMT) 18 MARCH 2001**

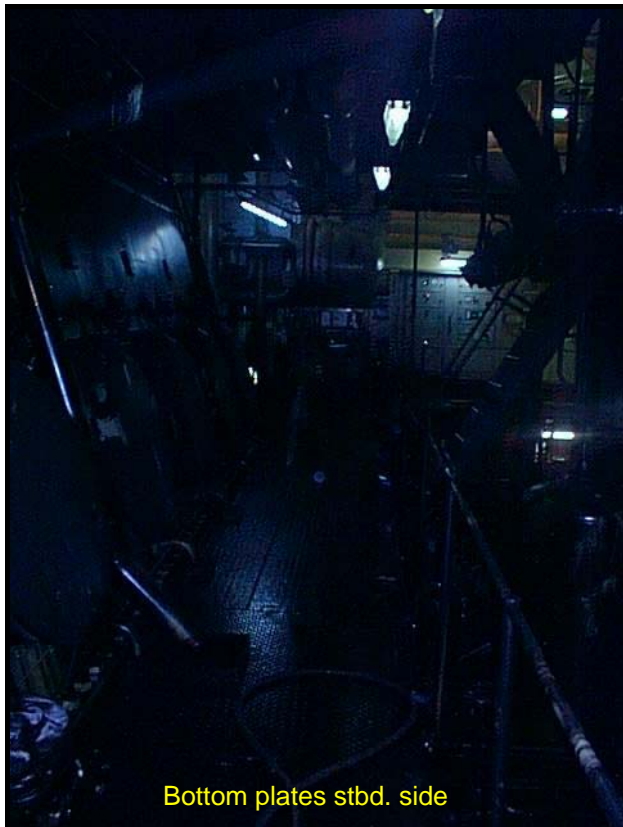
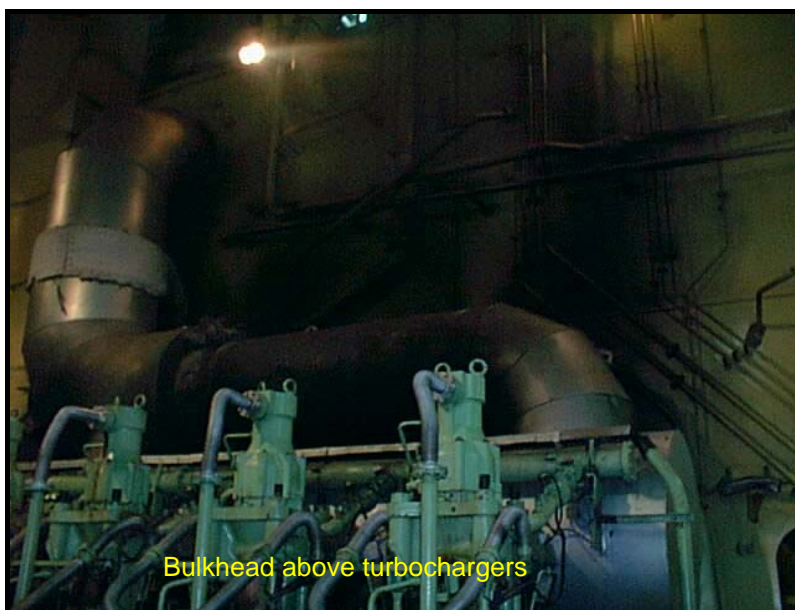
- 2.1 The engineroom was smoke/soot blackened on the starboard side, deck plates around the cylinder head area were distorted and dislodged from their original location, thermoplastic diffusers on fluorescent light fittings had melted sufficiently to flow easily under gravity and their own weight, physical contact damage was apparent in a number of locations.

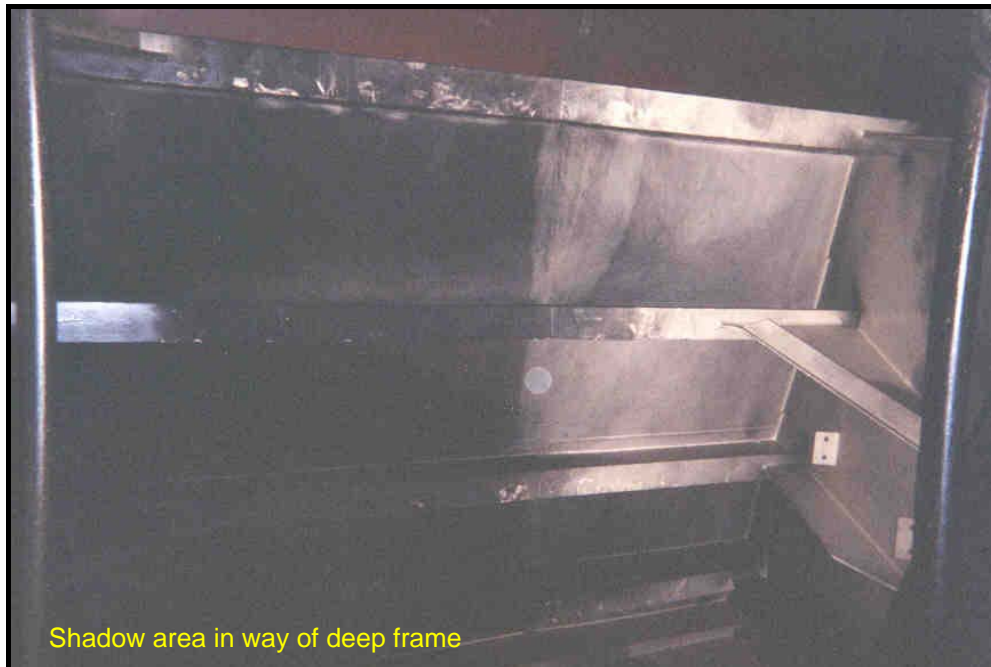
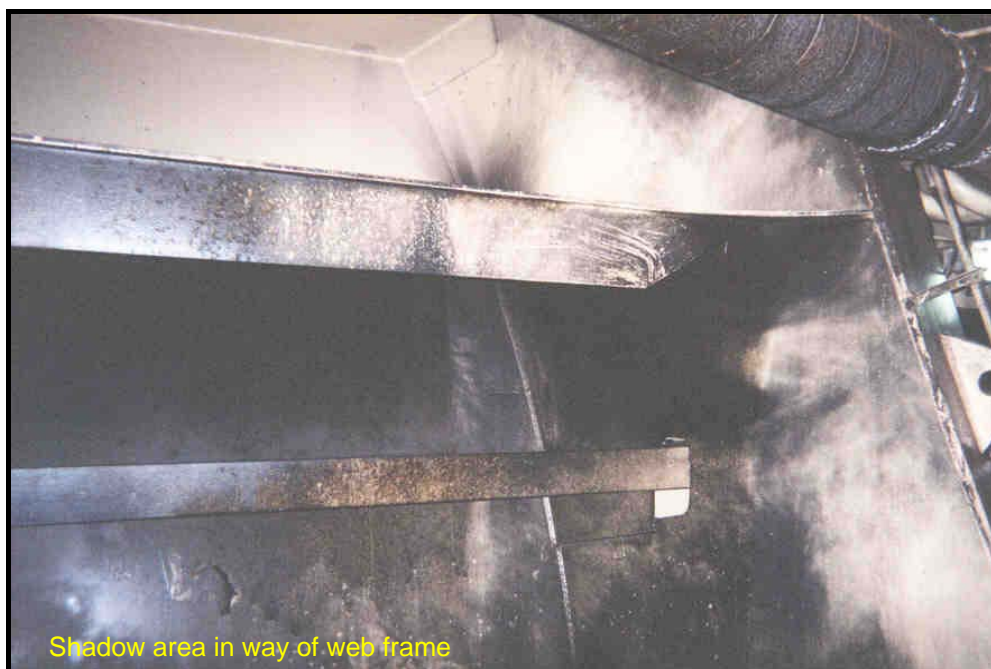
- 2.2 Soot was deposited over the entire side of the engine, on walkways, pipework, lagging and fittings facing the crankcase relief valves. Shadow areas (where soot was lightly deposited) existed on the ships side in way of deep frames and web frames in line of sight from the relief valves and where pipes intervened or the walkways turned back on themselves

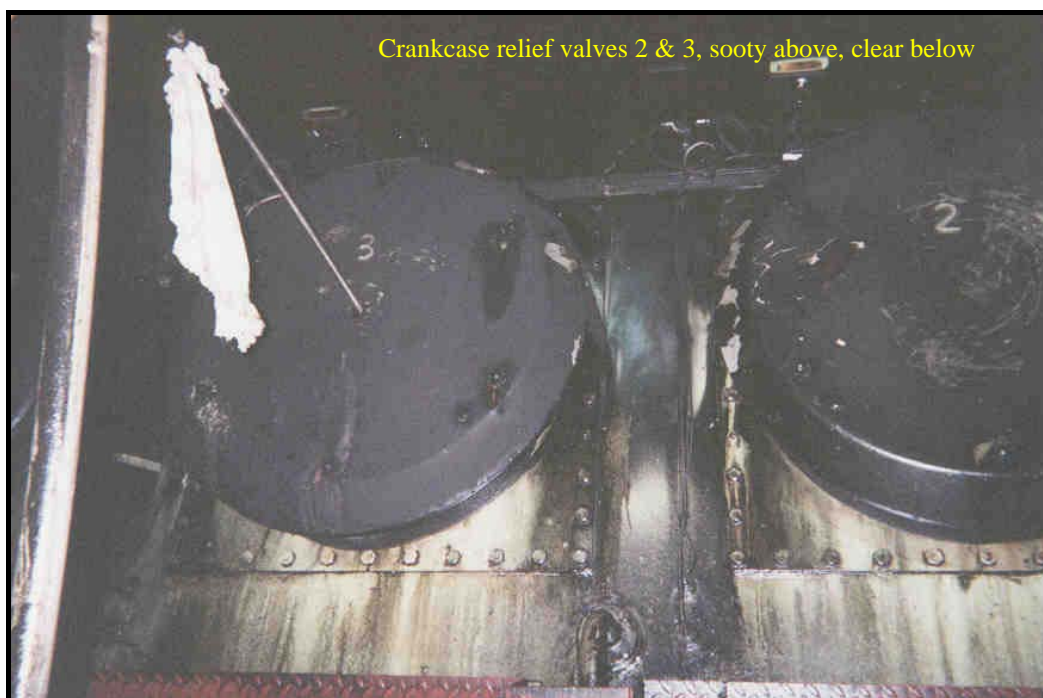
- 2.4 Ships staff performed a crankcase inspection, bearings and running surfaces were checked but nothing immediately obvious was discovered, a very small amount of 'squeezed' bearing white metal was found on top of the oil sump near no.8 main bearing, but not enough to raise suspicion of a hot spot. Engine monitoring systems indicated no bearing high temperature alarms initiated before or after the event and discoloration on internal surfaces was negligible to none existent.
- 2.5 External signs were that all eight crankcase explosion relief valves (located on the starboard side of the engine) had lifted, nos. 2, 5 and 6 were found to have incorrectly seated after closing under pressure from their return springs. Additionally two of the sealing rubber 'o' rings had become dislodged from their seats.

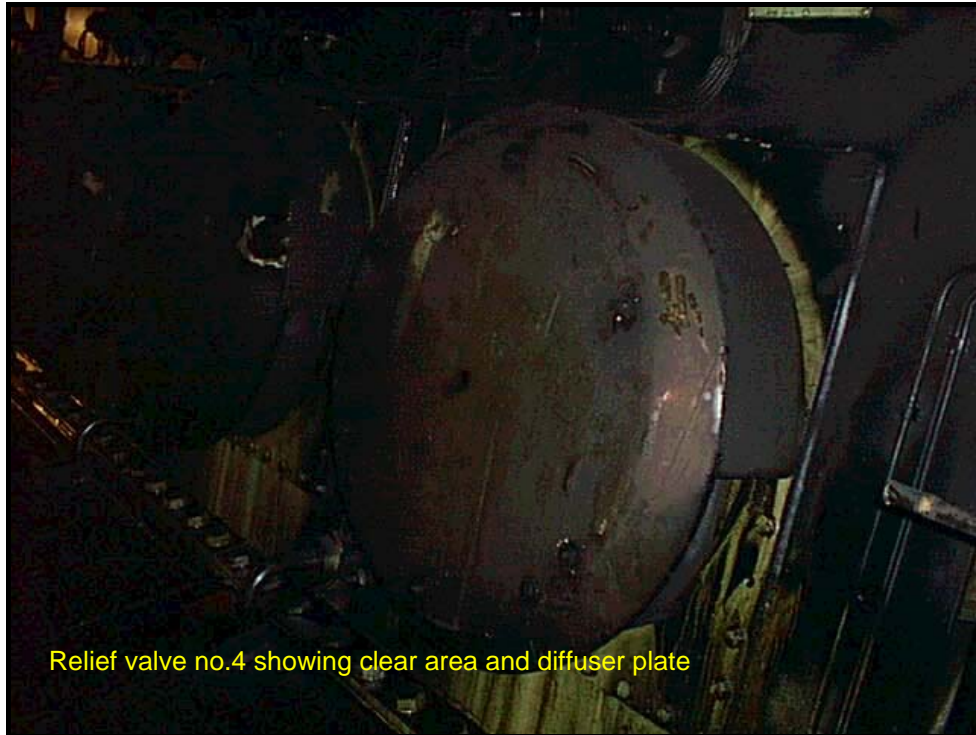
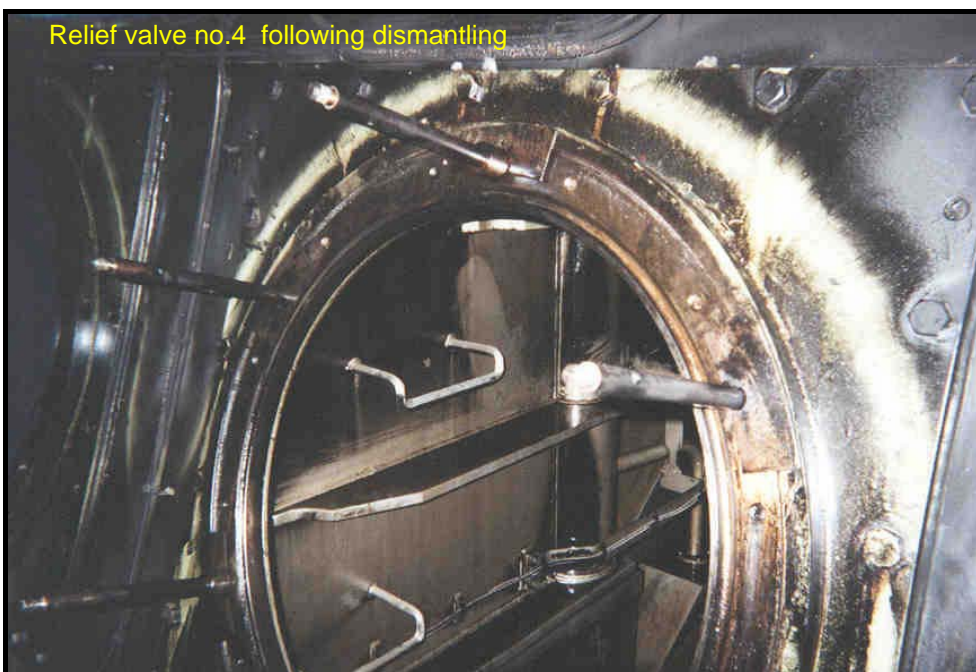
- 2.6 Paintwork immediately adjacent to the relief door periphery was relatively clean but approx. 40mm away it was covered in oily soot and approx. 100mm away, it was covered in dry soot. This soot was noted to be in the region “protected by the diffuser shield” (above the doors) whilst in the area below the diffuser shield (where gases are directed) the paintwork was observed to be less affected.

- 5.1 As a result of the evidence discovered during the investigation, we would propose in the interests of safety to recommend that crankcase relief valve diffusion plates be removed due to the reduction in effectiveness of flame arresting systems caused by the concentration of expelled gases. It is proposed that this would be achieved by making a submission to IMO for consideration and discussion at DE 46 (2003 ).

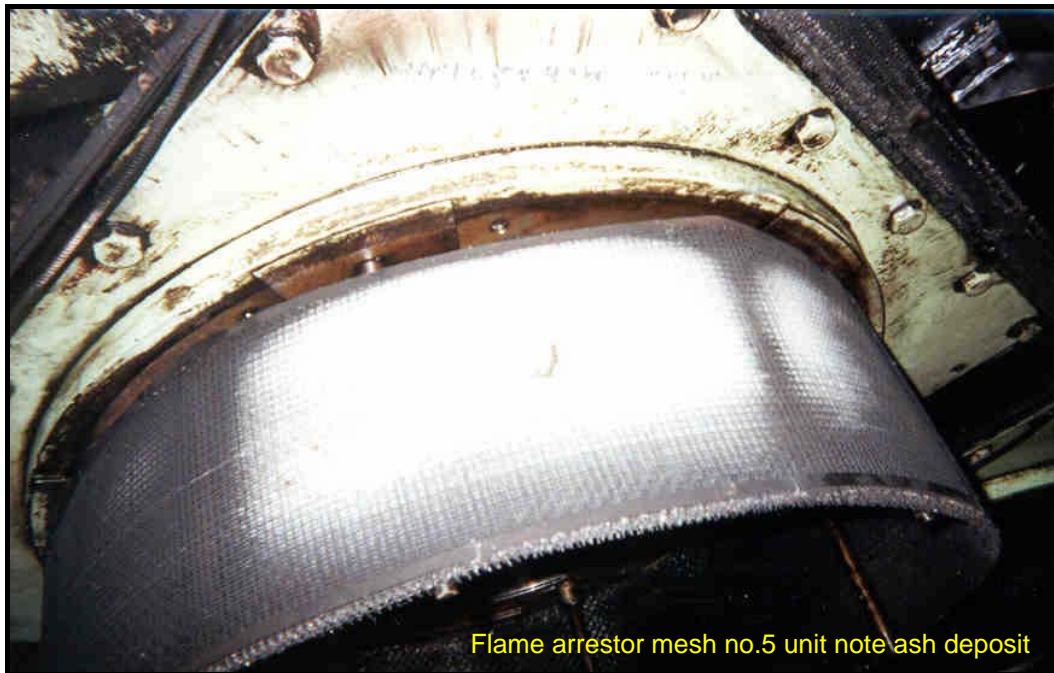
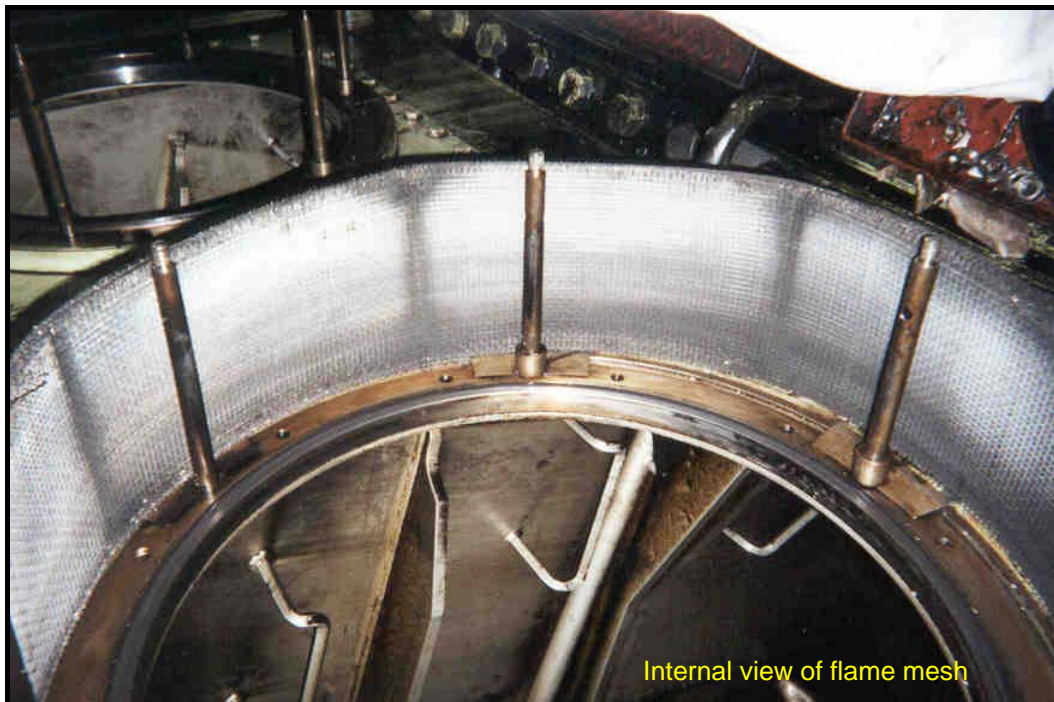
- 2.7 Flame arrestor mesh fitted to the relief valves Nos. 2,4,5,6 was seen to be very dry and had a whitish ash on the side exposed to the crankcase during lifting/operation, of these, no.5 exhibited the most obvious signs of high temperature

- 3.4 The flame arrestors failed to prevent expelled oily mist ignition and therefore did not perform as designed.
- 3.5 The crankcase oil mist monitor was found inoperable, the attending service engineer advised this to be a result of overpressure caused by the explosion(s), a crankcase high mist alarm occurred in the five second period between the first abnormality indication - ME governor minor fault and the ME cyl no.1 outlet high temp and would tend to support the theory that the damage occurred as a result of the explosion. Due to the short time-span between first indication and explosion, it would be doubtful if the monitor could have slowed the engine quickly enough to prevent an explosion.

- 5.4 The licensed engine makers have brought about a design change both to the relief valve itself and the flame arrestor for this type of engine as a direct result of this casualty, they have circulated information in respect of this and they recommend that in the interests of safety, the modifications be undertaken. Whilst costs for this work will be included in new engine pricing, existing modifications would have to be carried out at a cost to the owners.

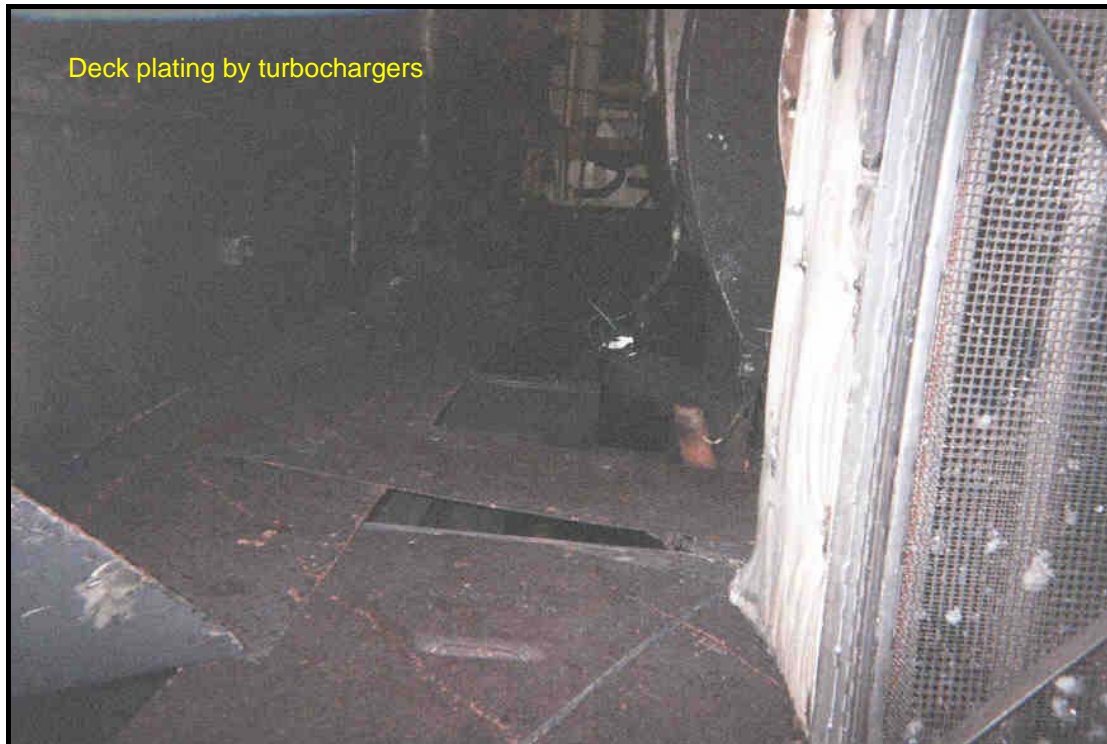
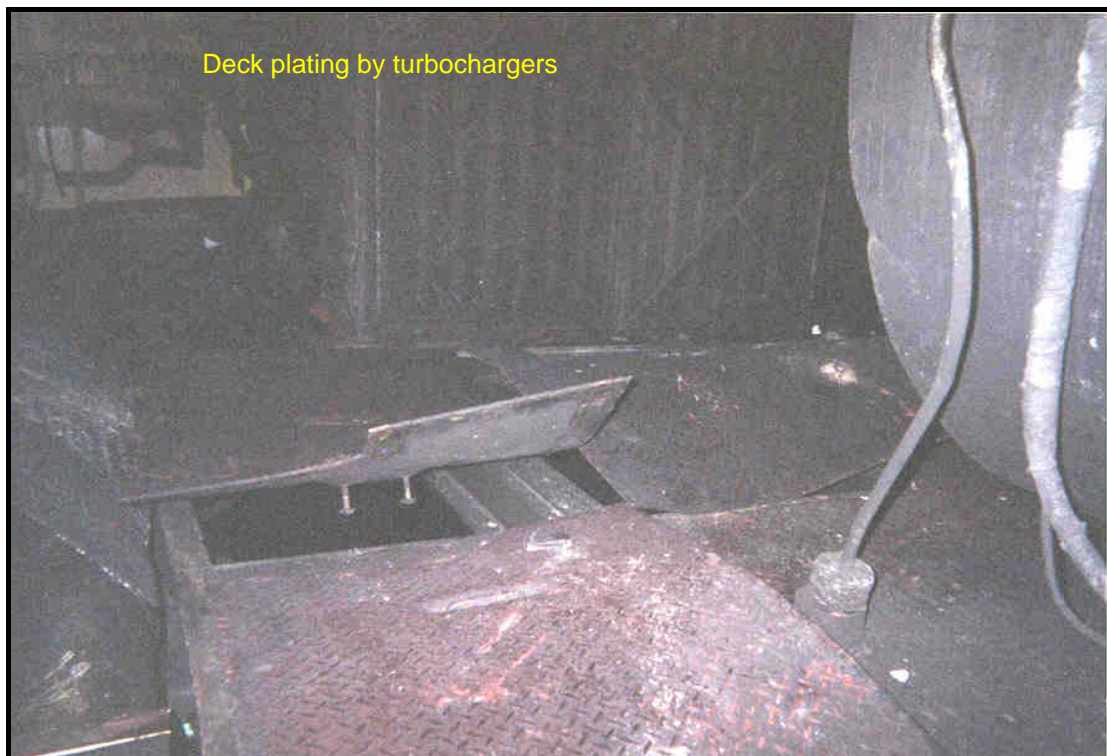
- 2.8 Fixed steel deck plating at cylinder head level was dislodged, distorted or lifted, particularly in way of the turbochargers and air coolers where the clear space around the engine is restricted, many securing screws had been sheared or stripped of their threads.

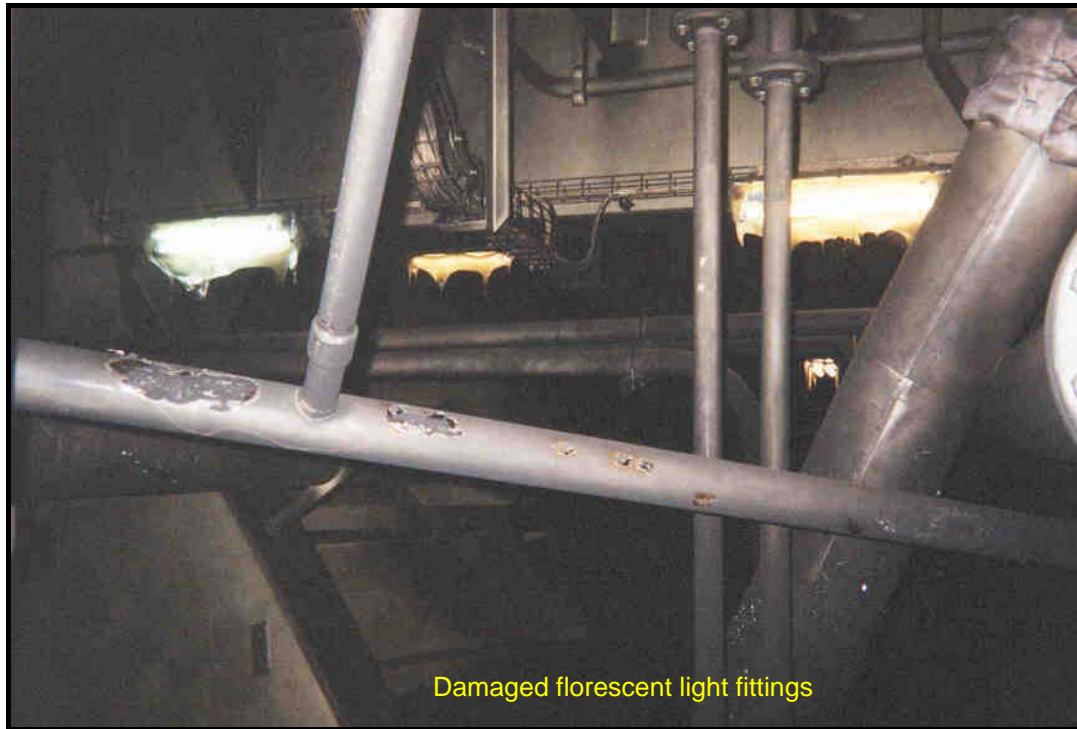
- 2.9 Significant soot and smoke damage on the starboard ships side, plates, walkways, pipes and ducts was apparent.
- 2.10 A number of fluorescent light diffusers had largely melted away, the area from the bottom plates level right up to cylinder head level on the starboard side of the engine room was affected

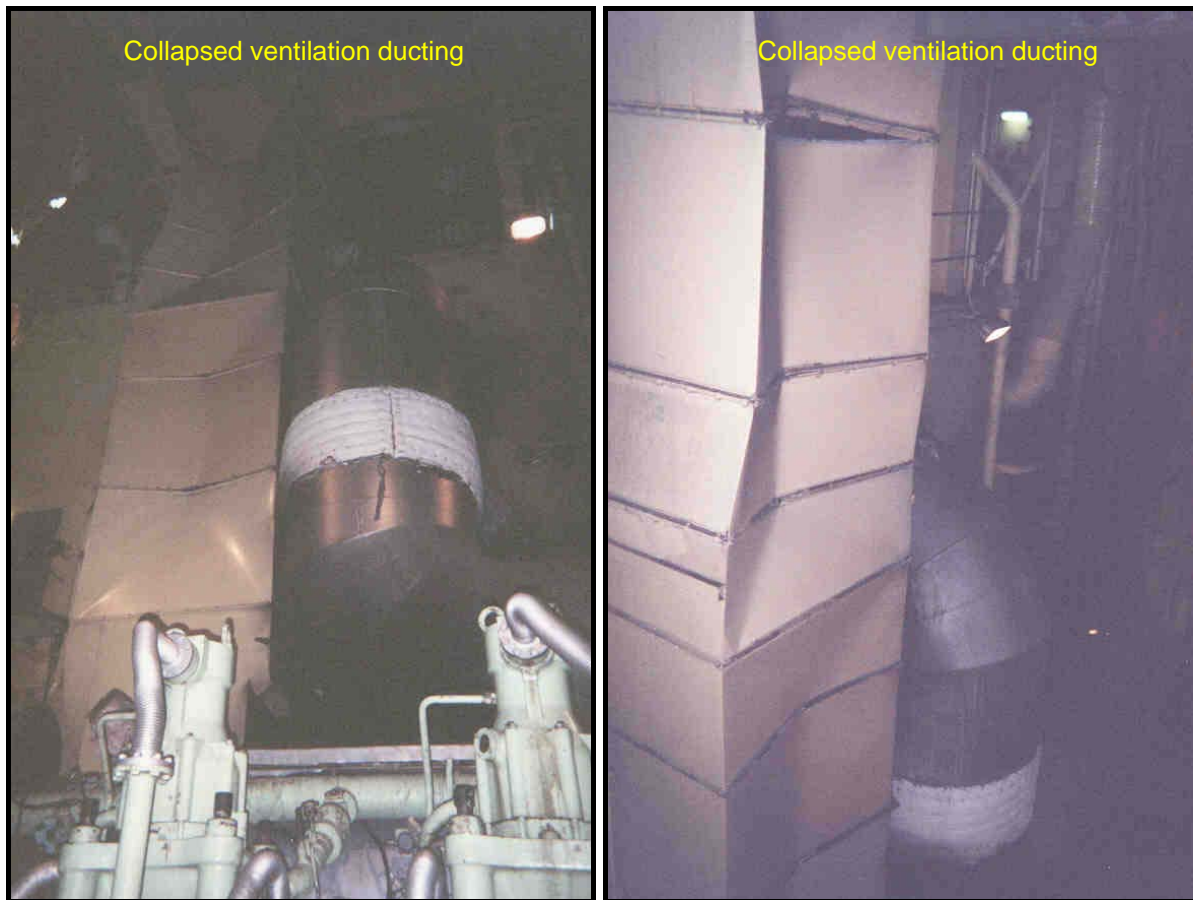
2.13 Engineroom ventilation ducting was significantly deformed, dislodged or collapsed and acoustic insulation was found littered over the after deck .

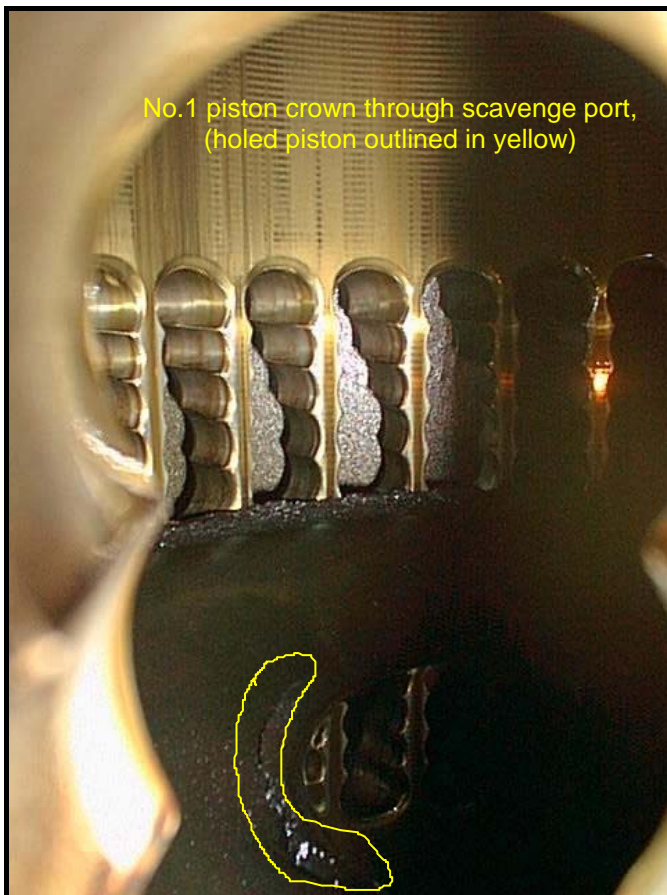
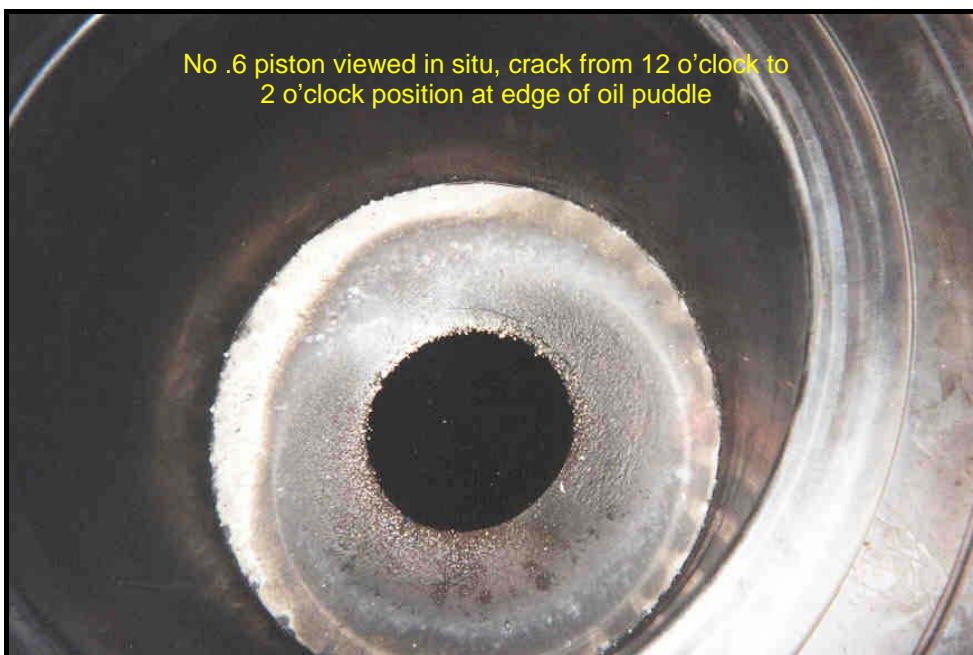
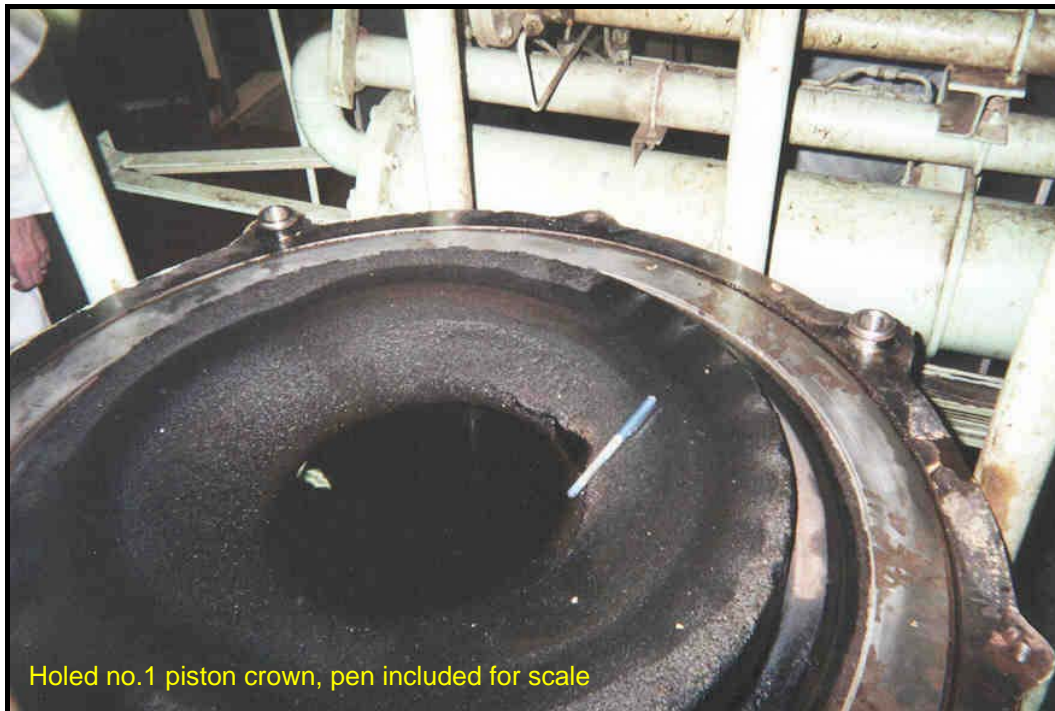
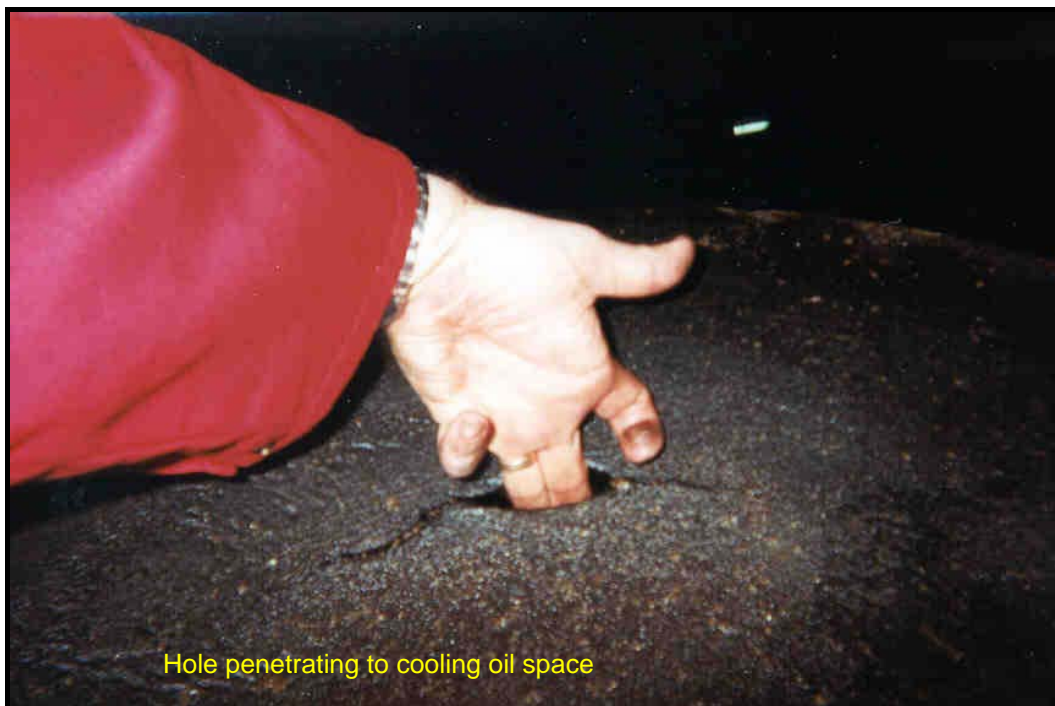
- 2.16 No.1 Piston crown was found to be cracked and holed which penetrated to the oil cooling space thereby allowing direct communication of the combustion space with the crankcase via the cooling oil passages and would indicate a probable initiation site.

- 4.1 The failure of no.1 unit, piston crown, allowed direct communication of the combustion chamber with the crankcase via the piston cooling oil passages. This allowed hot combustion gases to create and ignite a flammable oily mist mixture from the oil droplets normally present in the crankcase, causing a primary crankcase explosion.

- 4.3 Unusually large piston crown wear had occurred since overhaul in dry-dock in October 2000, the evidence gained indicates fuel impingement from poor atomisation which caused localised overheating and cooling oil breakdown on the internal surfaces of the crown and in turn increased the high temperature erosion in the areas of failure, ultimately leading to the mechanical failure of no.1 and no.6 piston crowns.

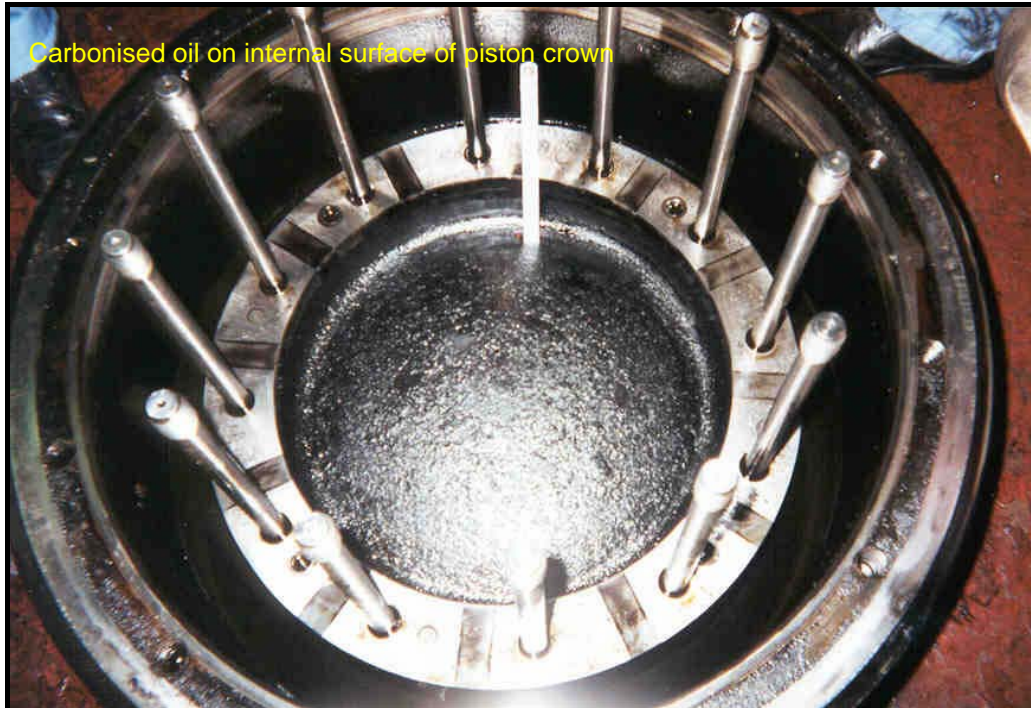
- 2.18 The scavenge space was found to be in a normal operating condition and showed no signs of internal fires.
- 2.19 Following dismantling, carbonised oil sludge was found to be coating the interior of the piston crowns.

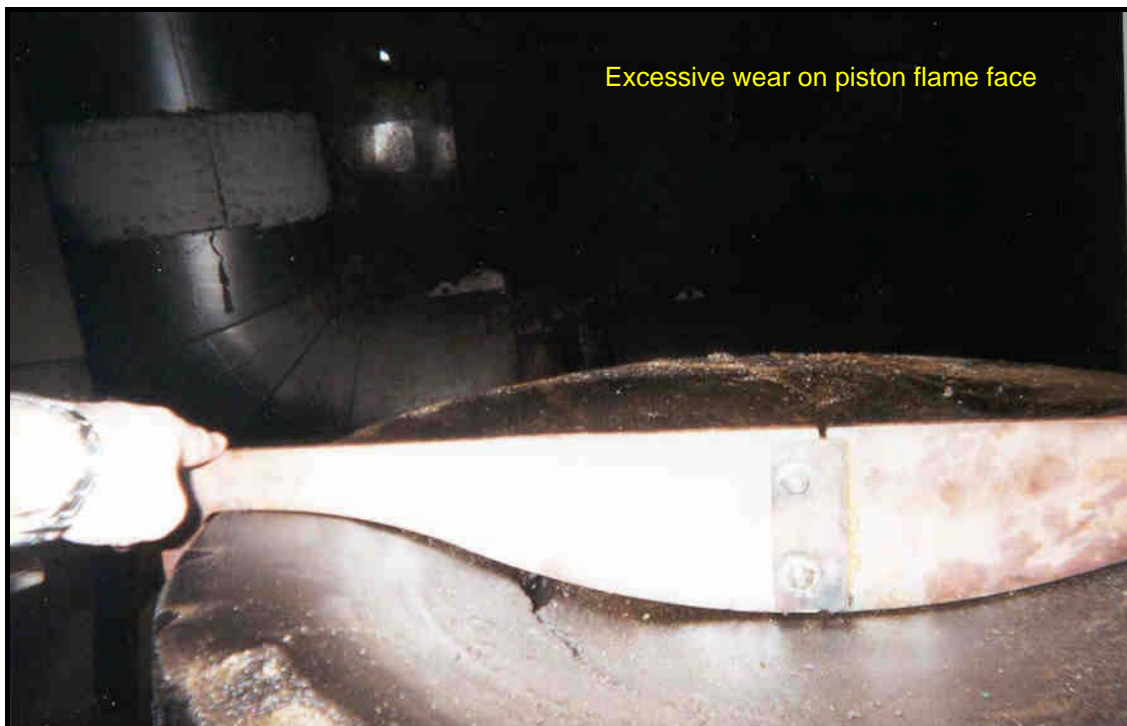
- 2.23 From historical records, it was determined that the engine performance monitoring system was not fully functional prior to the incident, this may have provided useful diagnostic information to developing problems with the combustion process.
- 2.24 During the investigation, calibrations showed No.1 and No.6 piston crowns to be out of tolerance for further use, whereas in dry dock less than eight months previously, calibrations had shown they were within wear tolerance for a further service period of 8,000 -10,000 running hours (approximately 11 - 14 months continuous service).

No.1 exhaust valve was also measured with the maximum allowed wear (12mm) and was recommended for exchange and reconditioning.
