Report on the investigation of
a fatal accident
during a vertical chute evacuation drill
from the UK registered ro-ro ferry
P&OSL Aquitaine
in Dover Harbour
on 9 October 2002

Marine Accident Investigation Branch
First Floor
Carlton House
Carlton Place
Southampton
United Kingdom
SO15 2DZ

Report No 18/2003
July 2003

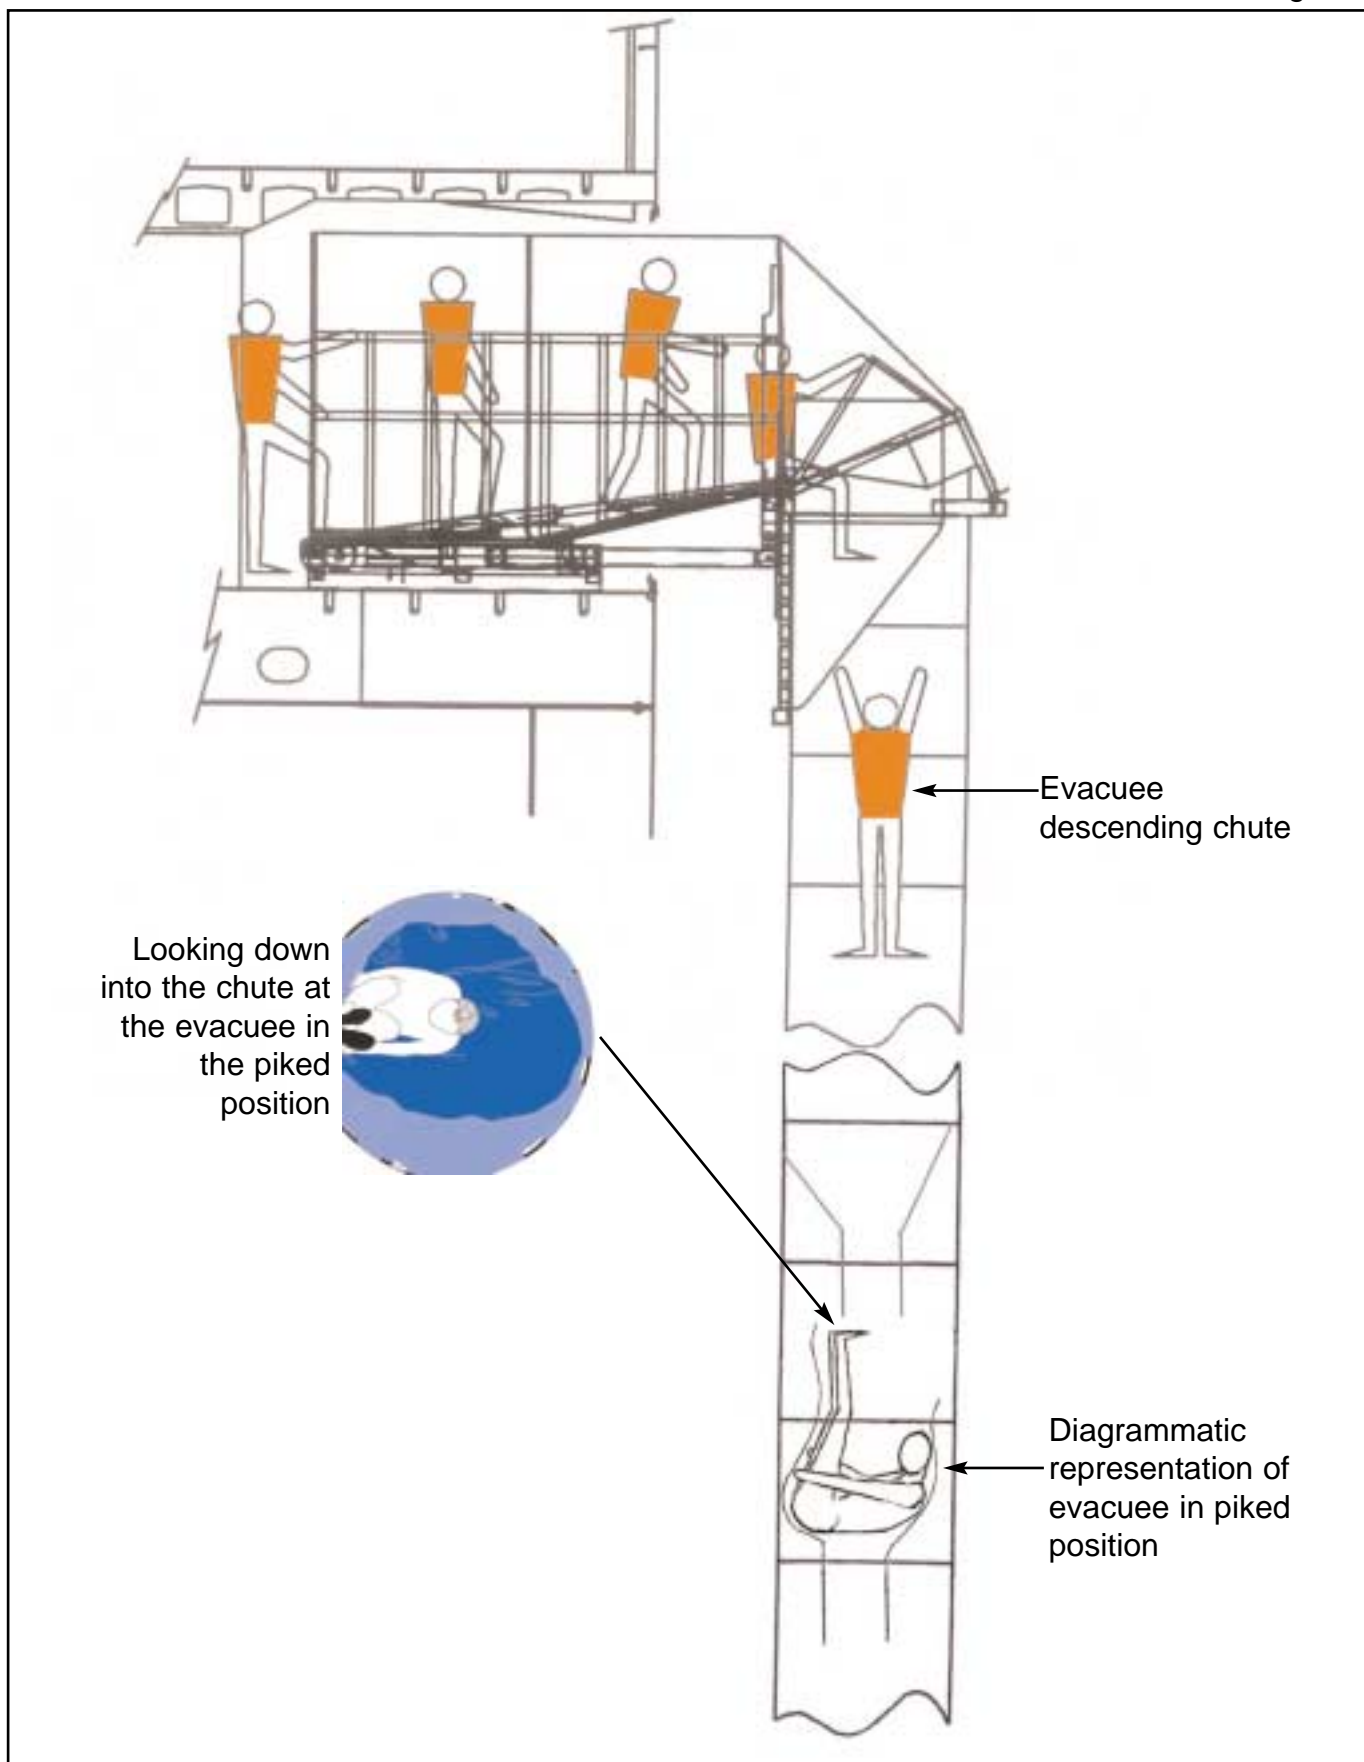
He found her stuck in one of the socks, with her arms and legs above her body in a back down, piked position (**see diagram 3**). Her lifejacket had come off and she handed it to him. He also found her day jacket, unbuttoned and off, in the cell. The sweeper noted that she was rational, able to follow instructions and was able to give him her hand. Her breathing did not seem laboured, although she did complain of having difficulty in doing so. Having moved the lifejacket and jacket out of the way, he took hold of her hand and tried to pull her up, but she could not move. He told her to bend her legs, and he pulled on her hands in an attempt to get her feet to go down first. Mrs McCabe-Jones then slid through the sock. The sweeper followed her down to the next cell but, again, found her still stuck in the same position. He tried to pull on her hand again, but was unable to move her.

Showing evacuees descending the chute and in the piked position

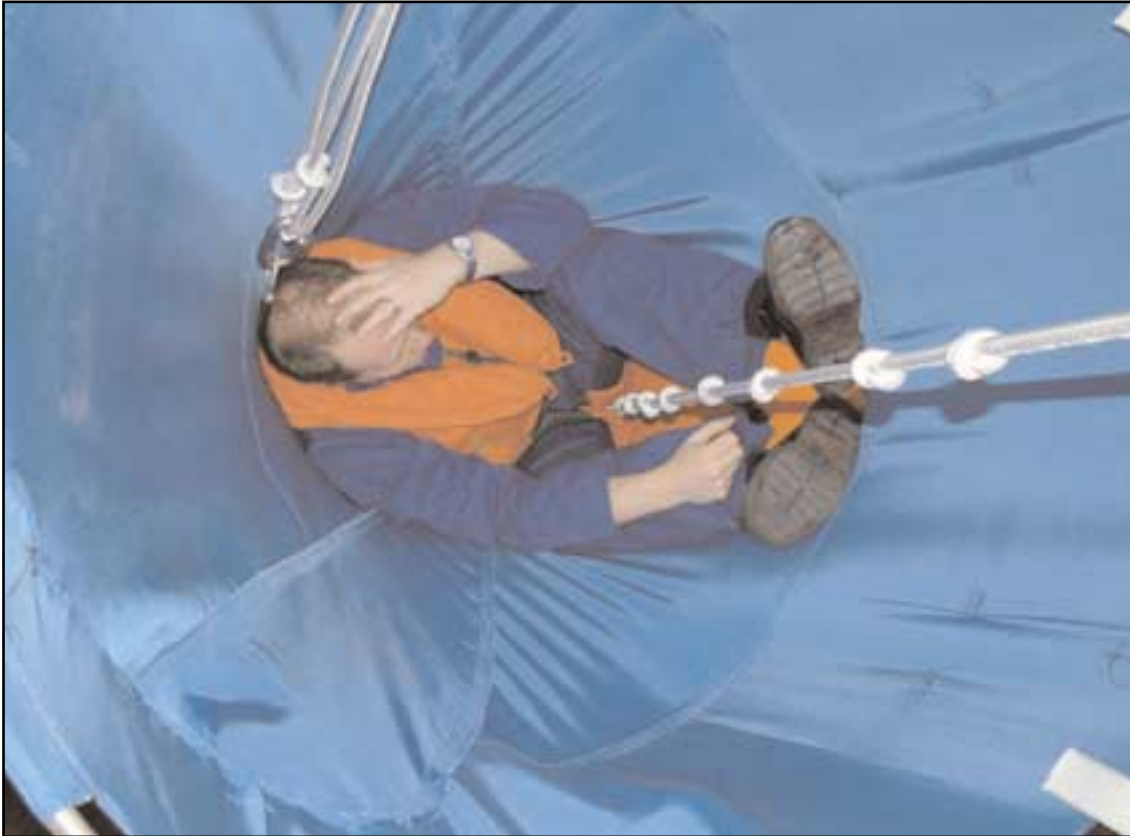
During the first day, each of the participants recreated (with the aid of a harness and a knotted line) the position in which Mrs McCabe-Jones was found. With growing confidence, the participants were able to assume quickly the same position, without great discomfort. Then the participants were able to explore different possible reasons as to how she assumed the piked position. The second day carried on with the latter work until a possible scenario was derived (**see photograph 10**).

A participant of the reconstruction sitting in a sock in the piked position

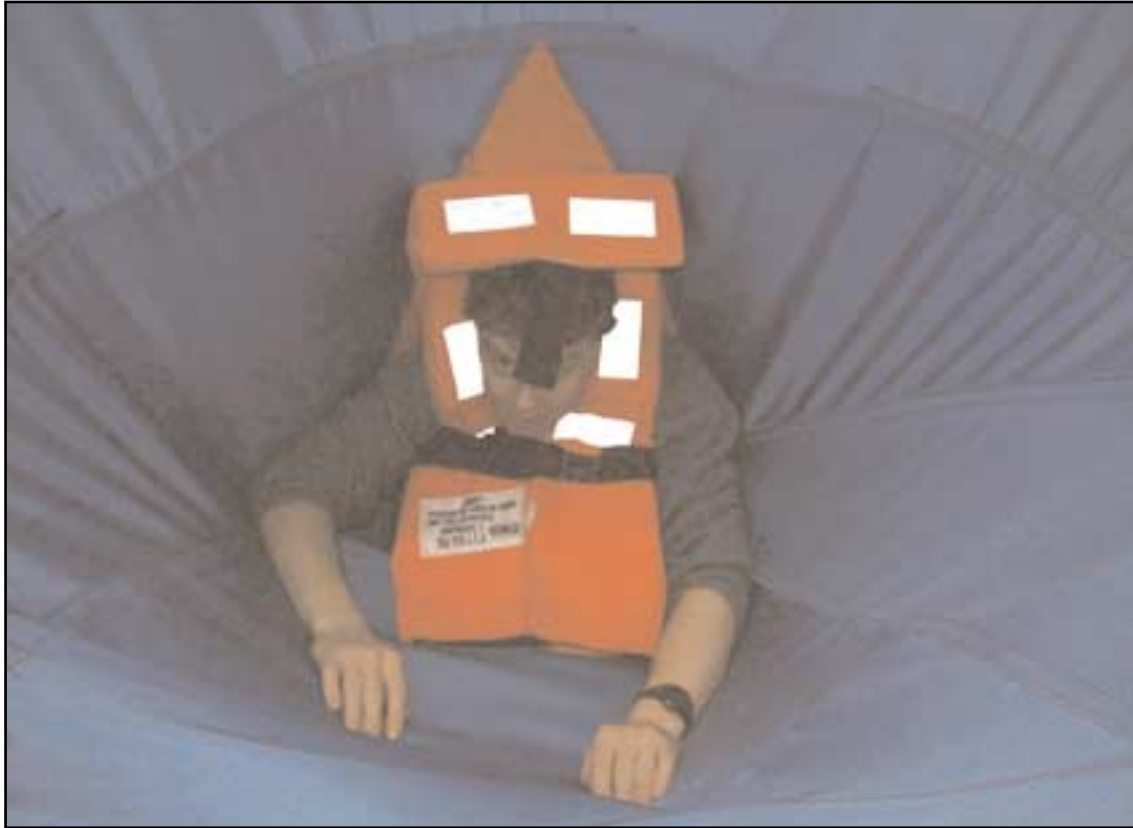
Stage 1 - Lifejacket rode up

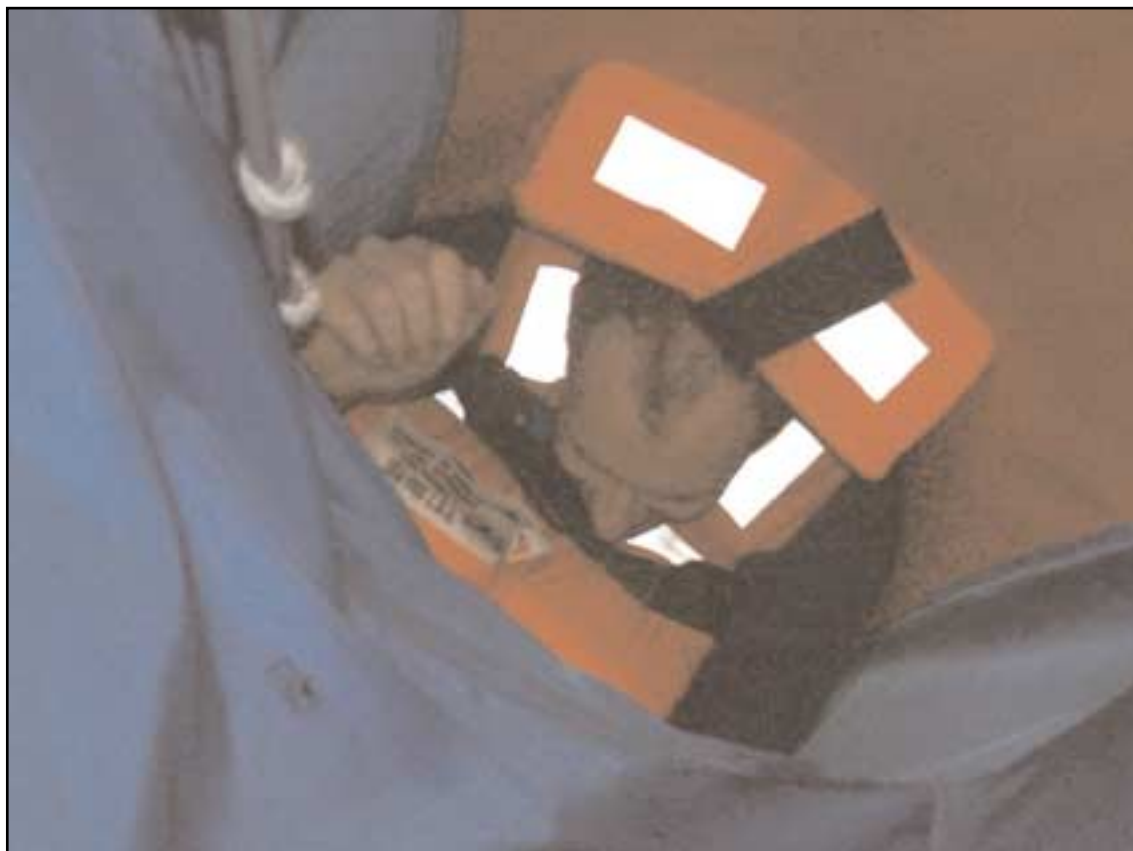
Stage 2 - Lifejacket rode up

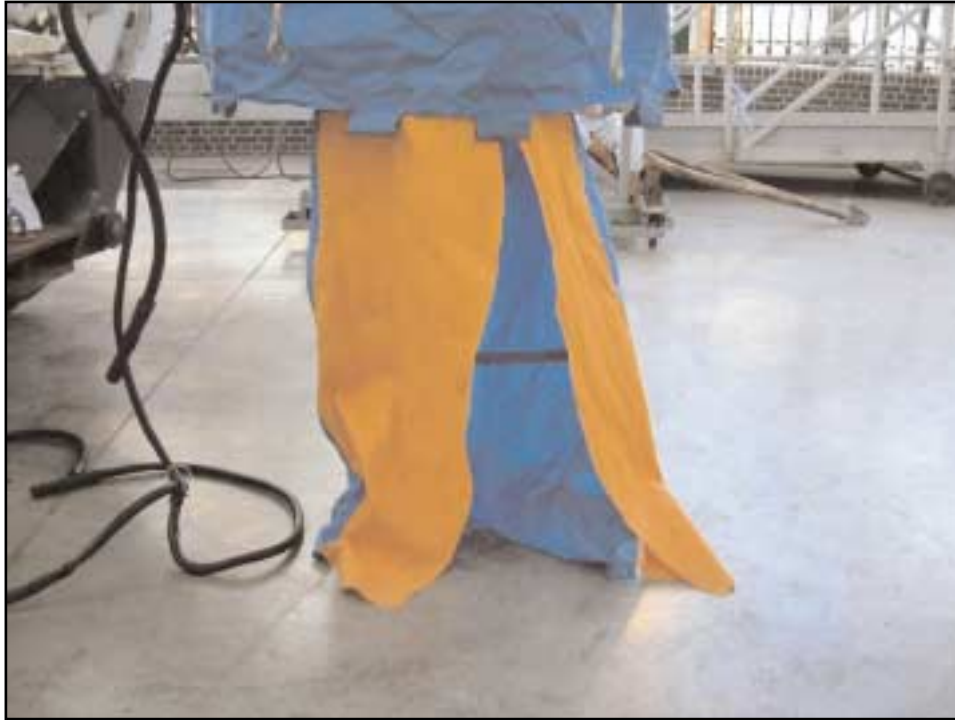
Photograph A1/8

Cell No.3 There is a vertical slit in the sock between bungee positions 3 and 4 (**see photograph A1/8**).
The mid-height hoop attachment, between bungee positions 3 and 4, is completely detached. Between bungee positions 2 and 3 it is 90% detached, and between bungee positions 1 and 6 it is 30% detached (**see photograph A1/9**).

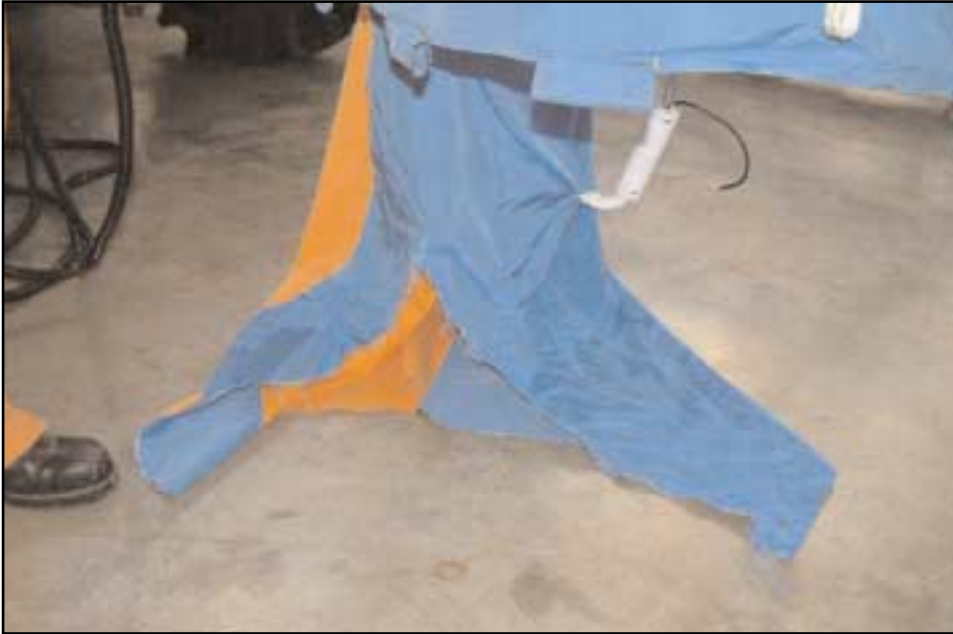
Photograph A1/10

There is a vertical slit in the lower 60% of the sock between bungee positions 3 and 4 (**see photograph A1/10**).

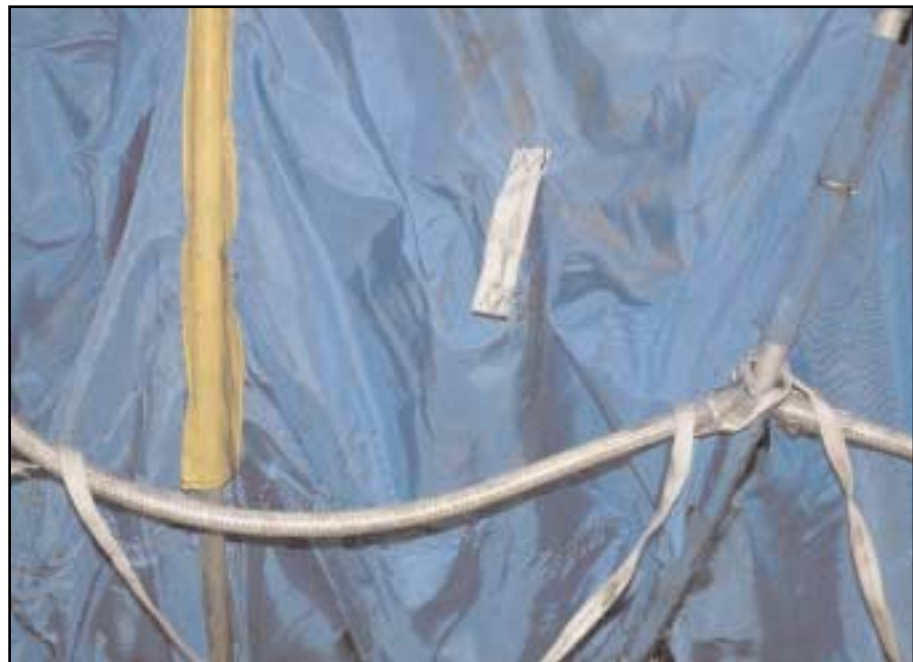
Photograph A1/18

The No. 4 bungee guide loop is detached at one end (**see photograph A1/18**).

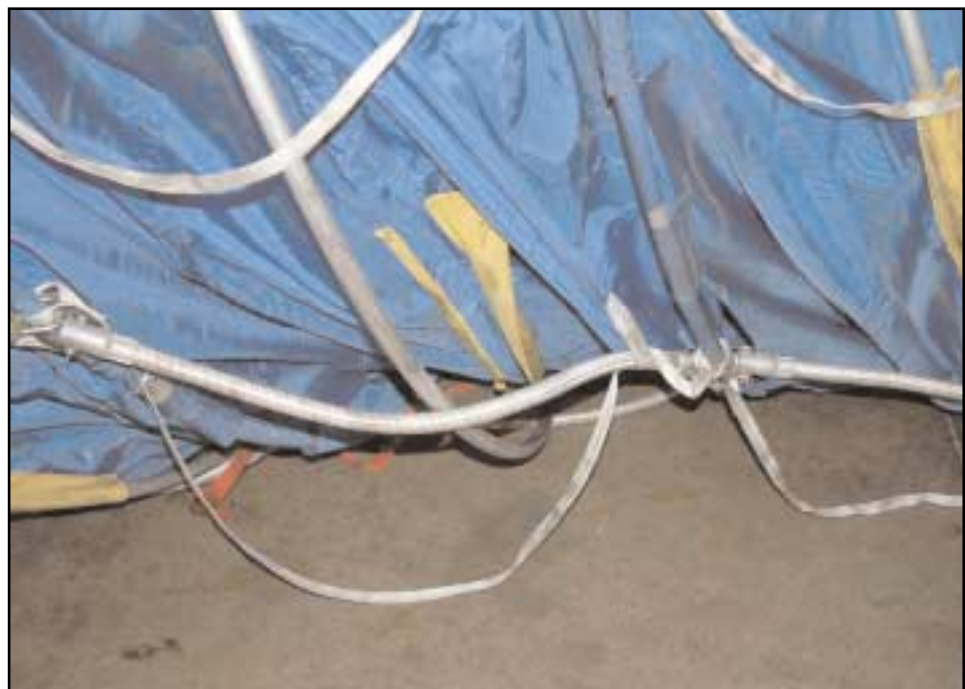
Photograph A1/20

- Cell No.10** The mid-height hoop attachment between bungee positions 1 and 2 is 30% detached, and between bungee positions 6 and 1 there is a small tear.
- The No. 4 bungee guide loop is detached at one end (**see photograph A1/18**).
- There is fraying of the blue fabric at the bottom of the sock, with the cross-threads only attached at one end (**see photograph A1/19**).
- Cell No.11** The blue fabric at the bottom of the sock has started to fray.
- Cell No.12** The mid-height hoop attachment between bungee positions 1 and 2 is 10% detached. Between bungee positions 3 and 4 it is 10% detached, and between bungee positions 1 and 6 it is 100% detached (**see photograph A1/20**).

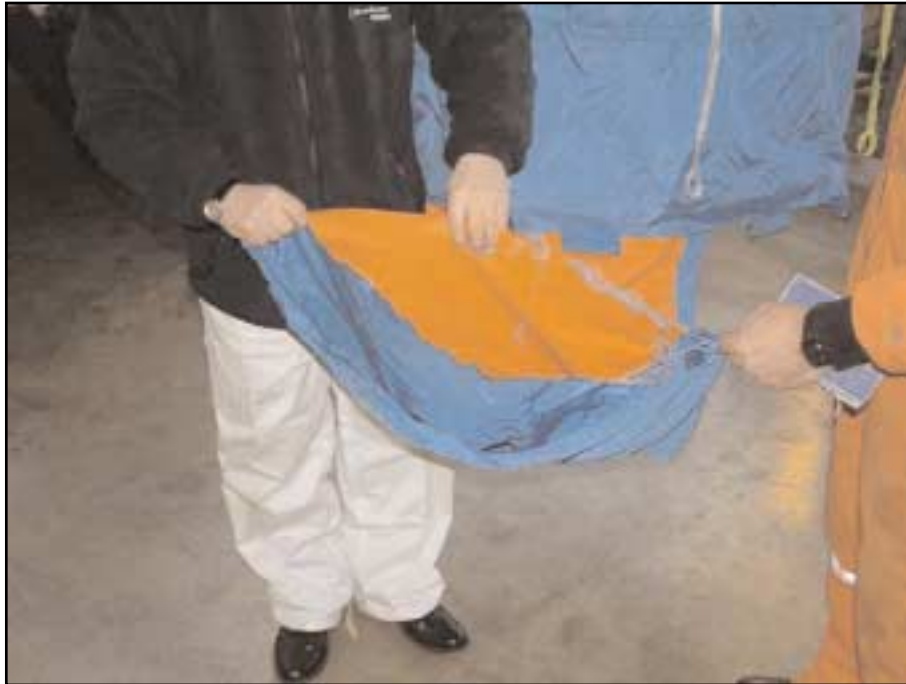
Photograph A1/25

There is fraying at the bottom of the blue fabric restraining panel, fitted over the elasticated panel. This is the only cell fitted with such a panel in the sock, and it is designed to take the initial shock load when an evacuee enters the chute (**see photograph A1/25**).

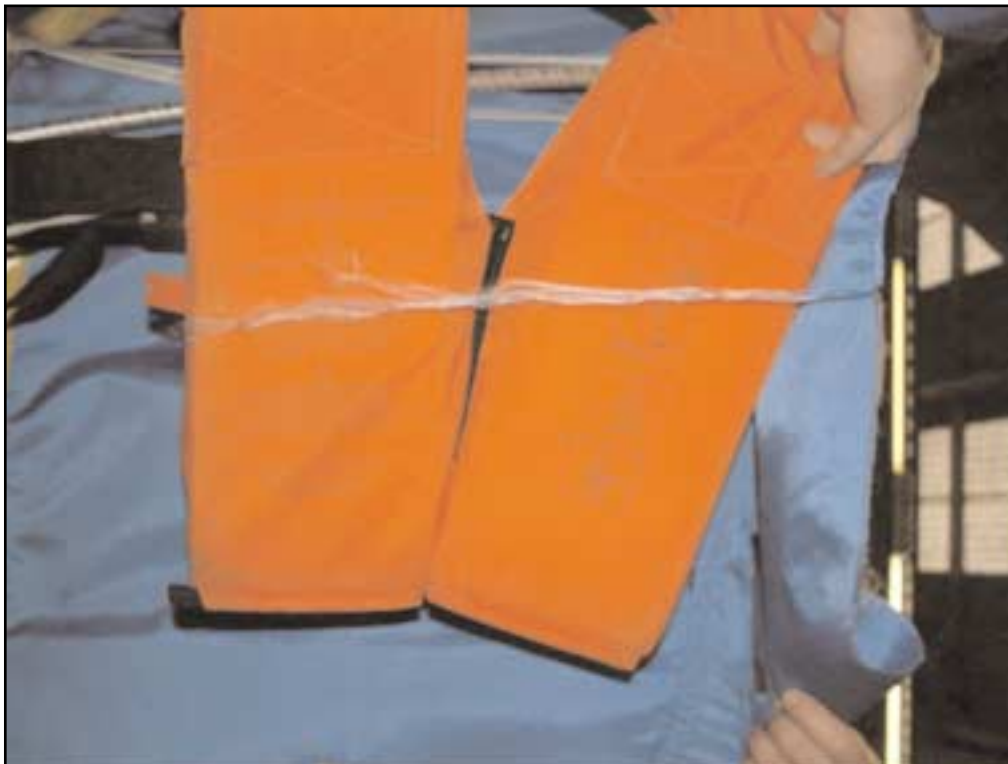
Photograph A2/6

During the reconstruction, it was found that, on catching a foot in this stIRRUP, it was broken easily under the weight of a person. **(See Photograph A2/6.)** Additionally, by the very design of the chute, the exit of the sock was hanging well into the next sock below, making it impossible to attain the piked position when a person's feet become caught in a stIRRUP.

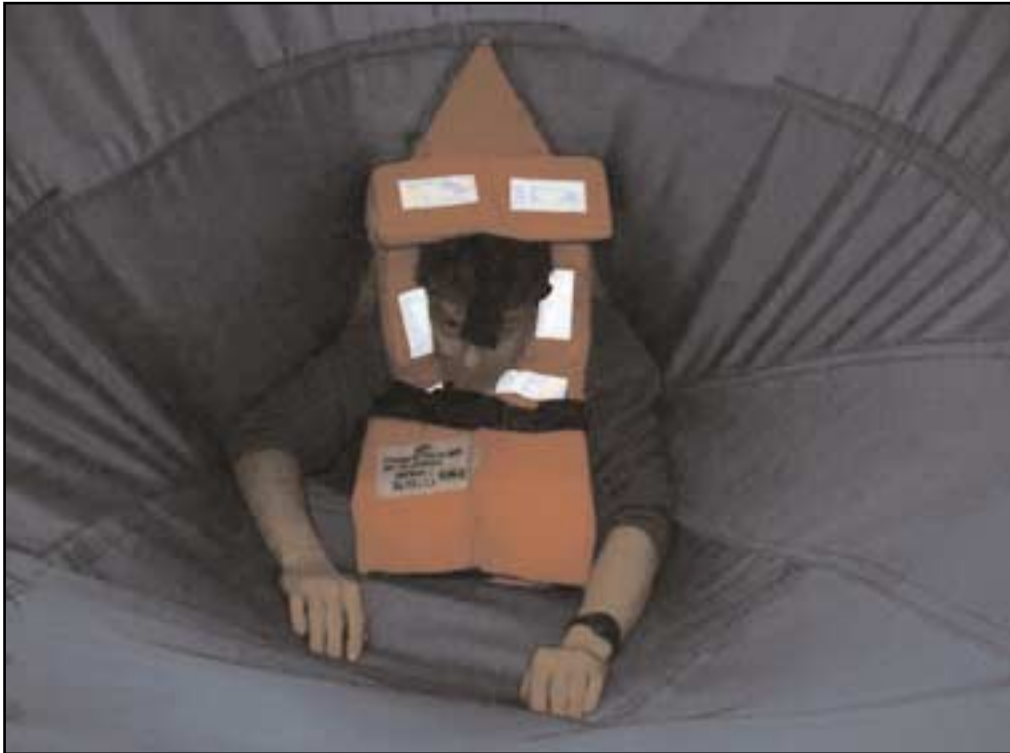
Photograph A2/8

After some trials it was found to be relatively easy for the lifejackets used in the *P&OSL Aquitaine* drill to ride up, while going down the chute. Female evacuees had a slightly higher incident rate than males (**see Section 1.9**) of lifejackets riding up, possibly because in some cases their lifejacket projects further out. It is quite conceivable that, while descending the chute, the bottom of the lifejacket would have become caught, because the chute narrows into the sock and effectively the lifejacket would have folded up around the wearer's head. (**See Photograph A2/8.**)

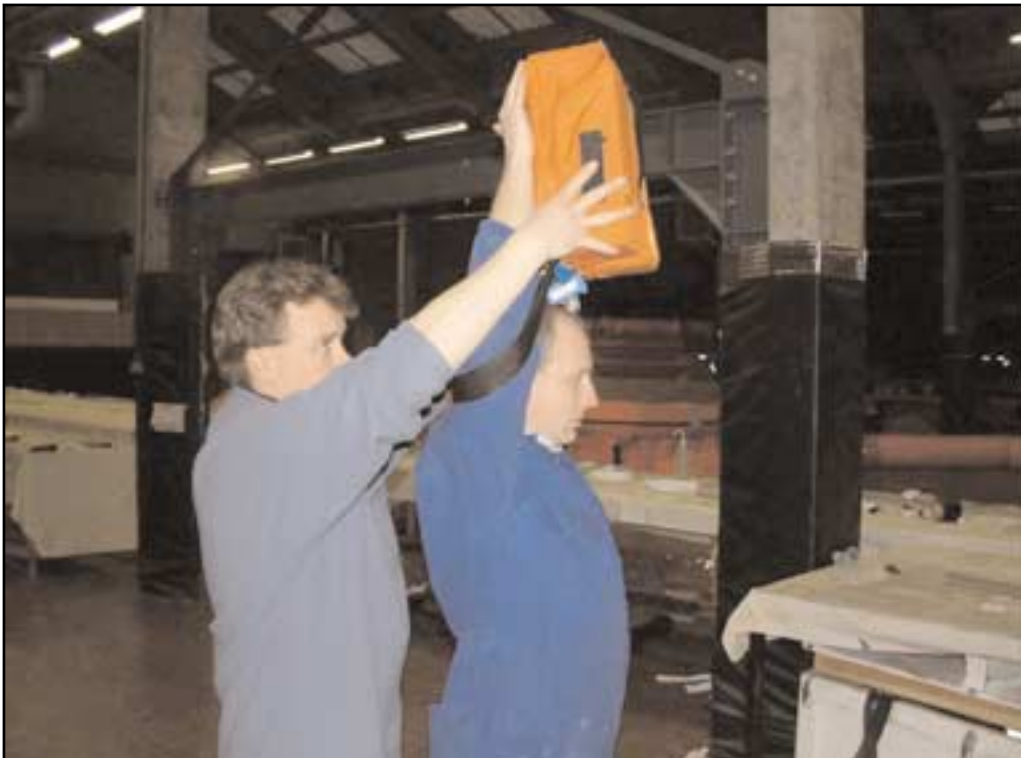
Photograph A2/9

This was very uncomfortable for the wearer, and it was easy for the lifejacket to pass over the head at this point. If the wearer also had their hands above their head, as instructed, while descending the chute, the lifejacket webbing would simply ride up the wearer's back and come off. (**See Photograph A2/9.**)
