Report on the investigation of
the fire and subsequent sinking of

Lady Candida

off Corsica

Report No 4/2008
February 2008

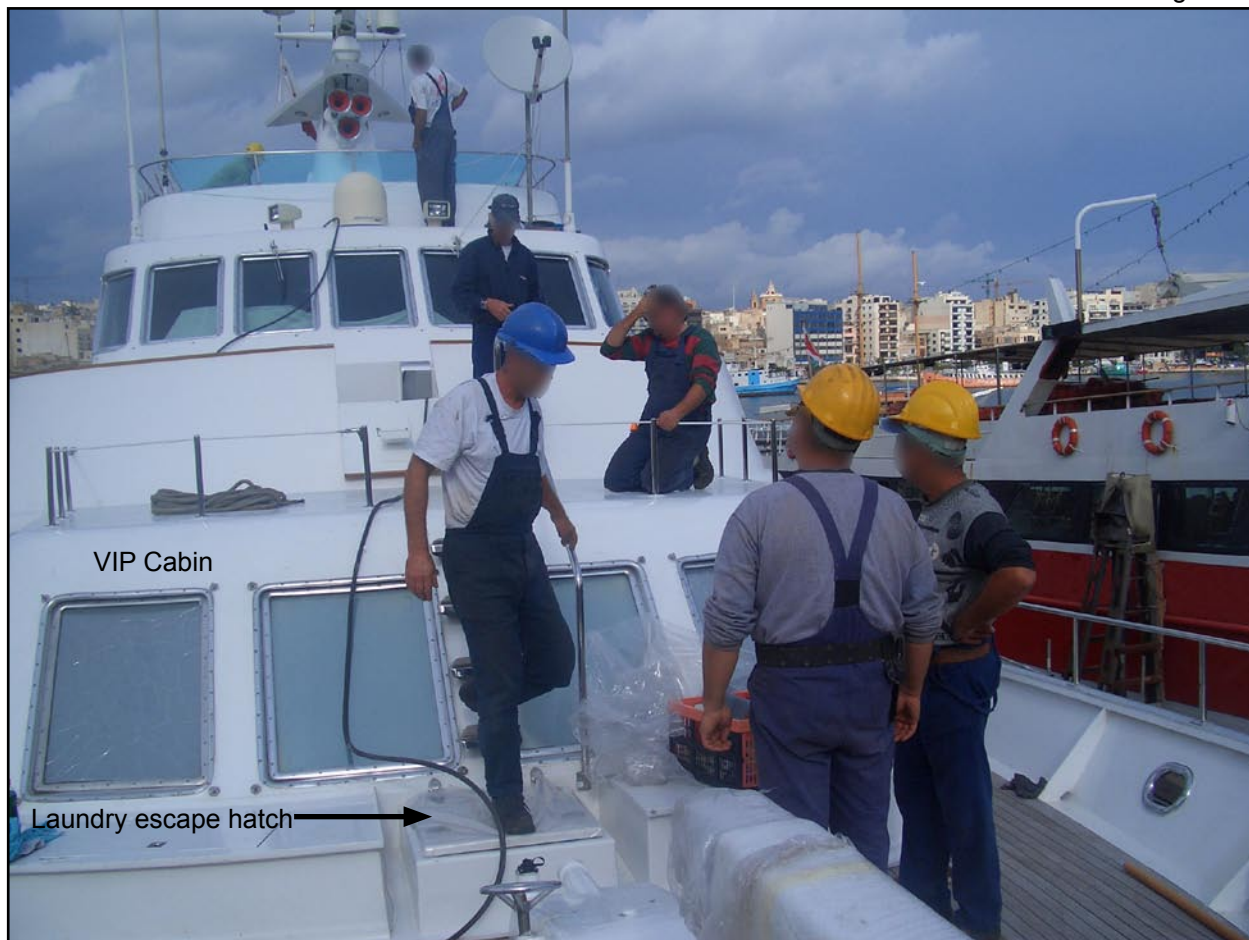
Foredeck, escape hatch and VIP cabin

Once the junior deckhand was clear, the captain looked through the escape hatch and saw flames at the compartment's deck-head. Flames were also seen coming out of the laundry vent, and the VIP cabin (**Figures 2 and 8**) was beginning to fill with smoke. The captain instructed the senior deckhand to go to the engine room and start the fire pump while he attempted to fight the fire through the open hatch using a portable extinguisher.

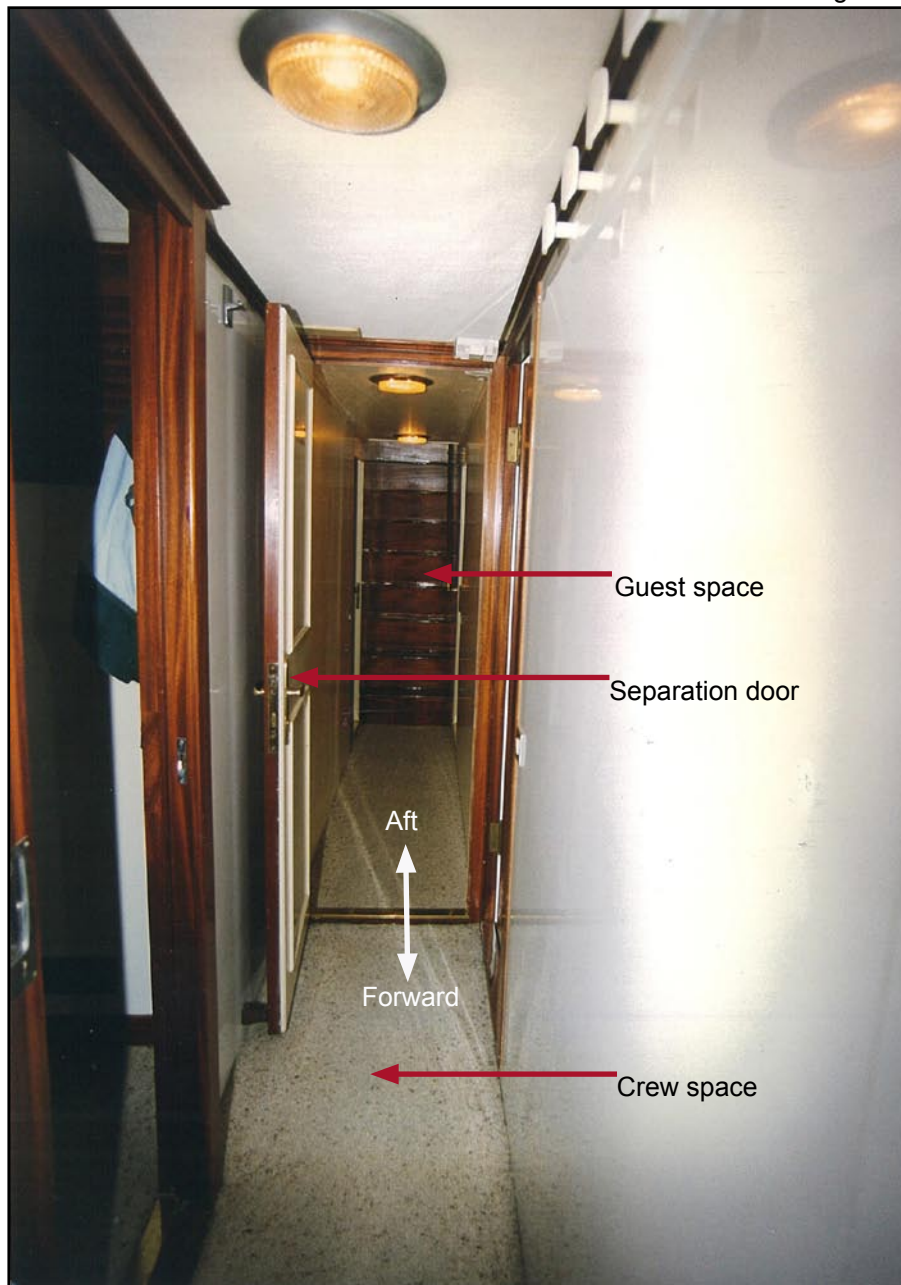
Figure 3

Internal alleyway

Internal access to the laundry was by an alleyway (**Figure 3**). At the forward end of the alleyway, a flight of three steps led to the laundry room and a crew cabin, which shared a common two-way door (**Figure 6**). The main control panels for the 110V DC windlass (**Figure 7**), which had a history of overheating, were sited behind the stairs.

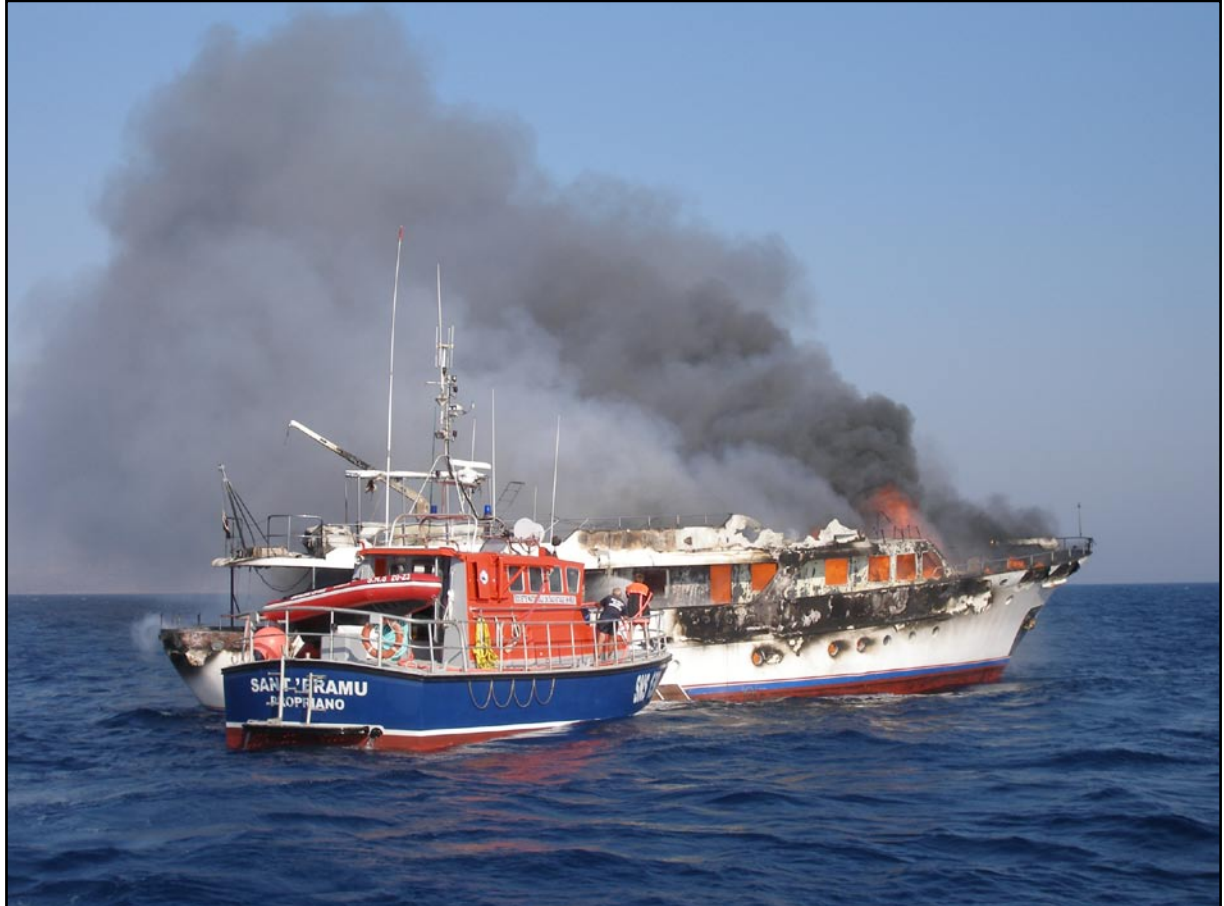
Figure 5

The rescue boat *Sant Eramu* arrived at the scene at 1732 and started to extinguish the fire. She was joined by a second rescue boat an hour later. By this time, much of the superstructure had disappeared, the engine room was in flames and the port holes of the cabins were missing (**Figure 5**).

Lady Candida on fire

As water was seen coming from the yacht's lower port holes about 2 hours before she sank, a considerable amount of water must have accumulated in the vessel during the tugs' attempts to extinguish the fire. It is evident that the weight of the water, together with free surface effect, was sufficient to cause the ship to lose stability and founder.

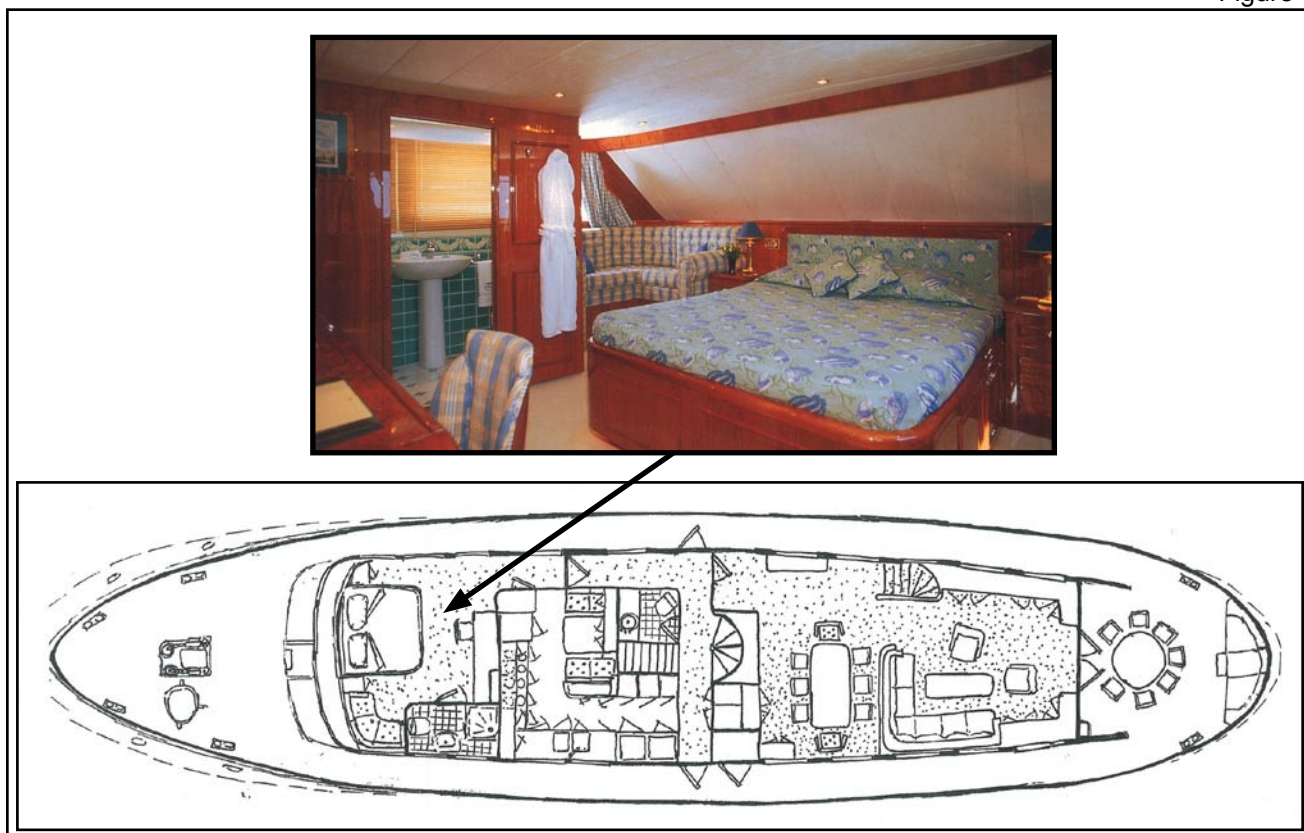
Figure 8

Above and aft of the laundry was the VIP cabin (**Figure 8**), which had been converted from a study. During the conversion, the stepped bulkhead below the cabin's front windows was cut away and a new sloping section, probably made from marine plywood, was inserted (**Figure 9**) to allow a bunk to be fitted as far forward as possible.

Position of VIP cabin

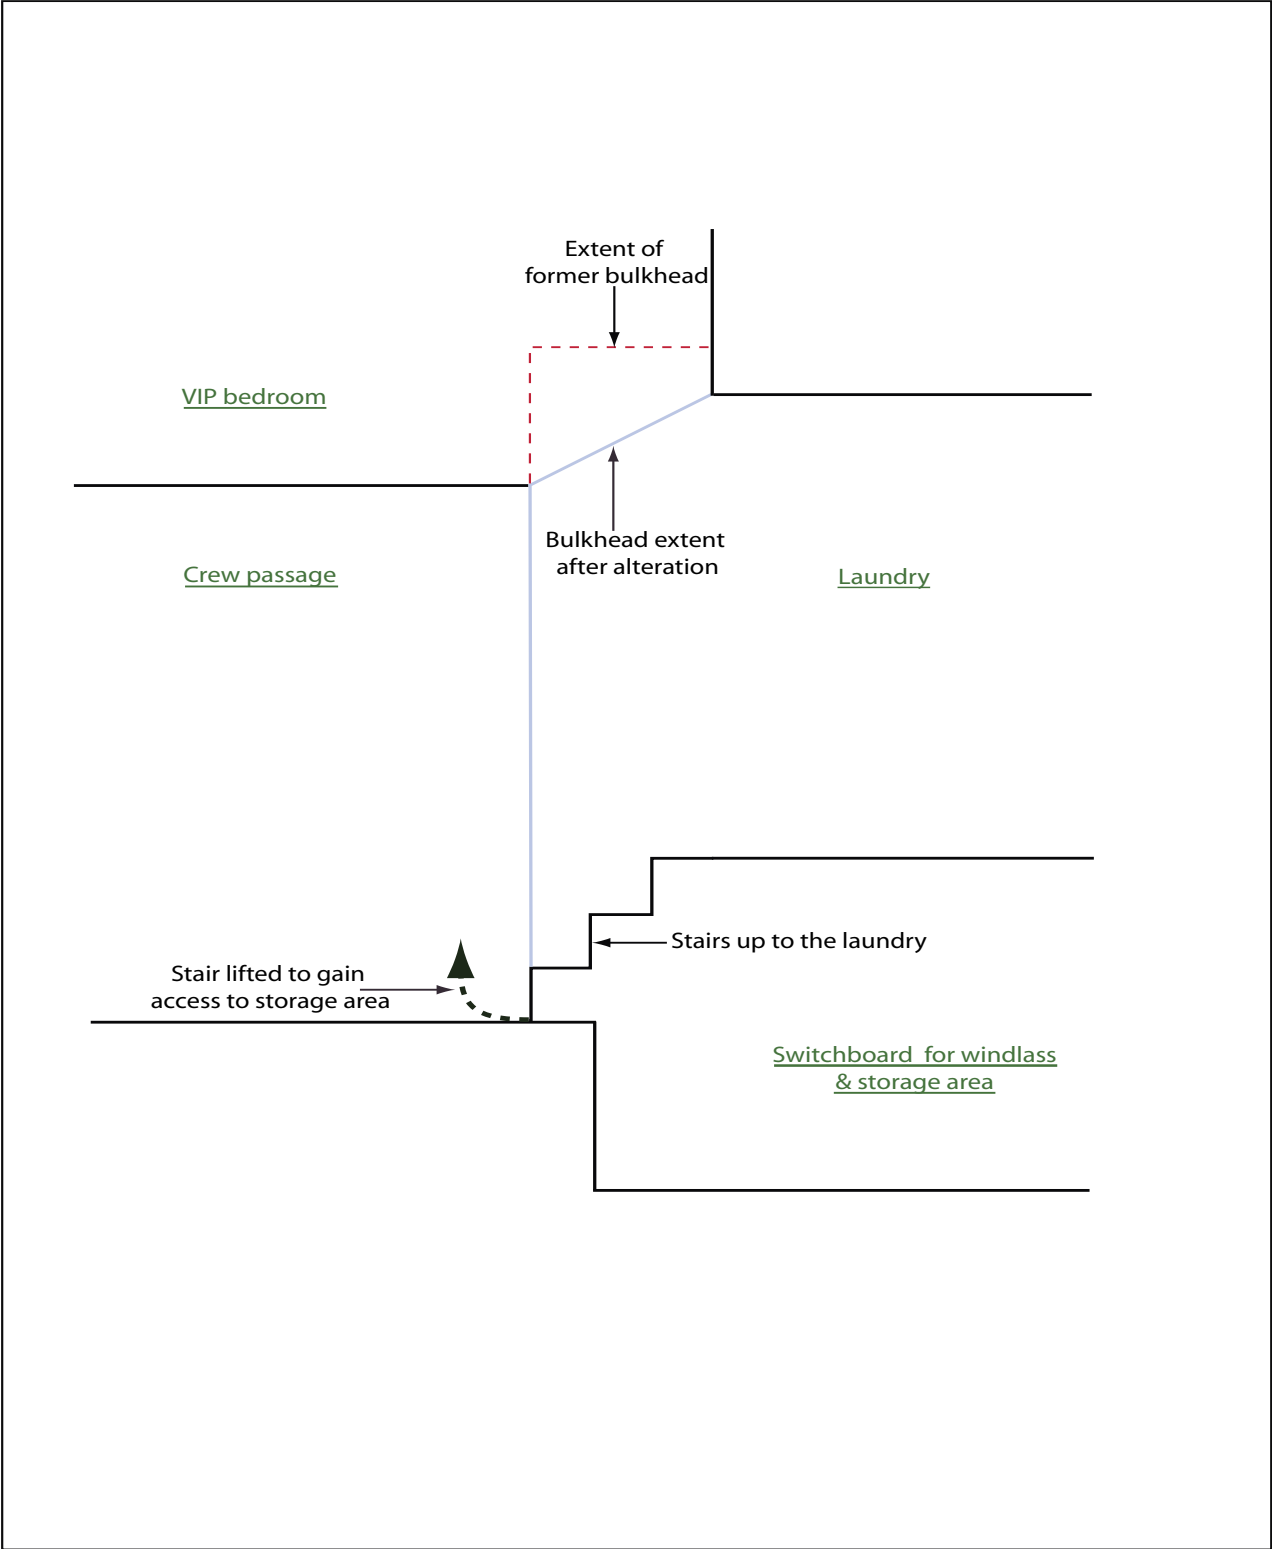
Figure 9

Internal bulkhead

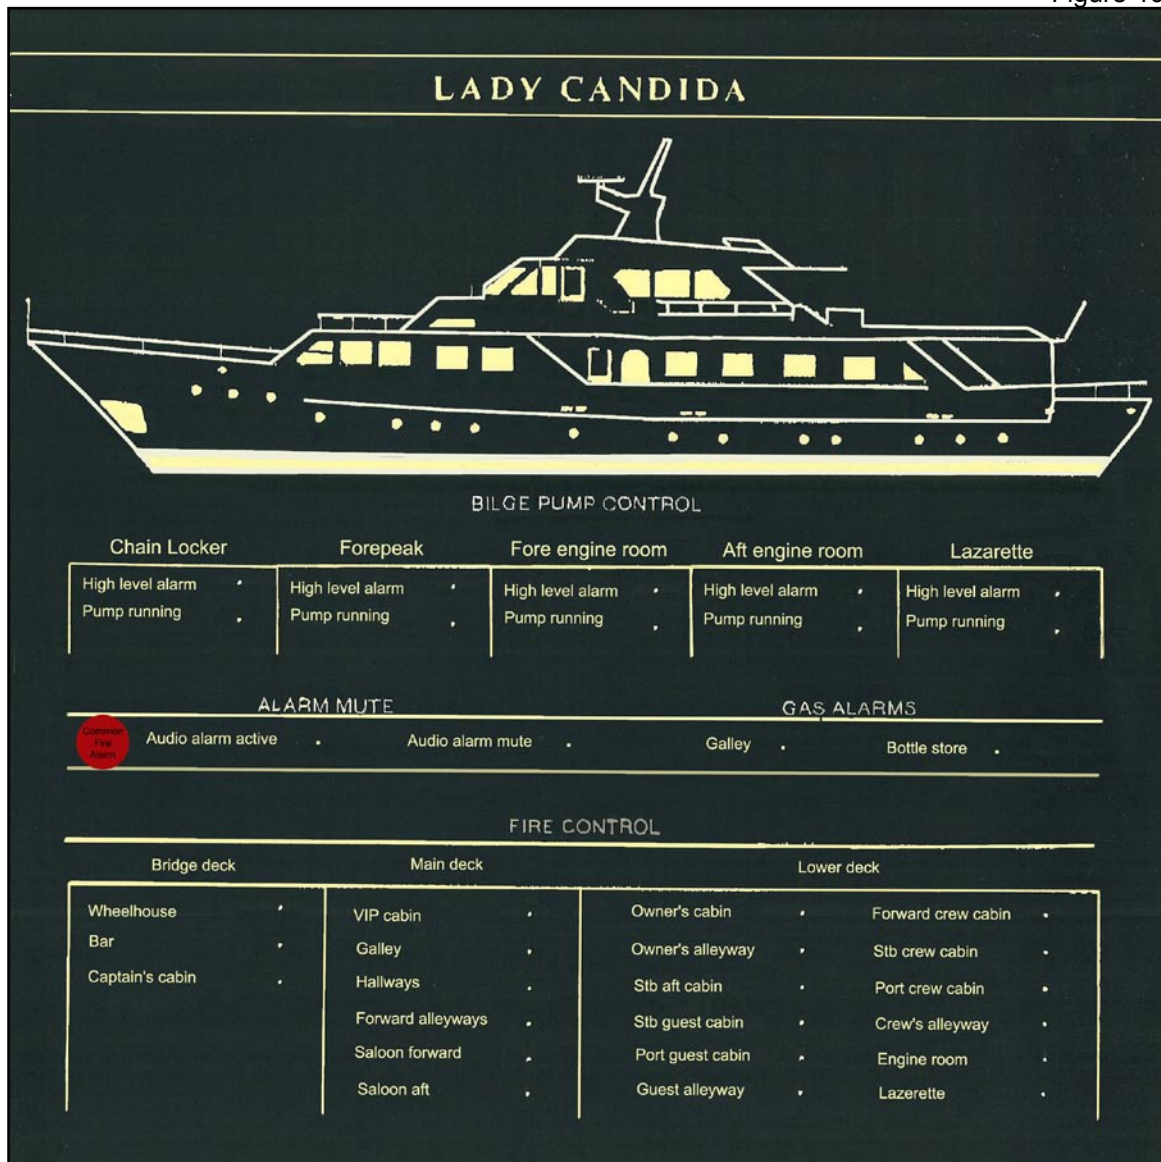
Figure 10

Alarm control panel

The control panel LEDs, which also provided indication for bilge levels, bilge pump operation and gas leaks, were arranged schematically for ease of identification. Switches on the control panel enabled the LEDs to be tested and for audible alarms to be muted. The status of the mute switch on the main alarm panel at the time of the fire is not known. The yacht did not have a dedicated general alarm, but the smoke sensors could be activated simultaneously by a push button on the control panel, which sent an independent 9V supply to each sensor. A high level alarm system for the vessel's black and grey water tanks was also sited on the bridge, the audible alarms of which were muted.

Given the large amounts of thick black smoke seen in the laundry and alleyway by the junior deckhand and captain respectively before any smoke alarms appear to have been heard, it is evident that the fire detection system failed to provide adequate warning. Although it is possible that the audible alarms on the bridge were muted, the failure of some alarms to sound locally, particularly the alarm in the forward crew alleyway, indicates that the sensors were not functioning correctly. In view of the lack of maintenance and testing, along with the captain's poor knowledge of the system, it is highly likely that some sensors did not work because their batteries were flat, as identified during previous inspections and surveys, or had been removed.
