Report on the investigation of
The machinery space fire on board

Oscar Wilde

In Falmouth Bay

Report No 3/2011
March 2011

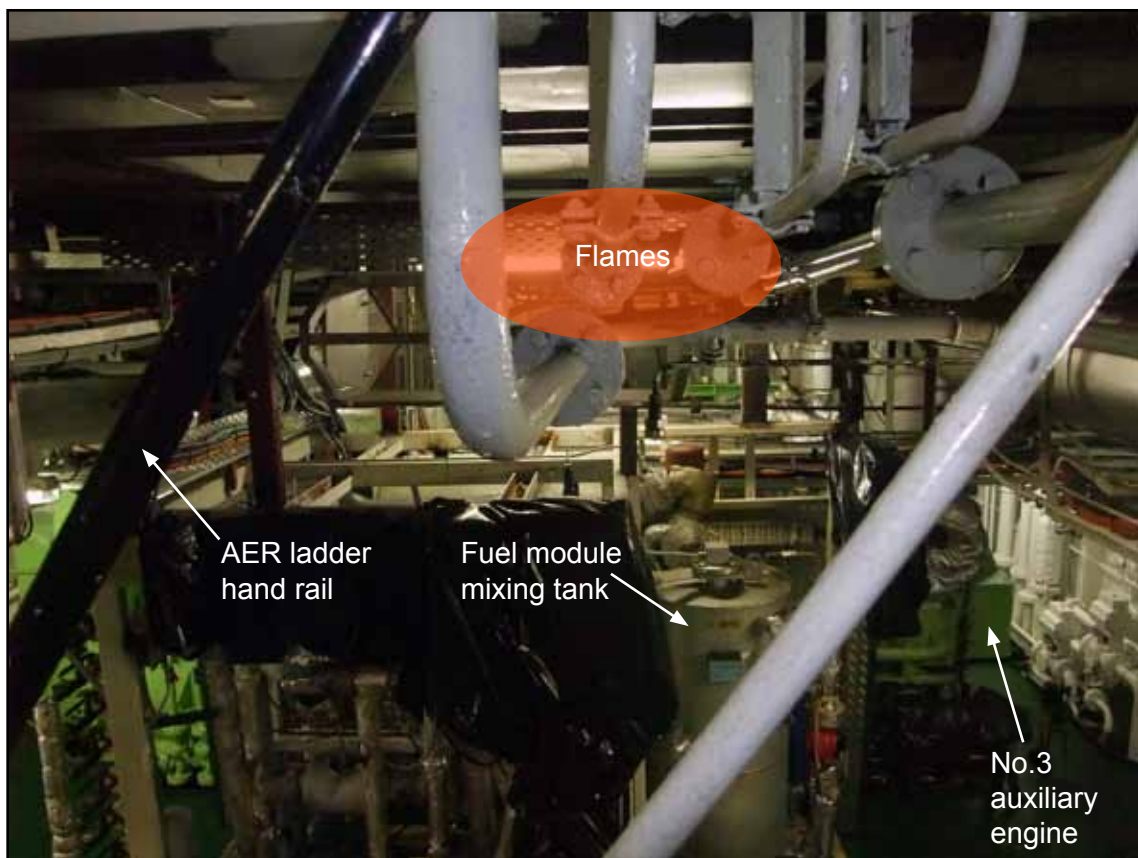
Figure 2

View of the fire from the auxiliary engine room ladder

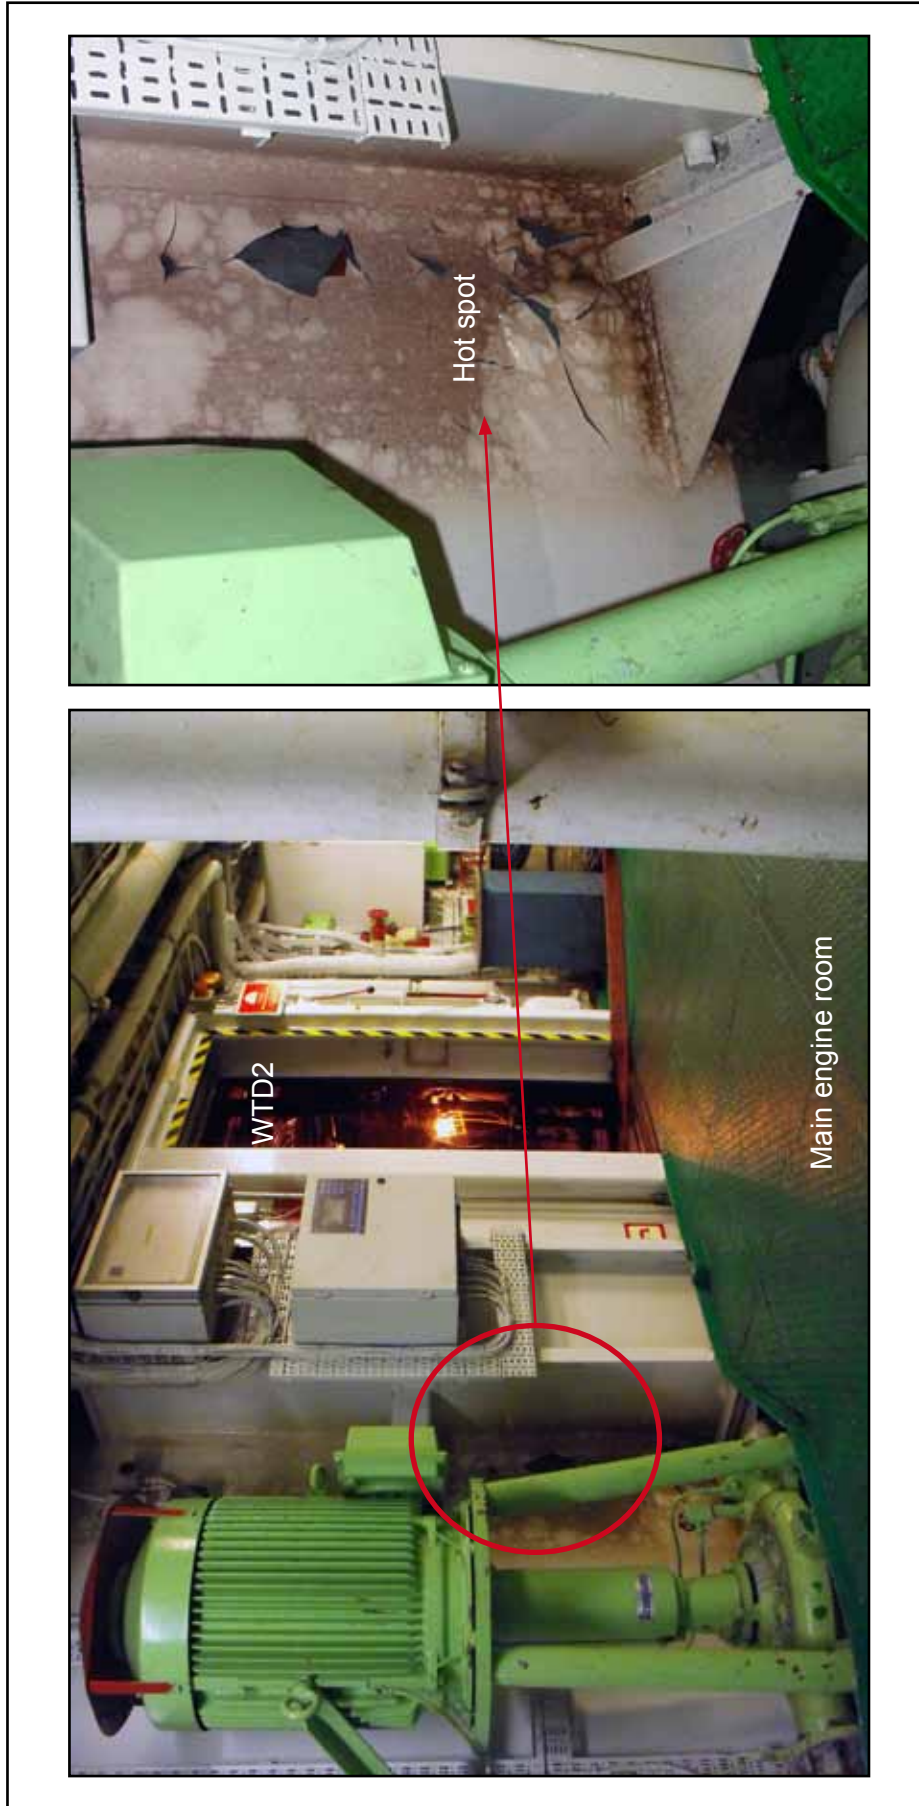
Figure 6

At 1927, the chief engineer reported hot spots on the deck of the lobby area outside the ECR. Two minutes later, the 2/E reported hot spots on the forward main engine room bulkhead next to WTD2 (**Figure 6**). The C/O interpreted this message to mean hot spots had been reported in the fire control station. This caused some confusion on the bridge as the control station was 2 decks above the AER (**Figure 7**).

Hot spots on main engine room bulkhead

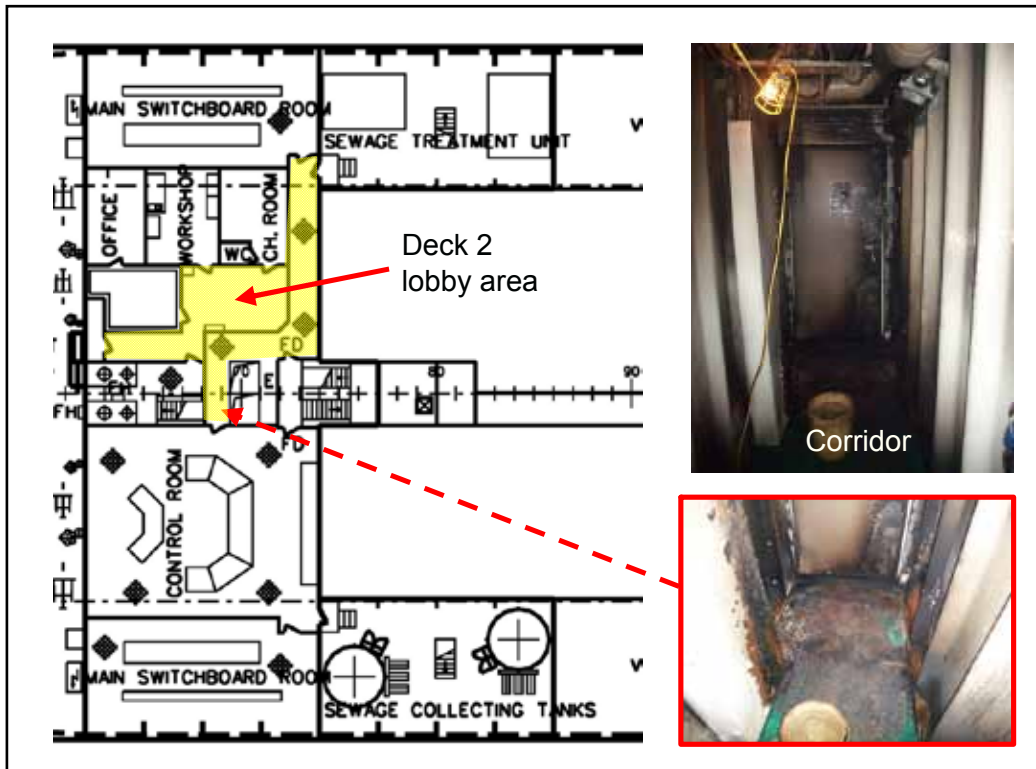
Figure 11

Seat of fire in corridor leading to the engine control room

The seat of the fire in the corridor outside the ECR was located at deck level on a cable tray that ran under a section of raised floor plates. The heat from the flames burnt paint on the bulkhead and ECR door, melted a light fitting and burst a sprinkler head bulb (**Figure 14**).

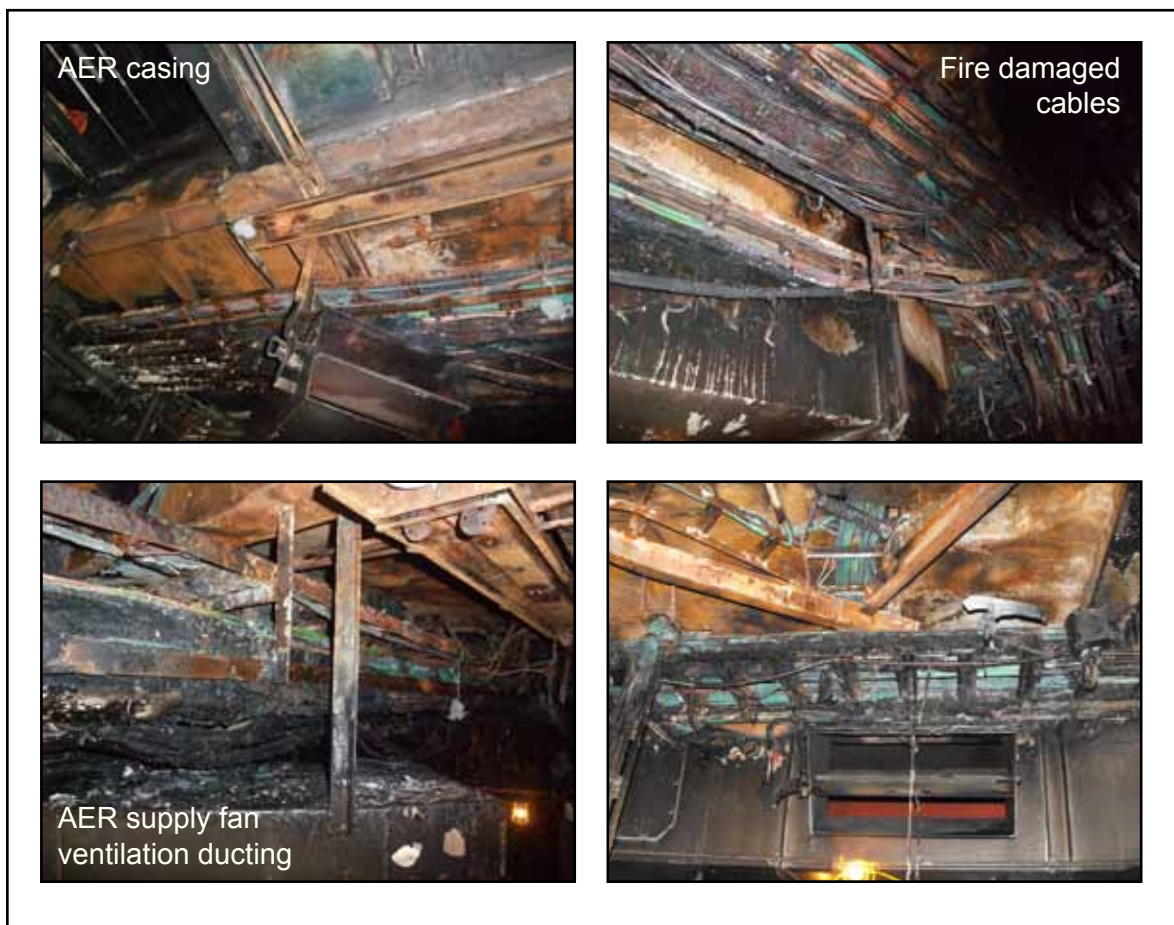
Figure 12

The heat damage and burn patterns on the outboard side of the fuel module indicated that the seat of the fire was low down but had spread to the electrical cables above. Damaged cables included the start/stop control cables for the emergency fire pump. No.3 auxiliary engine was not significantly affected by the heat radiated from the fuel module fire. The greatest damage at deckhead level was evident between the fuel module and the AER ventilation duct openings and starboard forward casing uptake area (**Figure 12**).

Fire damage to deckhead cables in the auxiliary engine room

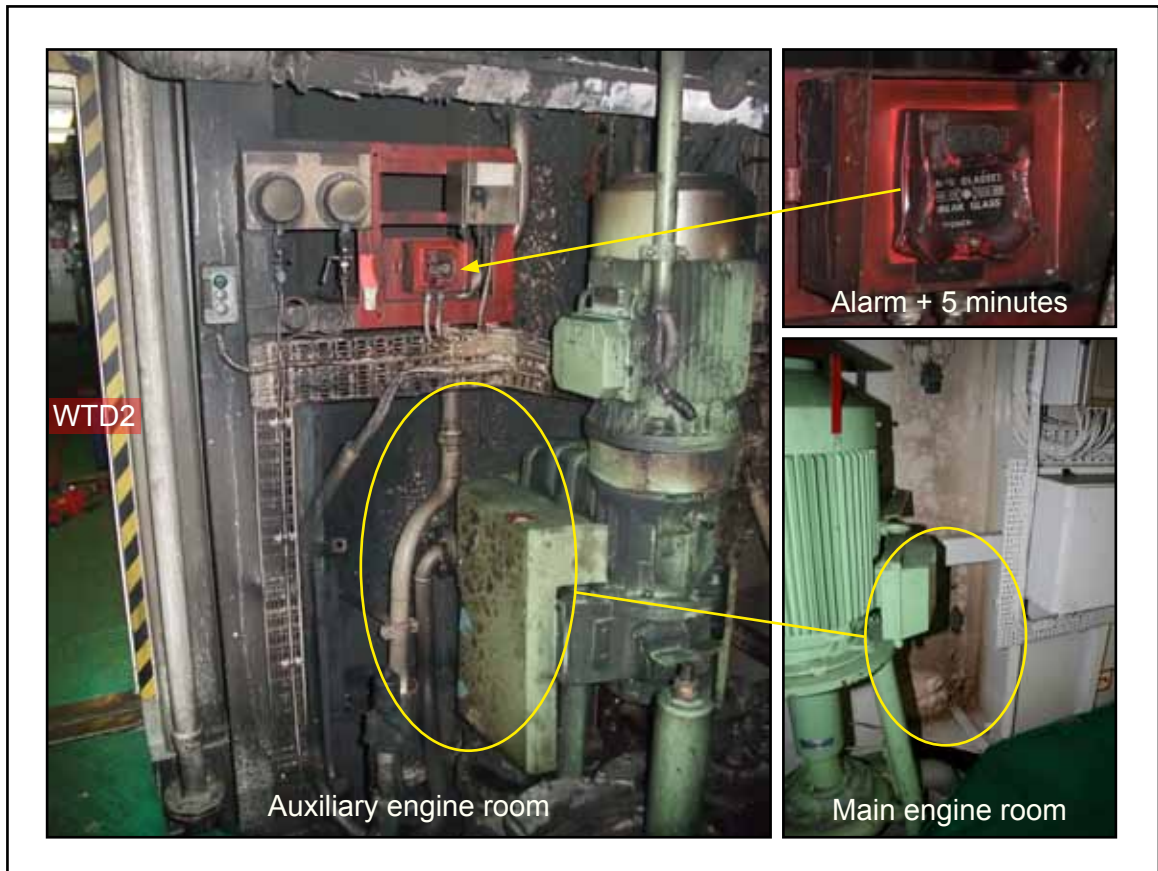
The heat from the bilge fires close to the aft AER bulkhead caused the casing of the manual break-glass fire alarm call point next to WTD2 to melt and the paint on the bulkhead in the main engine room to blister (**Figure 13**). The manual call point alarmed about 5 minutes after the initial flame sensor had activated.

Damage caused by bilge fire

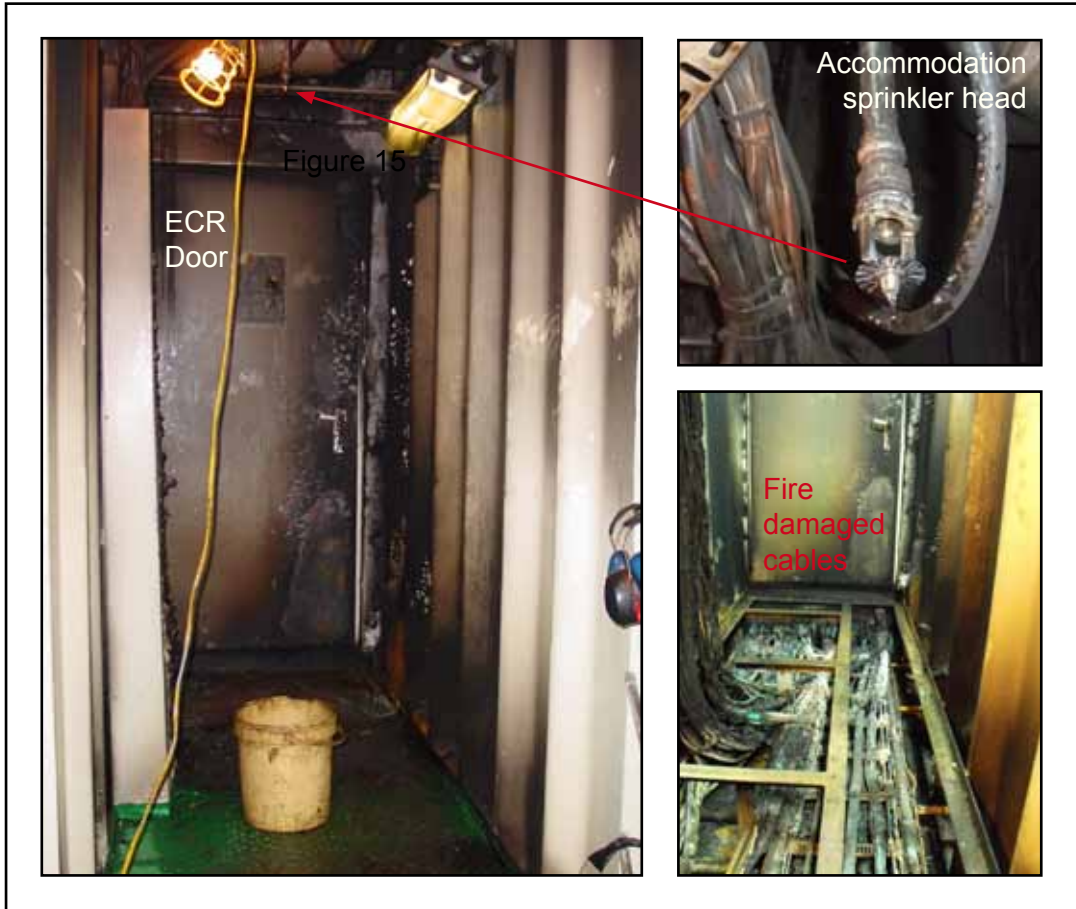
Fire damage on deck 2 outside the engine control room

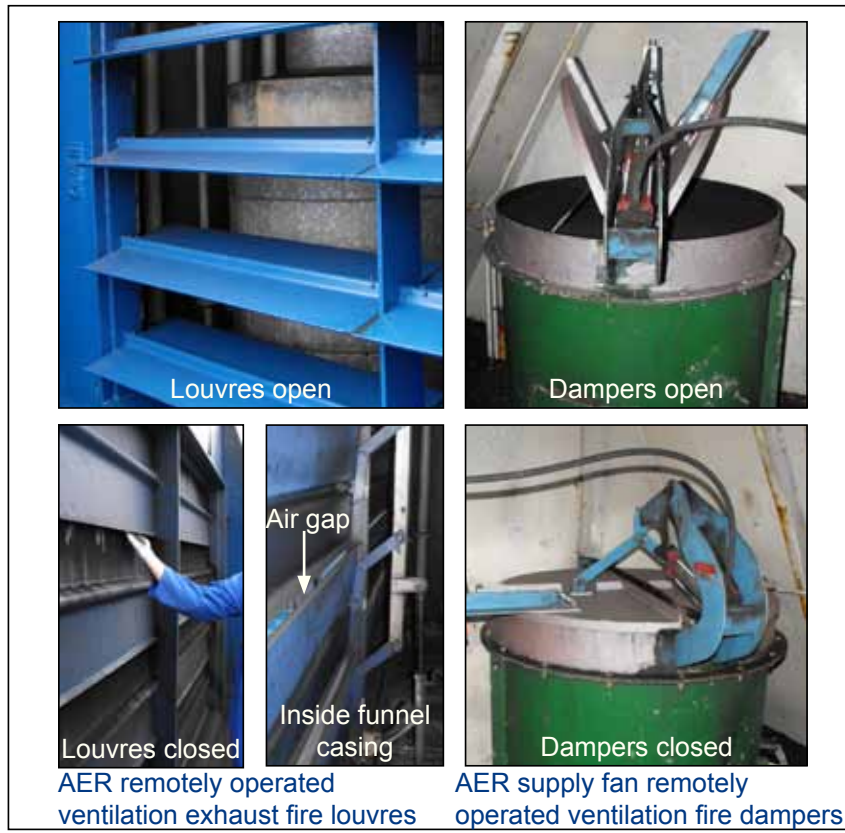
Figure 15

The AER ventilation dampers were found to be in the closed position (**Figure 15**). However, the exhaust louvres on the back of the funnel did not form a gas-tight seal when closed.

AER ventilation system fire dampers

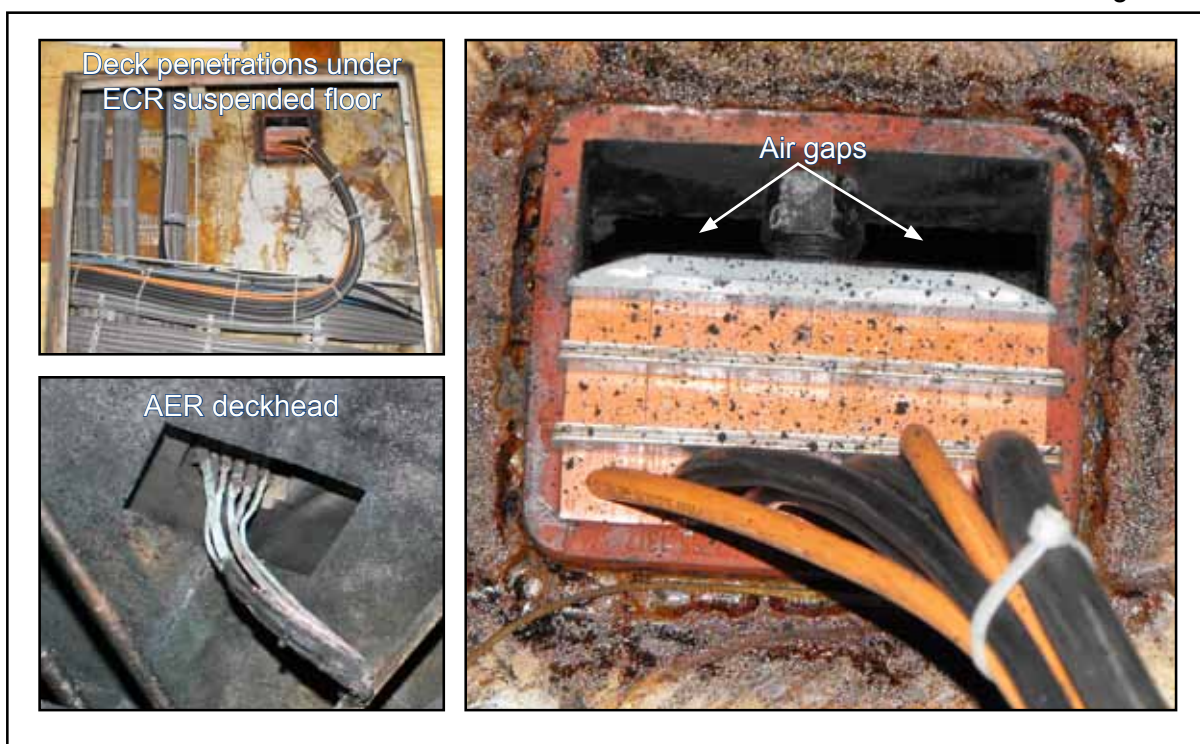
Several deck penetrations between the AER and ECR had not been properly packed and did not provide a gas-tight seal (**Figure 16**). The ventilation supply and exhaust system for the ECR and adjacent compartments was common to the zone 2 passenger accommodation spaces on deck 8. The crew was unfamiliar with the ventilation system, and the vent trunk fire dampers between these areas had not been closed. The doors to the switchboard rooms and other compartments on deck 2 were secured in the open position.

Engine control room deck penetrations

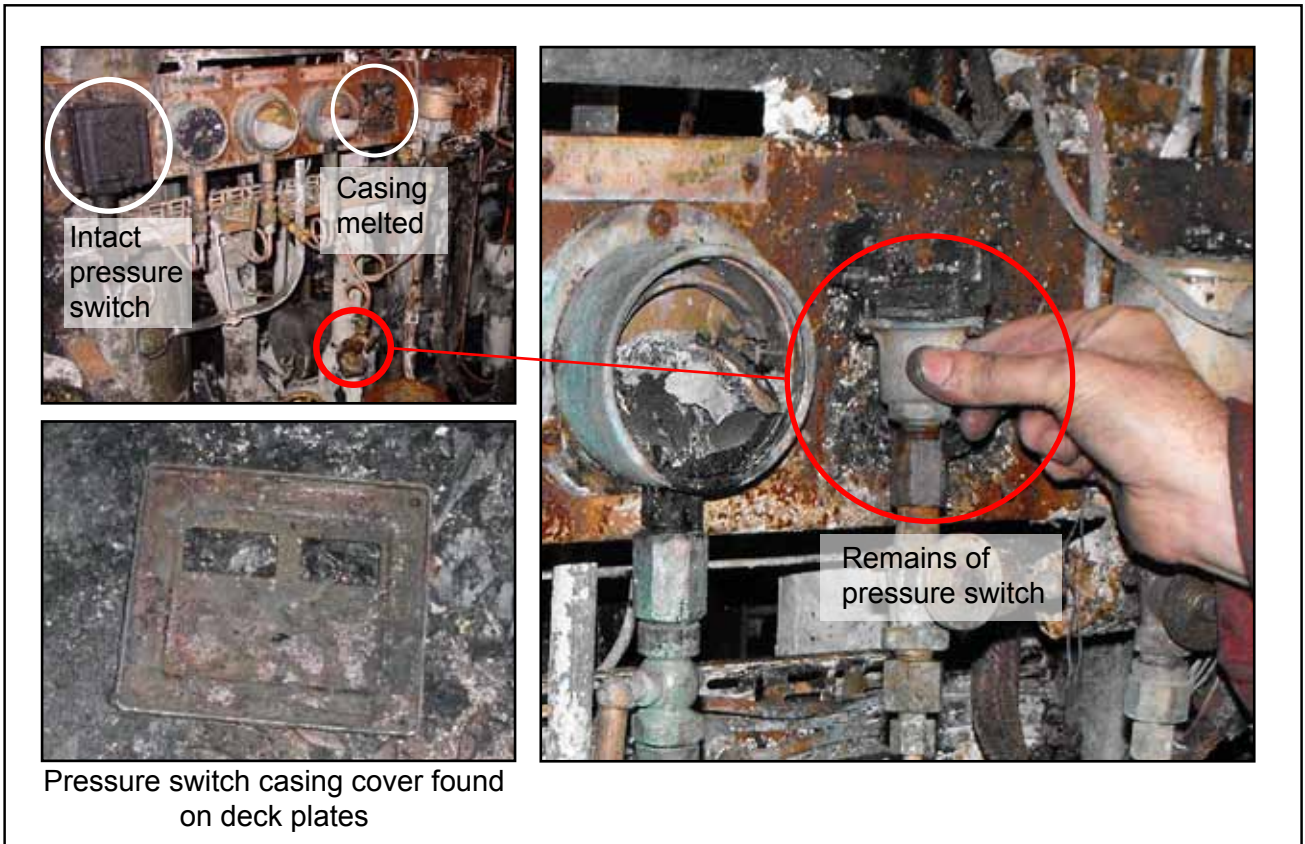
One of the module's pressure switches had been exposed to intense localised heat. Its metal alloy casing had completely melted and its steel casing cover was found on the deck plates close to No.3 auxiliary engine (**Figure 19**). The remains of the pressure switch were removed and closer examination revealed its pressure bellows to be intact.

Fire damaged pressure switch

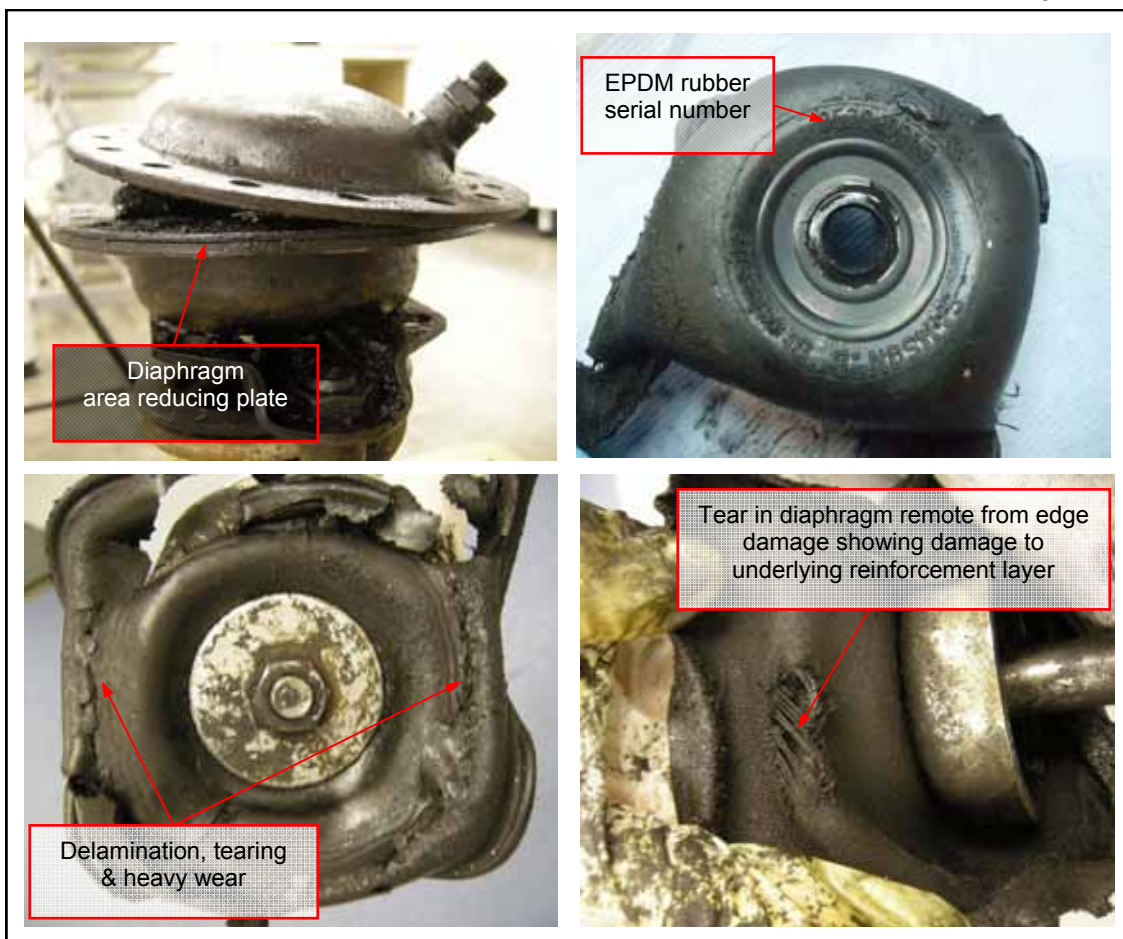
Figure 23

The test report on the diaphragm removed from the valve actuator identified deterioration of the rubber and a tear in its main flex region (**Annex B**). This damage was remote from the fire damage evident at its outer edge. The diaphragm was made from EPDM rubber and was therefore not suitable for use in fuel oil systems. The actuator had a diaphragm area reducing plate which increased the valves' operating pressure range to 4.5 to 10bar (**Figure 23**). The actuators fitted to the fuel modules on board *Oscar Wilde* were not fitted with any optional safety features.

Condition of the auxiliary engines' excess fuel pressure regulating valve diaphragm

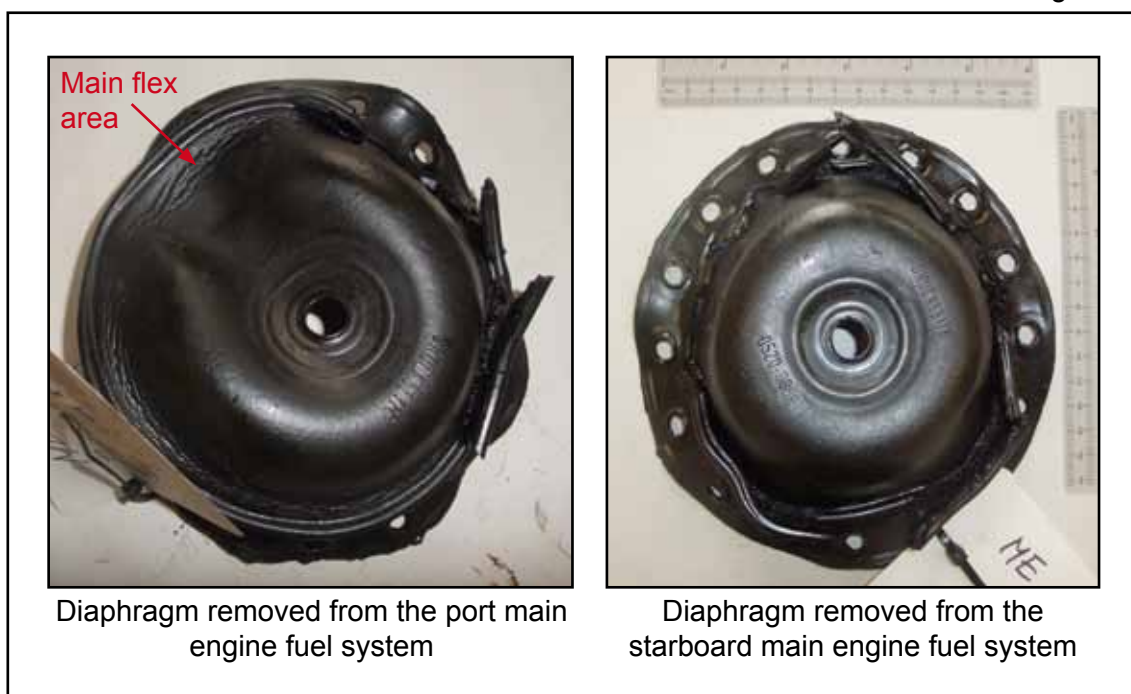
Figure 24

Following the examination of damage to the diaphragm from the excess pressure regulating valve, similar valves fitted to the vessel's two main engine fuel modules were replaced. The diaphragms in the main engine valves were also made from EPDM rubber and found to be severely degraded in the main flex area (**Figure 24**). The replacement valves were fitted with FPM diaphragms, diaphragm leakage glands and rupture indicators.

Main engine actuator diaphragms

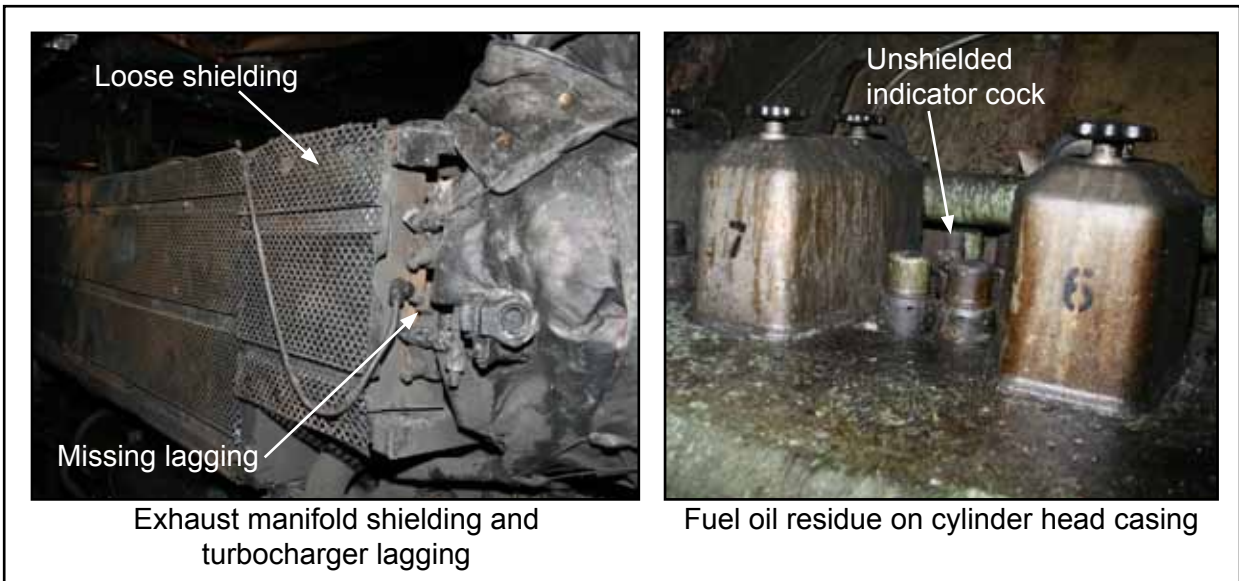
Fuel oil residue on number three auxiliary engine

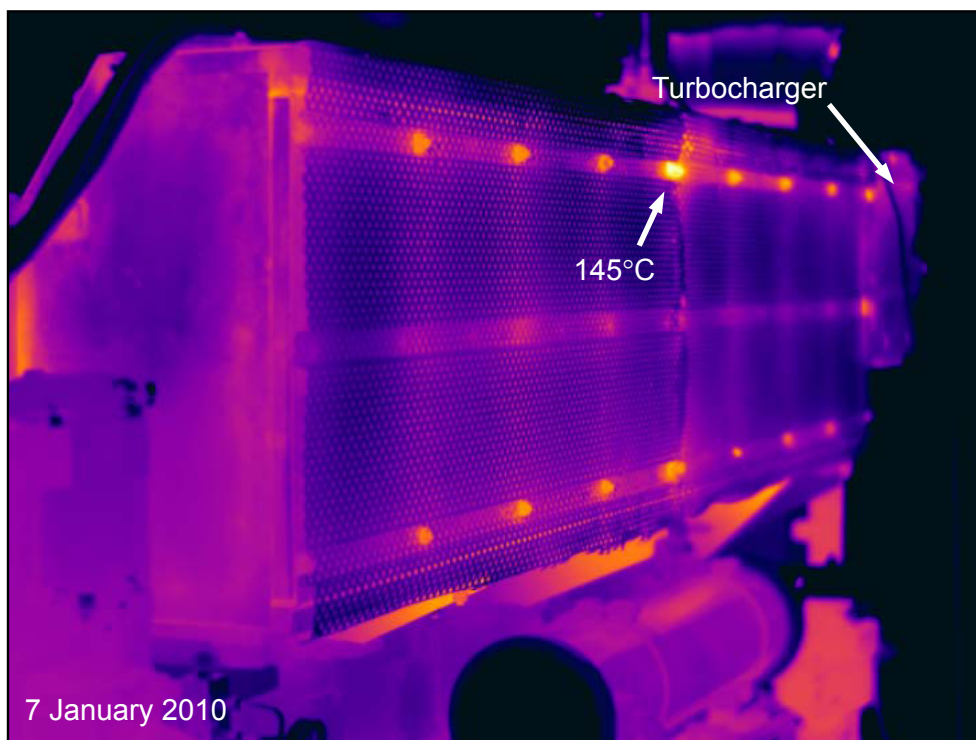
Figure 27

A thermal survey of the ship's electrical distribution system was carried out by a specialist contractor prior to the docking period. The main and auxiliary engines were not included in the work package but, at the request of the chief engineer, thermal images were taken of the auxiliary engine exhaust shields (**Figure 27**). These images identified hot spots, but information relating to the loading on the engines at the time of the survey was not available and no images were taken of the turbocharger or the outboard side of the engine. Work was carried out on the main and auxiliary engines during the docking period that would have required the removal of lagging and heat shields. However, a thermal survey was not carried out prior to the ship returning into service.

Thermal image taken of number three auxiliary engine exhaust manifold shielding prior to docking period

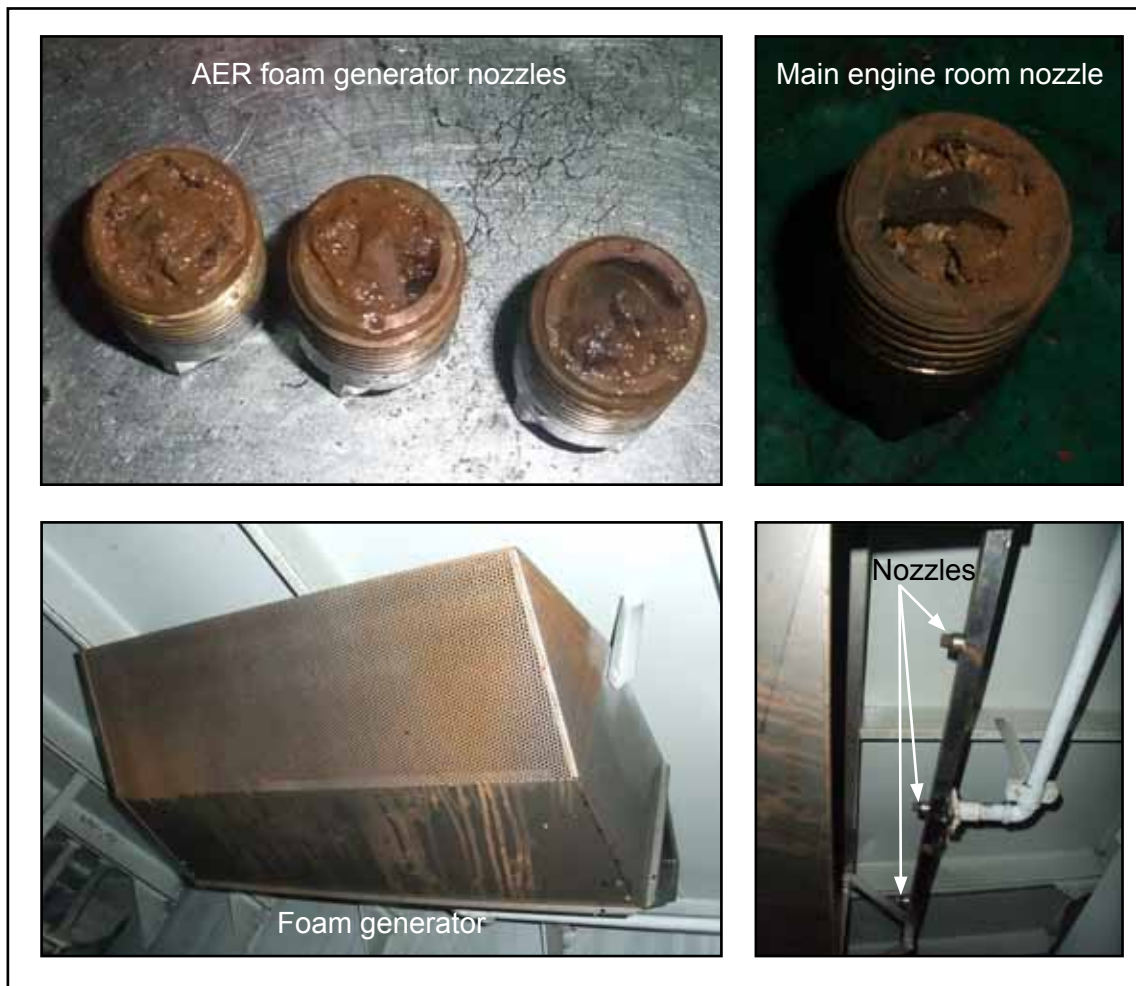
On 5 March 2010, manufacturer's representatives conducted a thorough examination of the system. The foam concentrate pump was found to be fully operational and the sea water strainer was clear. The foam proportioner was in good condition, set at the required 2%, and was functioning correctly. Thirty-one of the 39 AER foam generator nozzles were found to be completely blocked with rust and scale (**Figure 36**). The nozzles from the other protected spaces were removed for inspection, and approximately 50% were found to be blocked.

Blocked *Hotfoam* generator nozzles

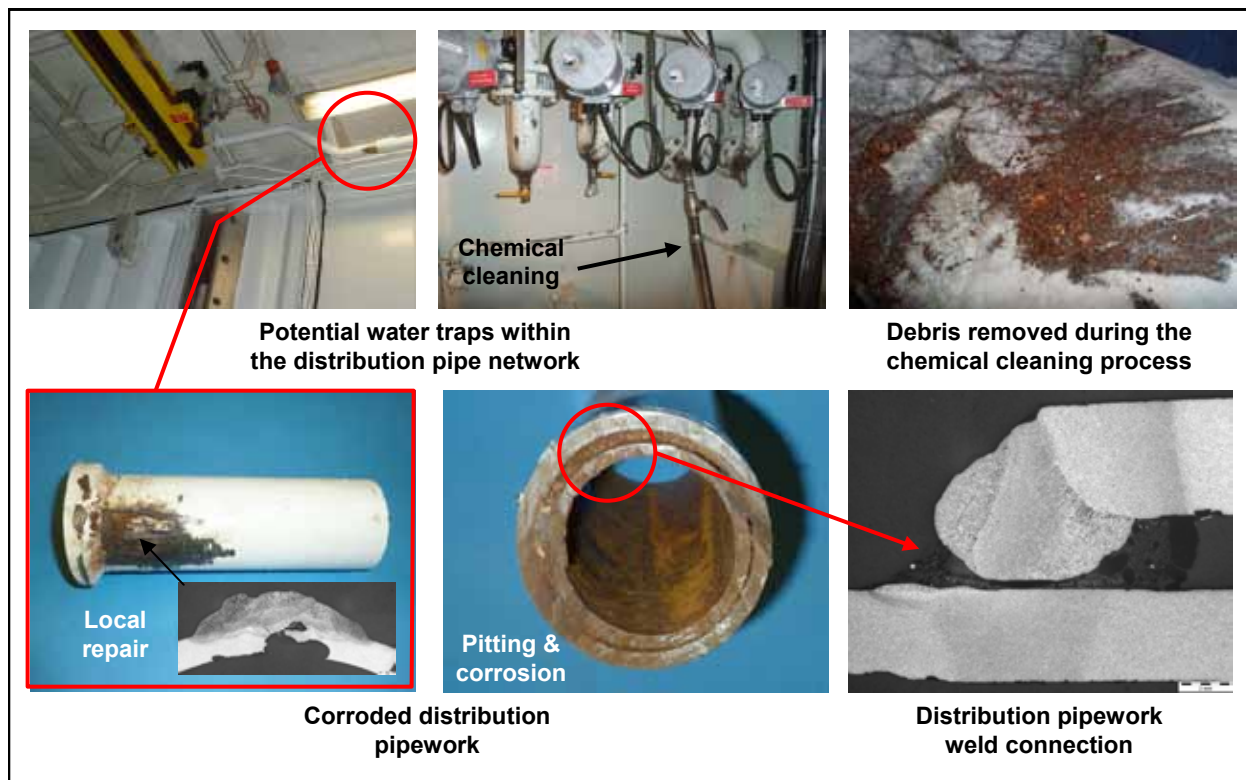
Figure 37

The distribution pipes were heavily corroded and contained debris, particularly in sections where liquid could become trapped (**Figure 37**). Analysis of a removed section of distribution pipe showed that it was made from mild steel and had not been galvanised or zinc coated. It was heavily corroded, had suffered a localised pinhole failure, and had not been effectively welded to its adjacent pipe (**Annex E**).

Hotfoam system distribution pipework

The distribution pipework was chemically cleaned and was proved clear of debris before being tested to the satisfaction of the class and flag surveyor. The manufacturer's investigation report included the following recommendations:
