MAIB SAFETY BULLETIN 1/2006

Fire on board the Bermuda registered cruise ship

Star Princess

on 23 March 2006

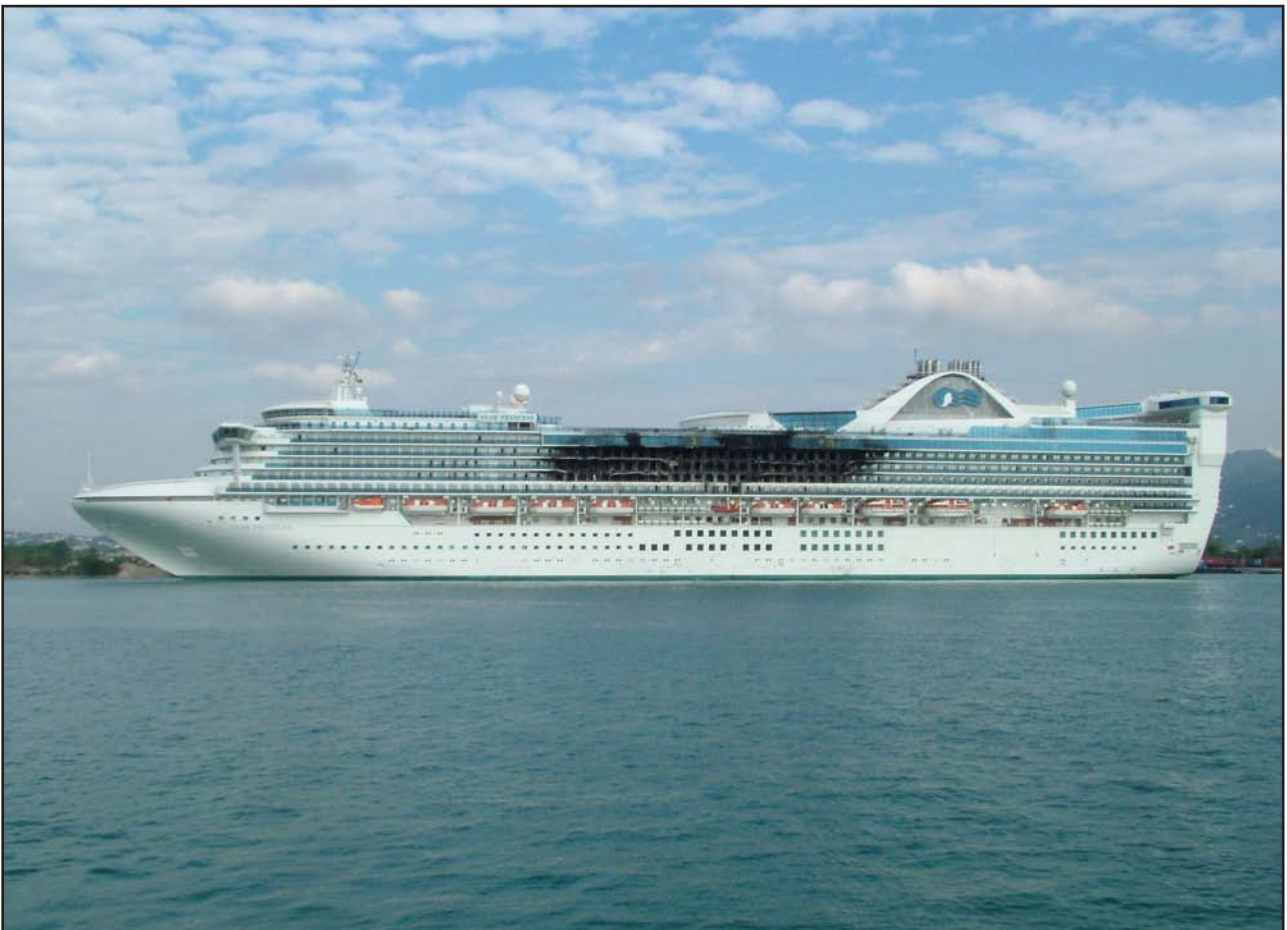
Figure 1

The fire was extinguished about 1.5 hours after it had started. The crew fought the fire with water hoses from adjacent external areas, and from internal alleyways. Difficulty was experienced in reaching the fire due to the construction and partitioning of the balcony areas. A total of 79 cabins were condemned after the fire, and a further 204 were either water or smoke damaged. The damaged area covered 3 vertical fire zones on 5 decks (**Figures 1, 2 and 3**).

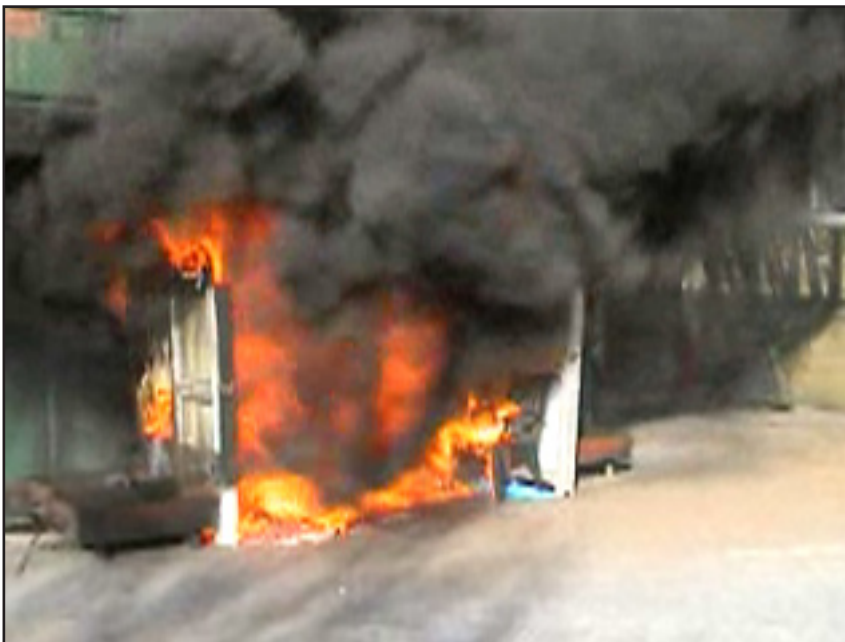
Figure 4

Following the accident, it has been determined by practical tests that the materials at the seat of the fire were readily ignitable, and that the polycarbonate balcony divisions generated intense heat and copious amounts of dense black smoke as they burned (**Figure 4**).

combustible balcony dividers on a priority basis and as soon as possible with dividers that are of non-combustible material.
