## MARINE INVESTIGATION REPORT

M01C0054

### STRIKING AND SUBSEQUENT FIRE ON BOARD

BULK CARRIER *WINDOC*

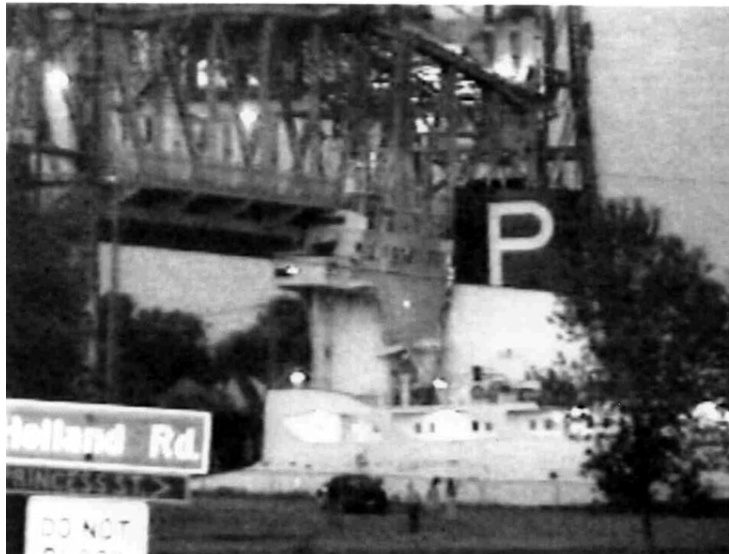
The master and third officer left the wheelhouse by the starboard navigation bridge wing. As they proceeded down the external bridge access ladder, the span of the bridge struck the vessel in way of the wheelhouse front windows, subsequently destroying the vessel's wheelhouse and funnel (see Photo 1).

**Photo 1.** Bridge 11 striking vessel in way of wheelhouse front windows. Reproduced with permission.

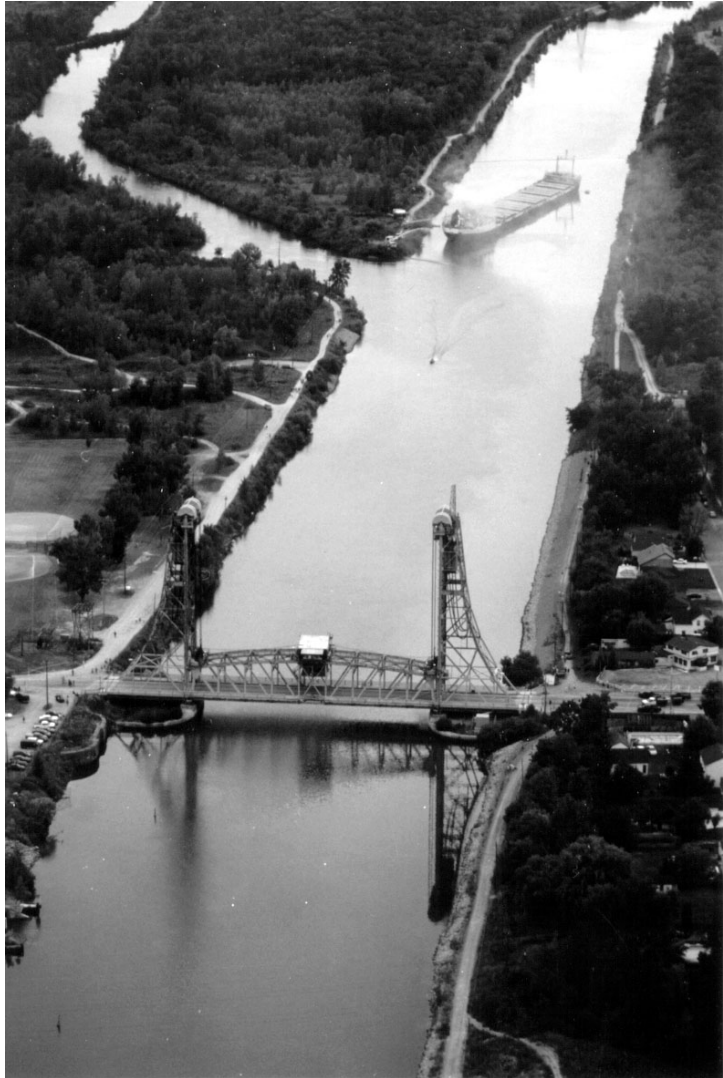
**Photo 2.** Aerial view looking north at the bridge and vessel after the striking. (Photograph by Harry Rosettani)

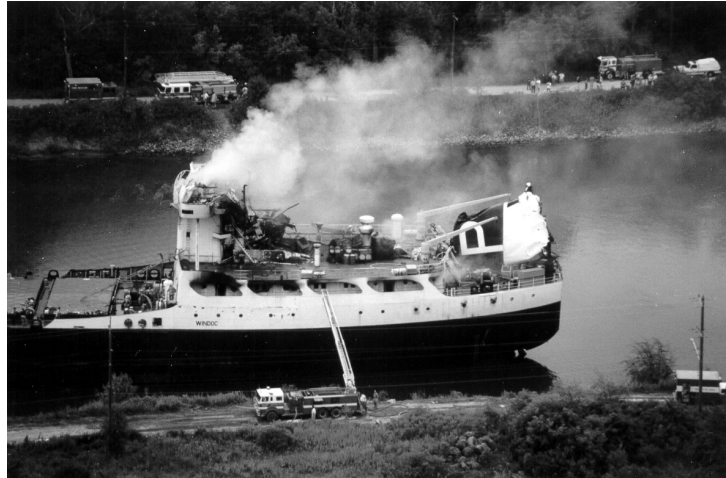
**Photo 3.** Aerial view of aft section of vessel with fire department vehicle on site. (Photograph by Harry Rosettani)

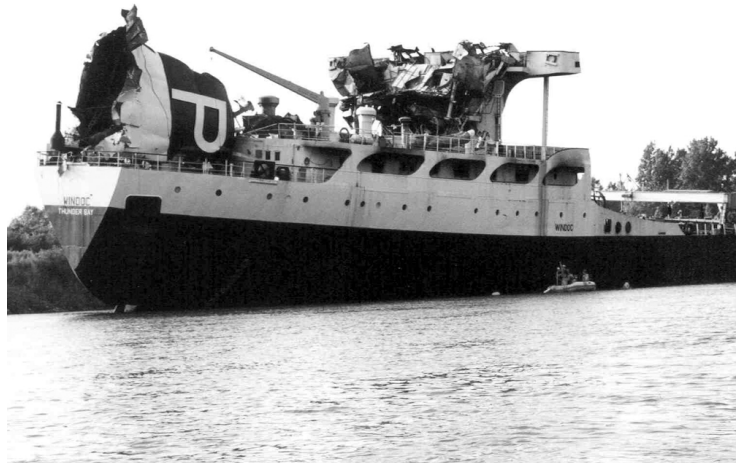
The wheelhouse, main mast, engine room vents, and funnel were destroyed by contact with the lift span of the bridge. The incinerator fuel oil tank, located in the funnel casing, was ruptured, spilling fuel into the engine room and onto the boat deck.

Accommodation on the various decks was destroyed by fire, heat, and smoke. The engine room casing and main engine were damaged by fire, heat and water. The bilge shell plating in way of starboard ballast tank No. 1 was creased and fractured. The aft bulkhead and bilge floors were distorted and torn adrift. The vessel was declared a constructive total loss. No damage to the cargo was reported (see Photo 4).

**Photo 4.** View of damaged superstructure and funnel.

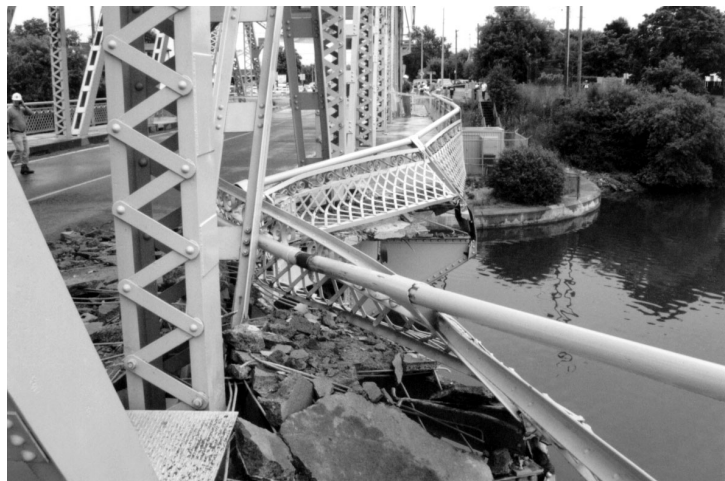
The bridge sustained structural damage to the centre of the vertical-lift span (see Photo 5). There was also

**Photo 5.** Damage to Bridge 11. (Photograph by Thorold Fire Department)

damage at the extremities of the span as a result of lateral movement caused by the striking.

Other than minor adjustments on the wire ropes which operate the bridge, there was no damage, mechanical or electrical, to the bridge's systems.

Repairs to the bridge were carried out while the vertical-lift span was in the fully-raised position to permit vessel traffic to transit the canal. Upon inspection by SLSMC engineers, the bridge reopened to vehicular traffic on 16 November 2001.

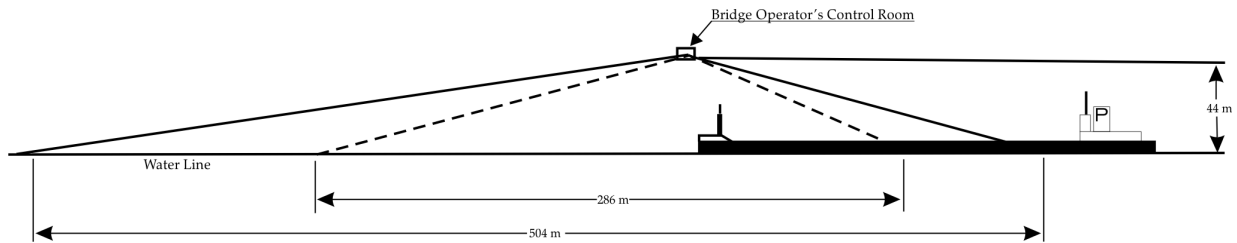
The span was being lowered when it struck the vessel in way of the wheelhouse front windows, at a height of approximately 18.6 m above water level. It took between 49 and 65 seconds to lower the span 18 m. With the vessel travelling at a speed of approximately five knots, its bow would have been under or just clear of the bridge when the bridge operator began to lower the span. The approaching vessel's aft superstructure would have been visible to the bridge operator (whether seated or standing) through the south-facing control room window (see Figures 1 and 2, Photos 6 and 7).

**Figure 1.** Diagram of a bridge operator's field of view when the bow of the vessel is under the operator's control room. Bridge is in the fully-raised position.

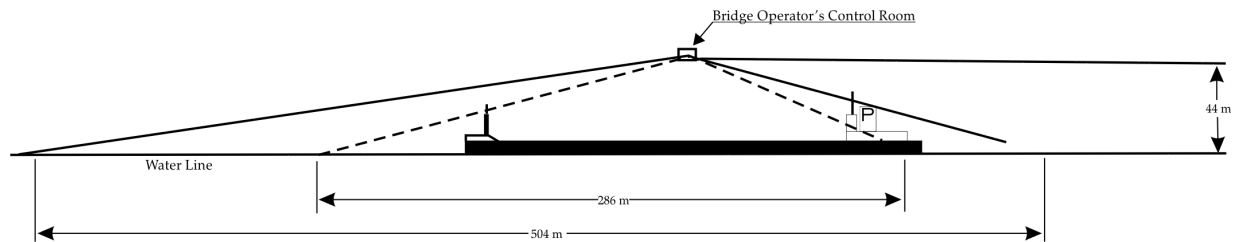
**Figure 2.** Diagram of a bridge operator's field of view when the vessel is amidships under the operator's control room. Bridge is in the fully raised position.

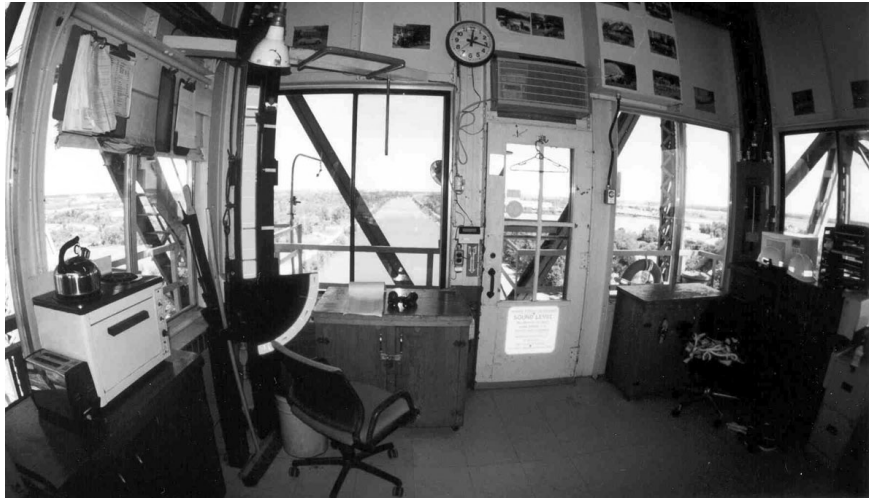
**Photo 6.** Looking north from inside bridge operator control room with bridge in fully raised position (using fish-eye camera lens).

The SLSMC's operations manual for Bridge 11 states that the bridge may be lowered when it is observed that the stern of the vessel is clear of the bridge.<sup>7</sup> The bridge operator described having seen the stern of the vessel through the north windows of the control room (i.e. looking downstream the canal) where the door is located.

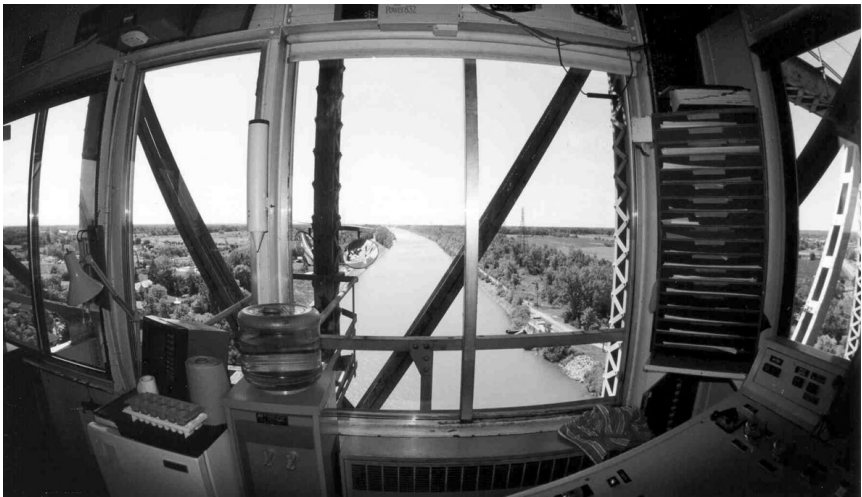
**Photo 7.** Looking south from inside bridge operator control room with bridge in fully raised position (using fish-eye camera lens).
