# UNITED STATES COAST GUARD

## REPORT OF INVESTIGATION INTO THE CIRCUMSTANCES SURROUNDING THE FIRE ABOARD ROYAL CARIBBEAN INTERNATIONAL PASSENGER VESSEL

# NORDIC EMPRESS

IN THE ATLANTIC OCEAN  
JUNE 15, 2001  
RESULTING IN MAJOR DAMAGE  
NO LOSS OF LIFE OR INJURY

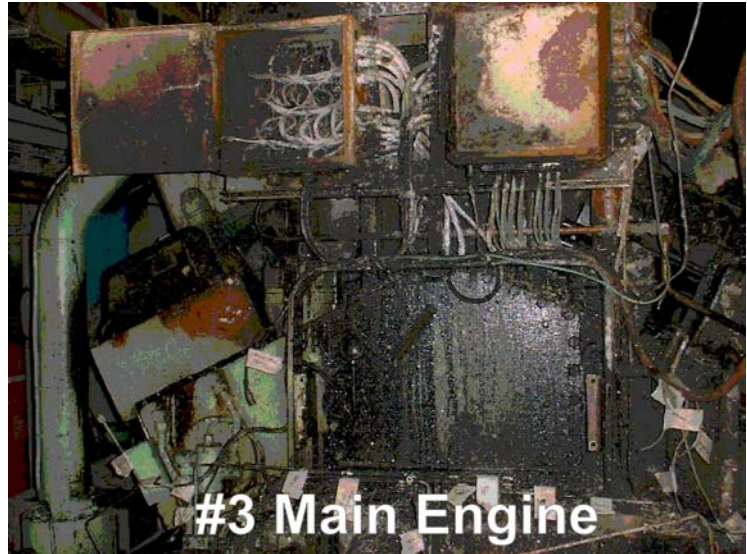
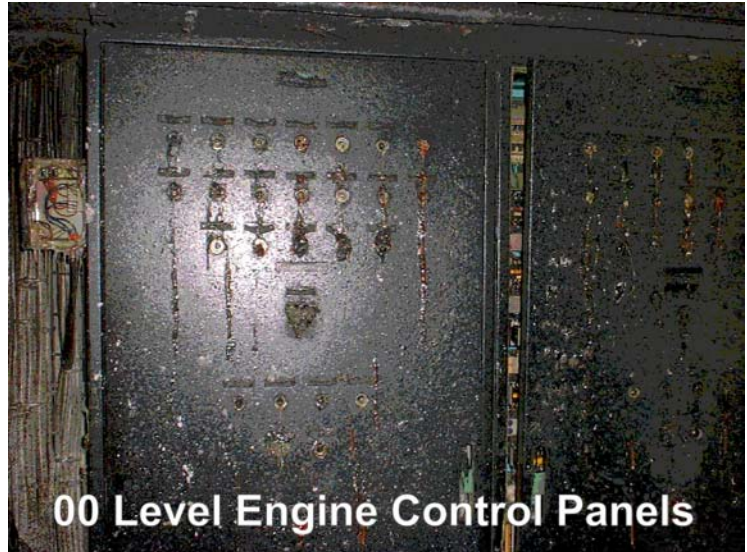
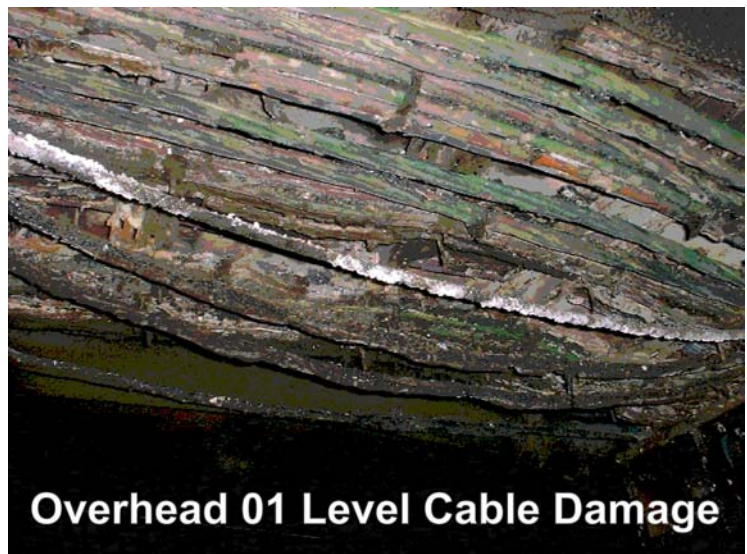
One deck up on the 01 level in the main engine room, forward side, is an athwartships platform that is about two meters wide for the width of the compartment. The aft edge of the platform does not overhang the area above the engine fronts. Along the centerline of the overhead above the platform runs a cableway for its entire length. The cableway contains hundreds of conductors serving various motors and controls for fans and pumps, valve actuators, ventilation, automation controls, remote indication systems and lighting circuits for the machinery, controls and equipment in the main engine machinery space. All of this wiring was destroyed, their insulation and shielding completely disintegrated revealing bare conductors.

Also damaged in this area was an eleven-section electrical control panel situated against the forward bulkhead containing the operating controllers for the machinery within the space. It suffered significant damage externally and limited damage internally.

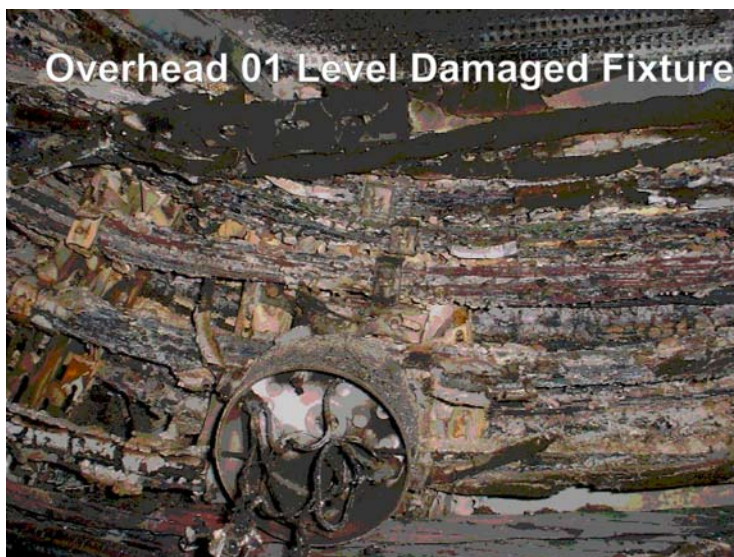
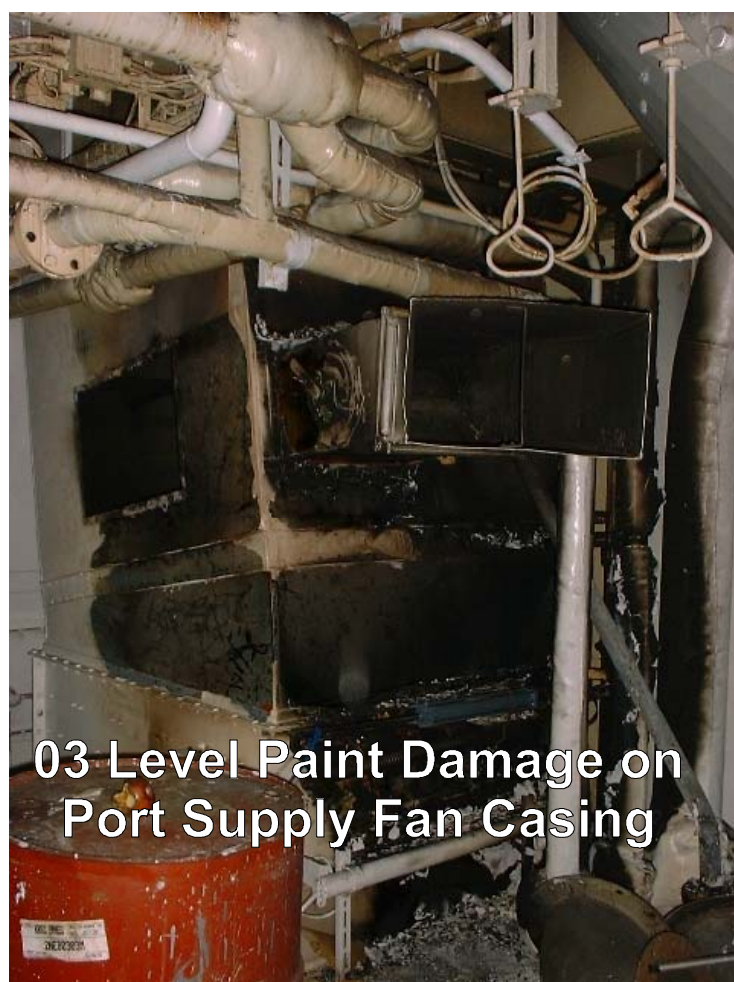
Generally all lighting, annunciating and visible alarms, shields and lense covers were destroyed on this level (01) and the next upper level in this space (02). The paint on various equipment, structures, and pipe lagging or coverings was damaged on the upper levels. Two large intake plenums above the port main engines were warped because of the fire. In the same general area and damaged after closing were actuating cylinders that operated the inlet dampers for exhaust fans of this space.

Structural damage appeared to be limited to a few slightly distorted stiffeners located on the forward bulkhead, port side, between the 02 and 03 levels. The stiffeners associated with the deck on the 03 level were also distorted and the deck plating at the forward end of the fan room was warped and bowed. However, none of the deflection affected machinery or its associated mounting arrangements within the fan room. The only other damage present in this area was the overheating of paint on the port supply fan discharge casing which resulted from the conduction and convection of heat from the intake plenums located above the port main engines.

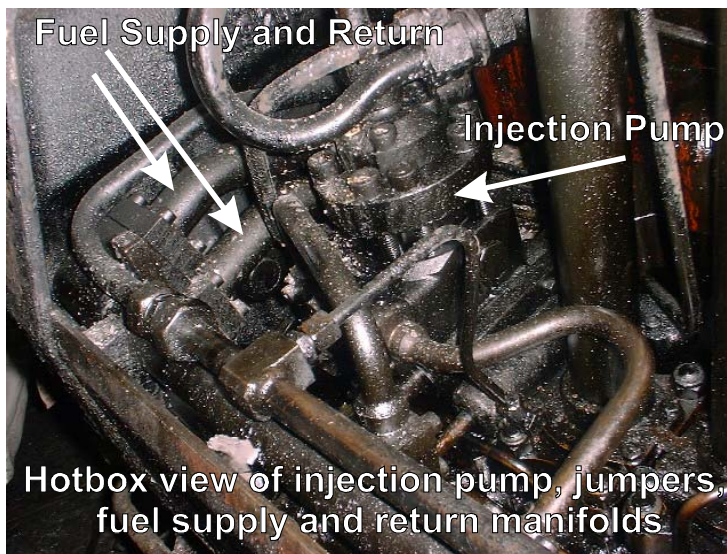
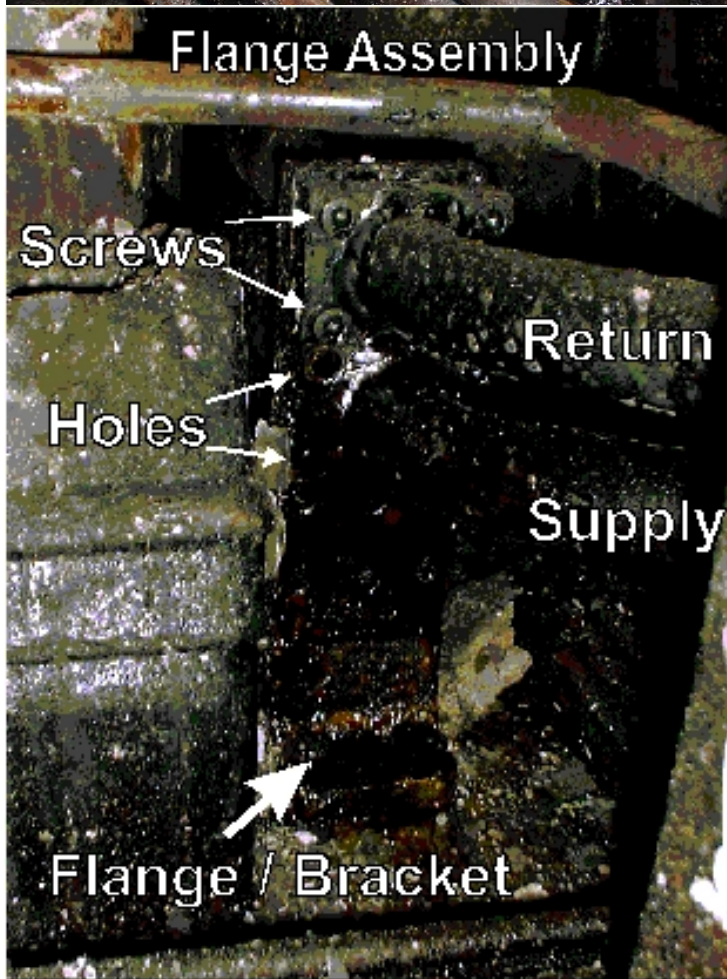
After the casualty, an inspection revealed that three of the four socket type hex screws attaching the fuel supply piping of the lower fuel line from the outboard manifold within the hotbox to the bracketed flange assembly had failed at the flange.

Only one screw remained which freely allowed movement of the pipe and facilitated separation at the flange. The sealing of the flange was accomplished by using an o-ring recessed in a groove machined into the surface of the piping flange.

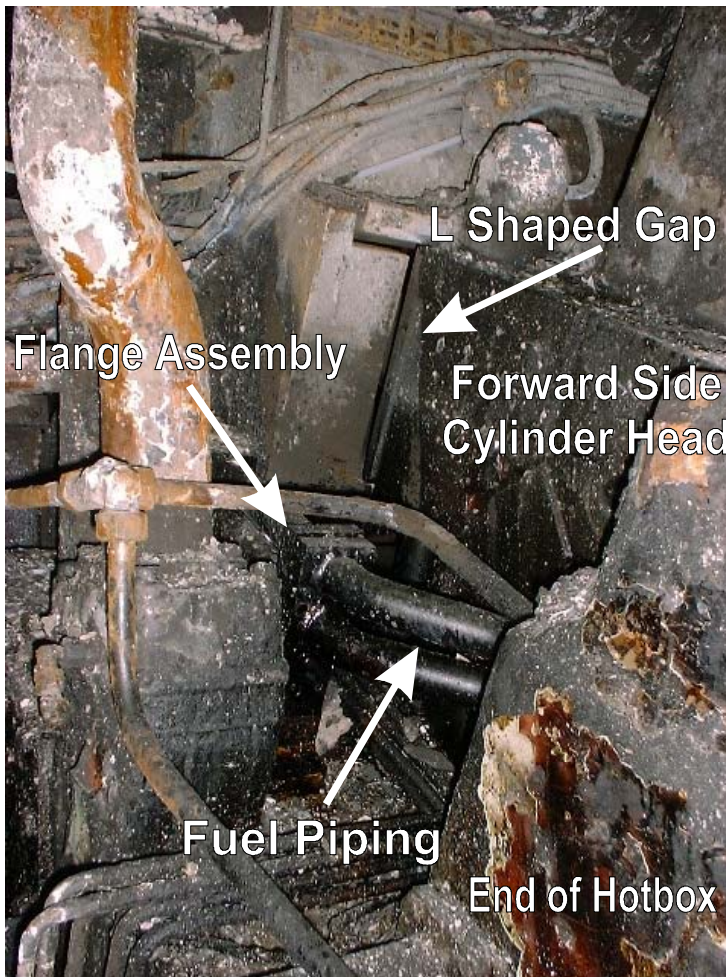
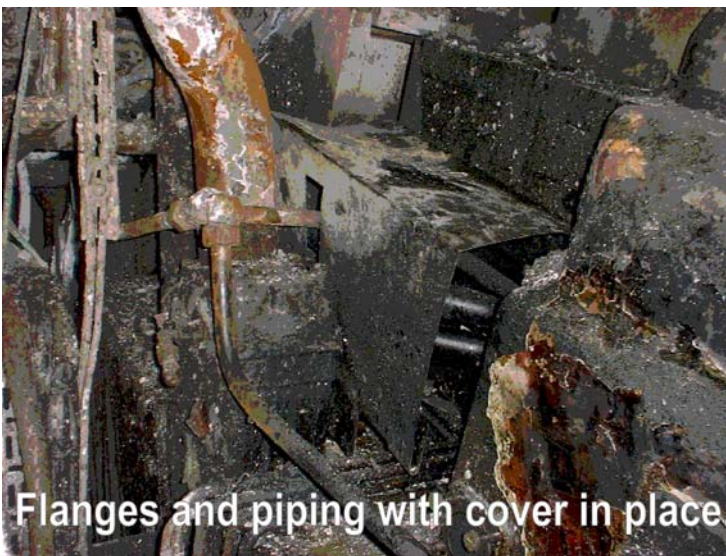
The failed flange was located along the forward side of the number one cylinder head. The exhaust piping from the cylinder was located on the inboard side of the cylinder head. The heads of each cylinder formed part of a larger manifold casing that in turn contained all the exhaust piping as it is piped to the turbocharger inlets. An inverted "L" shaped gap approximately 10mm wide by 260 mm in height with a 16 mm high by 60 mm wide horizontal opening was formed along the corner edge of the head and manifold casing. Just beyond this opening and less than 30 cm away from the failed flange, although not readily visible, was the exhaust piping from the number one cylinder.

The spraying fuel ricocheted and atomized under the piping cover. It was guided by the cover's aft edge to the nearby exhaust pipe and manifold. It instantly autoignited lighting off the remaining fuel spraying out in all directions from the openings in the cover. The fire engulfed the entire front of both engines serving the port propeller shaft.

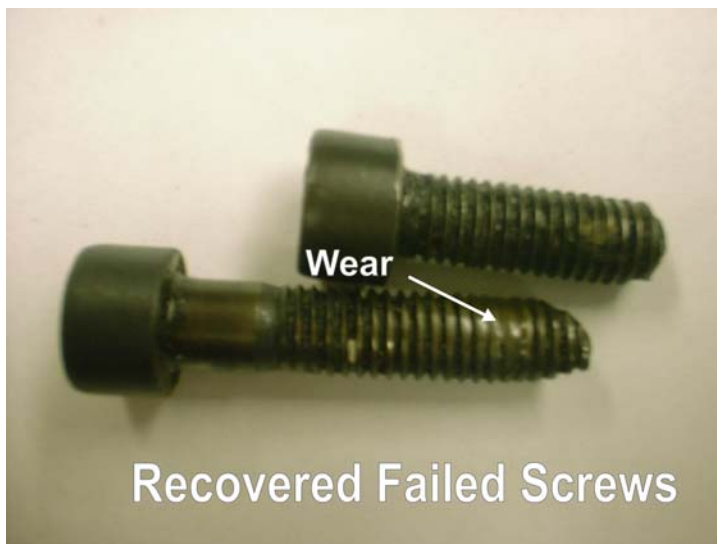
Two of the fractured screws recovered were 23 mm and 36 mm in length. The screws were also of different quality. Different qualities necessitated different torque requirements.

Tightening too close or beyond the screw's yield strength may result in failure or torque loss, while tightening to a lower range of the yield may result in insufficient preload for sealing and insufficient residual load to maintain the seal. The fuel line flange was designed for screws 30 mm long yet after the casualty a much longer screw requiring spacers was found. Additionally other improperly sized screws were observed on flanges of the number three main engine crossover piping.
