Extracts from ABB Turbocharging's Turbo Magazine 1990 – 2009

## ABB Turbocharging Tips for the operator

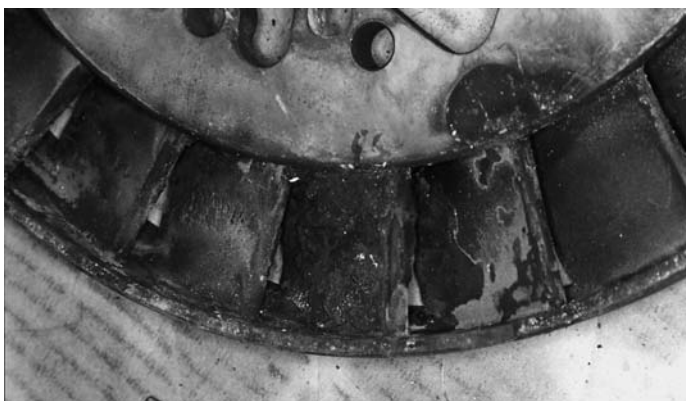
Dirty nozzle ring. Cleaning was not carried out according to our recommendations.

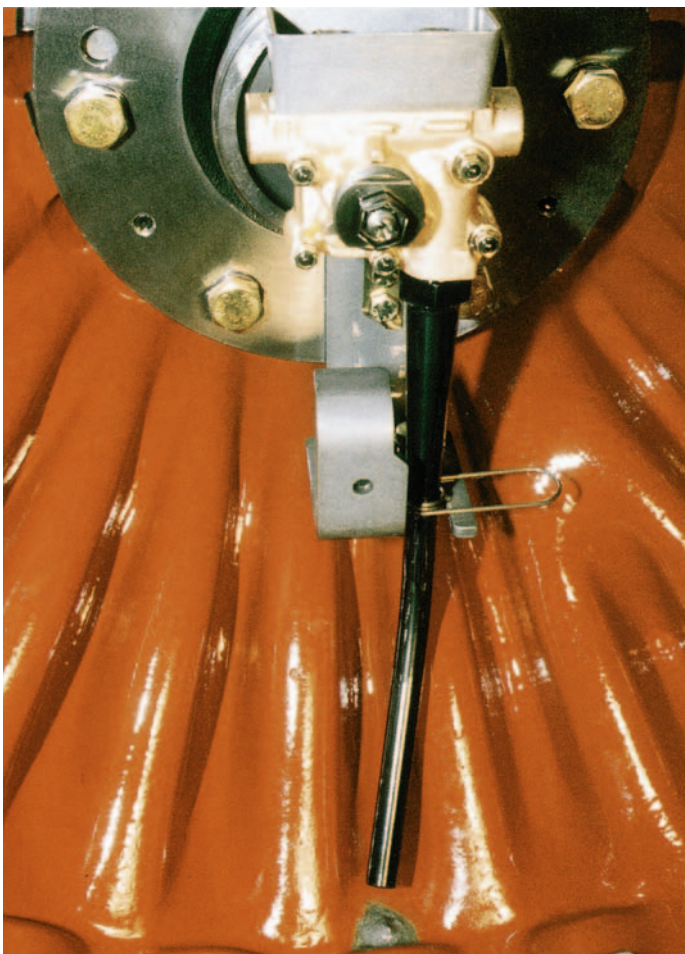
Some operators of VTR turbochargers worry when they see a grey-colored cone growing below the opening of the gear oil suction pump. There is no need to. It is an utterly harmless phenomenon.

A small cone-shaped accumulation of sludge and oil-aging residues, mixed with abrasion particles of steel, aluminum and bronze originating from the casing, pump and bearing damping parts, often forms just below the opening of the gear oil pump suction pipe.

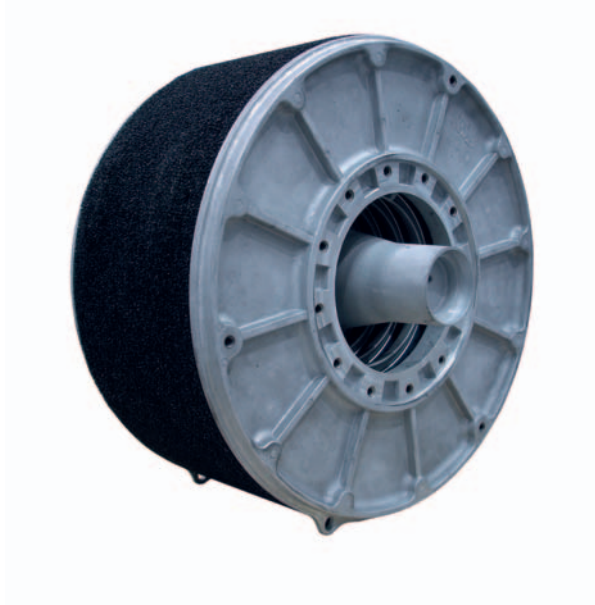
Field experience has shown that when disassembling and assembling the silencers (PN81100) fitted to the VTC..4, the cast-aluminum cone of the front funnel is susceptible to damage if incorrectly handled. This can lead to the cone breaking away during operation, causing turbocharger failure.

Extreme caution should therefore be taken when disassembling and assembling the silencer to ensure that the silencer does not strike the cone area of the aluminum front funnel. When removed from the turbocharger, the filter silencer must not be allowed to rest on the cone of the silencer. It should also be suitably protected when stored or in transit. If it is thought that the cone area may have been struck or damaged, it is recommended that a dye penetrate crack inspection be carried out before it is returned to service. When replacing the silencer, care must be taken to avoid contact with the compressor. In the event of the compressor being struck, the silencer should be removed and inspected for cracks. If there are signs of cracks the front funnel has to be replaced.

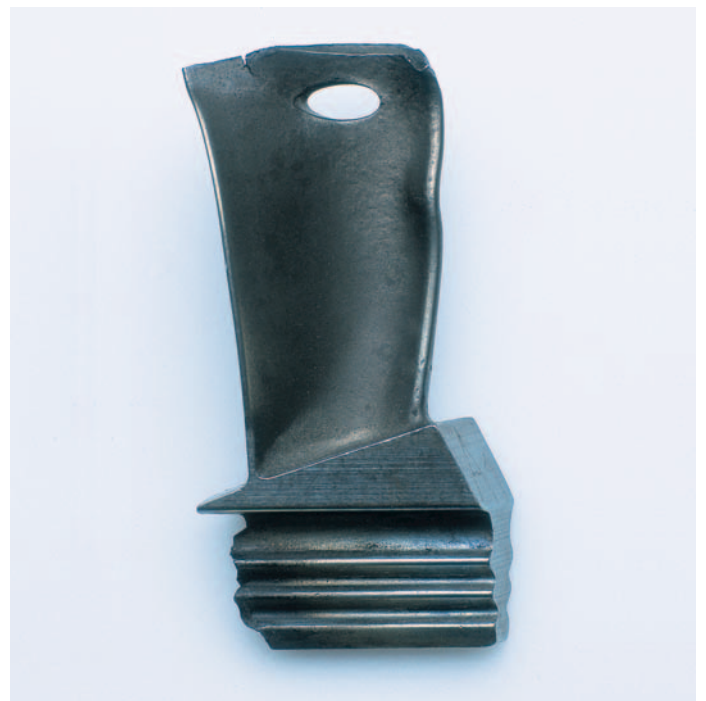
Signs of the following damage on a turbocharger could indicate a problem with the protection sleeves in the compensators. If they start to break away, they could damage the blades as shown. To avoid further damage, please check all of the compensators (it will be necessary to balance the rotor). Please contact your nearest Service Station.

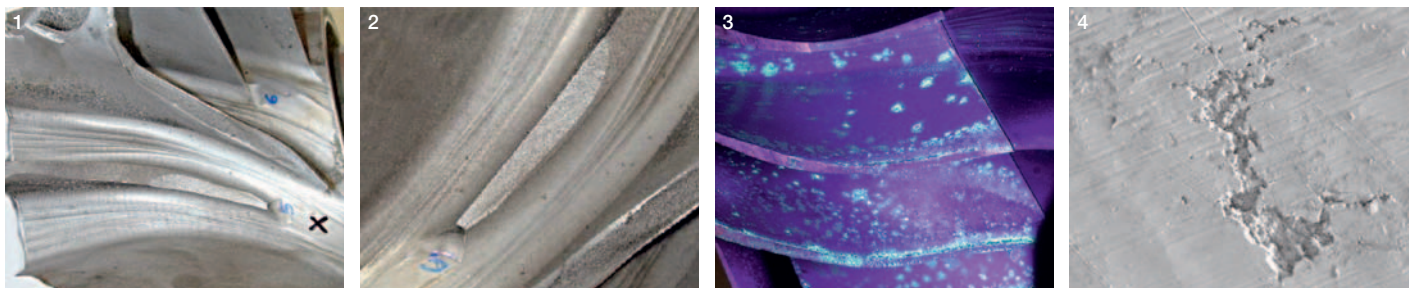
1 Damaged inducer wheel | 2 Close-up of a broken splitter blade | 3 Pitting corrosion revealed on inducer wheel blades by fluorescent penetrant inspection | 4 Pitting corrosion (detail)

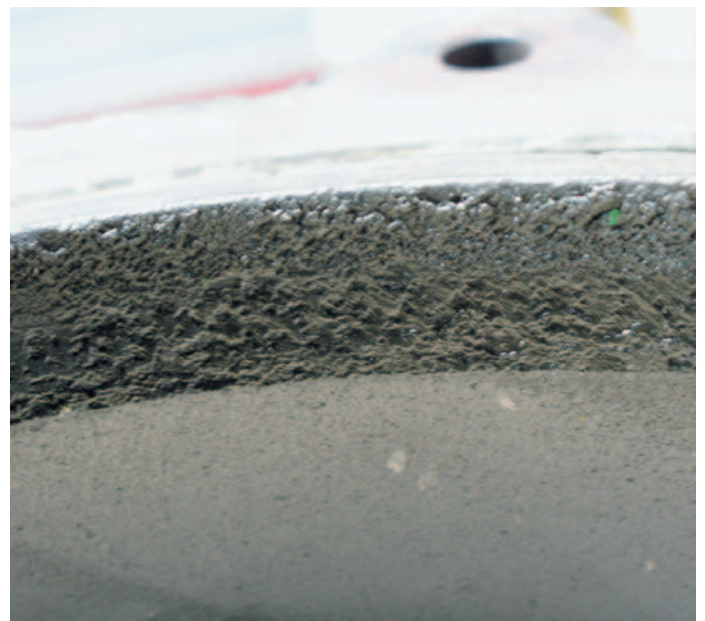
The layer of scale is usually removed during a turbocharger overhaul. However, in cases where there has been tip erosion the tip clearance may afterwards exceed the tolerance limits, causing a slight drop in the turbine's rotational speed and a loss of efficiency. After the turbocharger is returned to opera-

Layer of scale deposited on a turbine diffuser

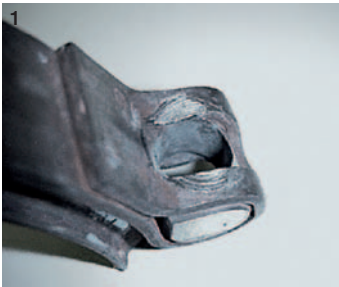
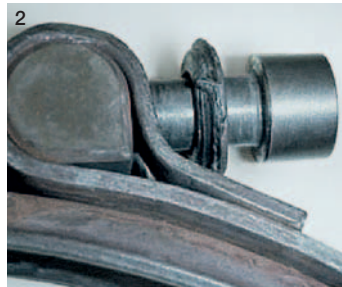
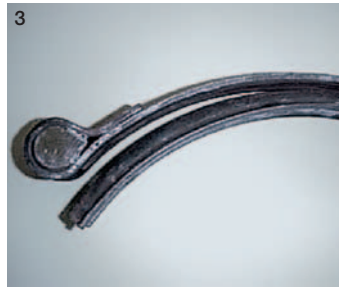
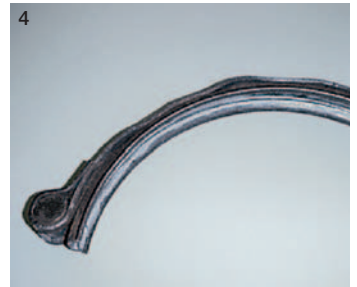
1 Severe wear at screw-head | 2 Deformed or wrong washer | 3 Cover tape detached | 4 Cover tape severely deformed

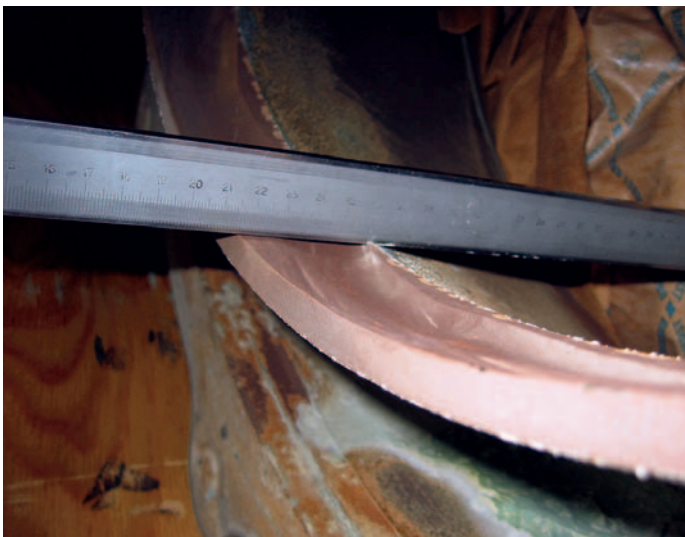
Erosion due to particles in the exhaust gas usually occurs on small segments of the turbine diffuser and outer hoop of the nozzle ring, equal to about 15 to 25 % of the total circumference. The wear starts more or less opposite the single radial gas inlet and then continues clockwise around the turbine (viewed from the turbine side). The tips of the turbine blades can also be affected, with all of them showing equal signs of wear.

Worn turbine diffuser.

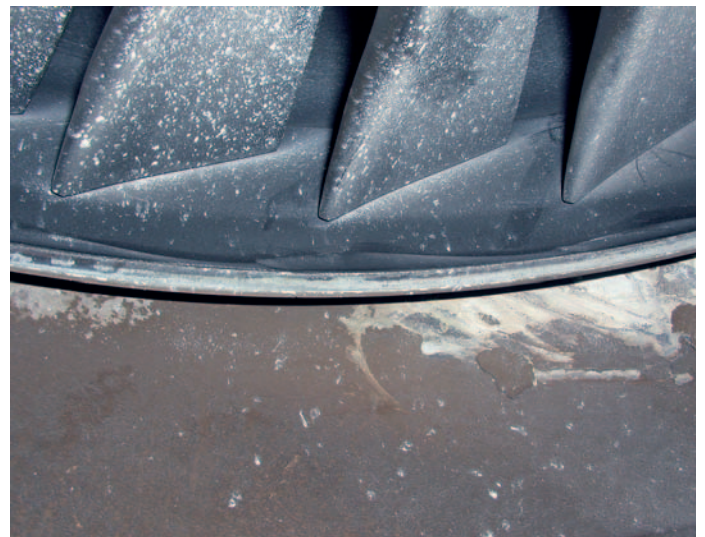
Worn turbine blade tips and turbine diffuser.

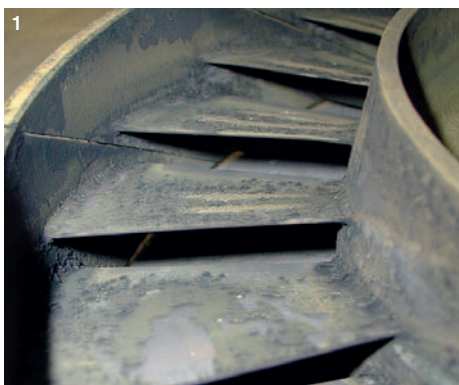
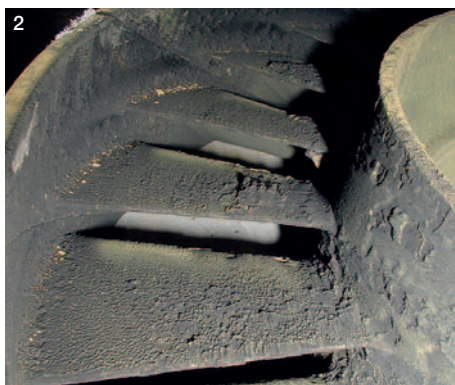
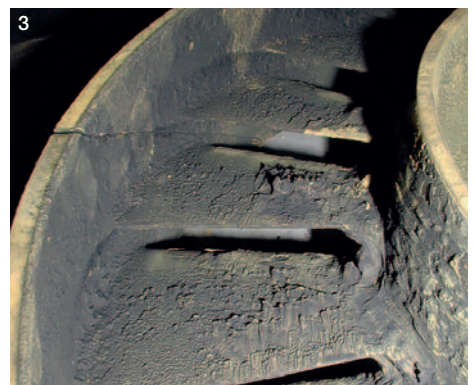
1 Components still very clean: cleaning intervals could be longer | 2 Components are sufficiently clean: no changes needed | 3 Components too dirty: shorten cleaning intervals

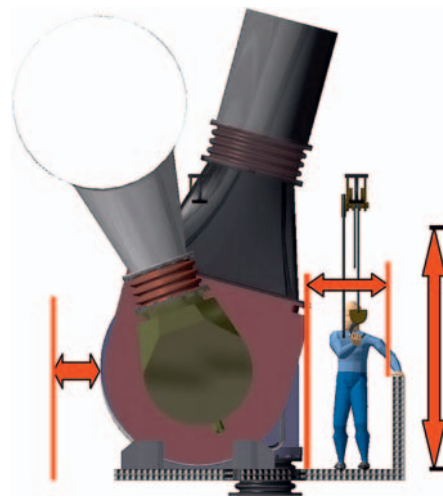
A poorly designed working environment – badly positioned or too few lifting lugs, railings that get in the way, platforms at the wrong height – not only increases the risk of damage to the parts being handled. Moving heavy turbocharger parts under such conditions is also a safety hazard.

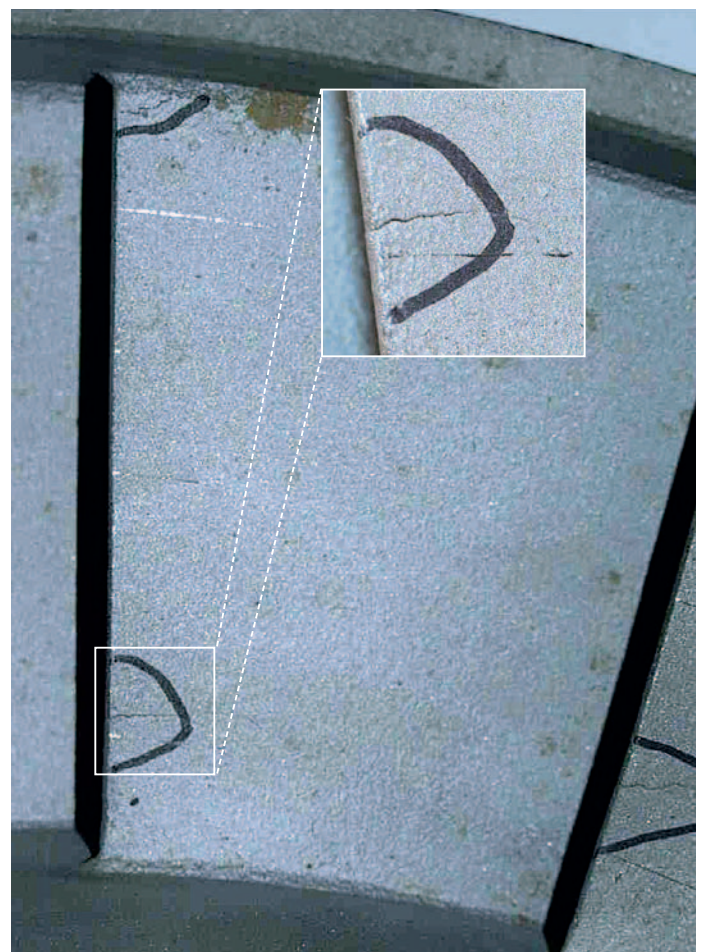
Some operators have tried repair-welding small, harmless cracks on the nozzle ring. Visually, this can look good, but it has no positive long-term effect and is not recommended by ABB. As already mentioned, hairline cracks are a natural form of stress relief, which repair welds remove, with the result that the welds will very likely break again shortly after the turbocharger is returned to operation. Also, there's always the risk with welding of extra thermal stress, with its negative effect on the base material.

Hairline cracks are a normal occurrence, but check with ABB if you are unsure.

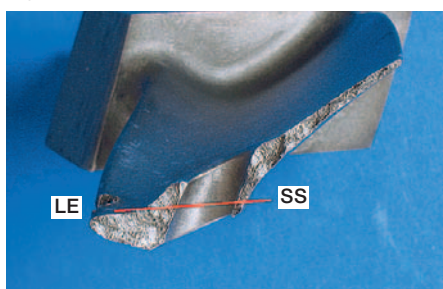
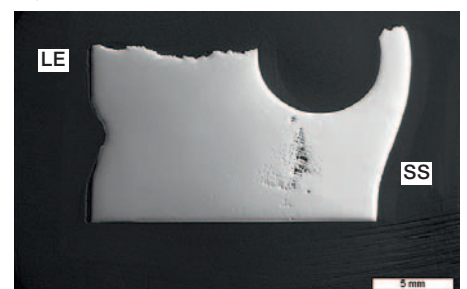
Metallographic examination of the failed blade (Figs. 2 and 3) also showed clearly that the reason for the rupture was porosity in the material around the hole for the damping wire, which is where the damage occurred (LE = leading edge, SS = suction side).
