Carnival Corporation
Holland America Line
Krystallon
Sea Water Scrubber Technology
Demonstration Project

Installation and early operations

Fall 2007

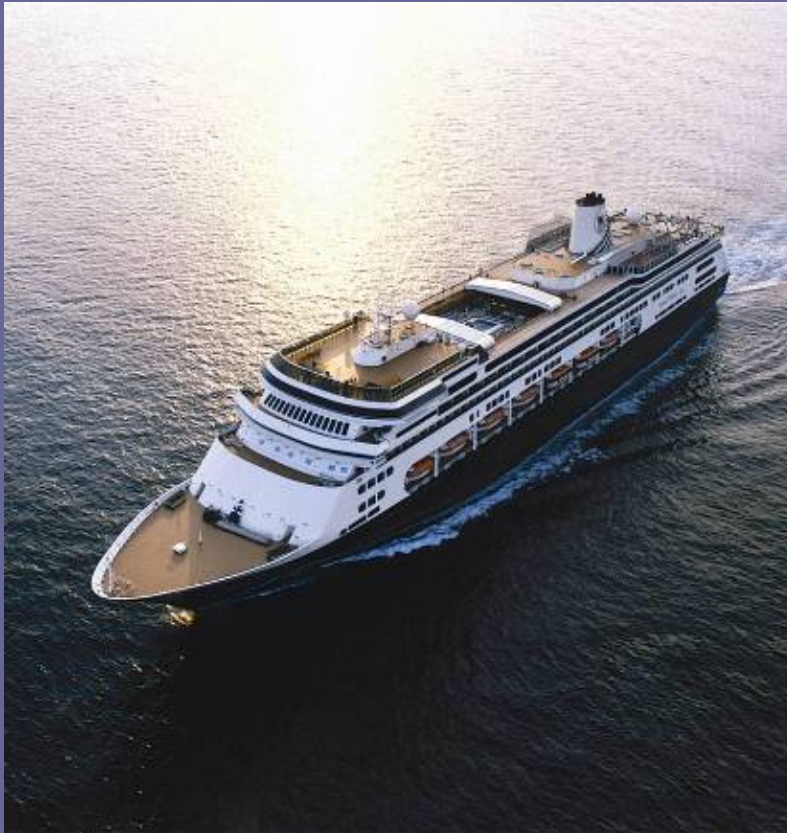
The ms Zaandam

- Keel laid 1998, delivered 2000
- Displacement: 68,000 tons.
- Ship's complement:
 - 1,432 guests
 - 600 Crew
- Propulsion:
 - Five 12-cylinder Sulzer ZA40S engines
 - 720 kW per cylinder
- 2007 – 2008 itinerary: Alaska, Hawaii, California, Mexico

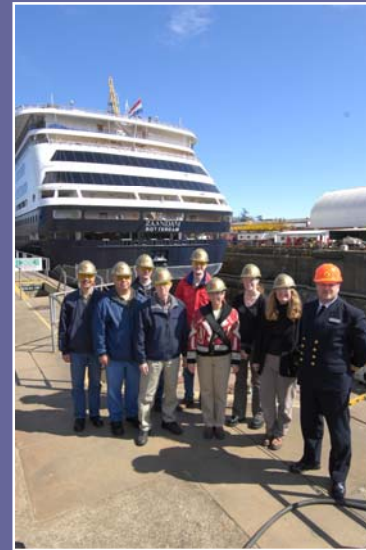
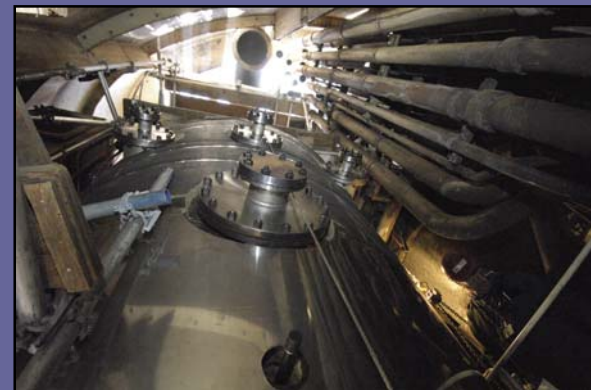
Scrubber Installation

- Scrubber unit installed at Victoria Shipyard – April 8-21, 2007
- Piping and instrumentation installed during ship operations – April 21 through August 11, 2007

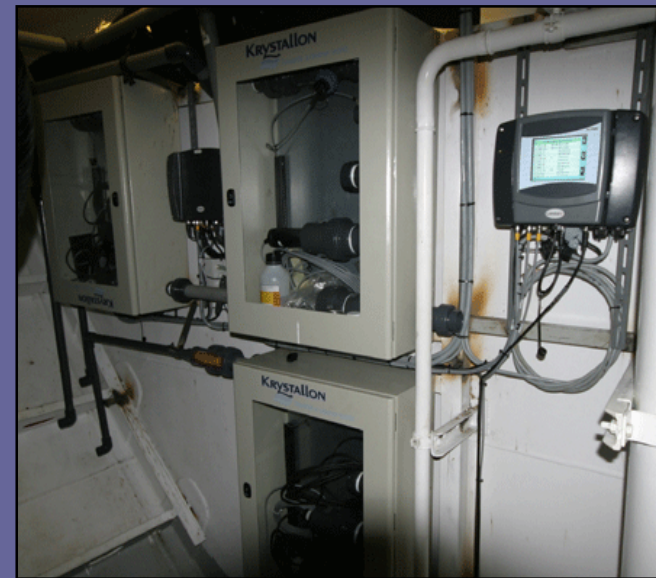
HMI = Human Machine Interface

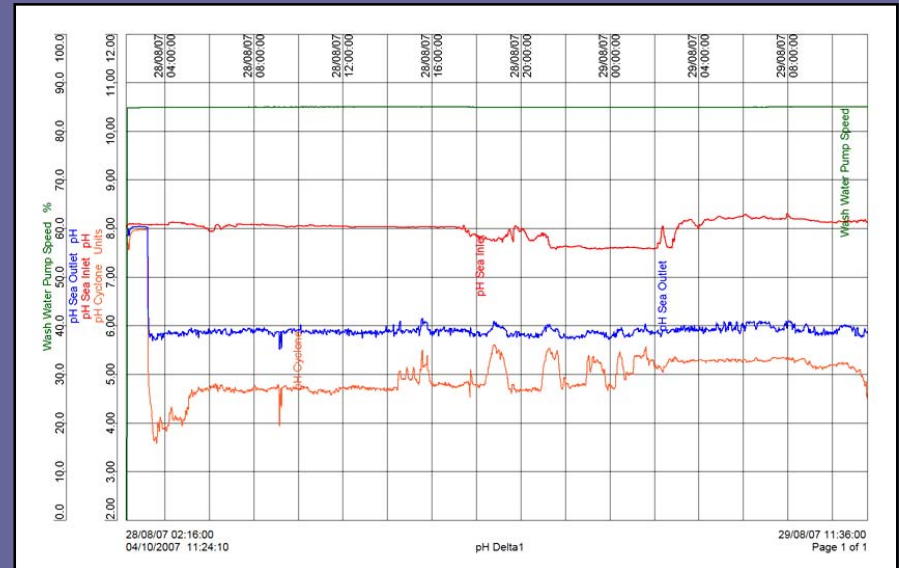
Data Management

- Data recorded by “Eurotherm” software
- Downloaded data into Microsoft Excel
- Data filtered to evaluate only data generated while the scrubber was running
- Analyzed 16,595 lines of data
- Completed statistical analysis of the data set

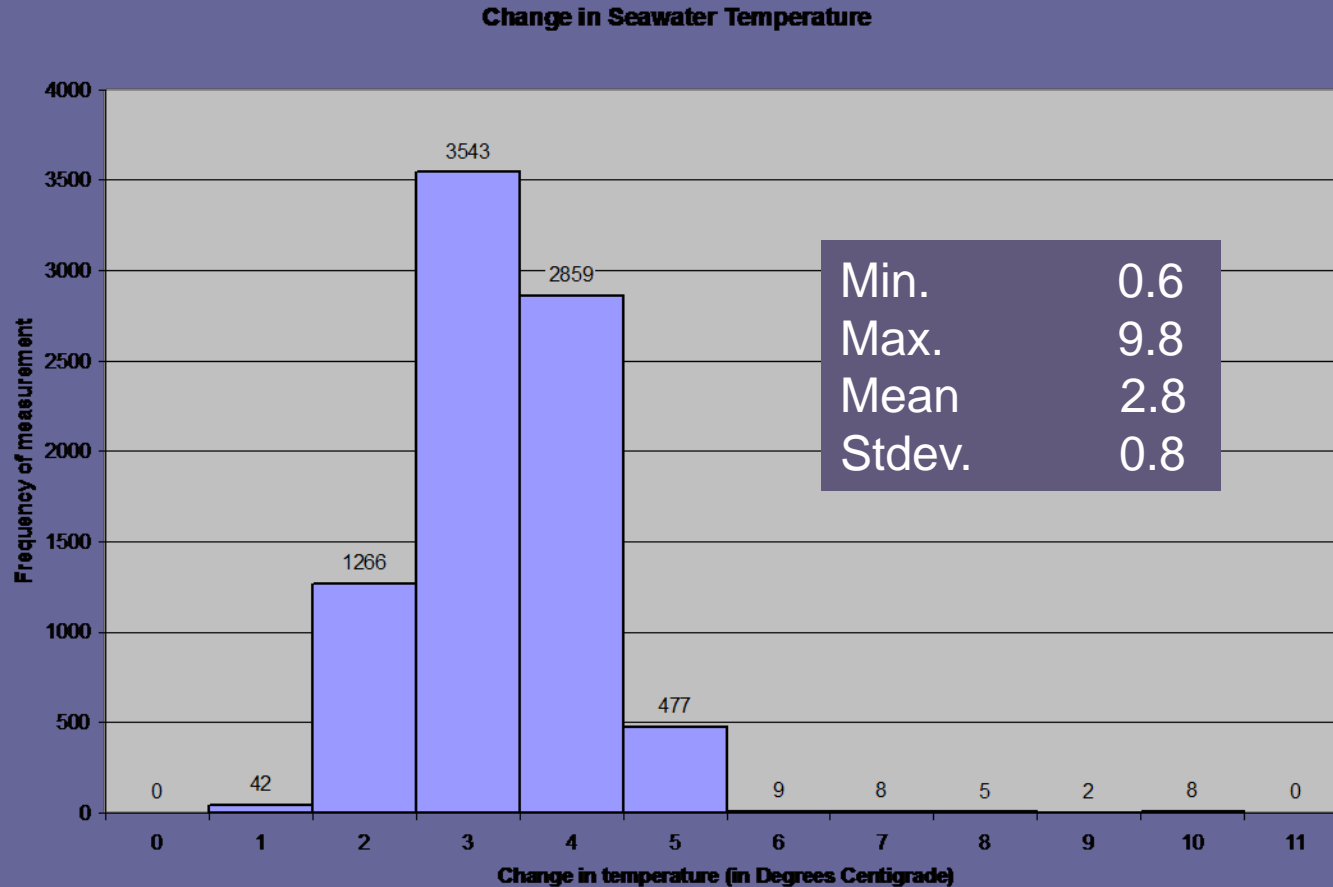
Temperature

Small Change Between Inlet and Outlet meets Expectations

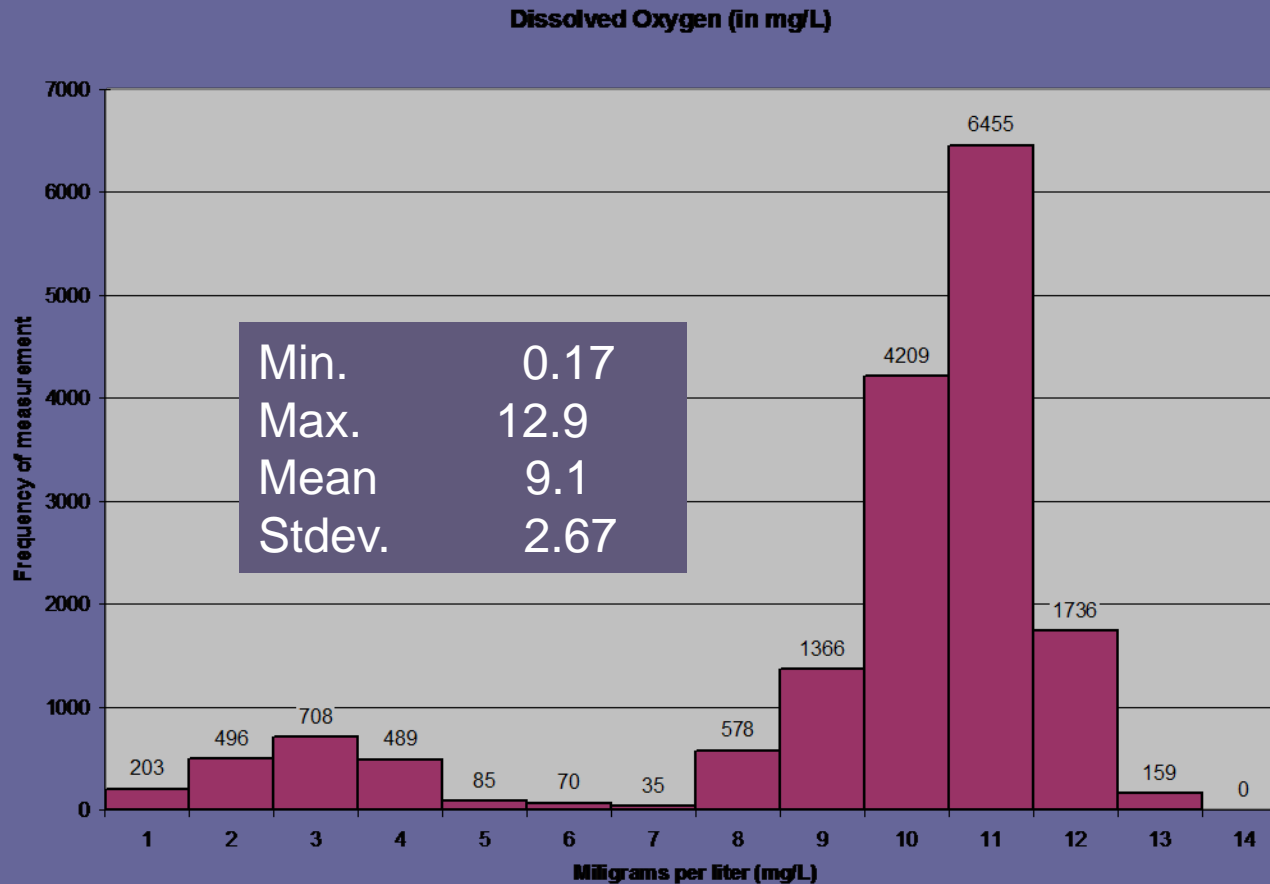
Dissolved Oxygen (DO)

Acceptable Concentrations of DO in the Discharge
