Report on the investigation of  
the catastrophic failure of a capacitor  
in the aft harmonic filter room on board  
***RMS Queen Mary 2***  
while approaching Barcelona  
23 September 2010

At 0425 on 23 September 2010, as *RMS Queen Mary 2 (QM2)* was approaching Barcelona, an explosion occurred in the vessel's aft main switchboard room. Within a few seconds, all four propulsion motors shut down, and the vessel blacked out shortly afterwards. Fortunately, the vessel was clear of navigational hazards and drifted in open sea.

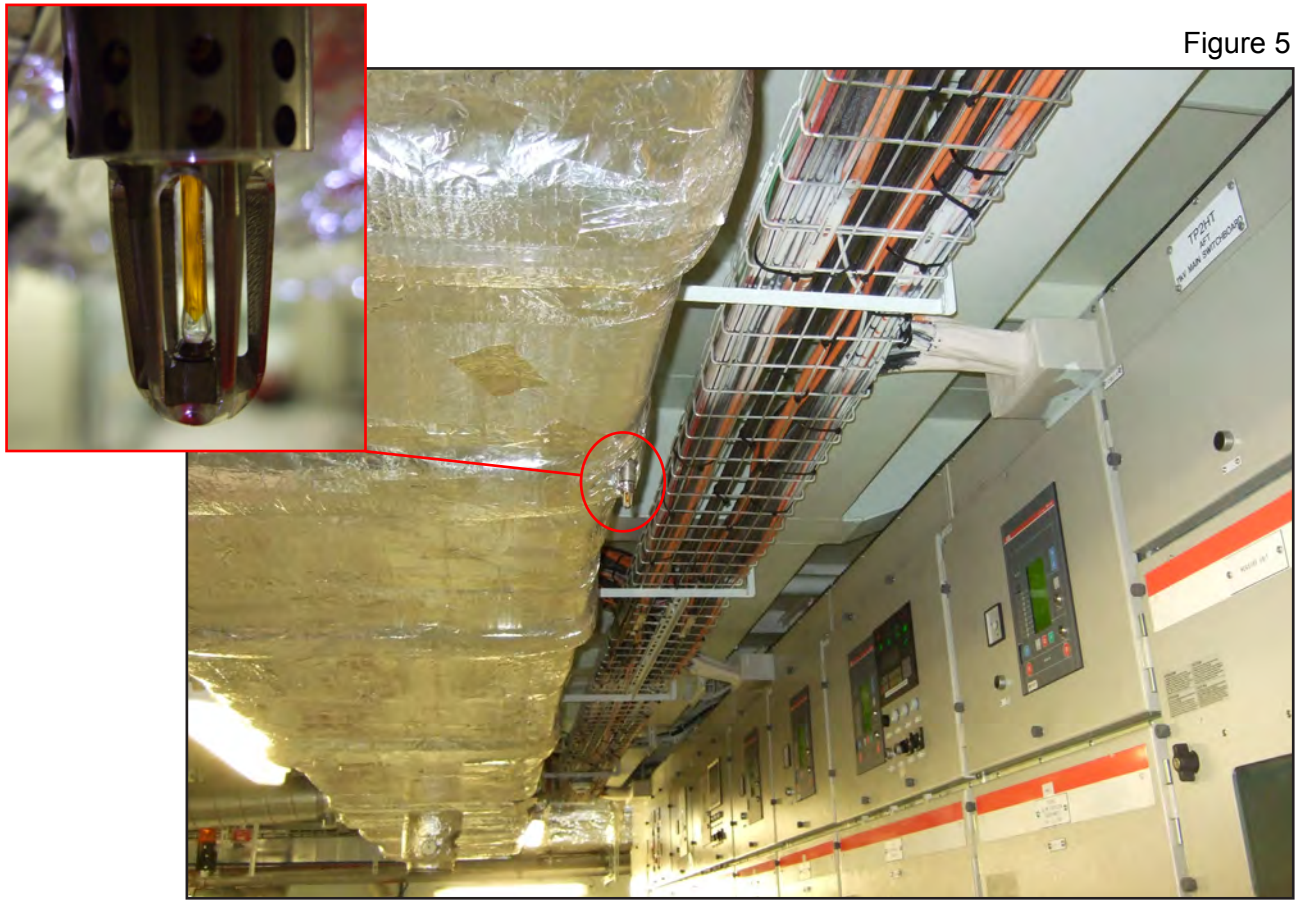
Figure 5

By 0439, the second electro-technical officer and a third engineer, both wearing breathing apparatus and carrying carbon dioxide portable fire extinguishers and a thermal imaging camera, were ready to carry out an inspection of the scene. They entered the aft MSB room and made their way into the HF room, stopping just after entering the doorway (**Figure 4**). They confirmed that the space was filled with thick black smoke; but there was no fire and, using their thermal imaging cameras, they did not detect any hot spots. Two *Hi-Fog* glass bulbs (**Figure 5**), one in the aft HF room and another in the aft MSB room had ruptured and there was approximately 10mm of water on the decks of both compartments (**Figure 6**).

*Hi-fog glass bulb in the aft main switchboard room*

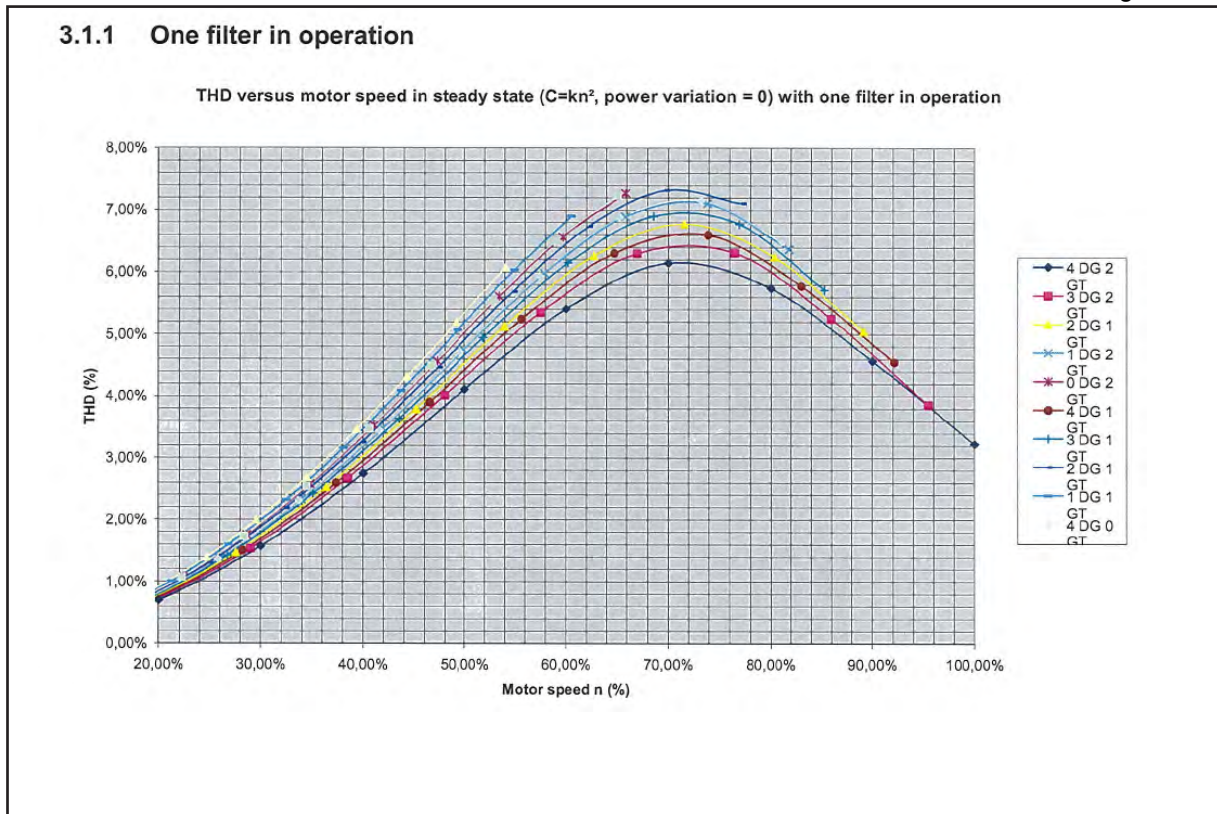
Figure 12a

A month after the accident, Converteam carried out a simulated study on harmonic distortion levels expected without any HF in use. By extrapolating the graph for the case with no filters in use, the THDv was predicted to exceed 22% at 70% speed. This estimation was subsequently confirmed by Converteam when they calculated the amount of THDv in this configuration (**Figures 12a, 12b** and **Figure 13**). In its conclusion, the Converteam study stated:

*This study highlights the necessity to use one filter or to operate at slow speed with no filter to keep the harmonic distortion level under 8%. Additional measurements on board should be done on board to check the harmonic level with the LV [low voltage] pollution. [sic]*

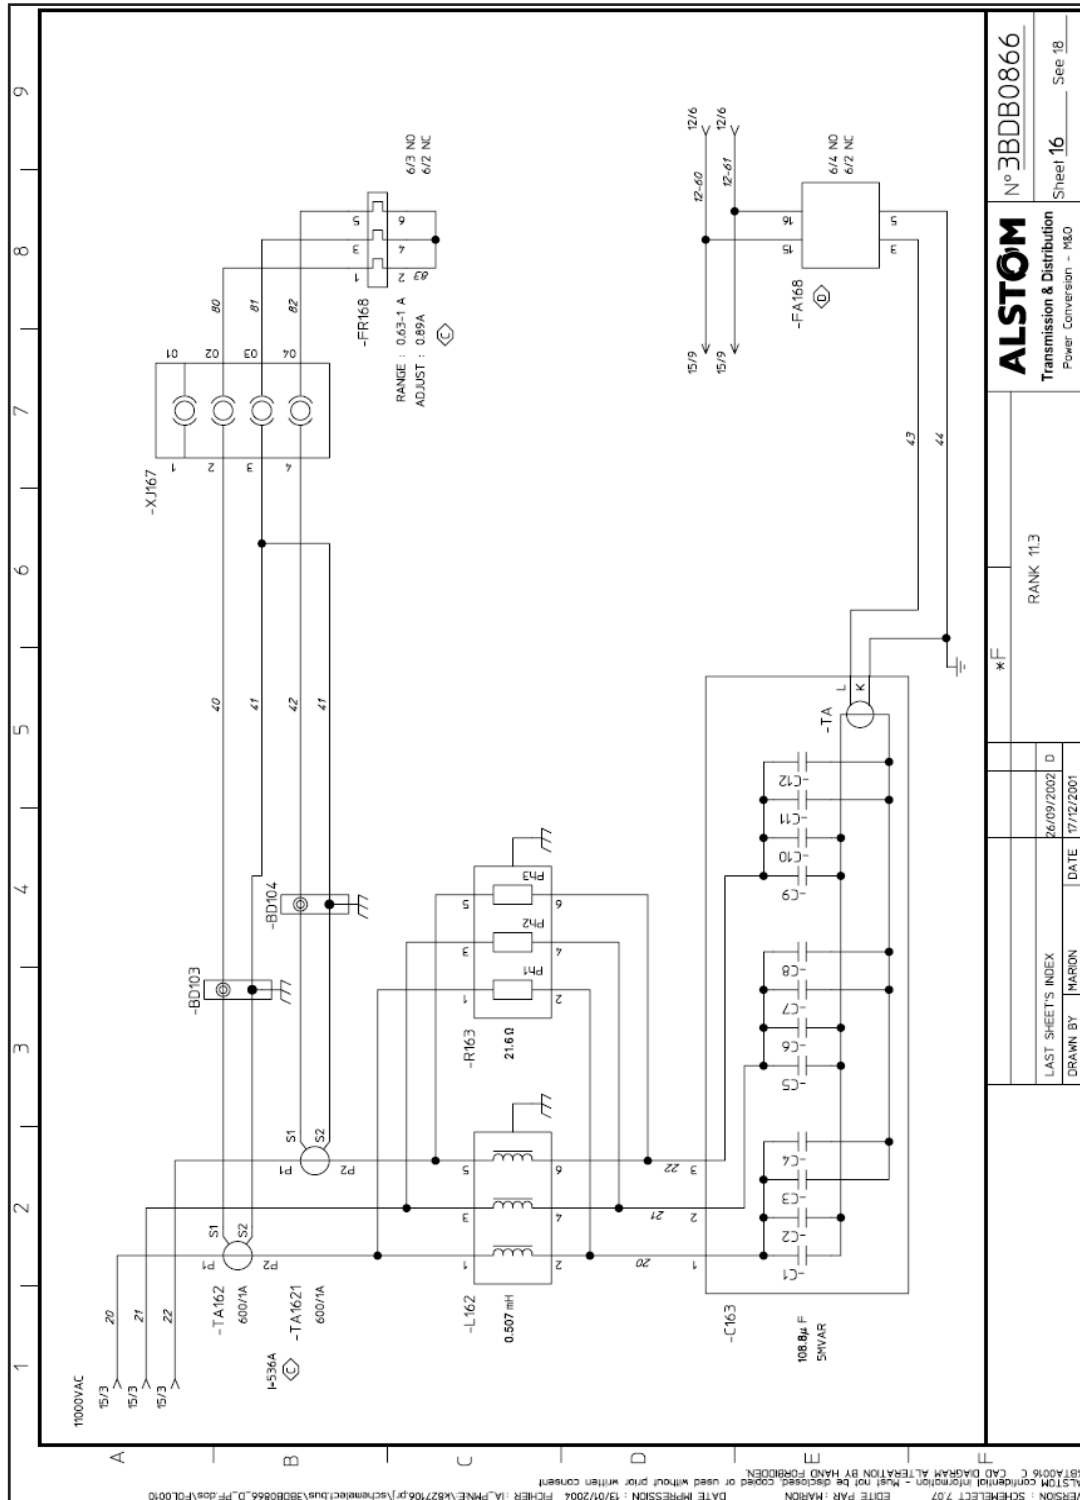
Figure 14

The harmonic filters on QM2 were supplied by Converteam, formerly part of Alstom Power Conversion, France. Each HF consisted of two sub-sections tuned to resonant frequencies equivalent to the 11.3<sup>rd</sup> and 4<sup>th</sup> harmonics, and referred to on board the vessel as rank 11.3 and rank 4 respectively. There were 15 capacitors in rank 4 and 12 in rank 11.3. The capacitors for each rank were connected directly to the three-phase 11kV mains supply with their terminals connected in a circuit configuration known as a double star termination (**Figure 14**). The 11.3 rank included a group of inductors, with a total inductance of 0.507mH and a bank of capacitors with a total capacitance of 108.8µF. A resistor bank was also connected in parallel to the inductors to limit the amount of in-rush current into capacitors when the HF was started up.

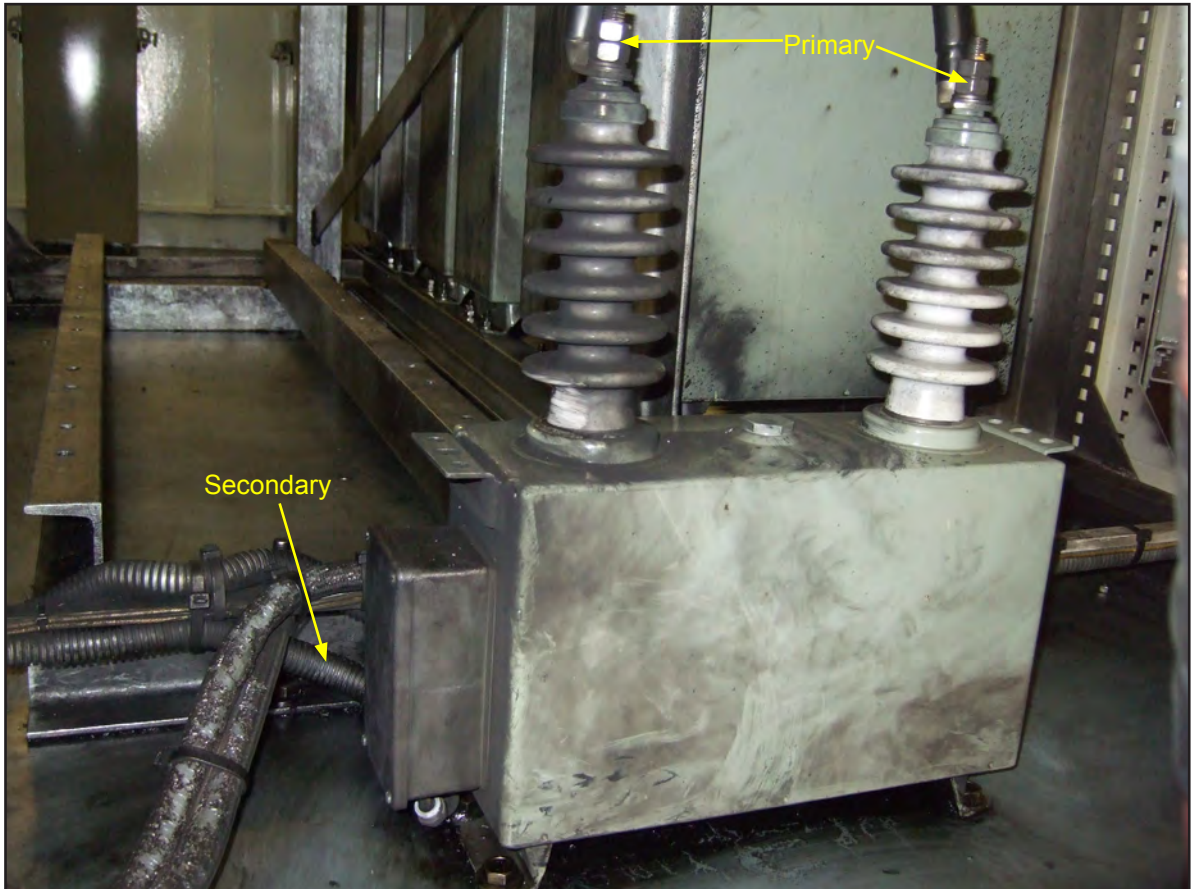
Figure 20

A current imbalance detection system, which was the only means to warn against capacitor deterioration, was found to be inoperable, and it was evident that it had not worked for several years.

The two neutral points at the double star termination of the capacitor circuit were connected to the primary coil of a current transformer (**Figure 20**) which had a current ratio 10:1 (50A at the primary winding and 5A at the secondary winding) and was part of the monitoring and protection system '*EstaSym 3C*' supplied by Vishay Electronics GmbH, Germany. There were no records available to verify the transformer's service history.

Current transformer for the imbalance detection system

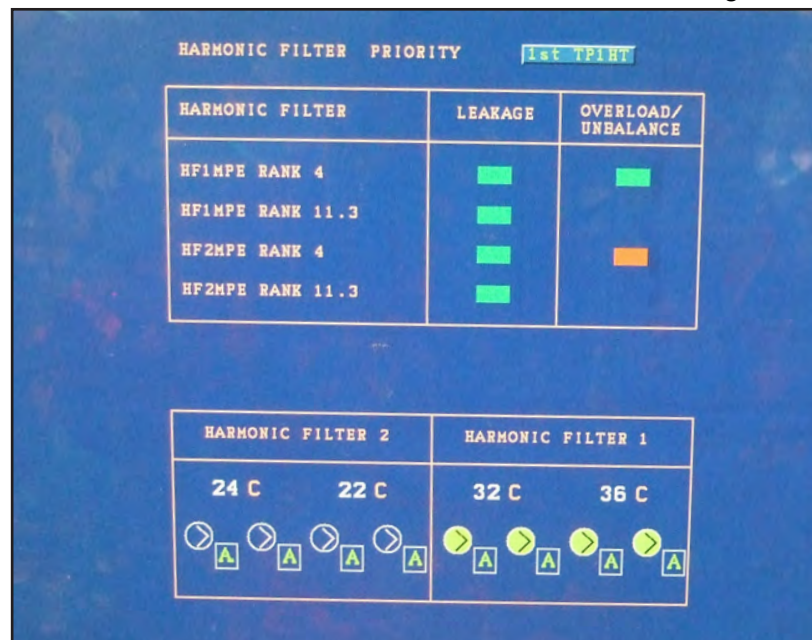
Figure 23

When the IAS received an imbalance or overload alarm from an HF, the duty engineer could interrogate the graphical user interface (GUI) in the ECR, which indicated the rank of the HF which was in alarm (**Figure 23**). The GUI display for both the overload and the imbalance alarm was combined, and read 'OVERLOAD/ UNBALANCE'. If the circuit breaker to the HF was tripped, it would be indicated as an additional alarm in the IAS, as an electrical fault on the breaker. There were no records of the imbalance alarms or trips being tested either at commissioning, or at any other point in the life of the vessel.
