MARINE ACCIDENT REPORT

December 2013

EMMA MÆRSK

Flooding of engine room on 1 February 2013

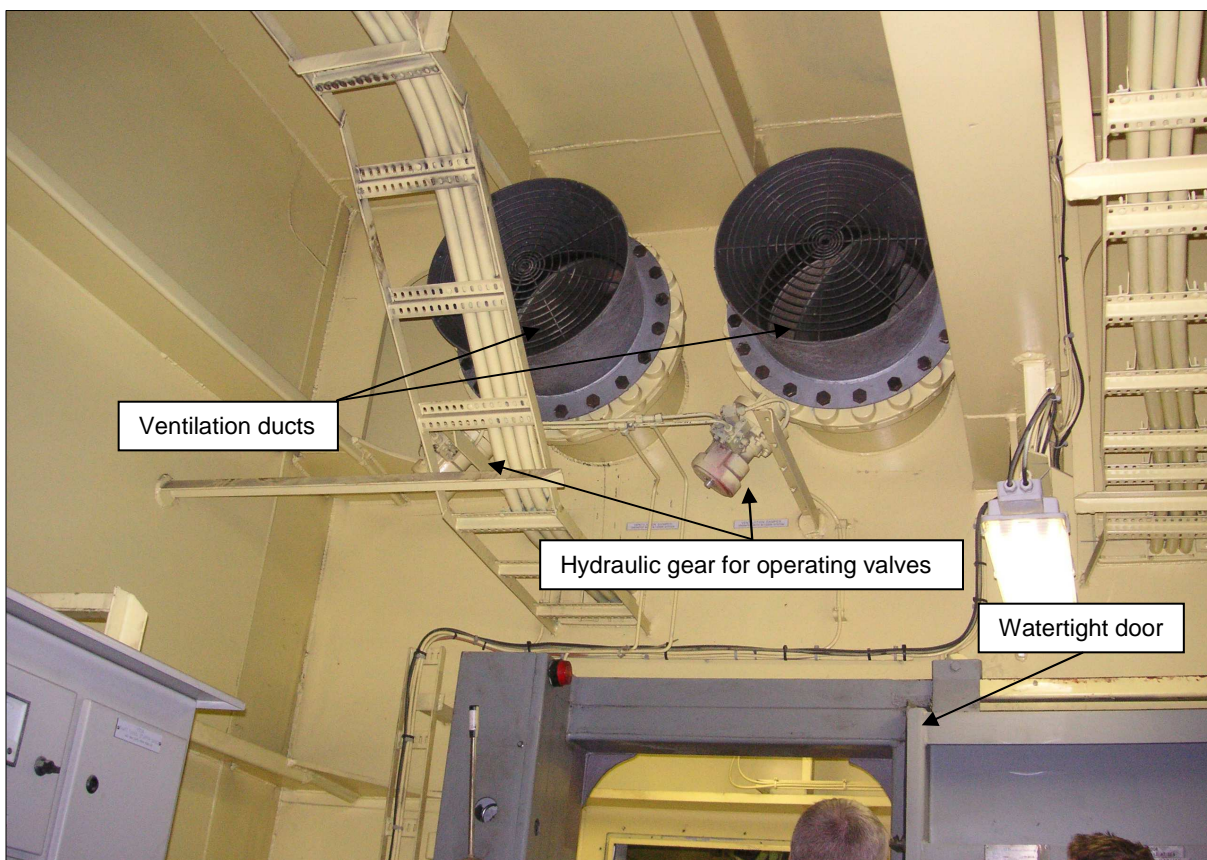
Figures 12: Hydraulically operated valves in ventilation ducts passing through the watertight bulkhead above the watertight door in a sister ship, viewed from the shaft tunnel

The watertight door was closed appr. 10 minutes after the first alarm was heard and the chief engineer again called and informed the master about the situation. The watertight door was closed locally and functioned correctly. Then the 2nd engineer hurried to the ship control centre at the deck office and closed two hydraulically operated valves in ventilation ducts passing through the watertight bulkhead situated just above the watertight door. These valves were situated in the shaft tunnel, on the aft side of the bulkhead (figure 12 on page 15) and could not be operated locally like the watertight door. He waited in the ship control centre to see the control lamps indicate that the valves were actually closed.

To ascertain that these valves were effectively closed, the engineers drilled large holes in the bottom of the ducts. This revealed that no water came through and the valves were effectively closed. For a short while, the engineers believed that the water ingress was confined to the shaft tunnel, but after a few minutes, water flowed through the propeller shaft sealing in the watertight bulkhead (figures 13 and 14 below) and soon after some seeping water was also observed at four of the cable penetrations in the bulkhead, above and below the propeller shaft. This was observed by engineers standing close to the watertight bulkhead and it caused some concern.

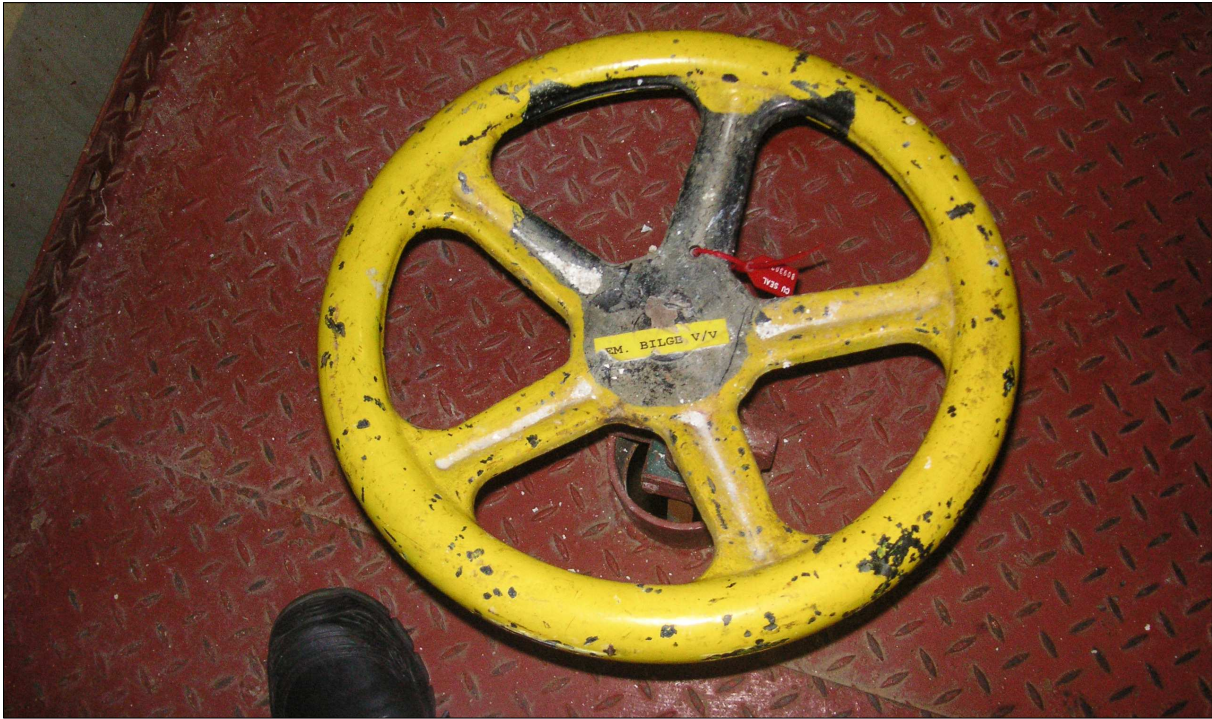
The emergency bilge suction valve provides direct suction from the engine room tank top. The opening of the suction valve was supposed to be carried out manually by a large handwheel just above the floor plate (figure 28 on page 28). The suction valve was situated just above the tank top and its spindle was connected to the handwheel by an extension rod (figure 29 on page 28) fitted to the valve spindle by a cardanic connection, the bushing of which was locked to the rod with steel pins (figure 27 below).

Figure 28: Handwheel for emergency direct suction from the engine room by the largest seawater pump of a sister ship
Source: DMAIB

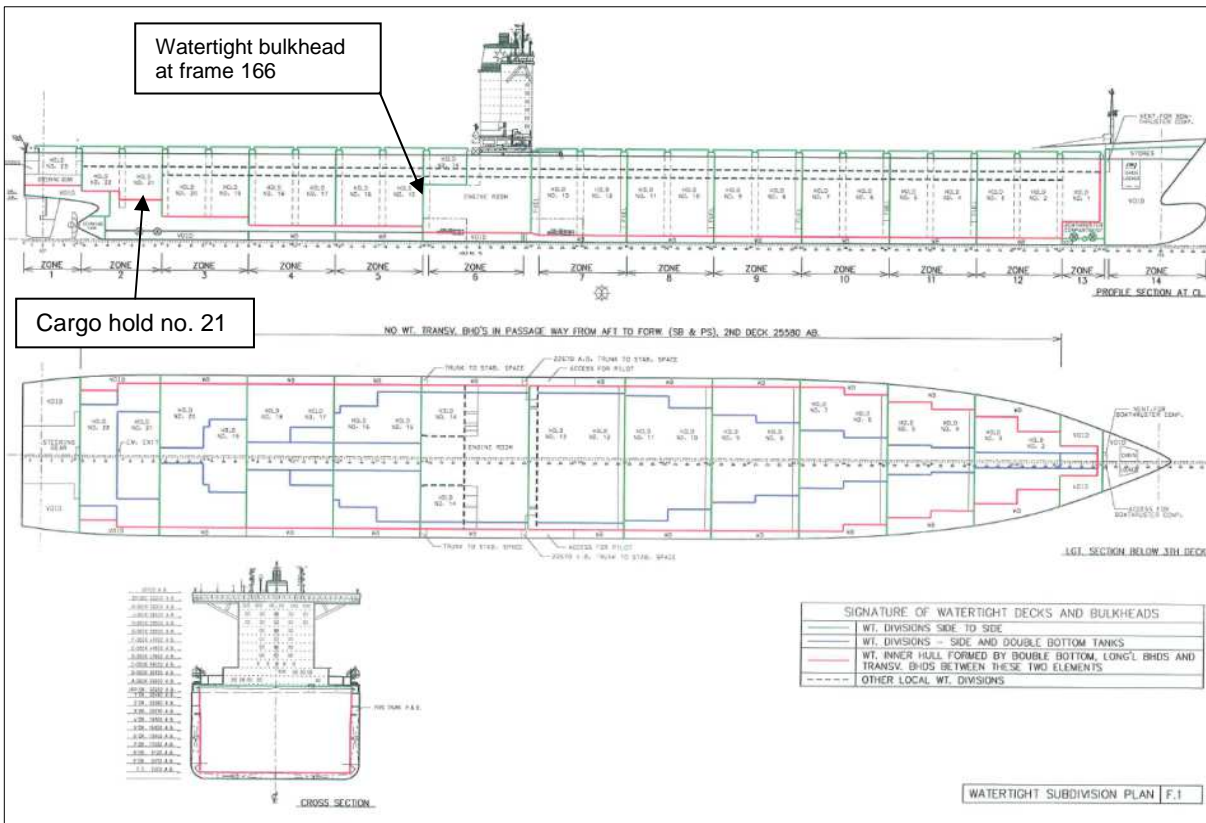
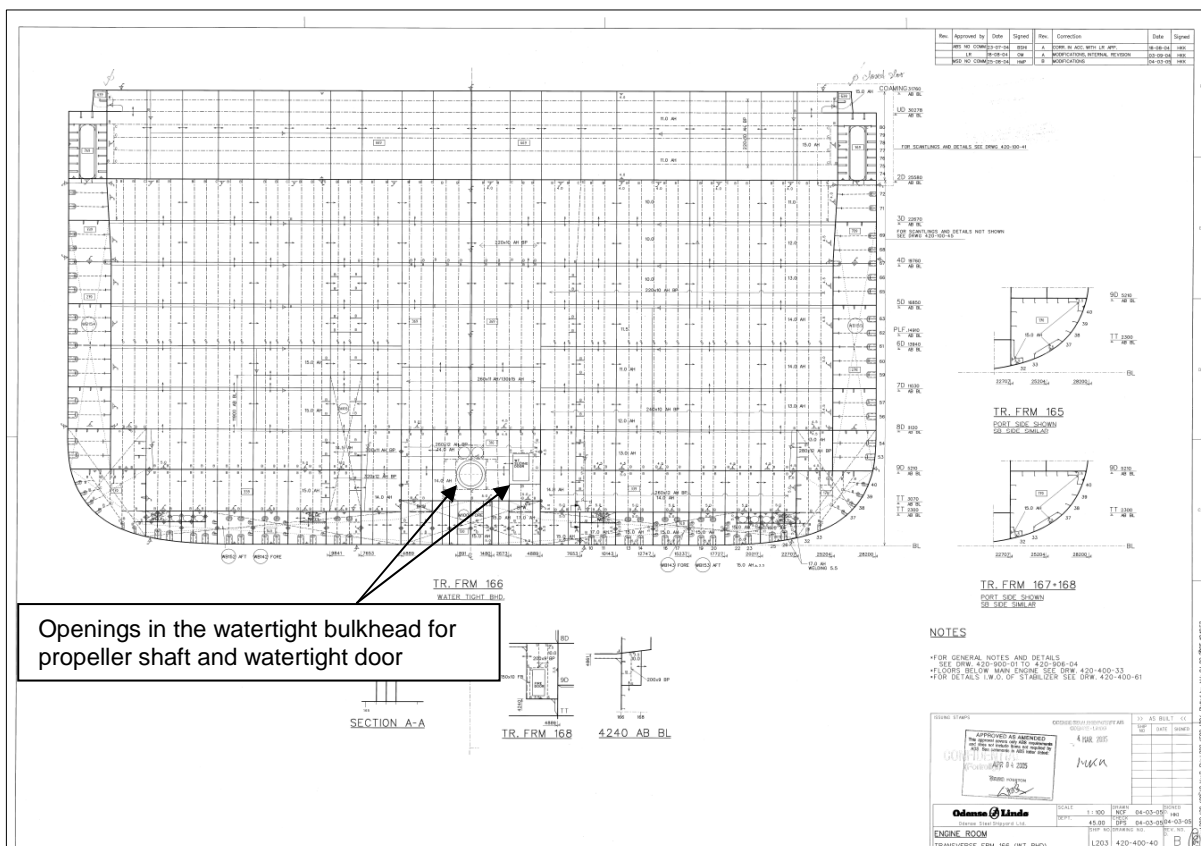
The bulkhead between the engine room and the shaft tunnel, situated at frame no. 166, was designed, constructed, approved and relied on as a watertight bulkhead (figures 30 and 31 on page 30).

Above the watertight door, there were two air ducts each of 600 mm diameter that went through the bulkhead for ventilation of the shaft tunnel. For each air duct there was a hydraulically operated valve fitted at the aft side of the bulkhead. The valves were remotely operated from the engine control room and the ship control centre at the deck office. They could not be operated locally. The position of the air ducts in the watertight bulkhead is shown on figure 12 on page 15.

There were six cable penetrations in the watertight bulkhead: Four for electric high voltage power supply for the shaft motors, and two for other purposes, one of which above and one of which below the watertight door. These cable penetrations are dealt with separately in the next section.

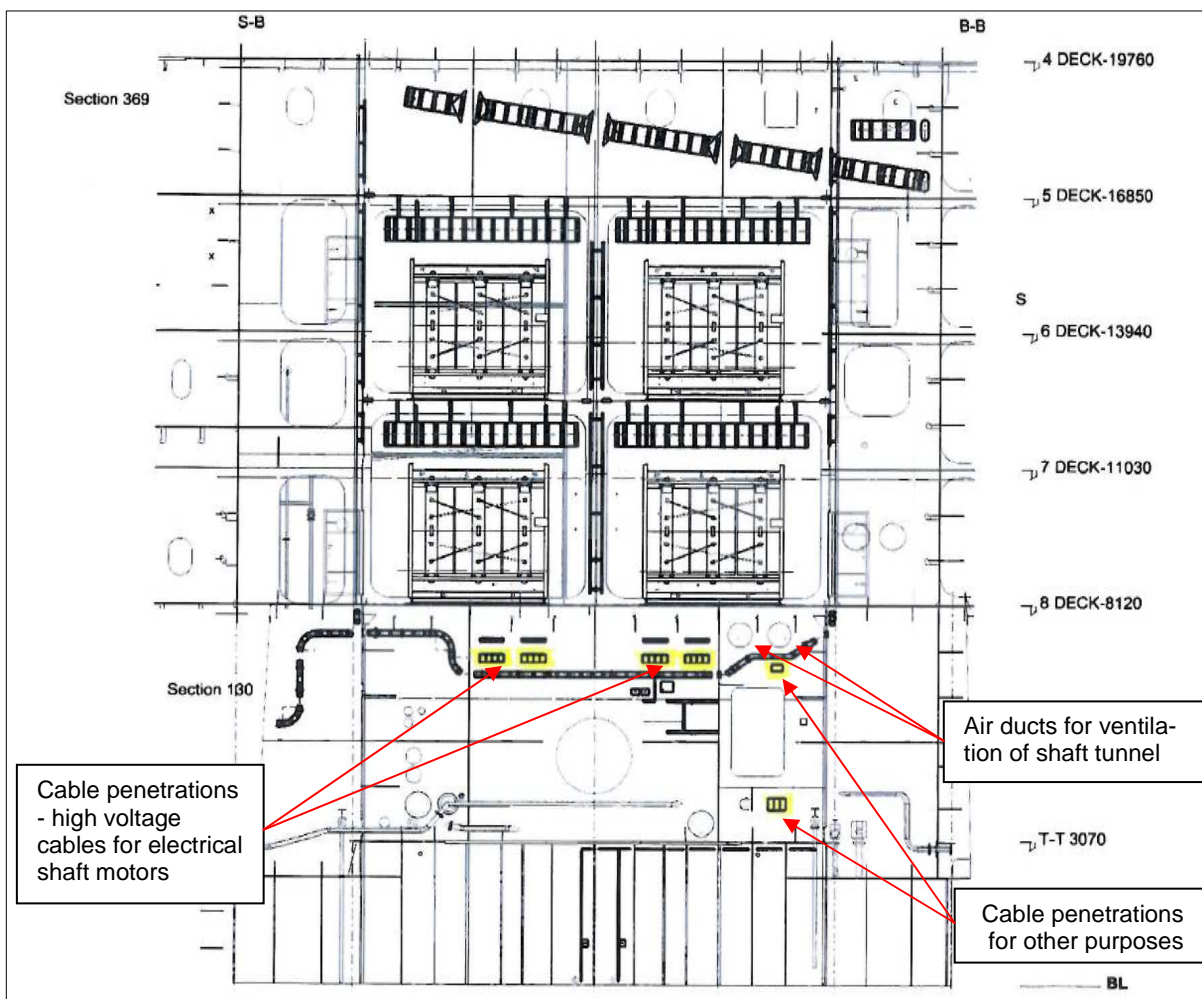
Cable penetrations were primarily fitted with plastic stay plates instead of stainless steel plates because they were easier to install and were less costly. The four high-voltage cable penetrations located above the propeller shaft in the watertight bulkhead at frame 166 were all fitted with stay plates of plastic. Another cable penetration located in the same bulkhead and below the floor plates was fitted with a stay plate of stainless steel.

When the four high voltage cable penetration sealings collapsed, the ship’s draught was about 16 metres. The high voltage cable penetrations in the watertight bulkhead were situated about seven metres above the ship’s basis line. Thus, the cable penetrations collapsed at a hydrostatic water pressure corresponding to the maximum water column of appr. nine metres equal to appr. 0.9 bar.

Figure 36: Detail of watertight bulkhead at frame No. 166 transverse section viewed from forward
 Source: The ship’s damage stability booklet

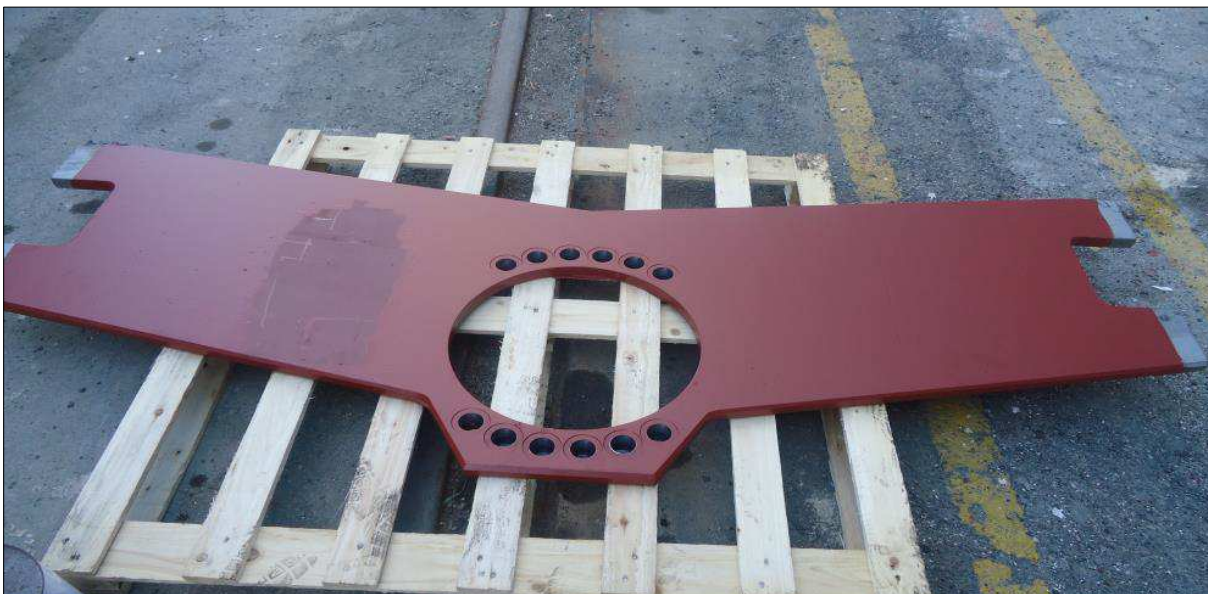
Figure 38: New supporting plate in upside down position
Source: Maersk Line

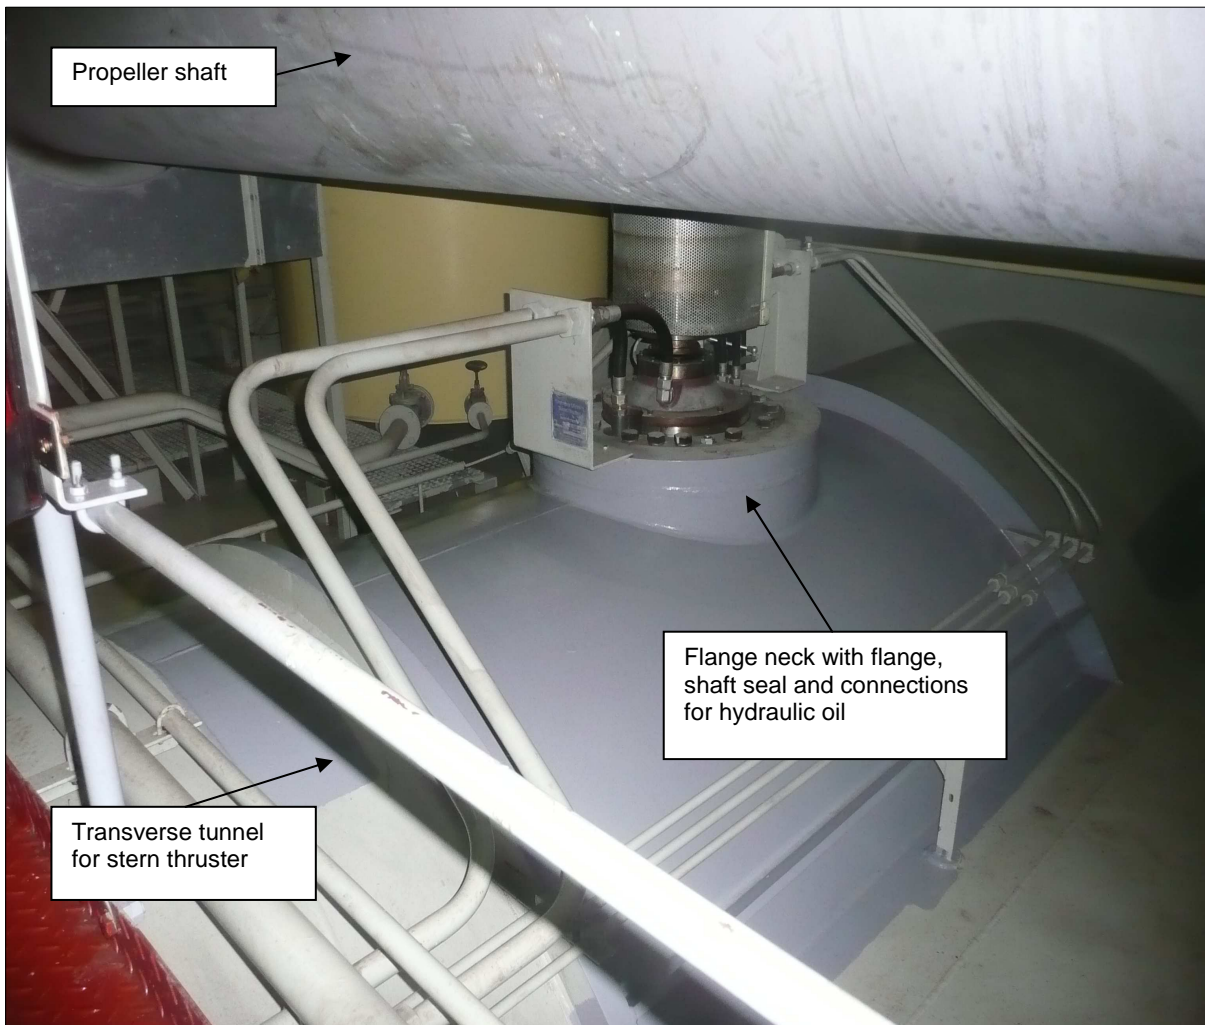
The 2nd engineer tried to get close to the leakage in an attempt to ascertain its origin and came as close as 1.5 – 2 metres from where he could see a dark area at the flange neck around the vertical shaft of the stern thruster. He realized that there was nothing to be done to stop the ingress and hurried back towards the engine control room and joined the chief engineer and the duty 3rd engineer at the system control computer on the 8th deck near the elevator.

Figure 40: Stern thruster tunnel with flange neck, flange, shaft seal and hydraulic connections in the shaft tunnel of a sister ship
Source: DMAIB

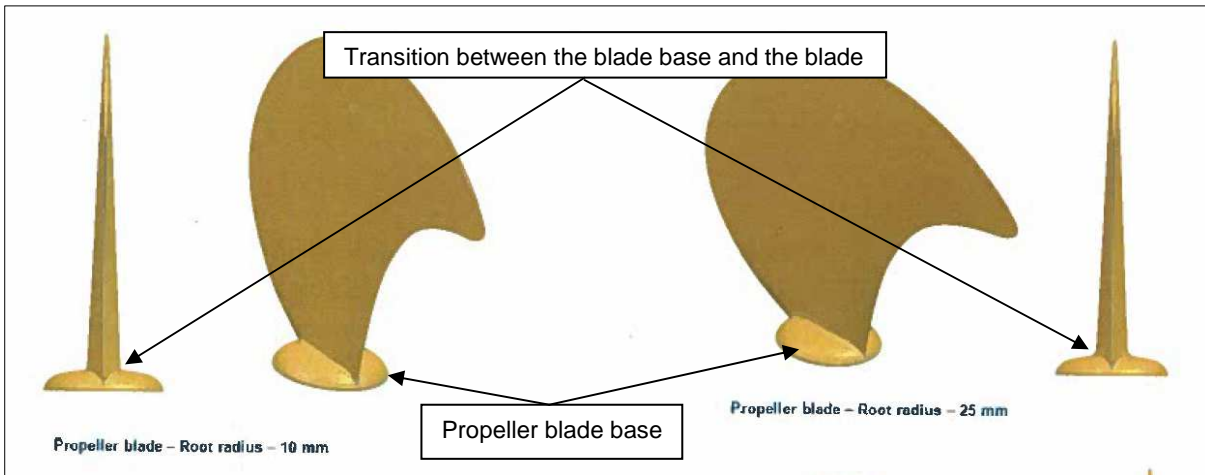
The damaged forward stern thruster that caused the leakage had a propeller design of the older design with a smaller radius.

Figure 50: Excerpt from presentation RRM – TT2400 EM Structural assessment, 03.09.2013
 Source: BANDAK Engineering
