MARINE ACCIDENT REPORT

December 2013

EMMA MÆRSK

Flooding of engine room on 1 February 2013

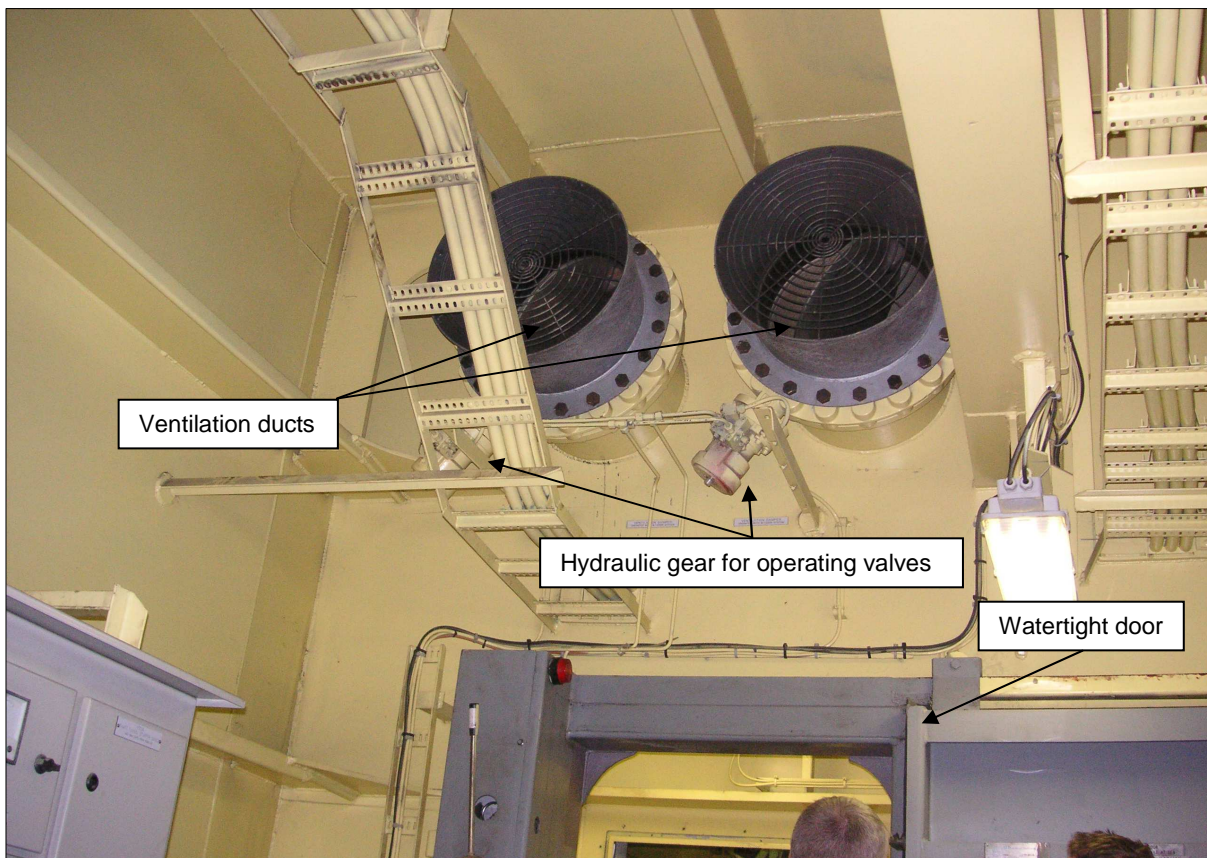
Figures 12: Hydraulically operated valves in ventilation ducts passing through the watertight bulkhead above the watertight door in a sister ship, viewed from the shaft tunnel

To ascertain that these valves were effectively closed, the engineers drilled large holes in the bottom of the ducts. This revealed that no water came through and the valves were effectively closed. For a short while, the engineers believed that the water ingress was confined to the shaft tunnel, but after a few minutes, water flowed through the propeller shaft sealing in the watertight bulkhead (figures 13 and 14 below) and soon after some seeping water was also observed at four of the cable penetrations in the bulkhead, above and below the propeller shaft. This was observed by engineers standing close to the watertight bulkhead and it caused some concern.

Above the watertight door, there were two air ducts each of 600 mm diameter that went through the bulkhead for ventilation of the shaft tunnel. For each air duct there was a hydraulically operated valve fitted at the aft side of the bulkhead. The valves were remotely operated from the engine control room and the ship control centre at the deck office. They could not be operated locally. The position of the air ducts in the watertight bulkhead is shown on figure 12 on page 15.

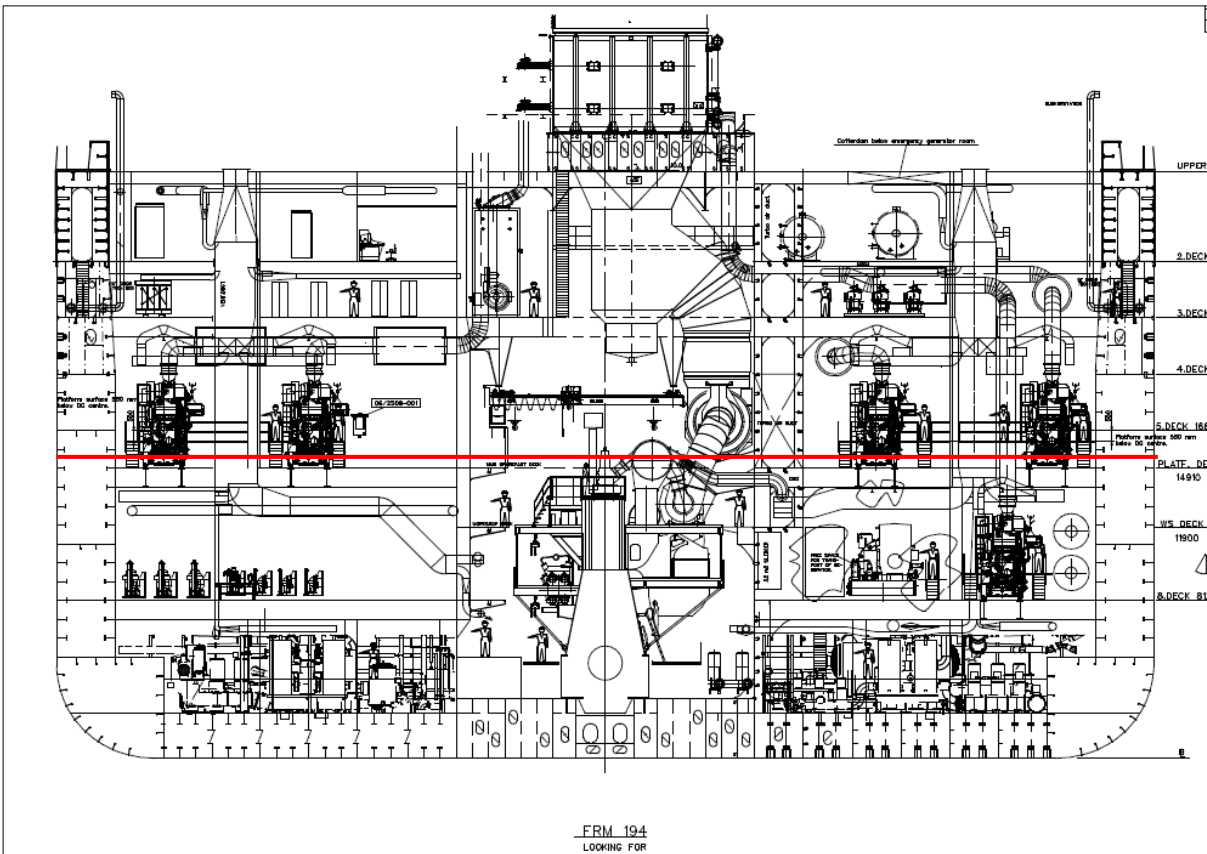
Within the following few hours, the main engine room was flooded up to the level of the exhaust valves of the main engine equivalent to the ship's draught (figures 24 and 25 on page 23). The total ingress of seawater into the shaft tunnel and the main engine room is estimated at 14,000 m³ (figures 17, 18, 19, 20, and 21 on pages 19, 20, 21 and 22).

Figure 22: Transverse section of the engine room with a red line indicating the maximum water level
Source: Maersk Line

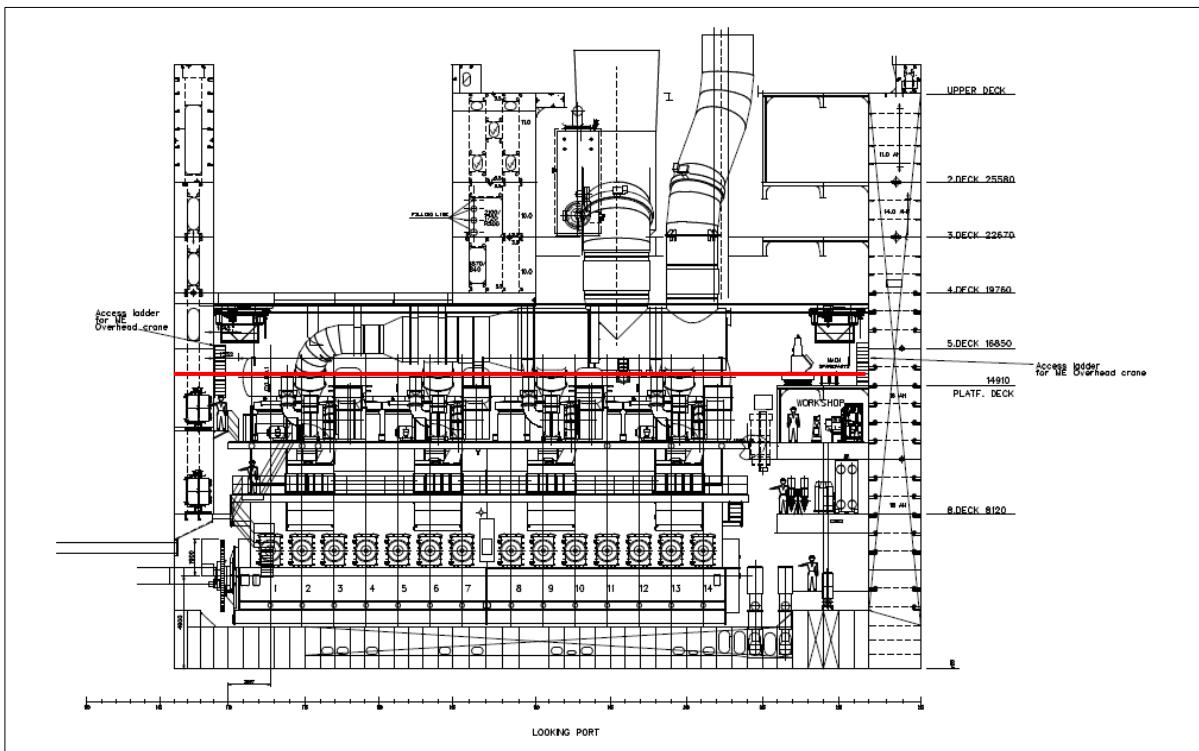
Figure 23: Longitudinal section of the engine room with a red line indicating the maximum water level
Source: Maersk Line

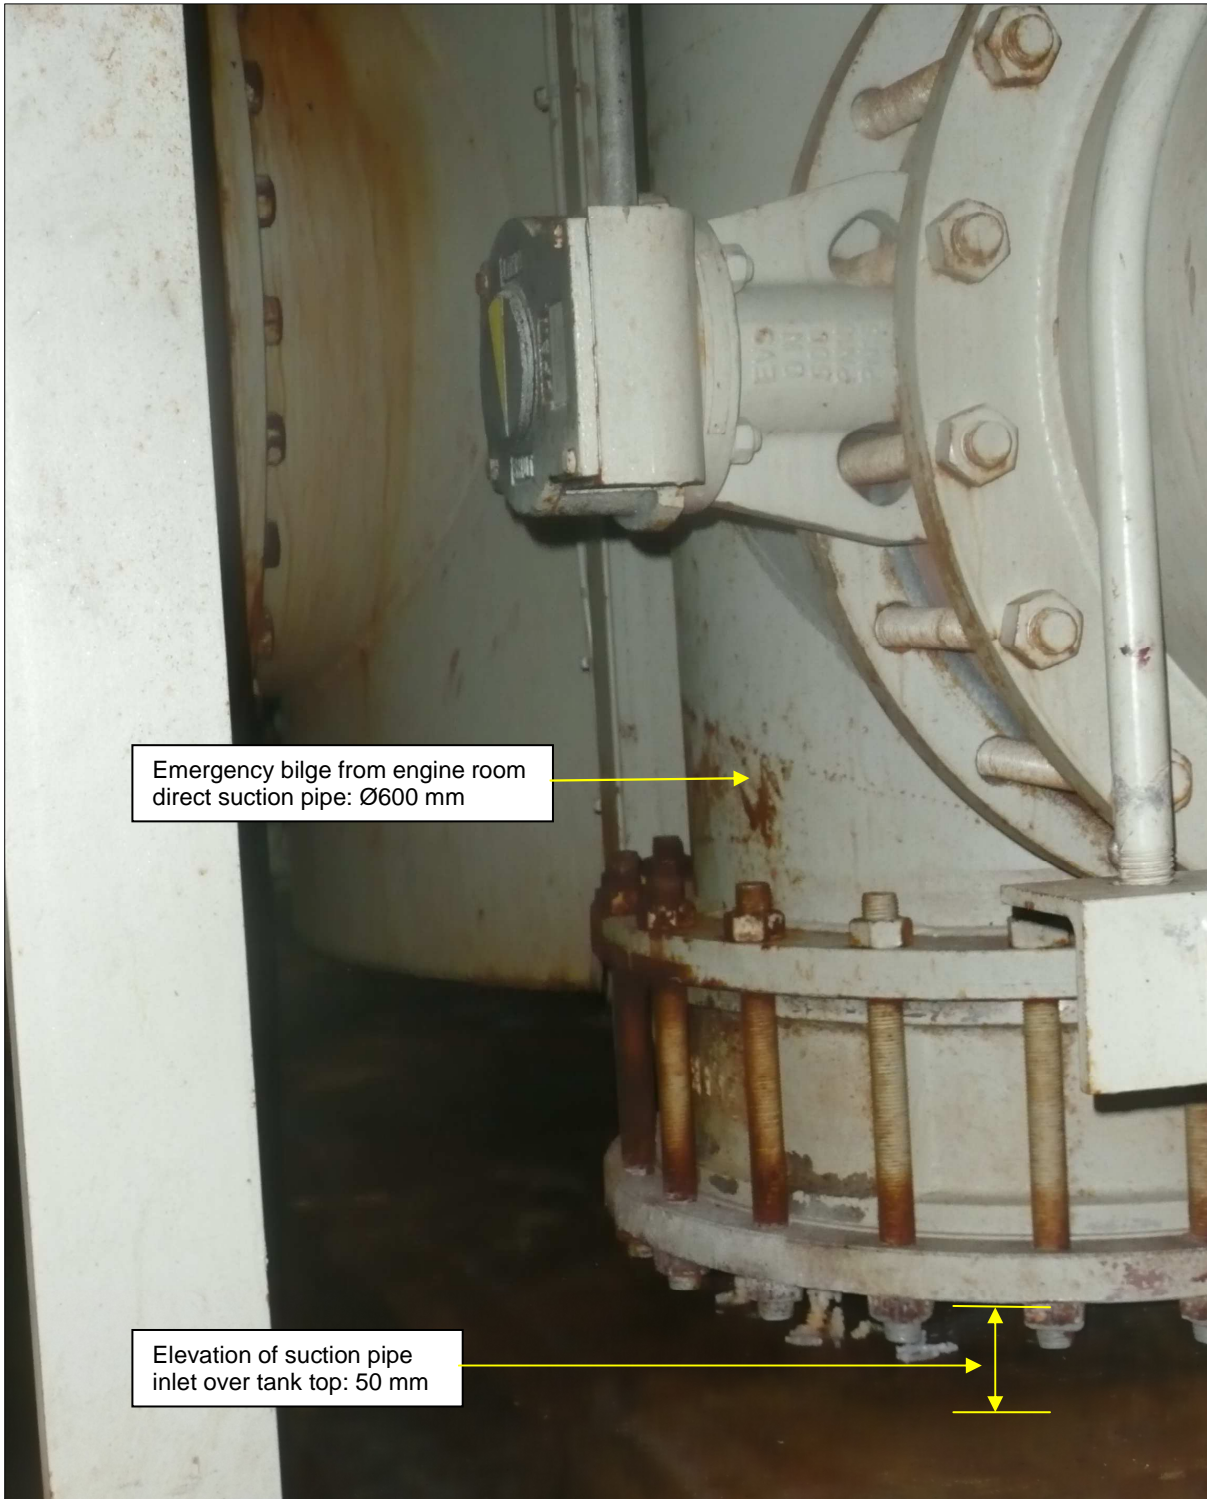
The emergency bilge suction pipe has a 600 mm internal diameter. It was situated just below the pump 50 mm above the tank top and had no strainer (figure 26 below). The area made up by this elevation (50 mm) multiplied by the pipe circumference is only one third of the internal area of the inlet pipe. Therefore the flow to the pump was reduced to an unknown proportion of what would be the case with an inlet area under the suction pipe equally large as the pipe itself.

Figure 26: Emergency direct suction from engine room by largest seawater pump of a sister ship
Source: DMAIB

Furthermore, the pump was running in parallel operation with the other seawater pump that was serving as a cooling water pump and the discharge from both pumps had to pass via the central cooler giving a pressure head of 3.0 bar. The backpressure from the coolers contributed to a diminished capacity of the pump.

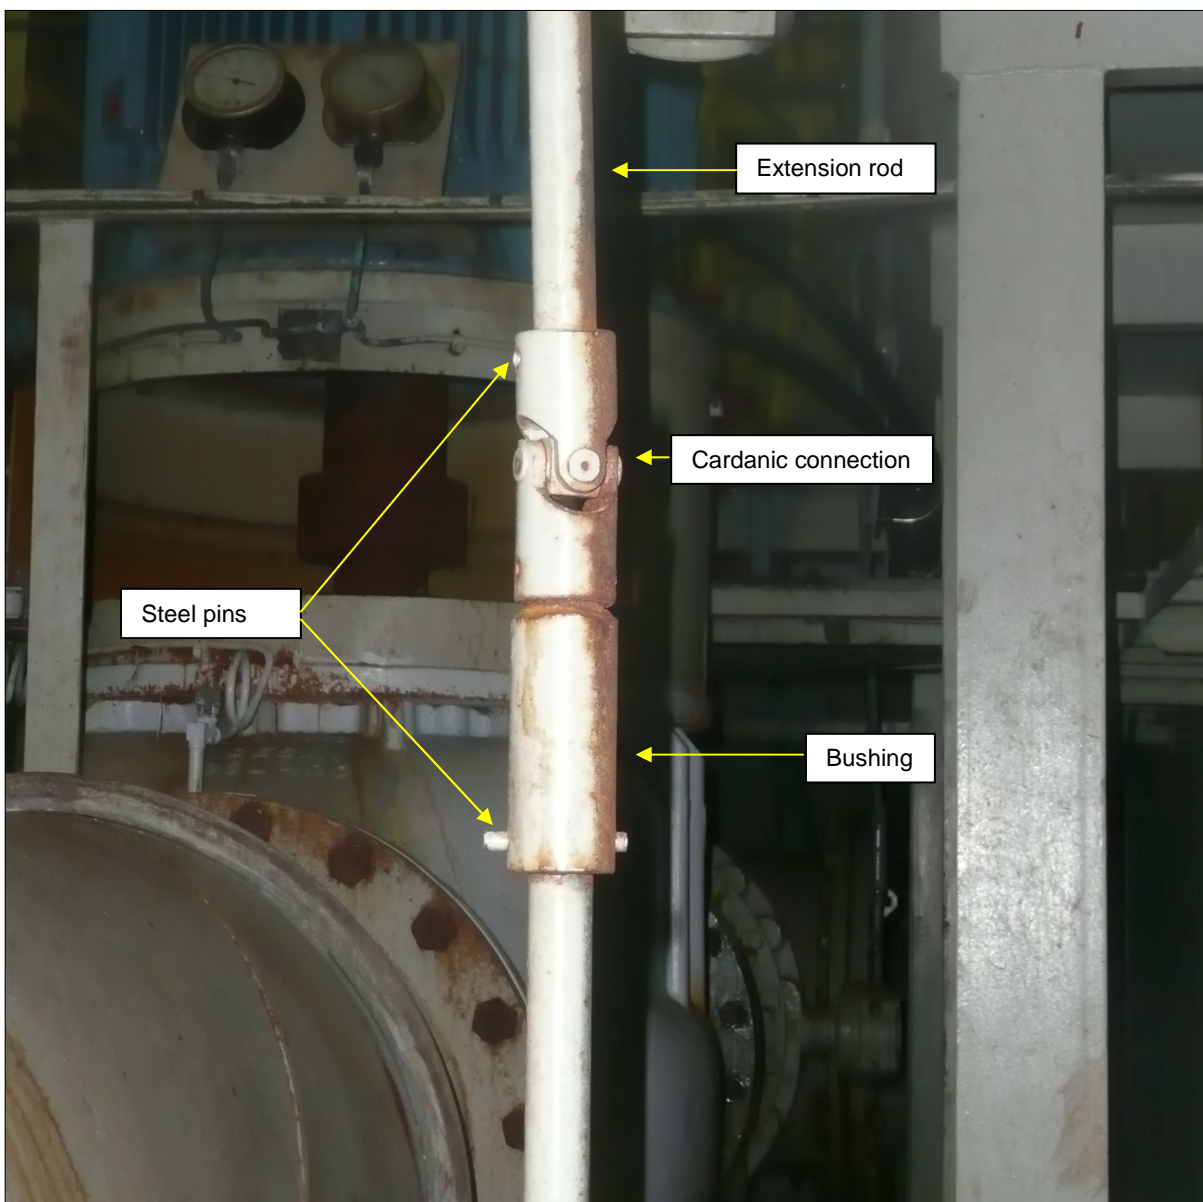
The emergency bilge suction valve provides direct suction from the engine room tank top. The opening of the suction valve was supposed to be carried out manually by a large handwheel just above the floor plate (figure 28 on page 28). The suction valve was situated just above the tank top and its spindle was connected to the handwheel by an extension rod (figure 29 on page 28) fitted to the valve spindle by a cardanic connection, the bushing of which was locked to the rod with steel pins (figure 27 below).

When operating the handwheel, a steel pin broke and the handwheel could not be used. The engineer then crawled under the floor plates and used a wrench to open the valve while standing on the tank top in water to the knees.

Figure 27: Extension rod with a cardanic connection fitted with a bushing and steel pins, in a sister ship and of the same type and principles as in EMMA MÆRSK
Source: DMAIB

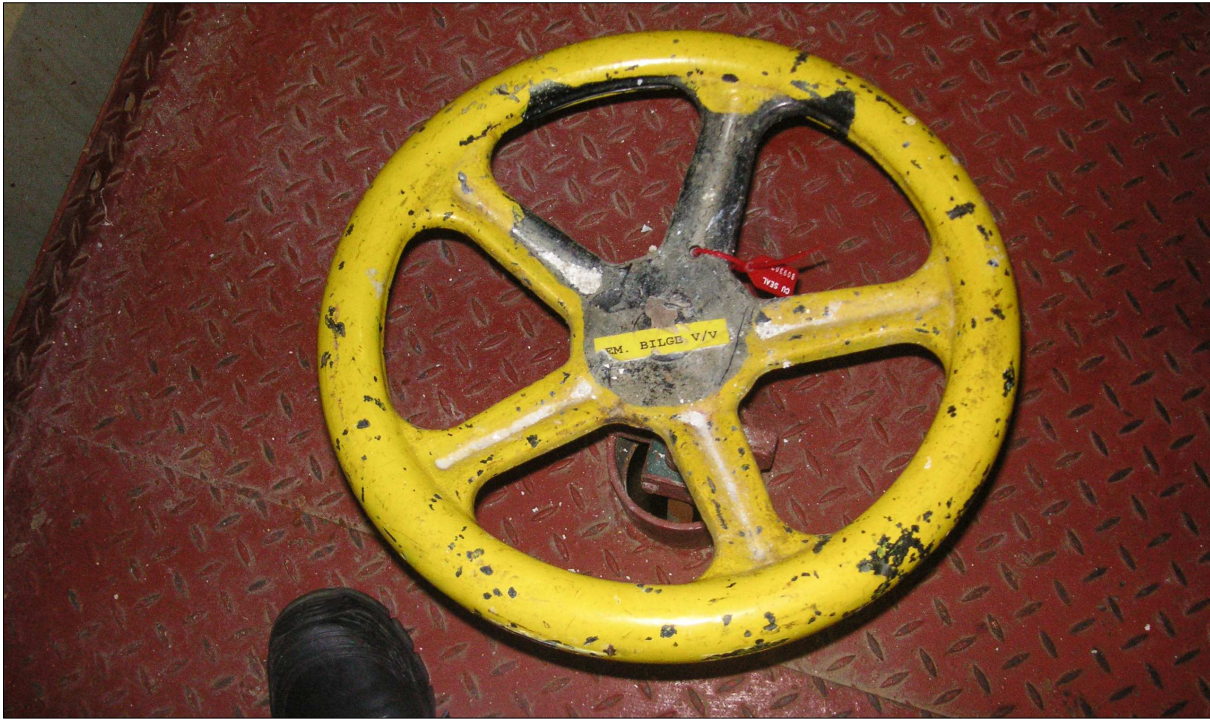
Figure 28: Handwheel for emergency direct suction from the engine room by the largest seawater pump of a sister ship
Source: DMAIB

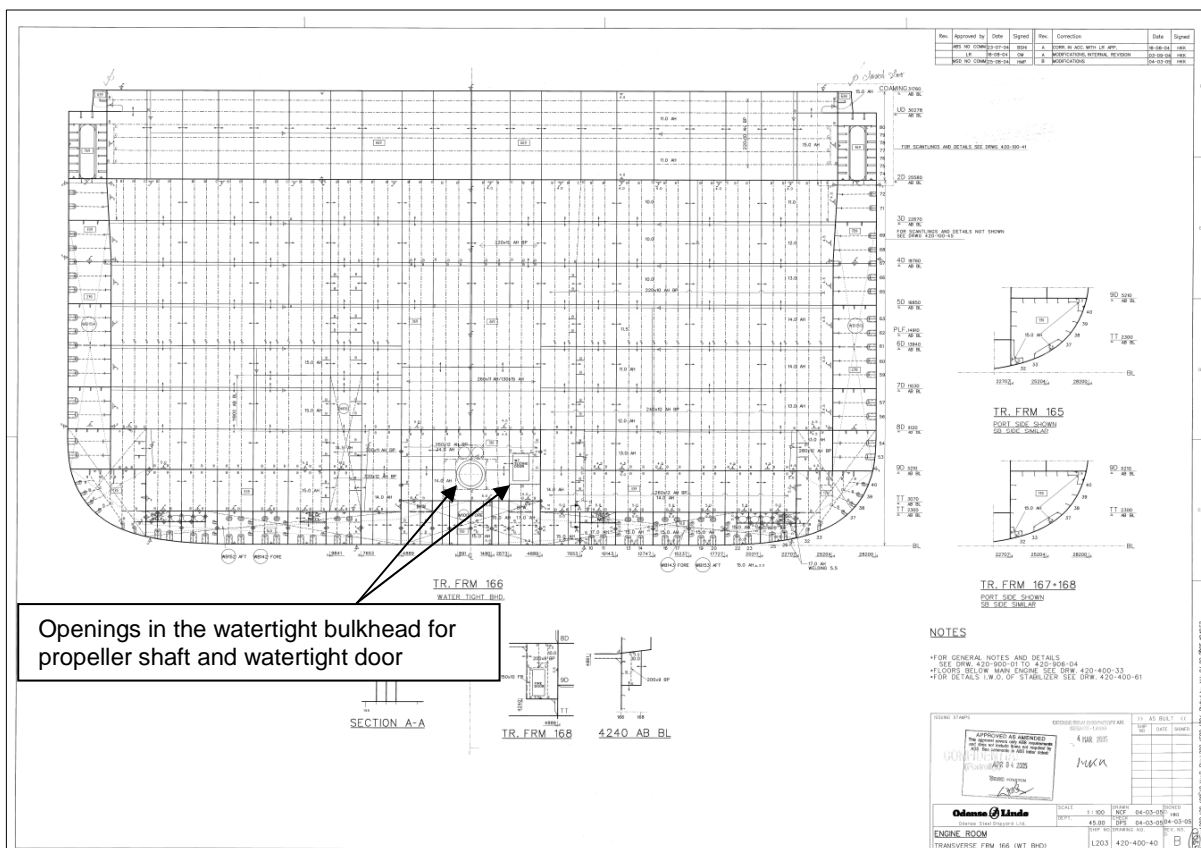
As the 3rd engineer investigated this unexpected scenario, he heard a sudden blast and saw one of four cable penetration sealings in the watertight bulkhead give way to the water pressure followed by a massive ingress of seawater. A few moments later, the other three cable penetration sealings also failed which resulted in an even larger ingress of water into the engine room.

There were six cable penetrations in the watertight bulkhead: Four for electric high voltage power supply for the shaft motors, and two for other purposes, one of which above and one of which below the watertight door. These cable penetrations are dealt with separately in the next section.

Figure 31: Watertight bulkhead at frame No. 166 viewed from fore
Source: ABS

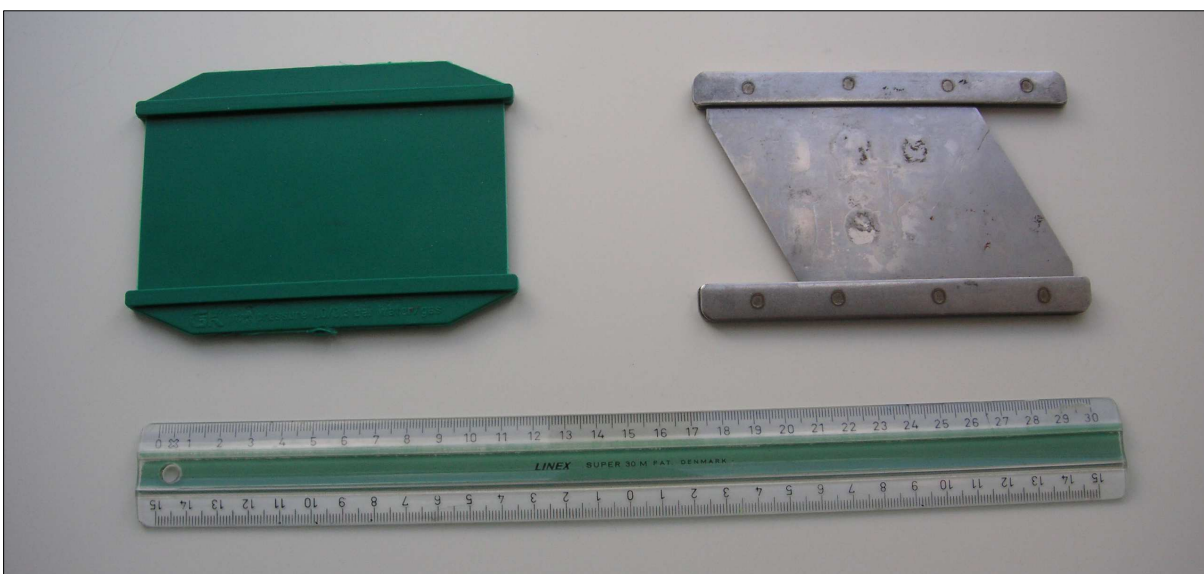
The stay plates are made of plastic material (elastomer), galvanized steel or stainless steel (figures 34 and 36 on page 33). It should be noted that the plastic stay plates mounted in EMMA MÆRSK were not marked with any maximum pressure.

Figure 35: Stay plates of plastic (elastomer) and stainless steel for "GK Packing System"
Source: DMAIB

The class approval certificate of the “GK Packing System” contained no obvious specification or differentiation between metal and plastic stay plates and their intended use, but referred to the selection of packing system components to be in accordance with the manufacturer’s recommendations.

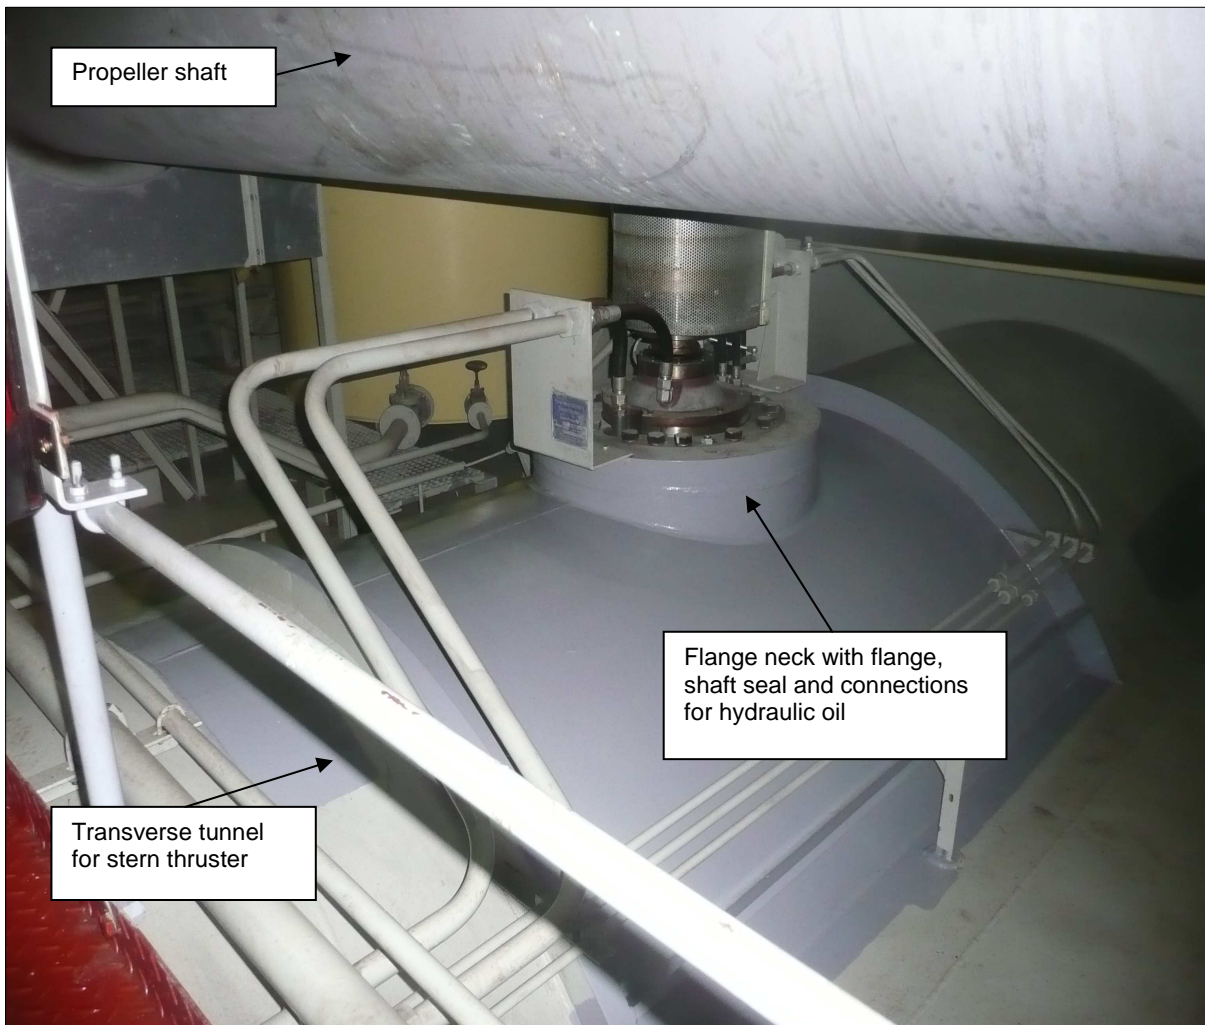
The 2nd engineer tried to get close to the leakage in an attempt to ascertain its origin and came as close as 1.5 – 2 metres from where he could see a dark area at the flange neck around the vertical shaft of the stern thruster. He realized that there was nothing to be done to stop the ingress and hurried back towards the engine control room and joined the chief engineer and the duty 3rd engineer at the system control computer on the 8th deck near the elevator.

Figure 40: Stern thruster tunnel with flange neck, flange, shaft seal and hydraulic connections in the shaft tunnel of a sister ship
Source: DMAIB
