# UNITED STATES COAST GUARD

## **MODU KULLUK**

**ON DECEMBER 31, 2012**

**REPORT OF INVESTIGATION INTO THE CIRCUMSTANCES SURROUNDING THE  
GROUNDING OF THE MOBILE OFFSHORE DRILLING UNIT (MODU) KULLUK ON  
THE EASTERN COAST OF SITKALIDAK ISLAND, ALASKA  
ON DECEMBER 31, 2012**

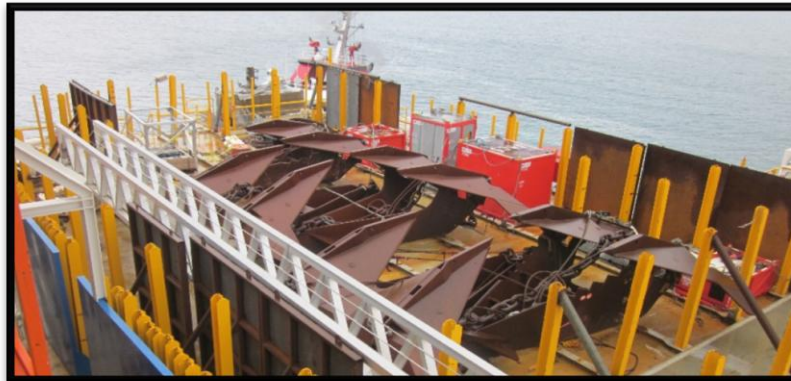
30. While not addressed in the towing plan contingencies, the KULLUK was equipped with a 15 ton “LWT” type survival anchor and the associated diesel powered anchor windlass, chain (900 feet) and ground tackle used to secure the anchor in the stored or deployed position. The additional 5 anchors specified in the plan (see above) were stored on the rig and would require the use of the onboard crane(s) for deployment. As such, they would only be available for mooring in sheltered waters or in favorable weather conditions due to the limitations in using the cranes in a higher sea state.

**Figure 7:** Five anchors stored aboard the KULLUK before transit. These were for use when the towing operation reached the Seattle Area while the KULLUK awaited dock space availability. (USCG Photo)

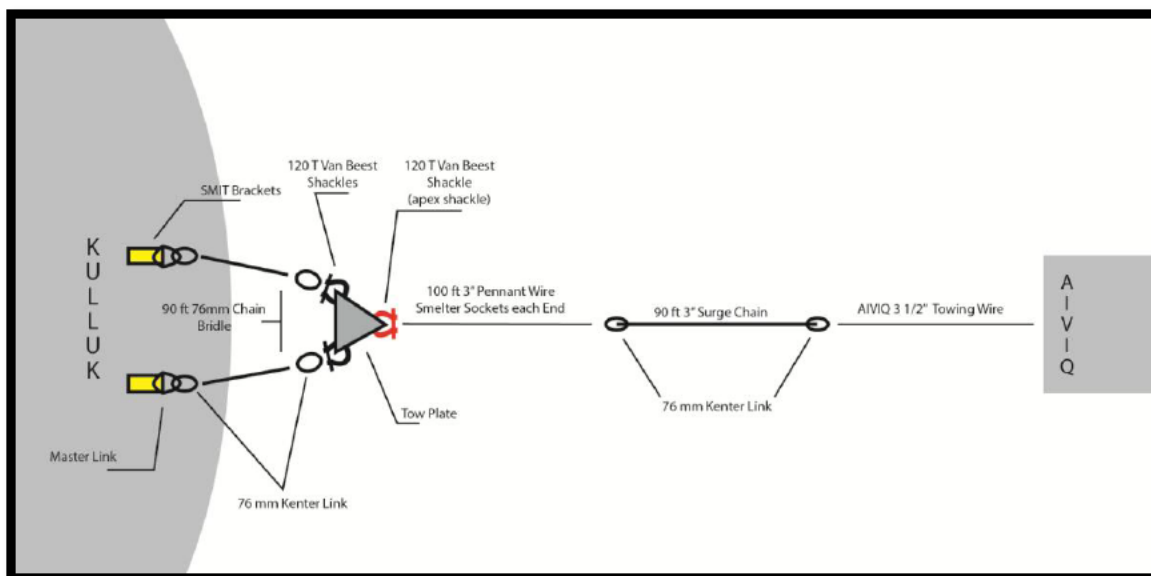
40. The SWL/WLL, PL and BL for primary tow configuration between the KULLUK and AIVIQ are listed in the following table. Figure 10 is based upon the actual configuration of equipment for the tow of the KULLUK in December 2012, detailed in testimony from vessel crewmembers and inspection of the equipment utilized. The equipment below would be connected to the AIVIQ's 3 ½ inch towline using 90 feet of 3 inch chain as surge gear.<sup>33</sup>

Figure 11: Diagram of towing configuration utilized in the KULLUK/ AIVIQ tows throughout 2012. (USCG developed)

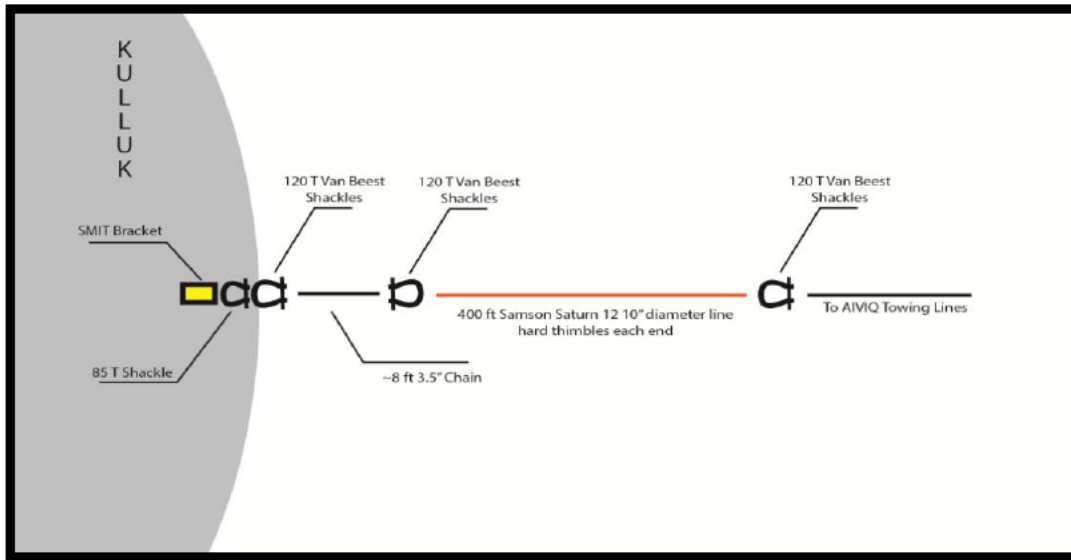
41. The KULLUK was equipped with an emergency towline, designed for use should the primary towing configuration fail. Figure 12 is based upon the actual configuration of the emergency towline configuration for the tow of the KULLUK in December 2012 as detailed in testimony from vessel crewmembers and inspection of the equipment utilized. At the terminus end of the Saturn® 12 line there is an eye with a thimble<sup>37</sup> lashed into the eye. A shackle then connected the equipment to the assisting vessels towline. The emergency towline was configured so that it could be easily deployed by the KULLUK crew as necessary.

**Figure 12:** Diagram of Emergency Towline as designed for use when under tow. (USCG developed)

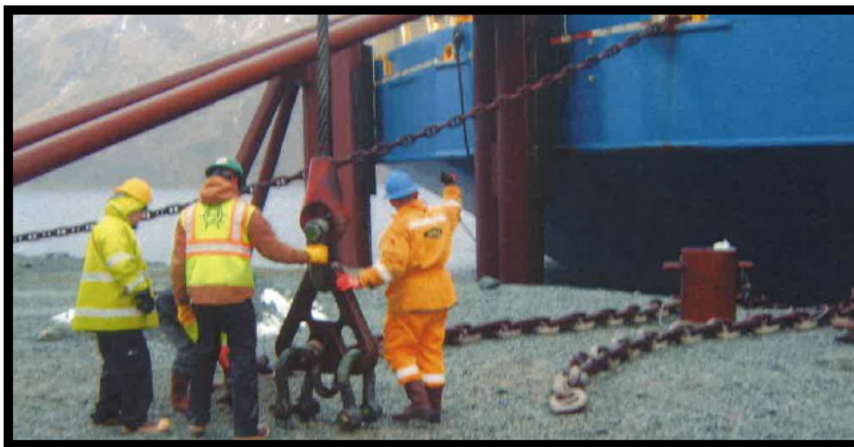
**Figure 14:** Preparing to Connect the Towing Plate to the Bridle Legs (Photo courtesy of GL Noble Denton, Mr. █████)

62. Using an OSI yard crane, the towing plate was maneuvered using the connected pennant wire and shackle as to allow shore side personnel to connect the two bridle chains to the towing plate, by way of shackles. Locking nuts were placed on the shackles and they were properly secured with cotter keys. See Figure 14. Once the shackles were connected, the towing configuration was raised by KULLUK's cranes into a standby position for connection to the AIVIQ once away from the dock.

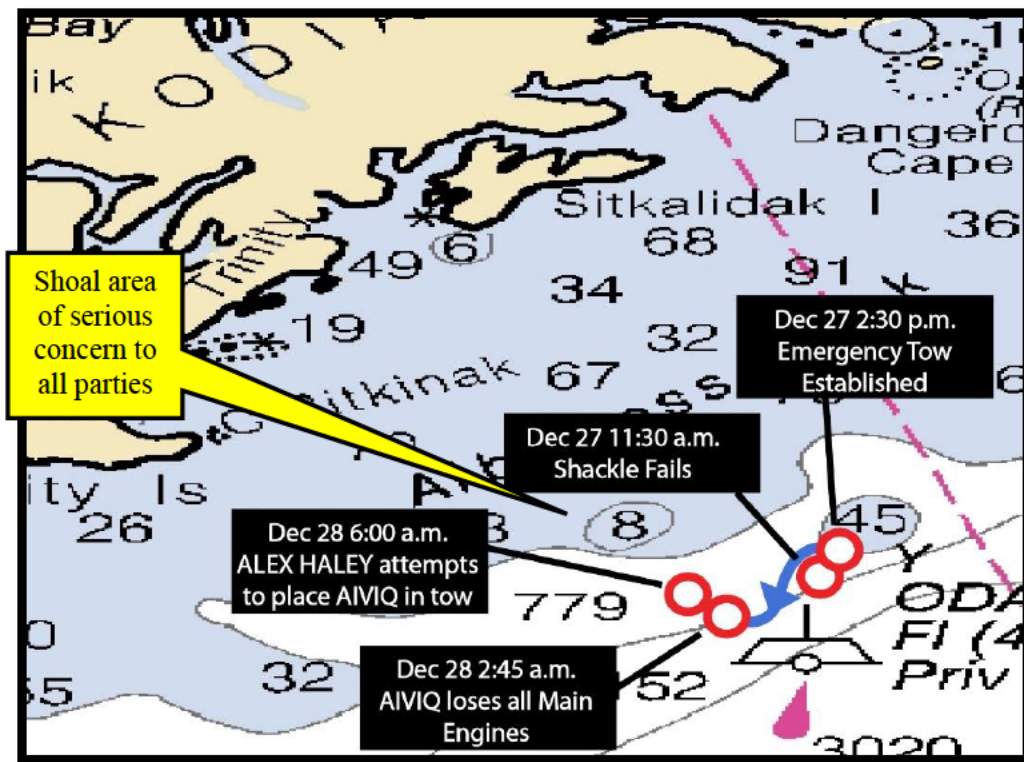
**Figure 23:** Diagram shows approximate locations of KULLUK between 11:30 a.m. December 27 and 6 a.m. December 28.<sup>66</sup> Significant events are highlighted and times are approximate. Blue line indicates general direction and location of KULLUK during this period. (USCG analysis)

96. Once the emergency tow was connected, the AIVIQ proceeded on a generally south-westerly course to keep increasing the distance away from Albatross Bank and an eight fathom shoal area (see Figure 23), which was north of their position. This shoal area was of serious concern due to the interaction of the sea and swell height and the 10.7 meter draft of the KULLUK.

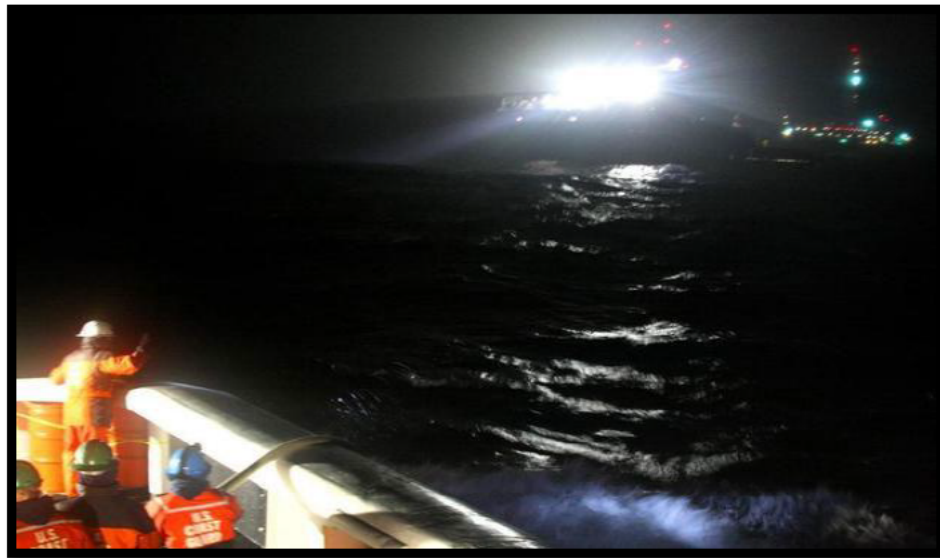
**Figure 25:** The crew of the USCGC Alex Haley attempt to pass the towline to the bow of the AIVIQ. Bright lights are located on the bow of the AIVIQ and the KULLUK is in the distance at the far right of the photograph. (USCG Photo)

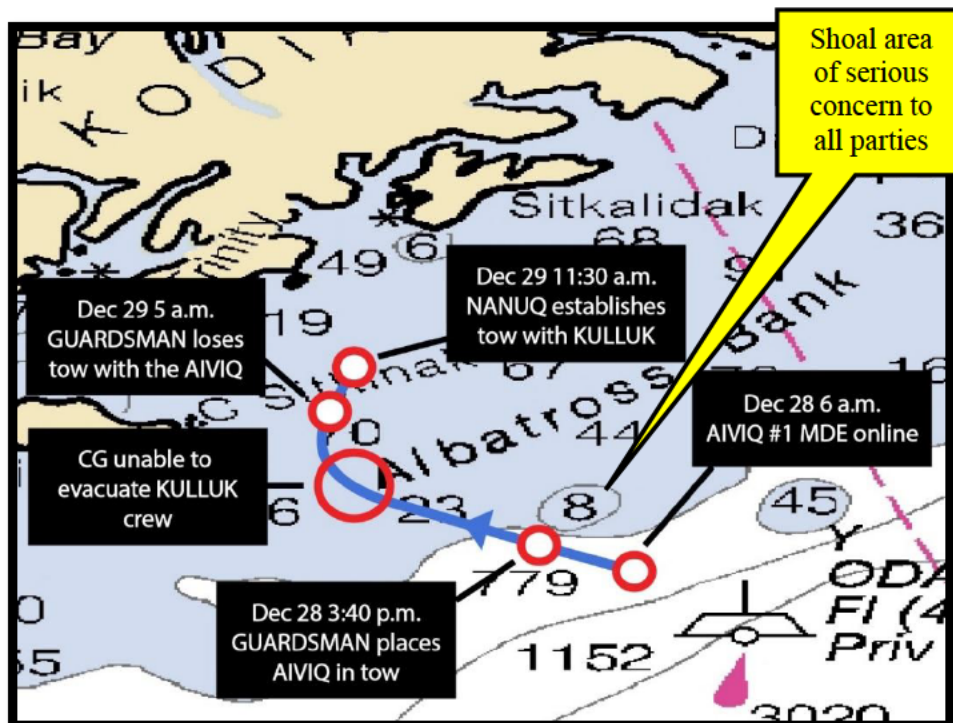
**Figure 26:** Diagram shows approximate locations of KULLUK between 0600 hrs December 28 and 1130 December 29. Significant events are highlighted. (USCG analysis)

113. With limited power on their #1 MDE and rotating azimuth and tunnel thrusters, the AIVIQ continued to be pulled astern by the KULLUK's wind driven drift, and the vessels were drifting slowly to the northwest. There was considerable concern that the KULLUK would drift on a marked 8 fathom area (see Figure 26), in which there was a chance that the KULLUK would ground or touch bottom in the seas. The drift of the KULLUK narrowly missed this area by approximately 8 miles, drifting to the west of this shallow bank.

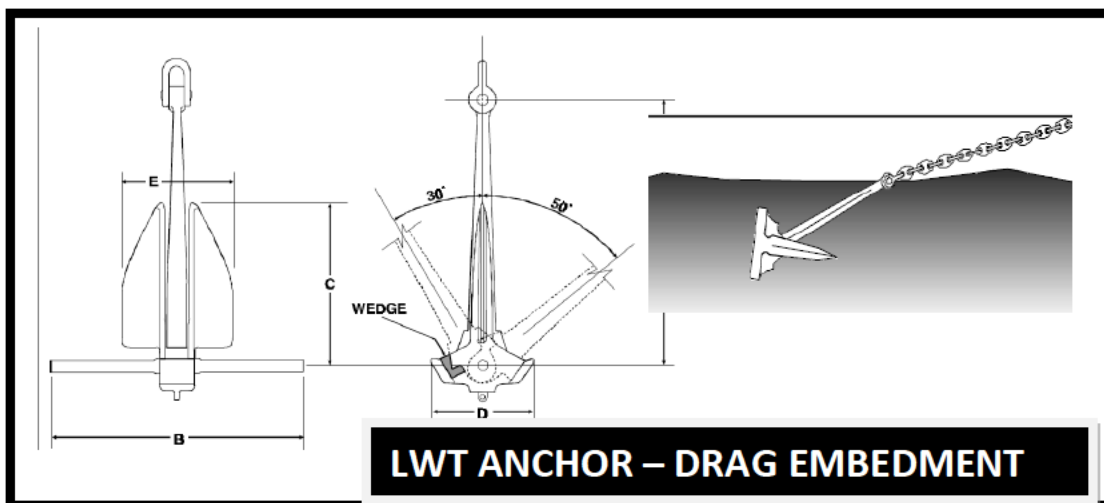
**Figure 29:** Diagram of a LWT anchor of a similar type carried aboard the KULLUK. The survival anchor was a 15 ton anchor. (Diagram U.S. Navy Towing Manual composite)

119. The KULLUK was fitted with one survival anchor which was fitted with the typical ground tackle for a ship's anchor such as hawsepipe, brake and securing device. The windlass for the anchor was located in a compartment on the KULLUK and the chain led out from the windlass onto the deck and then through a hawsepipe to the sea below. The anchor and windlass are located near the starboard quarter of the KULLUK, near the "stern" on the main deck in relatively close proximity to the helicopter deck area which was on the opposite end of the vessel from the main towing equipment, or the "bow" of the KULLUK.

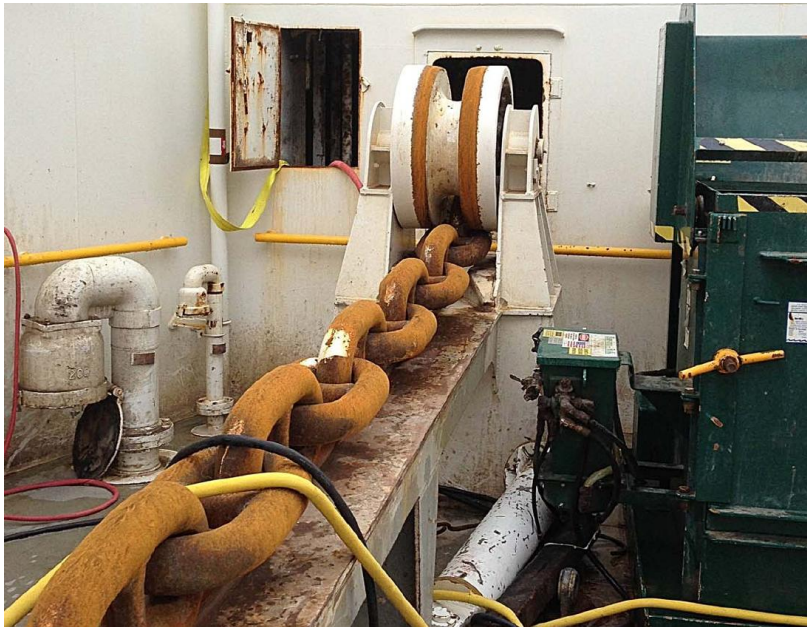
**Figure 30:** The anchor chain for the survival anchor leading out of the windlass room towards the hawsepipe. (Photo provided by Shell)

120. After the towing gear failure that occurred on December 27 the anchor was reported to have been dropped on two occasions. In one occasion this was as the result of a miscommunication between the KULLUK OIM and Tow Master and the crew of the KULLUK in a high stress situation. The anchor was released then quickly recovered. At this time the anchor was lowered to a reported depth of approximately two to three shots of chain or approximately 180 to 270 feet.

121. In the second occasion the OIM reported that the survival anchor was intentionally deployed to the bottom and was retrieved approximately six hours later. At this time the towing operation was near Albatross Bank a relatively shallower area of water 12-40 fathoms with a rocky bottom and areas of broken gravel. Nearer to the shore the water deepened with a mud bottom. According to the Van den Haak R study<sup>82</sup> the LWT anchor is not ideal for coarse gravel or rocky bottom. When the anchor was retrieved the OIM reported that he believed the anchor was on the bottom and as evidence he said the last links of chain were “shiny” which he attributed to dragging on a rocky bottom. This statement is supported by HSE Technician [REDACTED] in his interview statement.

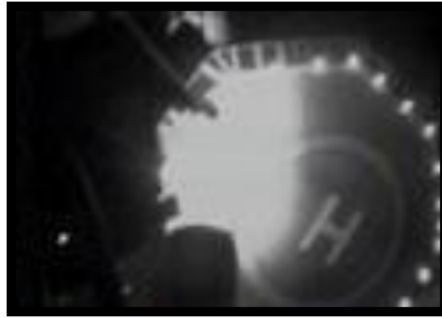
125. Edison Chouest shore side support personnel procured replacement injectors from various locations throughout the U.S. and had them flown via corporate jet to Air Station Kodiak for delivery to the AIVIQ. Between the hours of 0300 and 1000 on December 29, Coast Guard Helicopters from Air Station Kodiak delivered replacement injectors to the AIVIQ via multiple hoisting operations with twelve baskets of parts hoisted. During this period, approximately 74 injectors were delivered to the vessel. The AIVIQ crew immediately began to replace the failed injectors with the recently delivered replacements.

**Figure 31:** A USCG helo makes night time delivery of engine parts to the helicopter deck on the AIVIQ (USCG Photo)

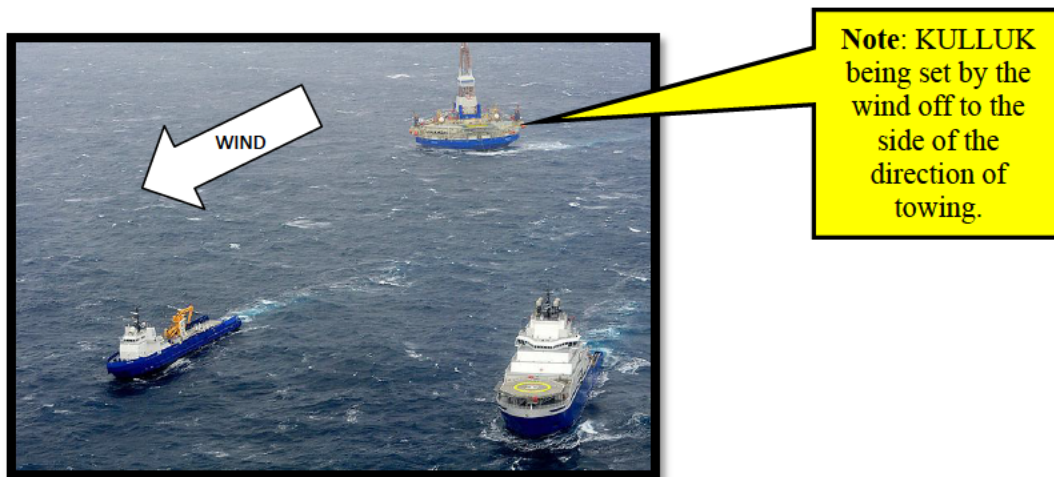
**Figure 32:** NANUQ on the left and AIVIQ on the right side of the photo with the KULLUK under tow in the distance (USCG Photo)

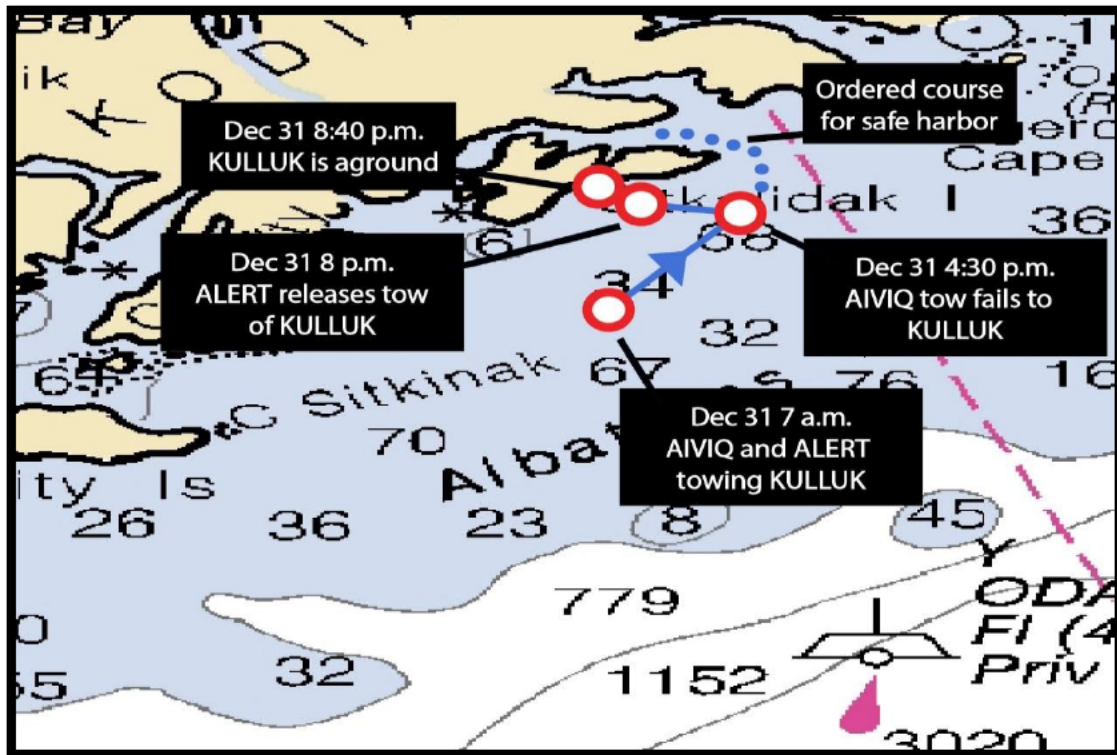
Figure 37: Diagram shows approximate locations of KULLUK between 0700 hrs AKST December 31 up to the grounding of the KULLUK. Significant events are highlighted. (USCG analysis)

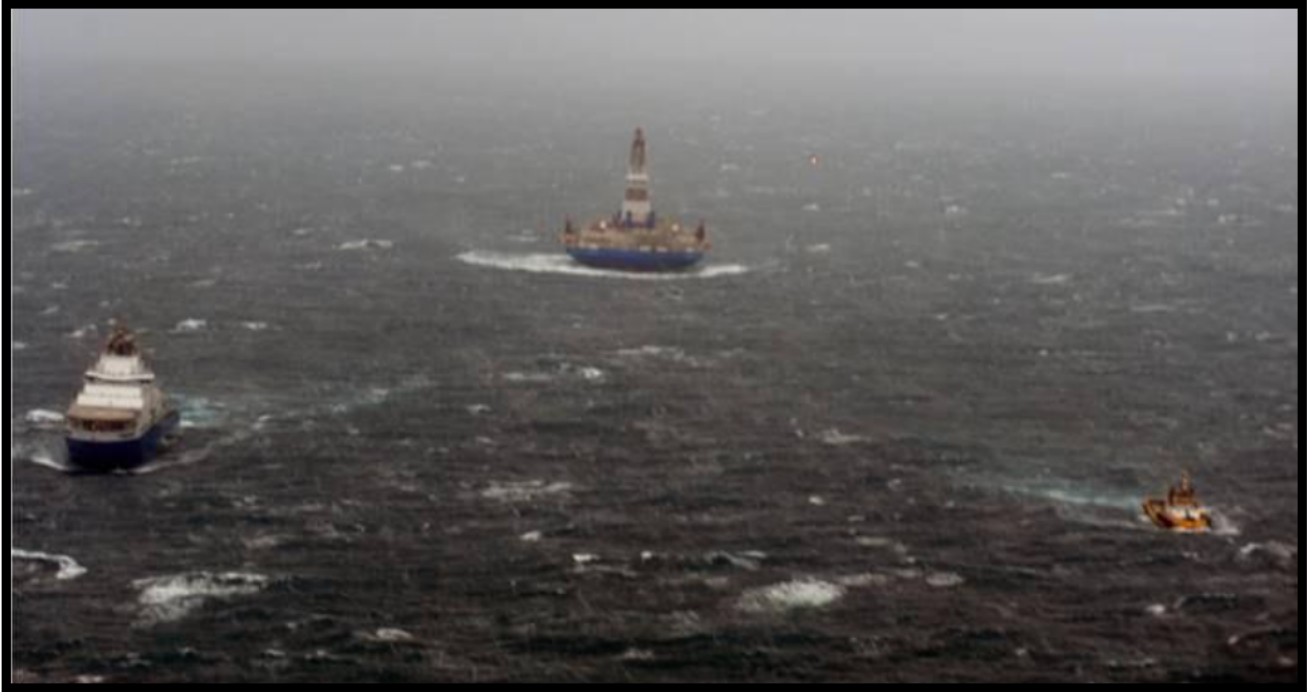
**Figure 38:** KULLUK under tow with the AIVIQ (left foreground) and the ALERT (right foreground) on December 31. (*USCG Photo*)

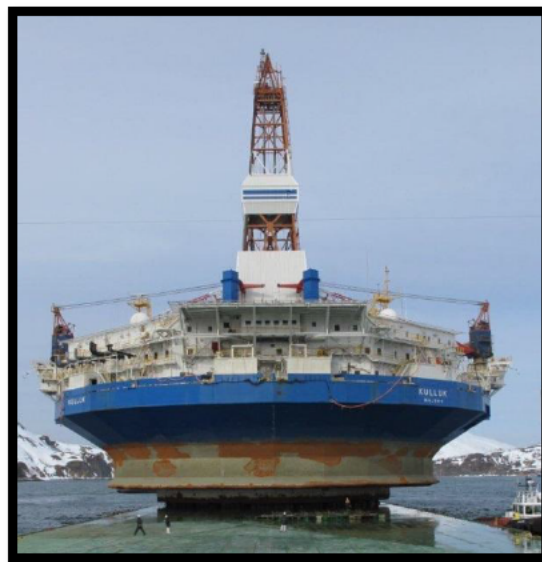
3. The KULLUK’s hull is conical in design, with no distinctive bow or stern. The design of the vessel exposes a broad expanse of the hull to hydrodynamic effects of the sea, including the effects of current and swells/ wind driven seas. The derrick, cranes, accommodation and control spaces result in significant sail area or the effects of wind on the vessel. The severe outward slope of the hull below the chine increases overall hull resistance to the seas when the vessel is pitching, rolling or heaving in heavier weather.

**Figure 46:** The KULLUK out of the water and loaded on the deck of a heavy lift ship. (USCG photo)

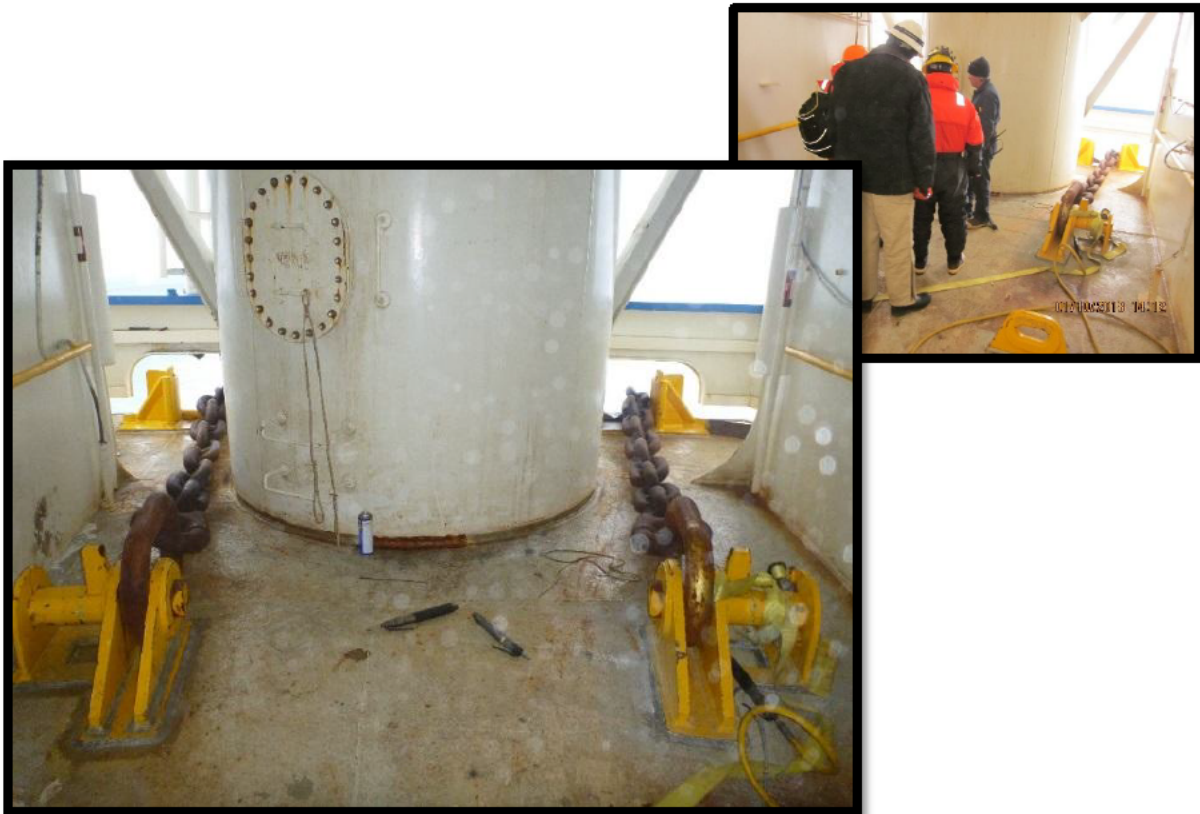
**Figure 49:** Photo of towing bridle connections to Smit Brackets (USCG Photo)

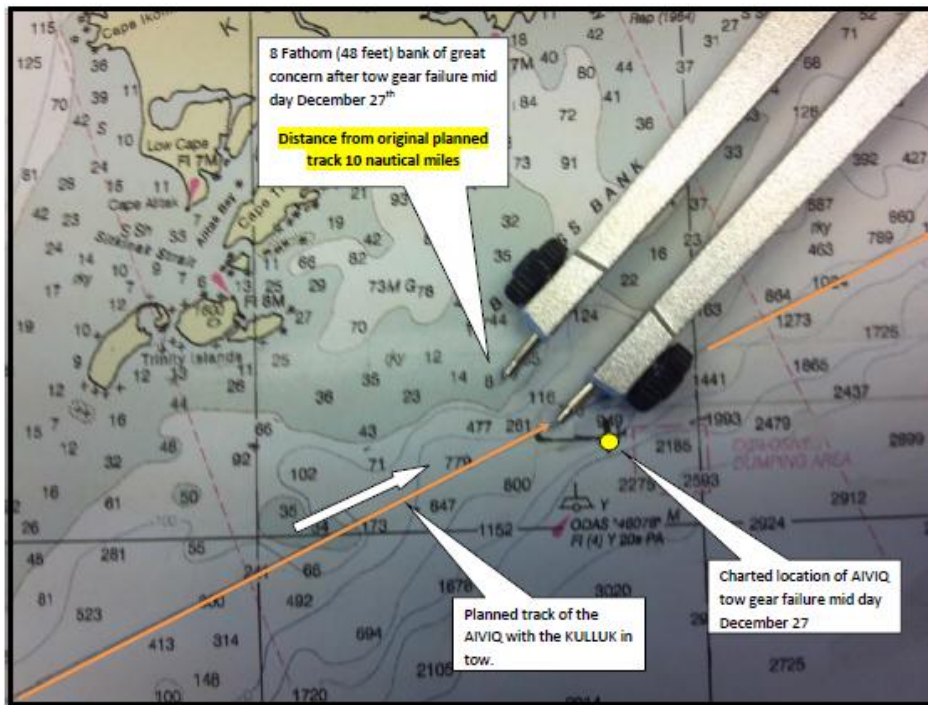
25. In hindsight, this route's proximity to shoal water and land masses proved to be a critical factor in the towing and response operations. At the time of the shackle failure, the KULLUK was approximately 40 miles from the closest point of the islands of Kodiak Island and less than 10 miles from Albatross Bank. The loss of the AIVIQ's engines and extreme weather moved the KULLUK north toward these hazards. This planned route denied the proper sea room necessary should a towline fail or the towing vessel experience a mechanical breakdown, particularly with no assistance or additional towing vessels onsite. Additionally, should the tow need to heave to in the event of a weather event, there was little safe water available to ride out storms.

**Figure 50:** Chart showing planned track line for towing of KULLUK demonstrating close approaches to land and other hazards. (USCG Developed)

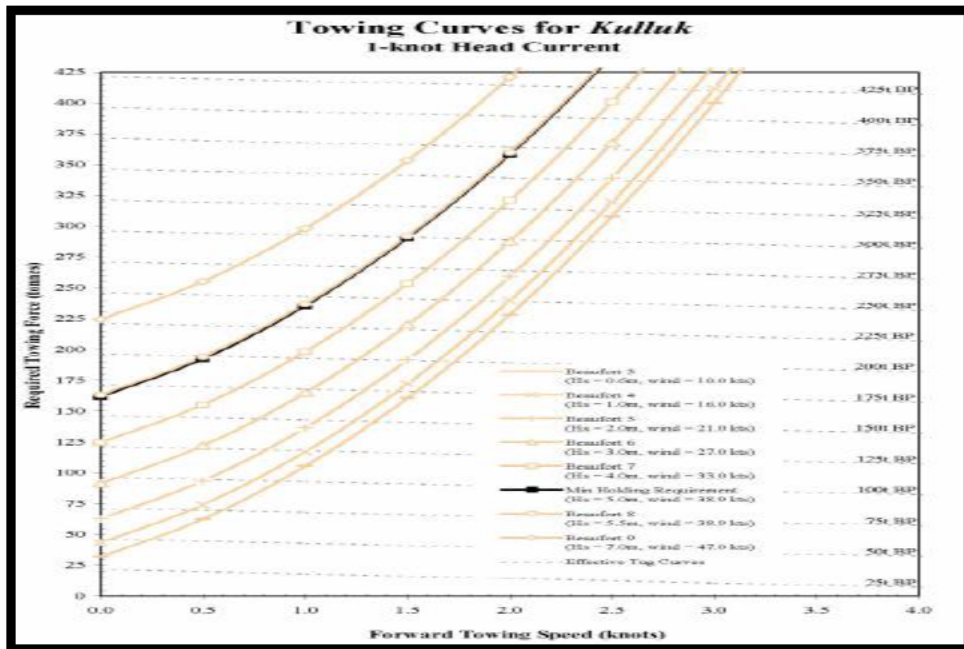
31. The 2010 study contains towing resistance curves for Beaufort 3 through 9 weather conditions. The 10% exceedance level for the December 2012 tow indicates 9.2 meter seas and 44.6 knot winds. These weather conditions are similar to Beaufort 9 storm conditions, being 2.2 meters above Beaufort 9 seas and 2.4 knots below Beaufort 9 winds. Referencing figure 52, extracted from the study, the bollard pull necessary to maintain position in a 1 knot current would require 225 tons of effective bollard pull by the towing vessel. Referencing the same document, a 200 ton effective bollard pull would be necessary under the same circumstances with no current. It should be noted that the prevailing currents along the southern coast of Alaska are out of the east, meaning that the KULLUK would most likely be towed into the current.

32. After analyzing the data, the AIVIQ would be capable of generally maintaining position with the KULLUK in tow during Beaufort 8 weather in 5 meter seas and 40 knot winds while encountering a 1 knot current, with all forces acting against the tow into the wind and seas. In weather conditions in excess of this standard, as predicted by the Metocean study, the AIVIQ could not be expected to maintain position, and would be pulled astern by the forces acting on the KULLUK. In the Alaskan maritime environment towing operations that are experiencing poor weather do at times allow themselves to be pulled astern until the weather subsides. These tow planners build sea room into the planning to allow for the weather. In the case of the KULLUK towing operation for December 2012, this would be an unacceptable risk considering the length of tow, the near shore routing, and the fact that, as the Metocean data suggests, this weather may occur over 10% of the tow transit.

**Figure 52:** Towing Curves (Tow Resistance) for the KULLUK with 1 knot head current as provided by Global Maritime 7/6/10 (Provided by Shell, Shell Alaska "Bollard pull calculations for Towing KULLUK from McKinley Bay to OSI South Reef Dock, Captains Bay, Unalaska Island, Aleutian Islands" GMH-6565-2575)

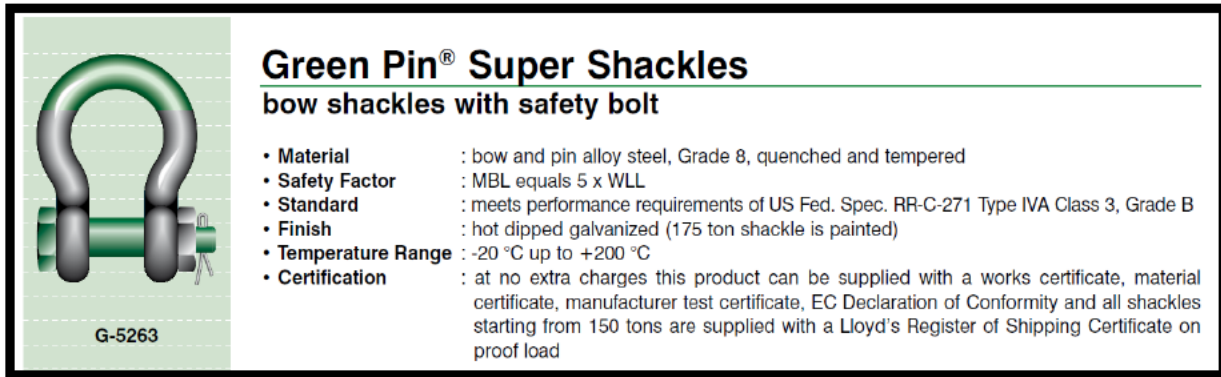
**Figure 54:** Description of Van Beest Green Pin Super Shackles from the manufacturer’s catalog. (*Van Beest product catalog available on the internet*)

38. The apex shackle that failed at approximately 1135 on December 27 has been identified as a Van Beest Green Pin Super Shackle.<sup>95</sup> It was one of six that were incorporated into the tow to replace the 85 ton shackles originally intended. As all the remaining 5 shackles were from the same "YP" manufacturing batch, it is assumed that the missing shackle is of that batch as well. During the investigation, Shell provided documentation that suggests that these "YP" batch shackles were purchased from Van Beest in 2007.<sup>96</sup> The work and usage history of the shackles could not be definitively ascertained, other than they were incorporated as part of the KULLUK towing configuration since July of 2012. Testimony suggests that these shackles may not have seen usage prior to this time.

41. The Proof Load (PL) of this shackle is listed by the manufacturer as 240 tons, or twice the WLL. The U.S. Navy Towing Manual defines the Proof Load of shackles as “the load at which no permanent deformation is observed after the load is released.” Shackles are often tested to their Proof Load prior to distribution by the manufacturer, and Van Beest conducts such tests for all Super Shackles batches prior to sale.

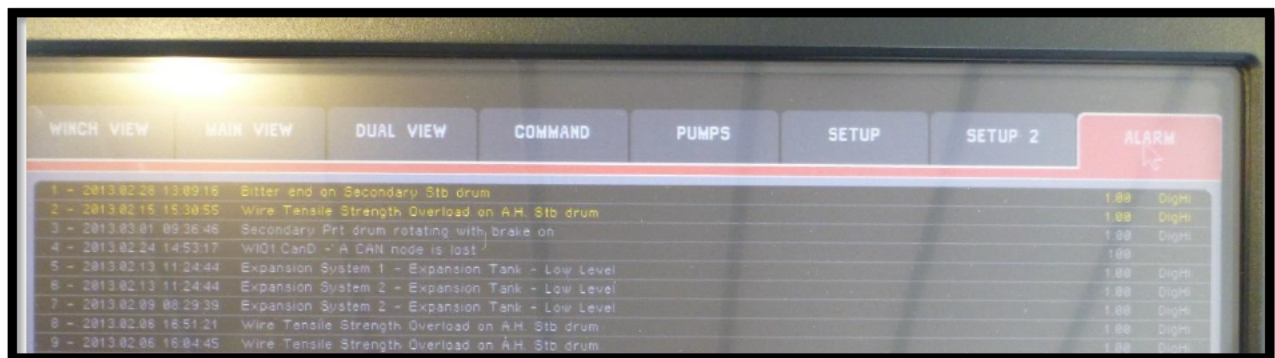
69. The AIVIQ’s towing winch system contained an advanced computerized monitoring and control system manufactured by Rolls-Royce called the Towcon RT. This system contained a means to monitor strain/tension of the towline (in Tons), tow line length, hydraulic pressure, among others, and would alarm should any of the pre-set limits be exceeded. With respect to tension monitoring, the user could easily set any strain/ tension limit by which an alarm would be activated. No user set tension settings were established, and the only high tension alarm active was a manufacturer set alarm that would activate upon reaching 50% of the tensile strength of the main tow drum. The tensile strength was set prior to the voyage at 600 tons, indicating that the alarm would activate at 300 tons of tension. See Figure 58.

Figure 59: Towcon alarm screen indicating alarms received on the bridge monitor, requiring acknowledgement of the bridge officers. Alarms indicated are for a later time period than investigation scope. (USCG Photo)

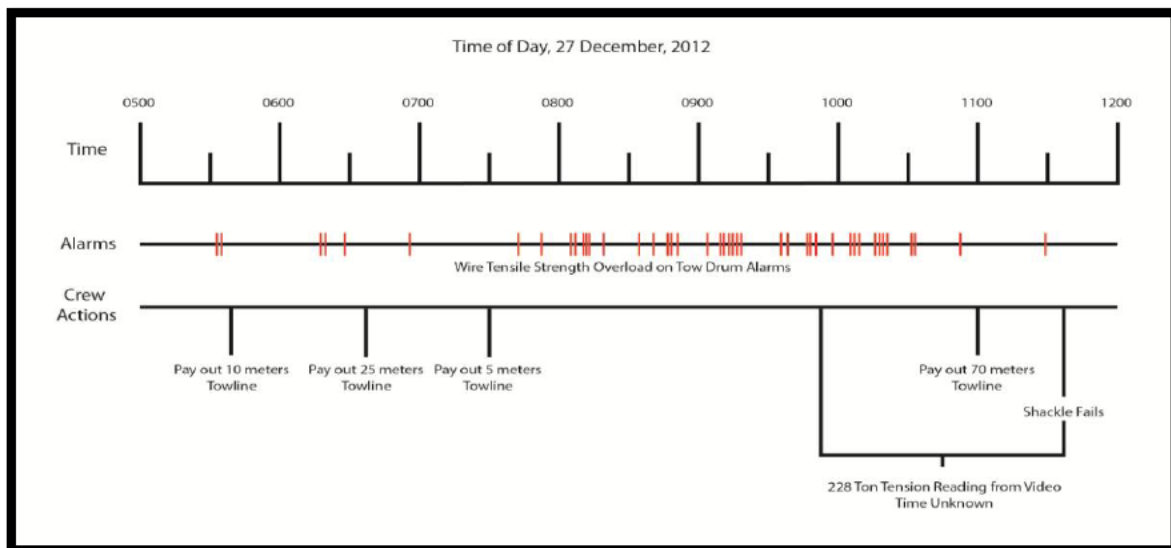
**Figure 60:** Summary of main towing drum data for the morning December 27, 2012 indicating time, alarms received towline length and shackle failure.<sup>107</sup> (USCG analysis)

78. As configured, the shackle that failed incurred the full load of the towline between the KULLUK and AIVIQ. The bridle shackles on either side of the towing plate generally shared the load. From the findings, the tow winch strain monitoring system logged 38 separate occasions during the morning of December 27 of towline loading over 300 tons. Additionally, video evidence from the 3<sup>rd</sup> Mate [REDACTED] on watch shows load fluctuations from 28 to 228 tons within the period of a few seconds, providing further proof of extreme fluctuations in the towline tension while towing the KULLUK. This event would not be logged in the towing system, so it is unknown on how many occasions the readings were high but went unrecorded as an alarm as they did not meet the 300 ton alarm threshold.

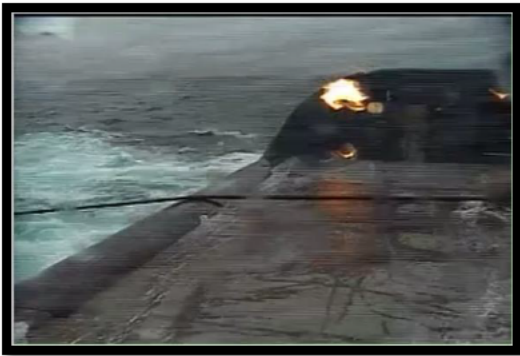
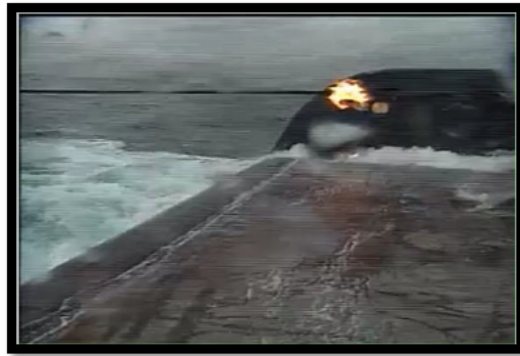
77. Examination of the CCTV aboard the AIVIQ and monitoring the towline indicates “snatching” (tensioning/loosening cycle) of the tow wire cyclically over a period of time, indicating dynamic loading to the towline and towing accessories. Periods of lower tension are indicated as the tow wire rides on the stern roller. Periods of higher tension are indicated as the

tow wire goes taut and comes off the roller and is suspended into the air above the deck. Higher tensions are also indicated by a loss of catenary between the towing vessel and tow.

**Figure 61:** Starboard aft CCTV stills showing fluctuations in towline tension. Still on left shows lower tension at 10:12:42. Still on right shows high tension at 10:12:48. (*AIVIQ CCTV Provided by ECO*)

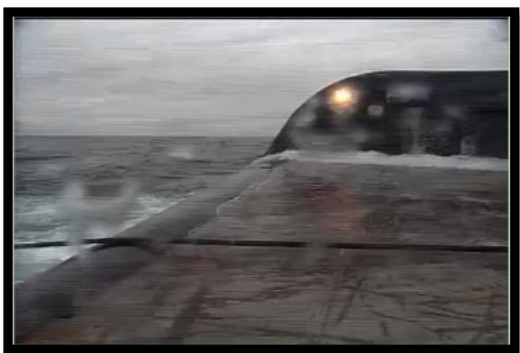
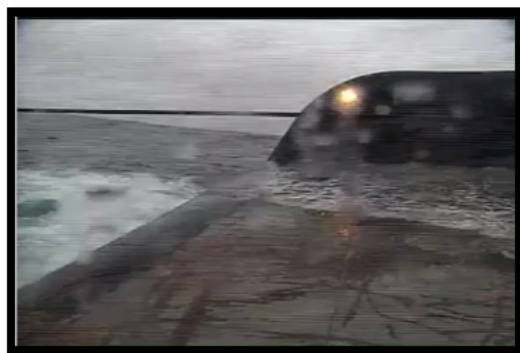
**Figure 62:** Starboard aft CCTV stills showing fluctuations in towline tension. Still on left shows lower tension at 11:17:14. Still on right shows high tension at 11:17:18. (*AIVIQ CCTV Provided by ECO*)

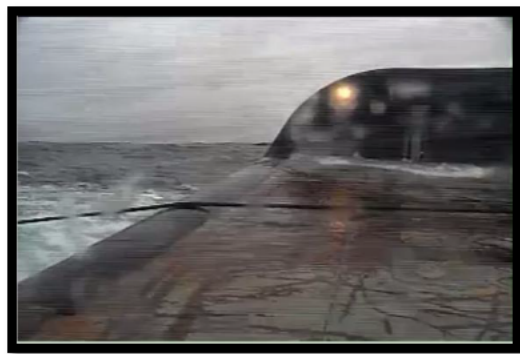
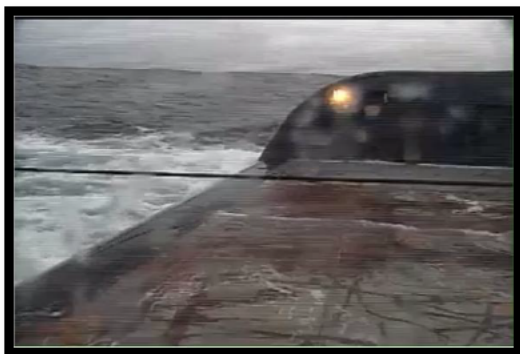
**Figure 63:** Starboard aft CCTV stills showing fluctuations in towline tension. Still on left shows lower tension at 11:31:49. Still on right shows high tension at 11:31:58. (*AIVIQ CCTV Provided by ECO*)

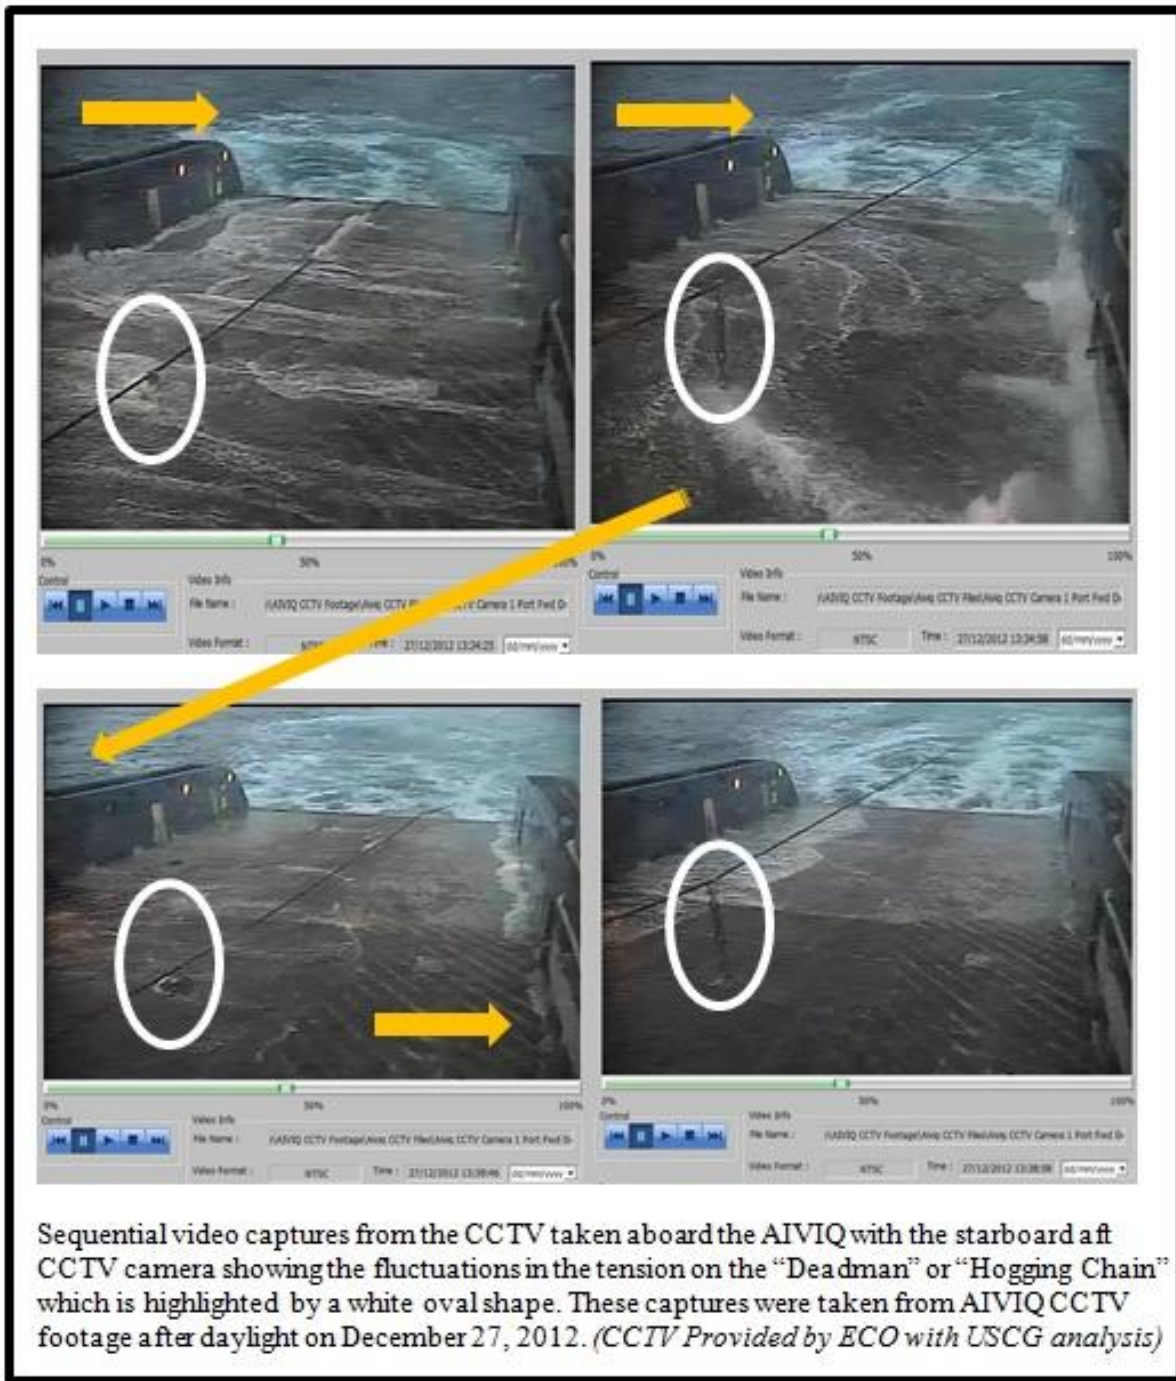
**Figure 66** – Movement of the Deadman or Hogging Chain aboard the AIVIQ on the morning of December 27, 2012.

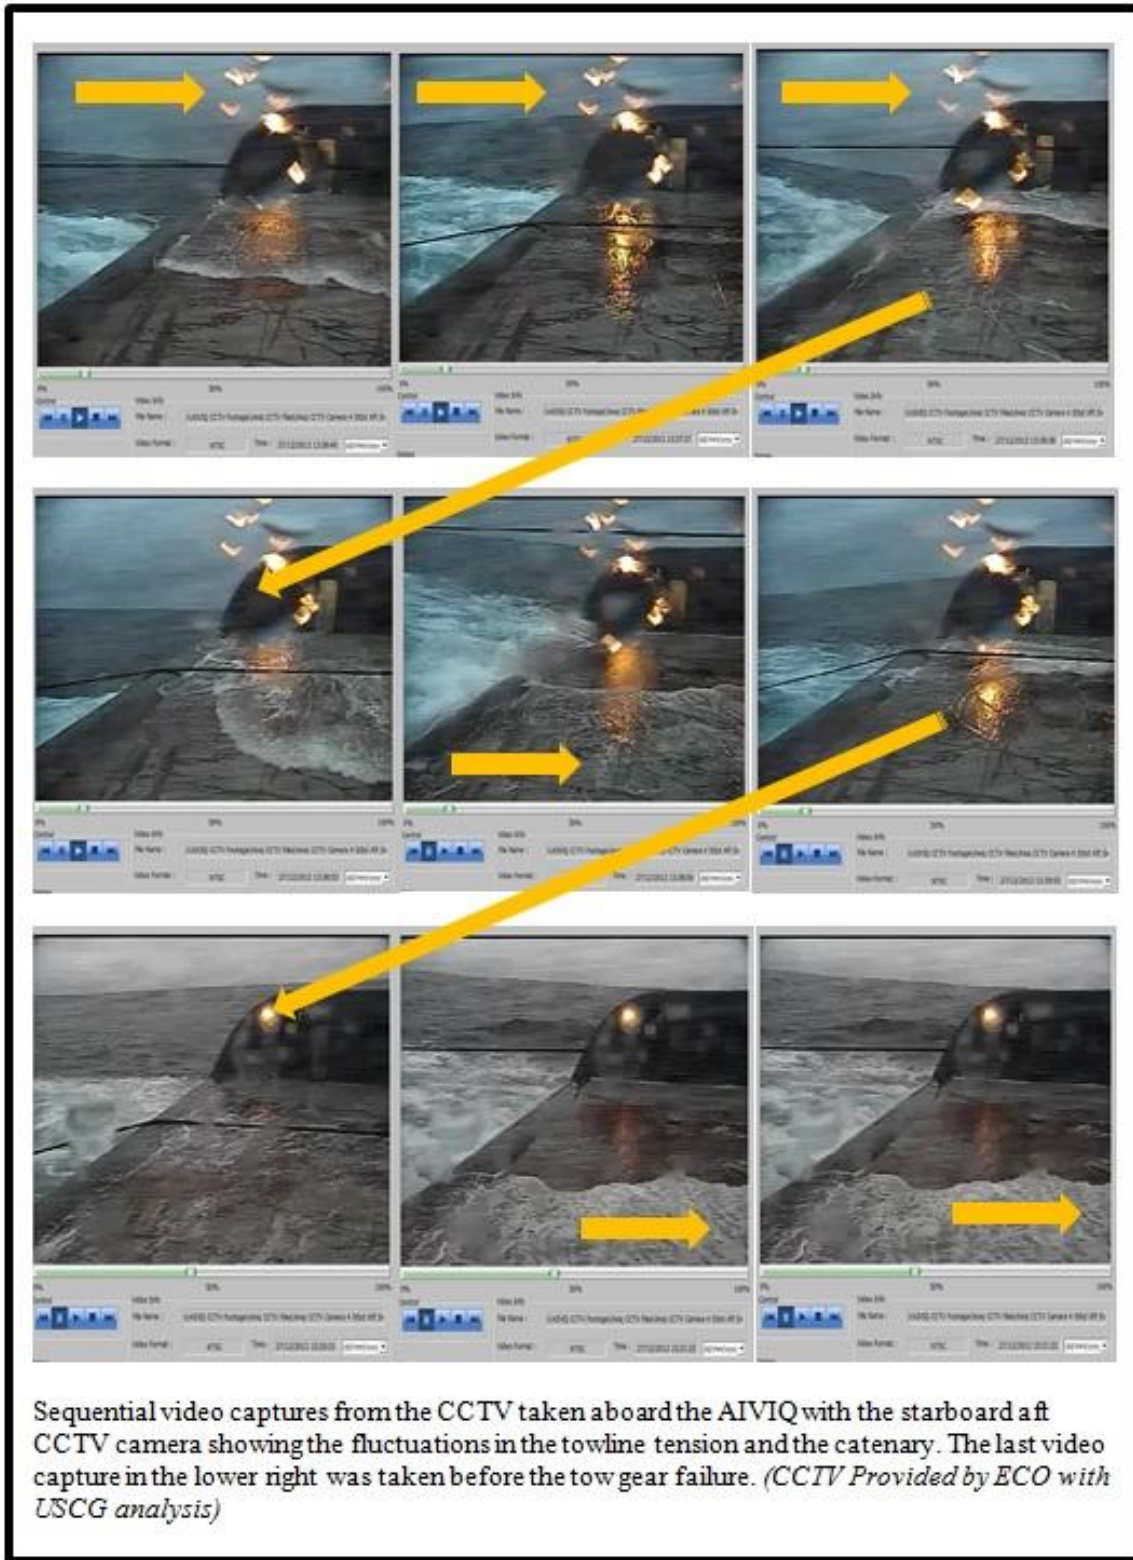
**Figure 67** – Movement of AIVIQ towline and tension on the line on the morning of December 27, 2012.

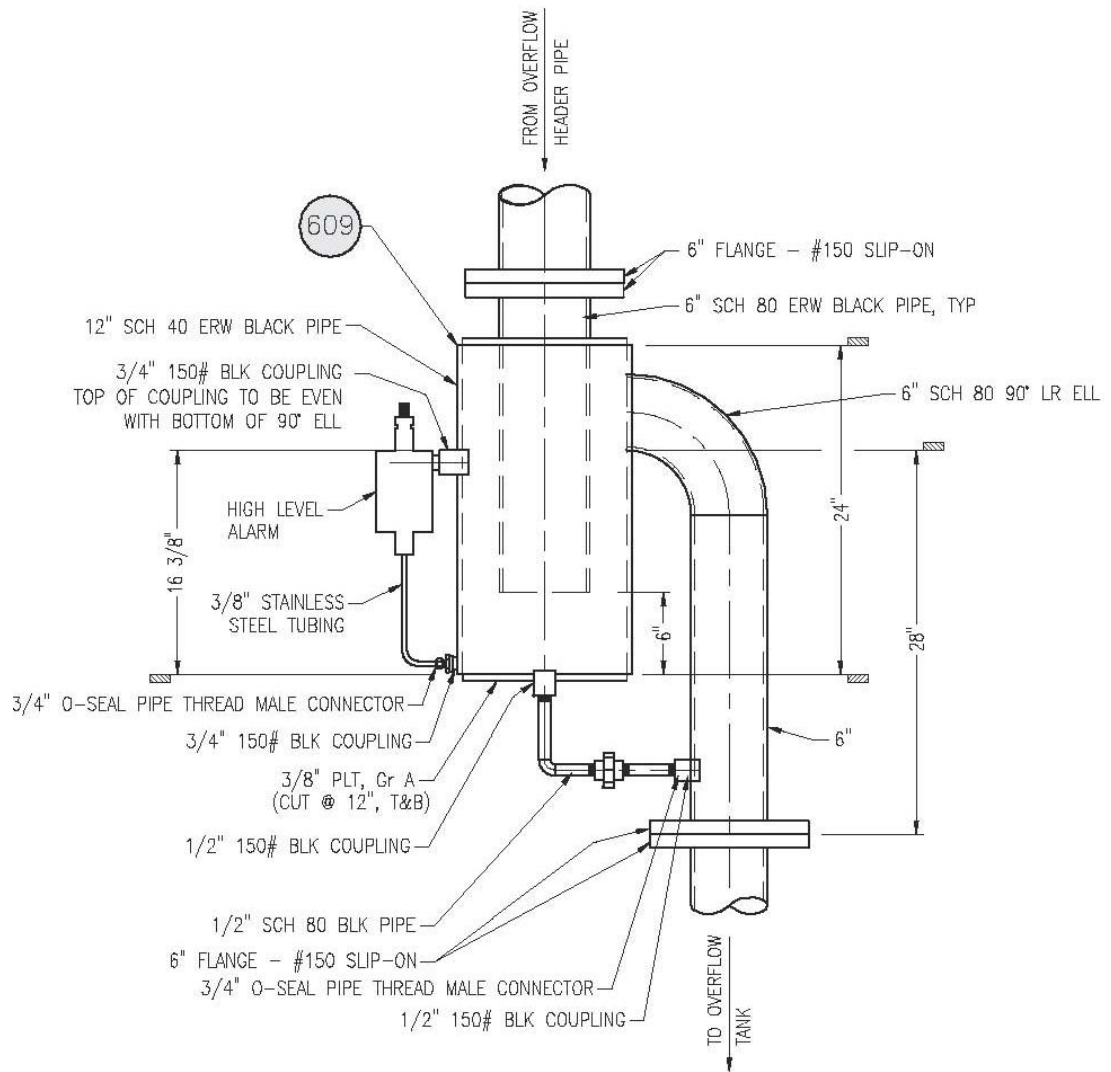
Figure 1 - Fuel Oil Overflow Alarm Sensor Arrangement (Source: reference (q))

- ii. Reference (q) shows an overflow alarm sensor arrangement (see Figure 1). The 8-inch vent/overflow headers are each reduced to 6-inch pipe prior to reaching the overflow alarm sensor arrangement. Per references (e) and (f), the crew experienced many problems with the fuel oil vent/overflow alarm system prior to the casualty.

- 08/25/2012: Reference (f) - Overflow alarm activated, found drain lines clogged on port side. Removed and cleaned.
  - 09/04/2012: Reference (e) - Cleaned P/S Overflow Collection Pipe Drains.
  - 11/21/2012: Reference (e) - Drained port overflow alarm system.
  - 12/26/2012: Reference (f) - Secured fuel overflow breaker ELP-201 Bkr 17.
- iii. In reference (c), the Chief Engineer acknowledged that the water on deck shown in a photograph during the interview was well above the height of the vent/overflow tank vents.

- iv. Reference (f) shows the circuit breaker for the fuel oil vent/overflow alarm was opened during the Midnight to Noon watch on 12/26/2012. In reference (c), the Chief Engineer indicated that during rough seas, with a full load of fuel, a certain amount of fuel would overflow into the FO Overflow Tank. If seawater entered the vent and overflow system, it would cause an overflow alarm condition.
