# UNITED STATES COAST GUARD

## **MODU KULLUK**

**ON DECEMBER 31, 2012**

**REPORT OF INVESTIGATION INTO THE CIRCUMSTANCES SURROUNDING THE  
GROUNDING OF THE MOBILE OFFSHORE DRILLING UNIT (MODU) KULLUK ON  
THE EASTERN COAST OF SITKALIDAK ISLAND, ALASKA  
ON DECEMBER 31, 2012**

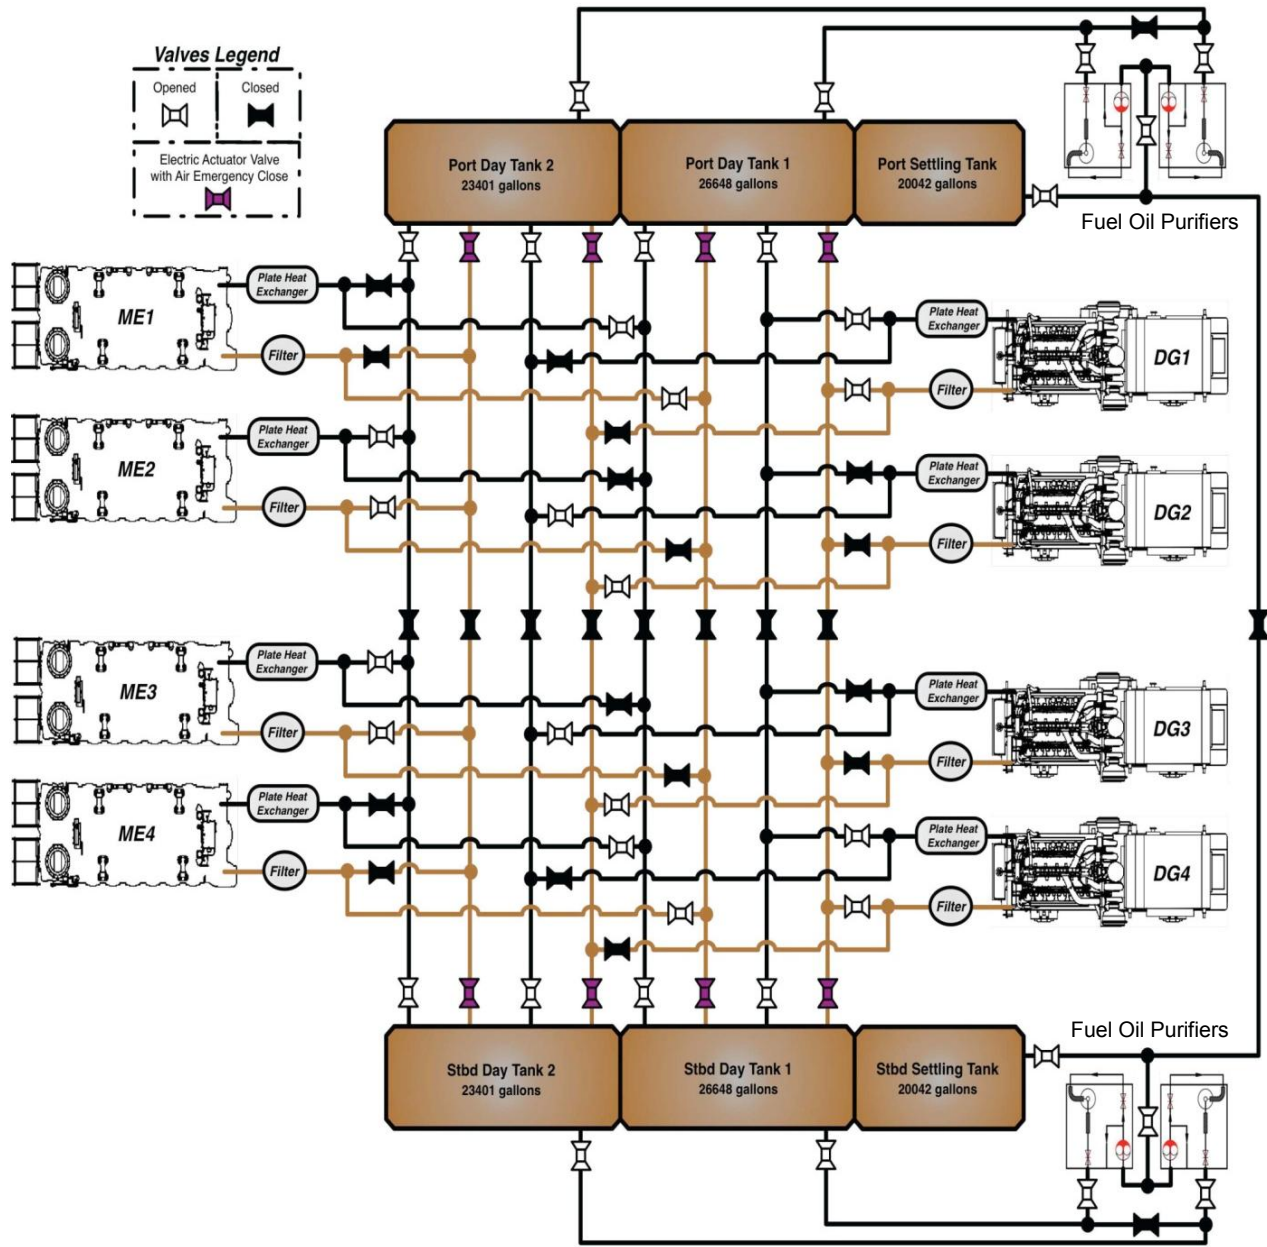
Figure 2 - AIVIQ FO Service System Diagram (Source: reference (s))

- i. Four fuel oil purifiers are installed, two port and two starboard (see Figure 2). One electric fuel oil heater is provided for each purifier pair. Fuel would be purified during transfer from the settling tanks to the day tanks. We note that the fuel oil system aboard AIVIQ lacks the ability to purify fuel oil in any of the day tanks via recirculation. While this is not required by reference (v), it is encouraged by the engine manufacturer in Figure 9 of reference (z), which shows a typical purifier installation and includes provisions for recirculating fuel oil in the day tank. It appears that the only means on board AIVIQ to purify oil in a day tank is to fill it until the fluid level reaches the overflow piping. Reference (g) shows overflow piping installed 3-inches from the top of each of the day tanks. These

- (b) Per references (r) and (s), the fuel oil service system is to be split at all times between the four fuel oil day tanks, with one main engine and one ship service diesel generator supplied by each day tank (see Figure 2). If operated in accordance with the references (r) and (s), the Worst Case Failure for the fuel oil service system (which is identified as day tank fuel oil contamination), would be limited to the loss of one main engine and one ship service diesel generator (notwithstanding cross contamination of day tanks via the fuel oil tank vent and overflow system discussed earlier).
