MARINE ACCIDENT REPORT

April 2016

CAROLINE MÆRSK

Fire in containers on 26 August 2015

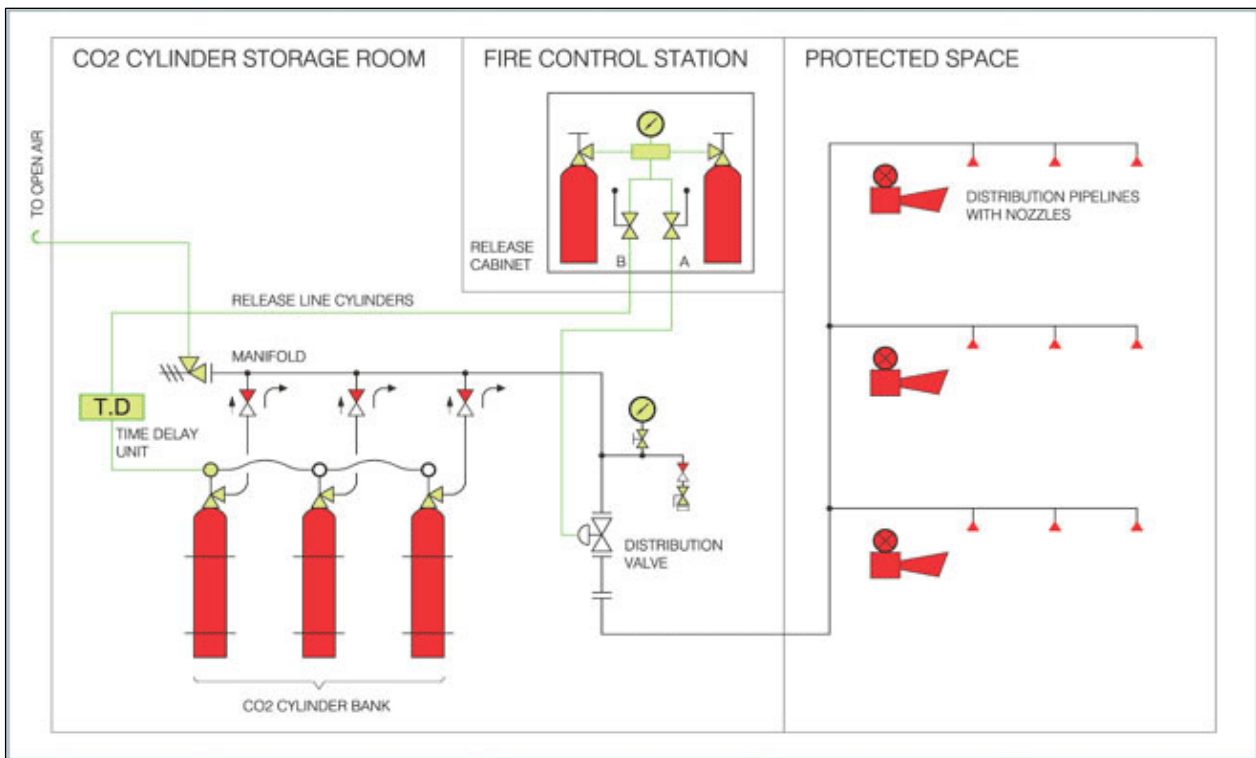
Figure 8: Principal diagram of a high pressure CO₂ system
 Source: FainKorea.com

A high pressure CO₂ system (figure 8) consists of a number of CO₂ cylinders, located in a central, separate room. The cylinders are interconnected and connected to a common manifold with main valves for distribution to the areas covered by the system, on container ships typically the engine room and the cargo holds. The cylinder valves and main valves are normally pneumatically operated by means of CO₂ gas from two smaller control cylinders, called pilot bottles. As a safety precaution, the system is manually released from a release cabinet located outside the protected space. Typically, release cabinets are located in the fire control station with an extra release cabinet in the CO₂ room. When opening a release cabinet, micro switches will ensure that CO₂ warning alarms are activated and that the ventilation is shut off. The piping and nozzle arrangement allows the CO₂ gas to spread rapidly to the protected areas.

The CO₂ system on board CAROLINE MÆRSK was place made, i.e. built into the ship during the newbuilding process. It was later modified to meet new regulations. The system was of an industry standard high pressure total flooding type. It consisted of 306 cylinders of CO₂, placed in a dedicated CO₂ room located on the starboard side of the upper deck, with a vertical access ladder from the A-deck. The cylinders were divided into four blocks of 102, 71, 87 and 46 cylinders respectively.
