Paris MoU

on Port State Control

Name:	HUANGHAI DEVELOPER
IMO:	9458444
Flag:	Hong Kong, China
Type:	General Cargo
GT:	20682
Class:	Bureau Veritas
RO:	Bureau Veritas
IMO Company:	Tianjin Xinhai Intl Ship Management
Date keel laid:	17/12/2008
Delivery date:	10/03/2013

MV "HUANGHAI DEVELOPER" IMO: 9458444 flying Hong Kong flag, arrived at Hamburg/Germany on 09/08/2016 for cargo operation, no survey or repair work was planned for the port call.

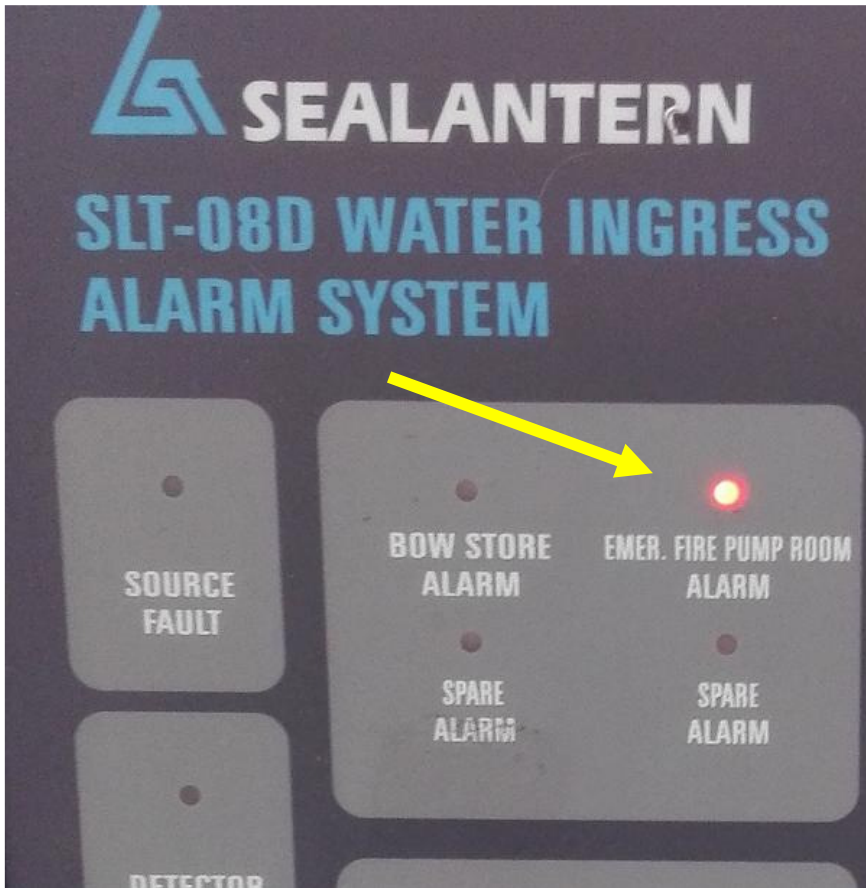
During the inspection of the WATER INGRESS ALARM the EMERGENCY FIRE PUMP ROOM was in alarm. (See pictures below)

An oily water mixture was discovered in the bilge of the emergency fire pump room (about 25cm sounded). According the bilge pumping arrangement a direct discharge to sea was possible. This deficiency was recorded with ground for detention.
