DEPARTMENT OF THE NAVY
OFFICE OF THE CHIEF OF NAVAL OPERATIONS
2000 NAVY PENTAGON
WASHINGTON, DC 20350-2000

Enclosure (1) Report on the Collision between USS FITZGERALD (DDG 62) and Motor Vessel ACX CRYSTAL

Enclosure (2) Report on the Collision between USS JOHN S MCCAIN (DDG 56) and Motor Vessel ALNIC MC

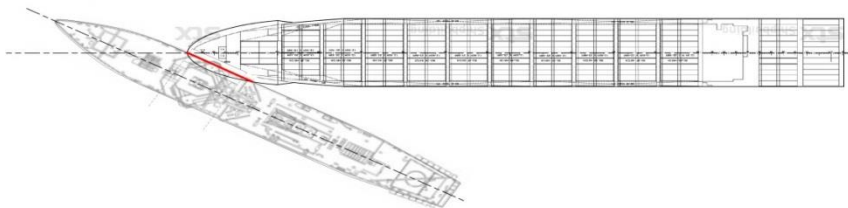
Figure 6 – Diagram of Approximate Collision Geometry

The port (left) side of CRYSTAL’s bow, near the top where the anchor hangs, struck FITZGERALD’s starboard (right) side above the waterline. CRYSTAL’s bulbous bow, under the water, struck FITZGERALD on the starboard side just forward of the middle part of the ship. CRYSTAL’s bulbous bow struck the starboard access trunk, an entry space that opens into Berthing 2 through a non-watertight door.

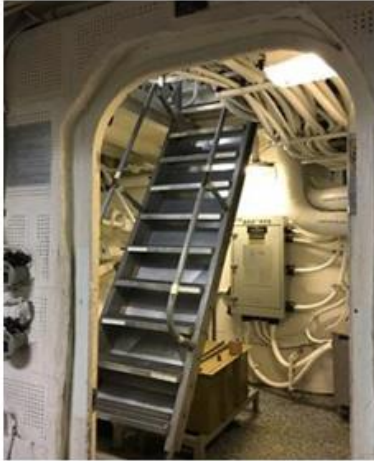
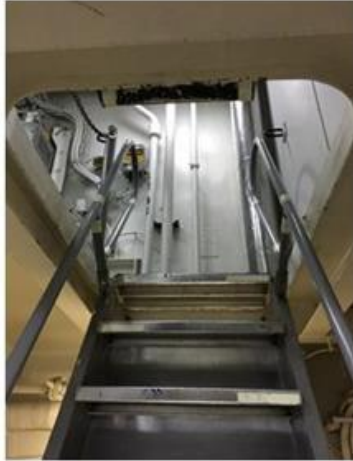
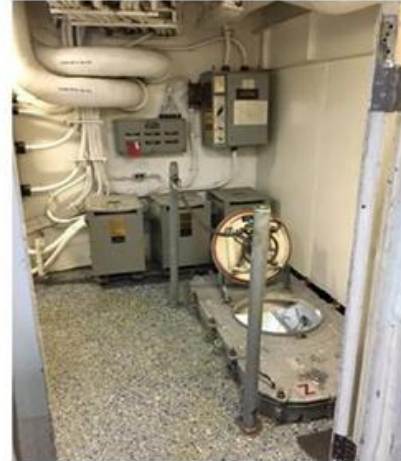
FITZGERALD. A non-watertight door leads from Berthing 2 to the starboard access trunk. In that trunk, a ladder leads up one deck into a space just outside of Berthing 1. Figures 11 through 13 are examples of the starboard side egress on a ship of the same class as FITZGERALD. There is no hatch separating the starboard access trunk outside Berthing 2 and the space above it. Also in this starboard access trunk is a hatch and watertight scuttle connected to a ladder going down to the Forward Interior Communications (FWD IC) space. FWD IC is not manned underway and has no other exits.

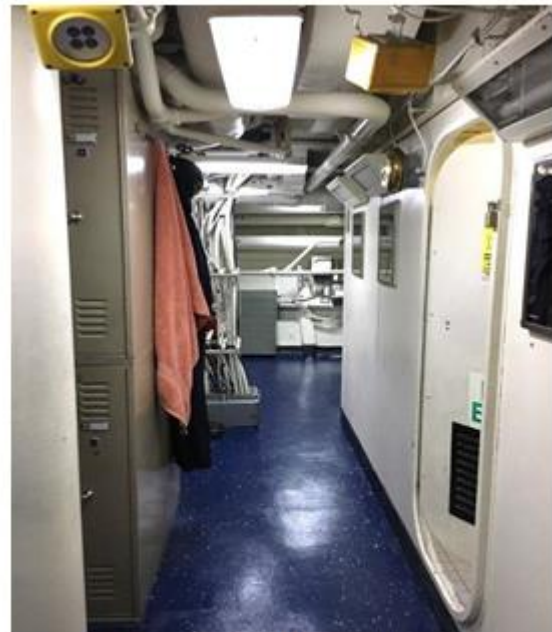
the starboard side to the port side. Many of the Sailors recall that the battle lanterns were illuminated. Battle lanterns turn on when power to an electrical circuit is out or when turned on manually. The yellow boxes hanging from the ceiling in Figure 14 are battle lanterns.

Figure 14 – Sample Berthing 2 View from Row 3 of racks to the port side (open door on right leading to head)

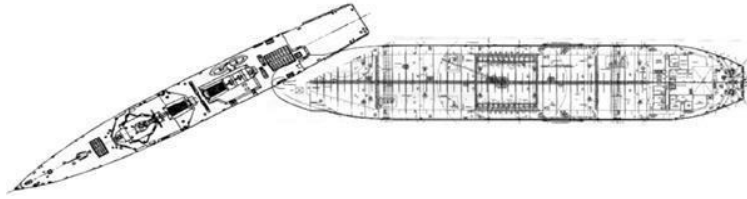
Figure 7 – Approximate Geometry and Point of Impact between USS JOHN S MCCAIN and ALNIC MC

The bulbous bow of ALNIC MC impacted JOHN S MCCAIN on the port (left) aft side. The impact created a 28-foot diameter hole both below and above the waterline of the JOHN S MCCAIN. See Figures 7, 8, and 9.

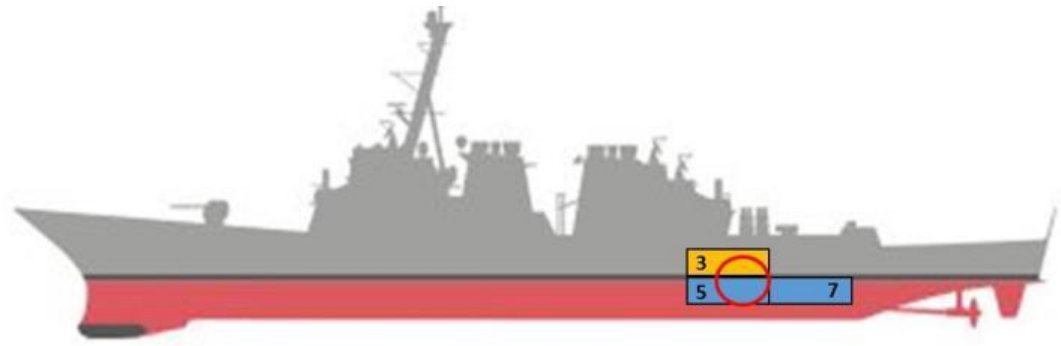
The point of impact was centered on Berthings 3 and 5 as noted in Figure 9. All significant injuries occurred to Sailors that were in Berthing 3 at the time of the impact. All ten of the fallen Sailors were in Berthing 5 at the time of impact.

Figure 10 - Depiction of Approximate Location of Point of Impact

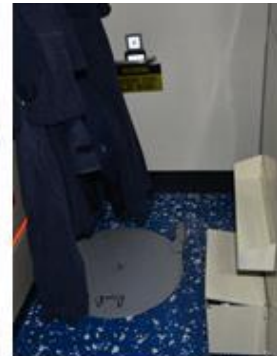
Figure 13 – Escape Scuttle from Berthing 5
Left: From within Berthing 5
Right: Above in Berthing 3

During Modified ZEBRA, the hatch is closed, but the scuttle is open for ease of access. The escape scuttle is normally closed at all times, as it was at the time of the impact. The collision knocked debris in Berthing 3 on top of the escape scuttle connecting Berthing 3 to Berthing 5 below it. This would have made any attempts to open and exit through the escape scuttle very difficult.

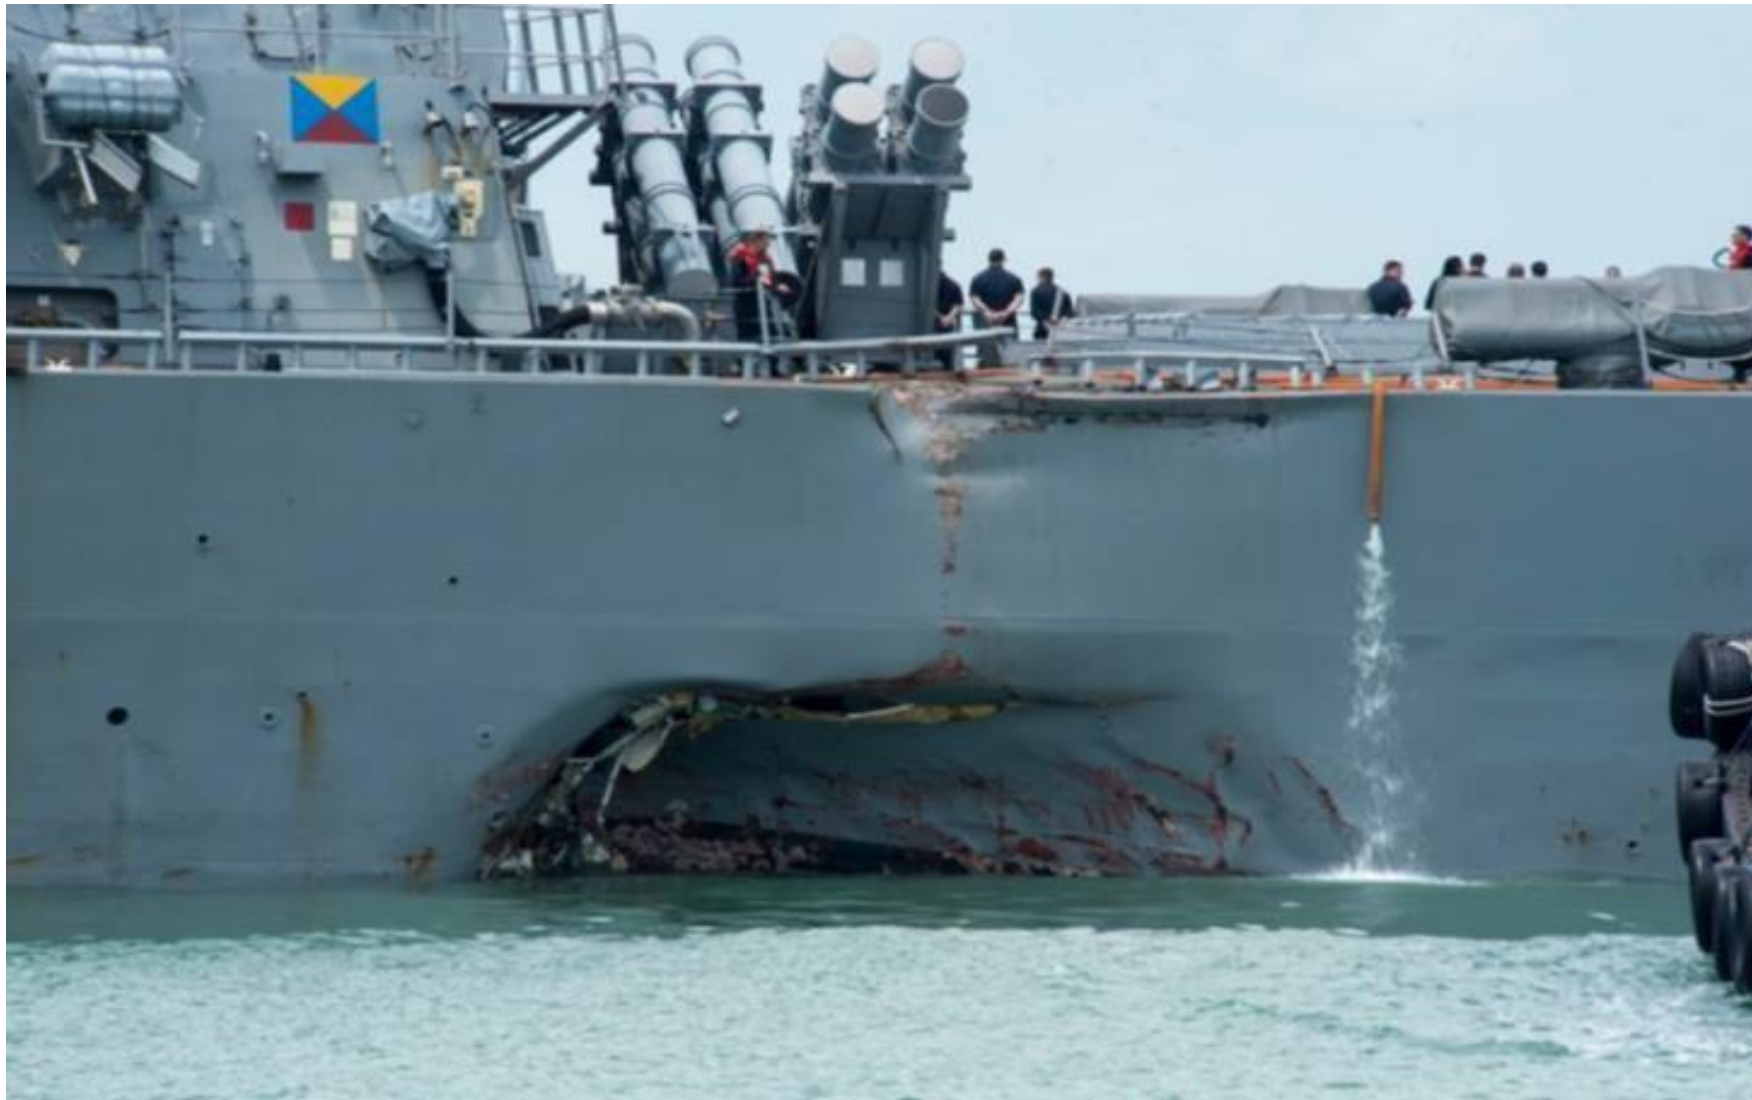
B1: Port side view of JOHN S MCCAIN post-collision

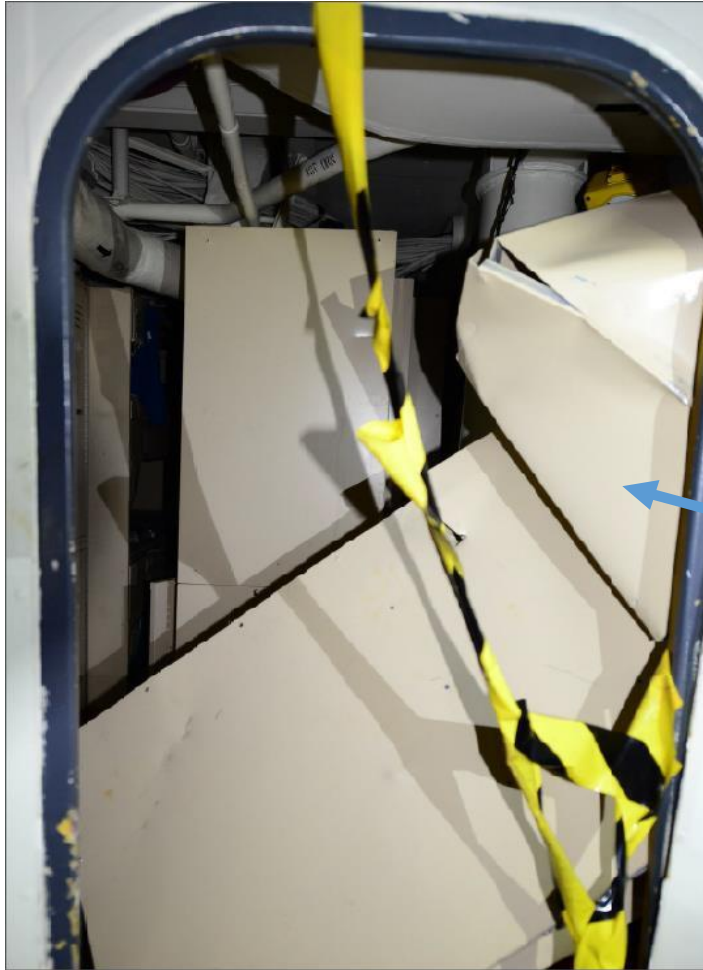
B3: Berthing 3 Primary egress (ladderwell) of JOHN S MCCAIN post-collision, with views into Berthing 3

View through hatch into Berthing 3

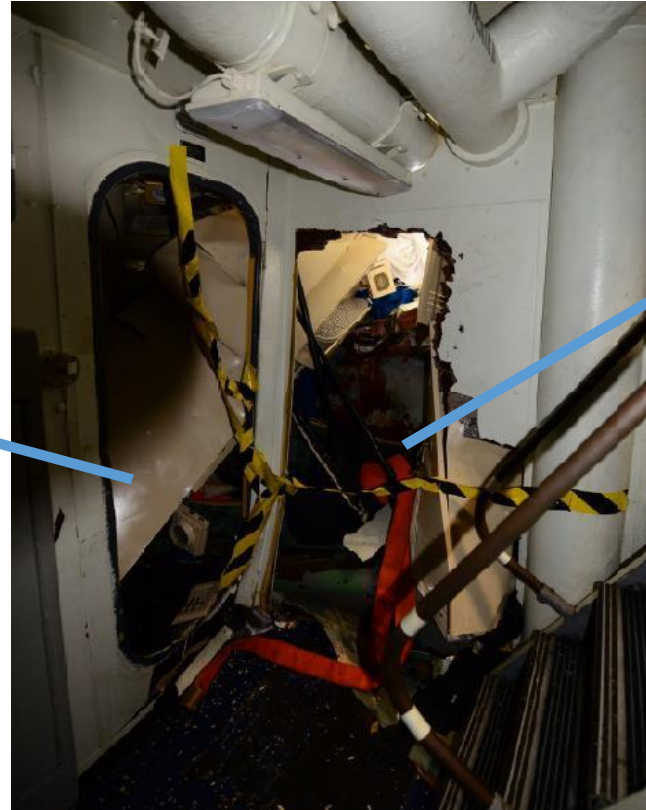
View through hole cut into bulkhead (wall)

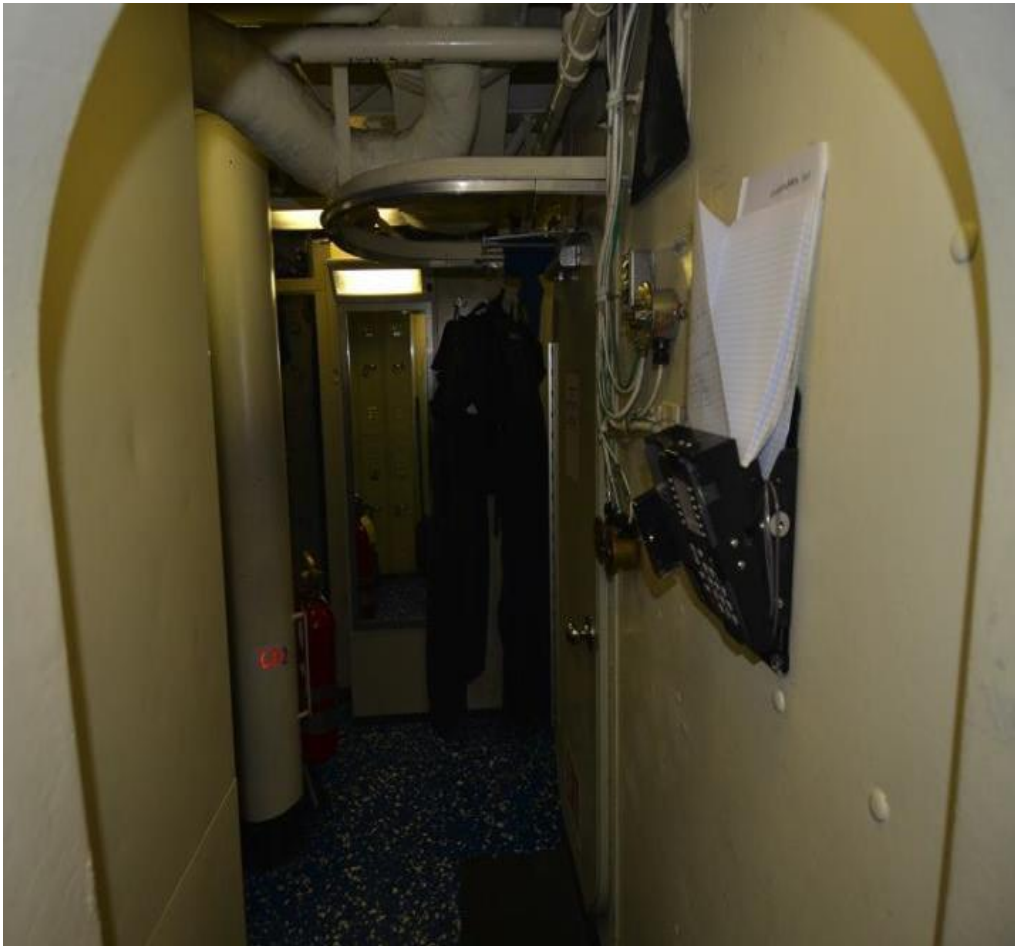
B4: View within Berthing 3, facing port (comparison)
