MARINE SAFETY INVESTIGATION REPORT

Safety investigation into the serious occupational accident on board the
Maltese registered heavy lift /pipelay vessel

PIONEERING SPIRIT

MARINE SAFETY INVESTIGATION REPORT NO. 02/2021

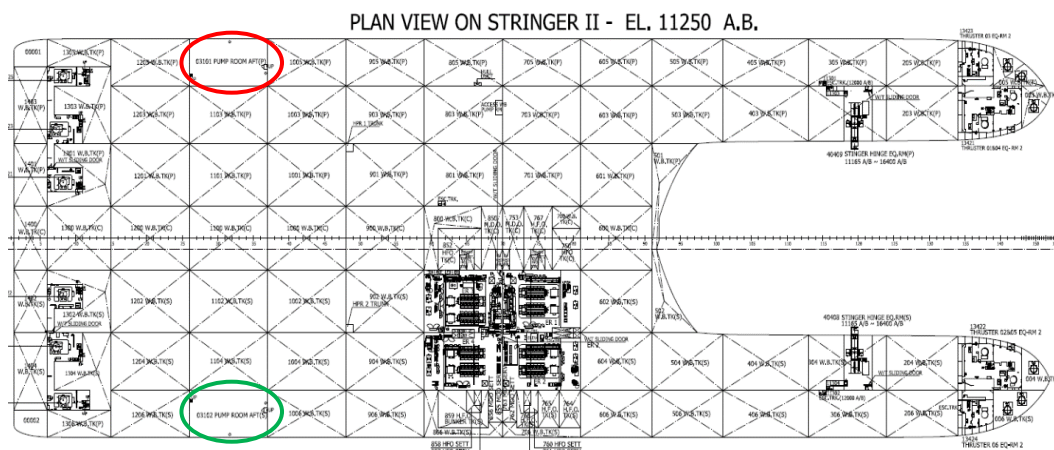
Figure 4: Extract from General Arrangement plan - Position of WBT no. 1006 marked in green and WBT no. 1005 marked in red

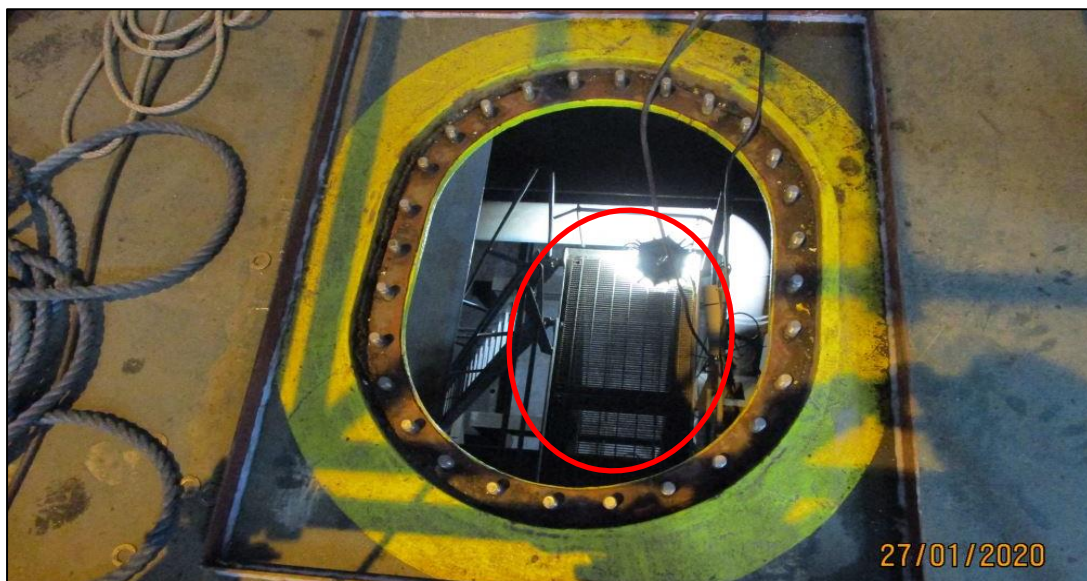
Figure 8: Access to WBT no. 1006 - First level platform with lighting installed marked

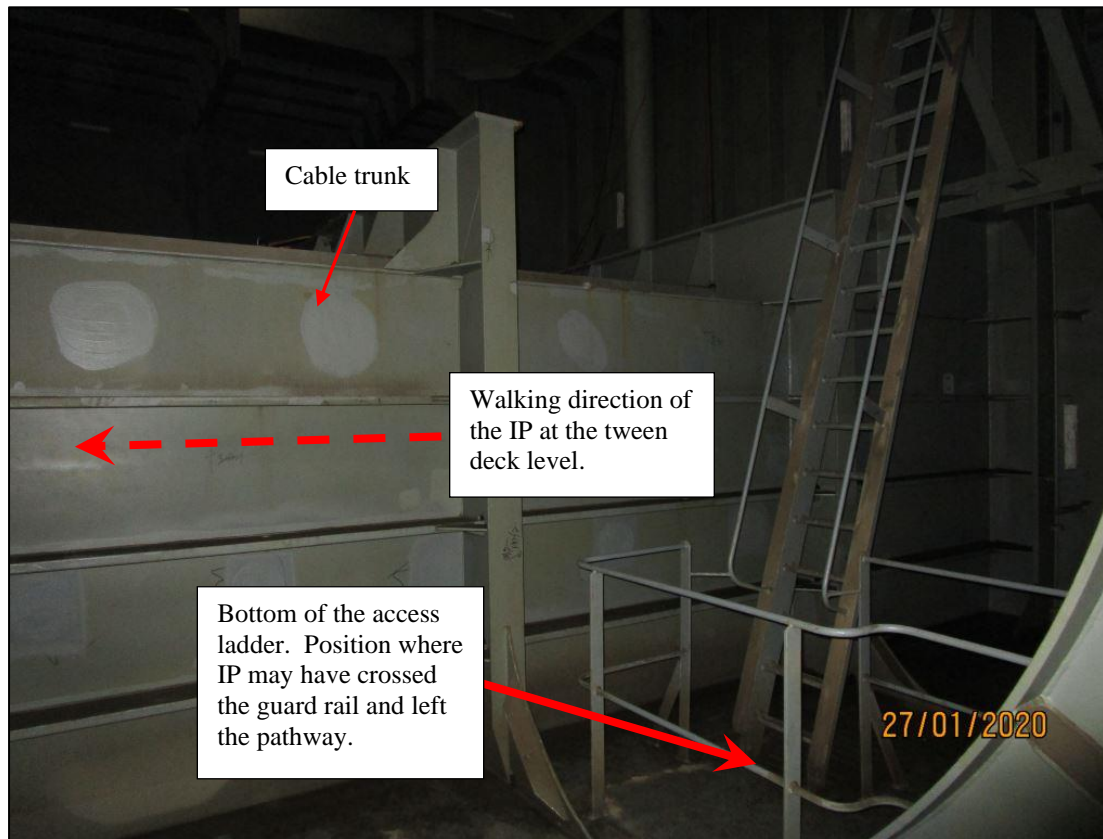
Figure 11: Access ladder ending at the tween deck

The IP deviated from the guided access inside the tank by crossing a guardrail which served as a barrier in between the access ladders and pathway, and the rest of the tank (Figure 11).. The IP fell through the opening in the deck on his way to the work site, landing on the bottom of the tank, a drop of about 16 m (Figure 15). The final location of the IP was slightly offset from the deck opening above, in an aft ward direction. This suggested that the IP was in motion and in the direction of the work site, when he fell through.
