**NOU (Norwegian Public Reports)**

**2008:8**

# The loss of the “Bourbon Dolphin” on 12 April 2007

Report from a Commission appointed by Royal Decree of 27 April 2007.  
Submitted to the Royal Norwegian Ministry of Justice and the Police on 28 March  
2008

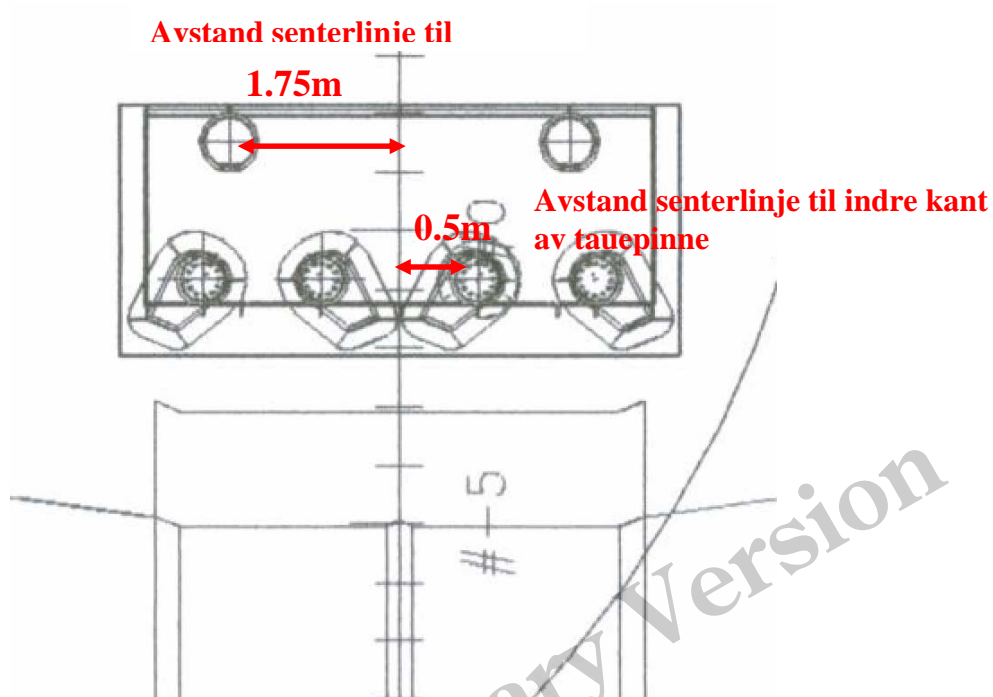
Figure 5.8 Dimensioned sketch of shark-jaws and towing-pins

It is 2.7 metres between the centre of the inner starboard pins and the centre of the outer port pins, see Figure 5.8. Shortly afterwards the “Bourbon Dolphin” listed dramatically, according to several witnesses by as much as 30 degrees to port. This lasted about 15 seconds before the vessel righted herself again. The Chief Engineer thereafter warned the bridge that the starboard main engine had stopped. There was

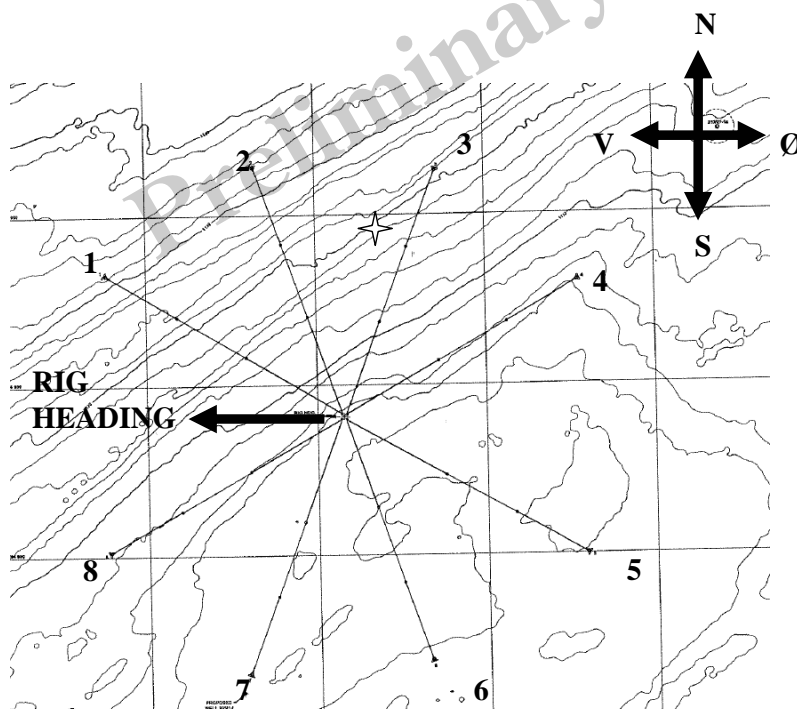
Figure 6.3 The mooring pattern of the "Transocean Rather"

Mooring lines 6 and 2 run diagonally out from the rig at the same angle as the prevailing north-easterly current (the Gulf Stream) in the area, confer Figure 6.3. The challenges of forcing a lateral current are thus direct comparable for the two mooring lines. Experience gained in deployment of anchor no. 6 will therefore be relevant to deployment of anchor no. 2.

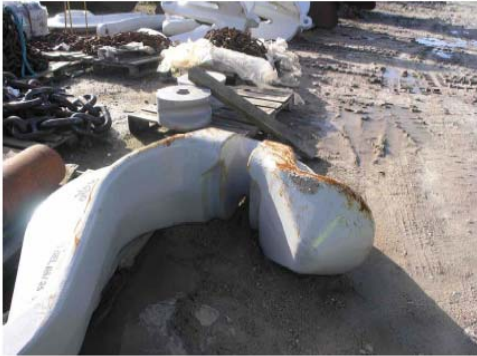
**Figure 6.4 Lockable J-chaser**

After the mooring at Location G commenced, the players began their preparations for the move to Location I. Trident's Sean Johnson testified before the Commission that they gained some experience from the move to Location G. Among other things the chasing system did not work, so that they had to use J-chasers, see Figure 6.4. Because of the forces and weight during deployment of the anchors at Location G, there were problems with the winches on the rig. The problems that arose were not with the tension, but with the winches' dynamic braking system, which was not

dimensioned for the weight of the extra chain. On this rig move they burnt out a set of disc brakes while running out chain. More information on the winch problems during the rig move to Location G will be found in Annex 1, Section 3.7.

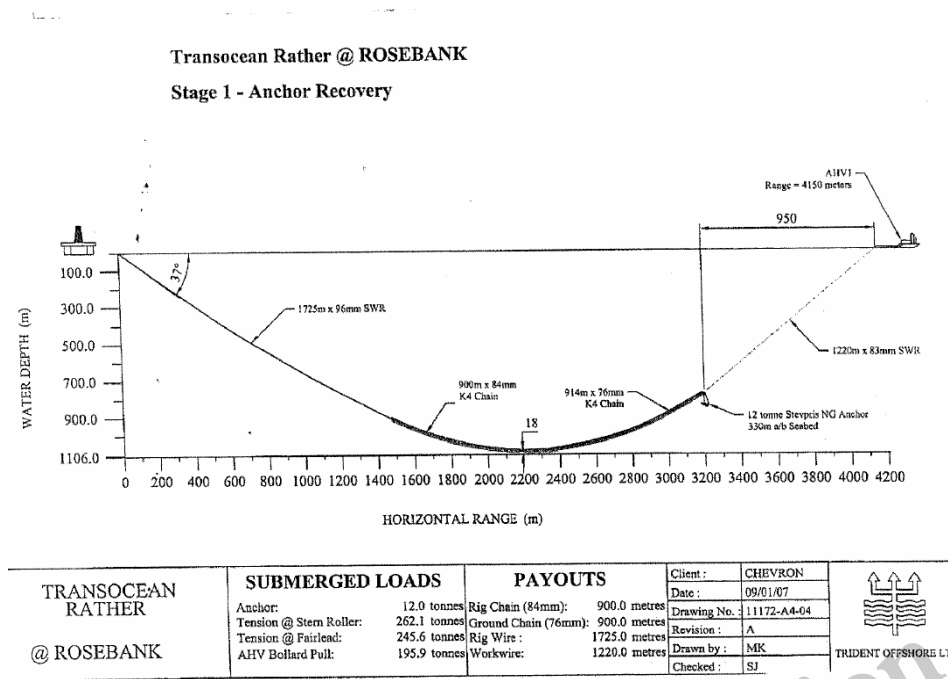
**Figure 6.7 Anchor recovery -- Stage 1**

For the recovery analyses, stage 1 (see Figure 6.7) resulted in the greatest forces. Forces due to the weight of just the mooring lines were 262 tonnes at the vessel's stern, which resulted in a necessary bollard pull of 195.9 tonnes. In addition to these forces, calculated total external weather forces due to wind, current and wave drift were calculated at 10.9 tonnes in a head sea and 48.8 tonnes in a lateral sea. The static forces were calculated for maximum waves of 4.0m with a period of 8.5s, current speed of 1.0m/s and wind speed of 10m/s. Current against the mooring lines was not taken into account in these calculations, as confirmed in the Commission's questioning of Martin Kobiela.

According to the simplified dynamic calculations, one would then see forces up towards 318 tonnes on the vessel’s winch.

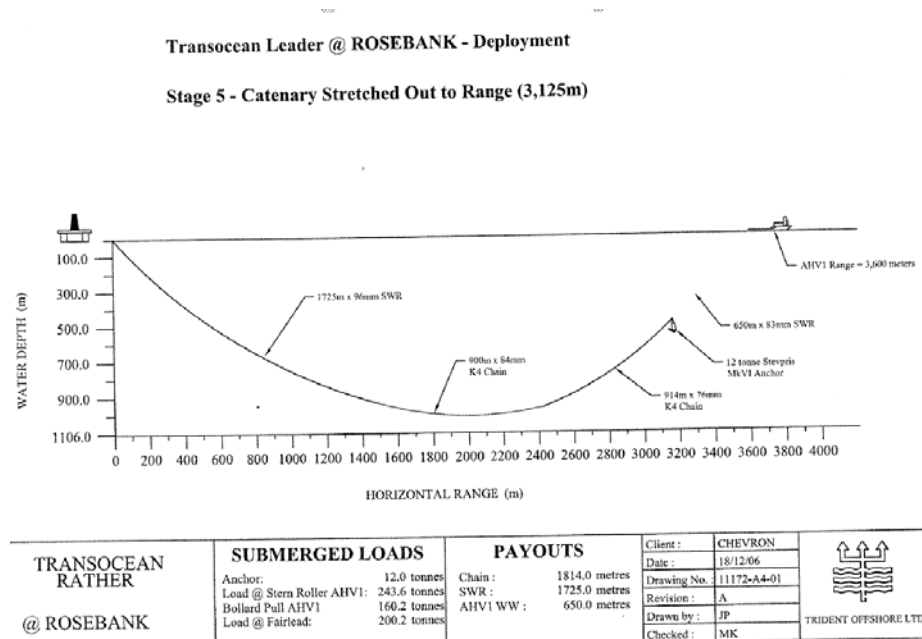
**Figure 6.8 Anchor recovery – Stage 5**

For the deployment analyses, step 5 (see Figure 6.8) resulted in the greatest forces. Forces due to the weight of just the mooring lines were 243.6 tonnes at the vessel’s stern, which resulted in a necessary bollard pull of 160.2 tonnes. In addition to these forces, total external weather forces due to wind, current and wave drift were calculated at 10.9 tonnes in a head sea and 48.8 tonnes in a lateral sea. The static forces were calculated for maximum waves at 4.0m with a period of 8.5s, current speed of 1.0m/s and wind speed of 10m/s. Current against the mooring lines was not included in these calculations.

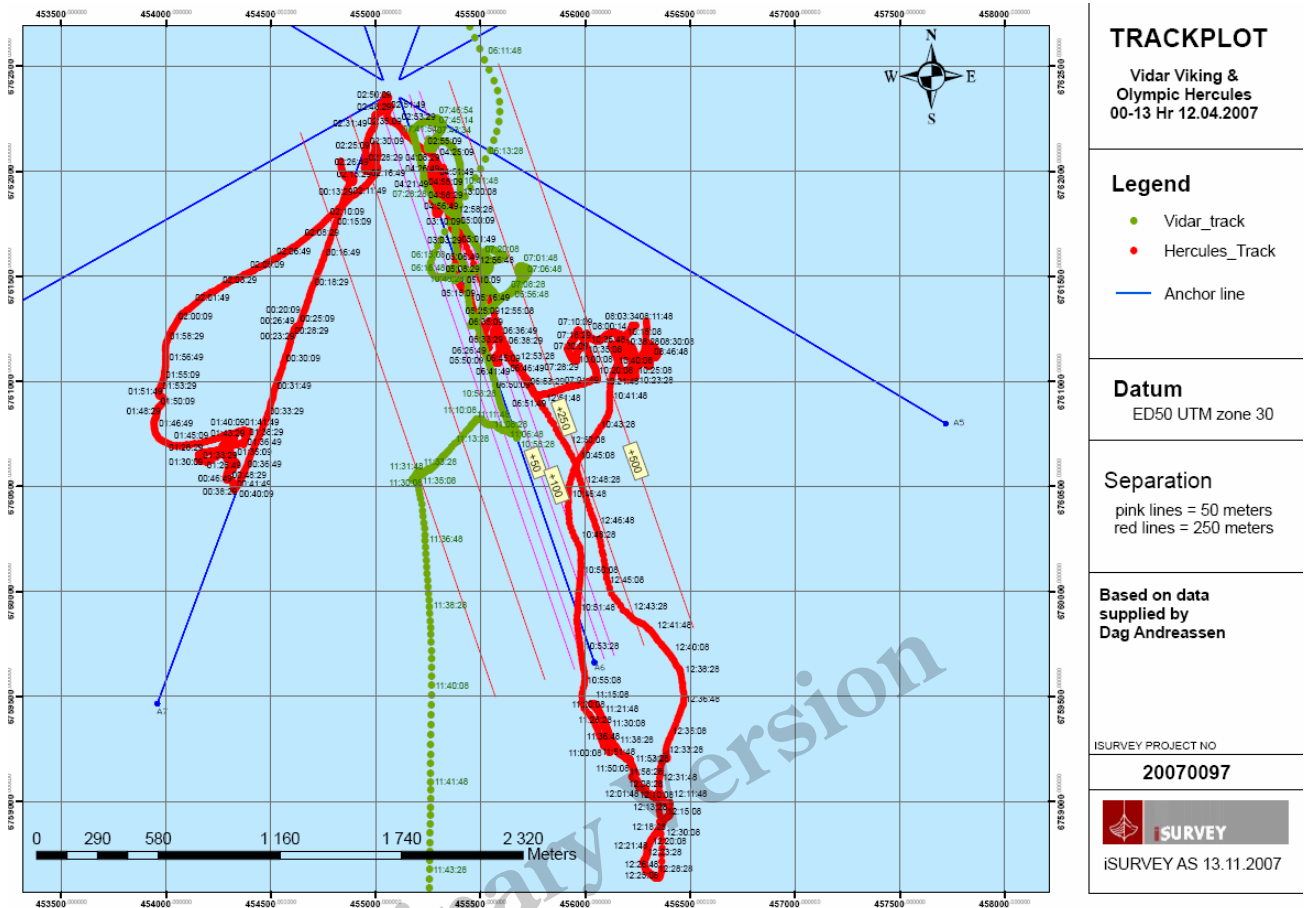
Figure 9.1 Trackplot for deployment of anchor no. 6

When the rig slacked off the wire, the vessel obtained propulsion in the water and could make use of her rudder. By giving starboard rudder and full speed ahead and use lateral thrusters, Bergtun managed to manoeuvre the "Olympic Hercules" back against the current and up to the line. He testified that, due to the weight of the chain and the manoeuvring, then listed up to 12 degrees to starboard. According to the testimony the chain shifted between the outer towing-pins.

The "Vidar Viking" went off the chain at 11:19. At 12:30 anchor no. 6 was deployed on the seabed in the correct position. The "Vidar Viking" was then allowed to leave the field.

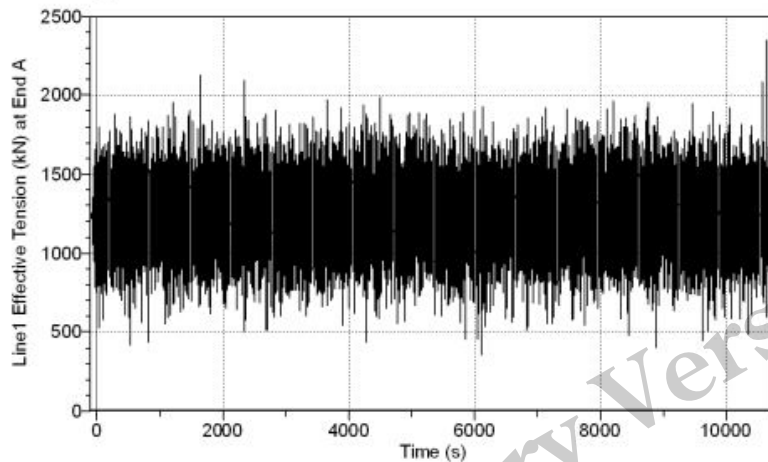
Figure 9.8 Line loads

The analyses show that there is a mean force of 126 tonnes with a standard deviation of 22 tonnes, see Figure 9.8. The vertical component of this force is 100 tonnes and the horizontal component 78 tonnes. The tensions in the simulation vary between 35 and 240 tonnes. As seen in Figure 9.8, the forces vary between 80 and 180 tonnes most of the time. The tension variation has a period corresponding to the waves, confer Section 9.5. This is in conformity with observations made by First Officer Syversen, who stated that he could read tension off the winch as 80 and 180 tonnes during the deployment of anchor no. 2.

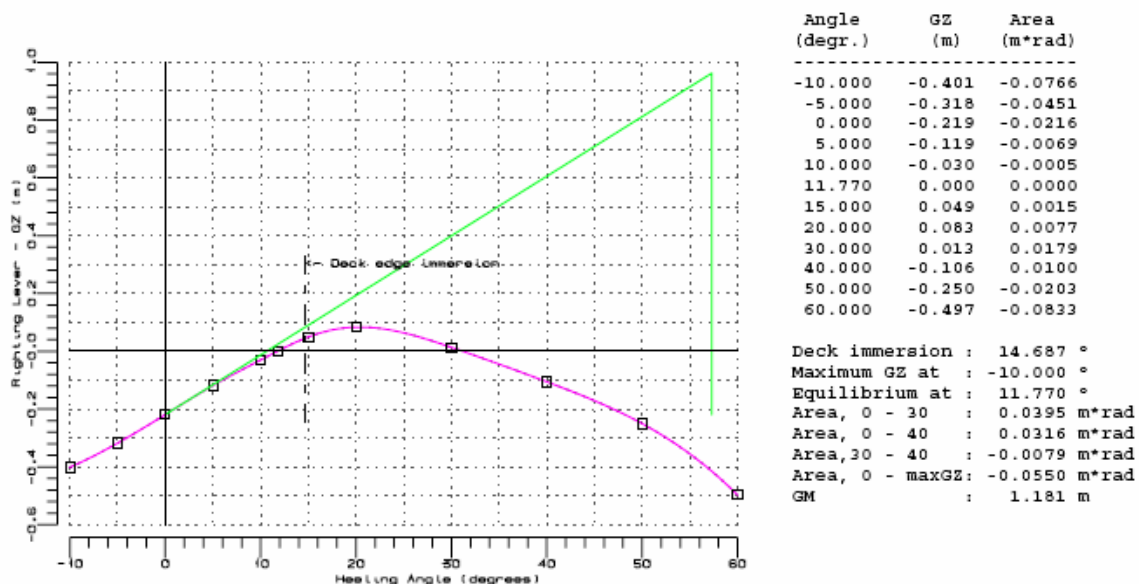
Figure 9.16 Correcting and heeling arms for load condition 3.2 after towing-pin is depressed, 60° angle of attack, 180 tonnes tension

We see from the calculations that with an angle of attack of 60°, the list angle is 11.8°. The GZ curve for this situation is shown in Figure 9.16. See also Annex 1, Section 1.12 (pages 21-25). This GZ curve means that the vessel should have sufficient stability to tolerate the maximum tension of 180 tonnes even with an angle of attack of 60°, taking into account that the vessel is lying with a permanent list angle of 5-7° with mean chain tension.
