Report on the investigation of
a fatal accident
during a vertical chute evacuation drill
from the UK registered ro-ro ferry
P&OSL Aquitaine
in Dover Harbour
on 9 October 2002

Marine Accident Investigation Branch
First Floor
Carlton House
Carlton Place
Southampton
United Kingdom
SO15 2DZ

Report No 18/2003
July 2003

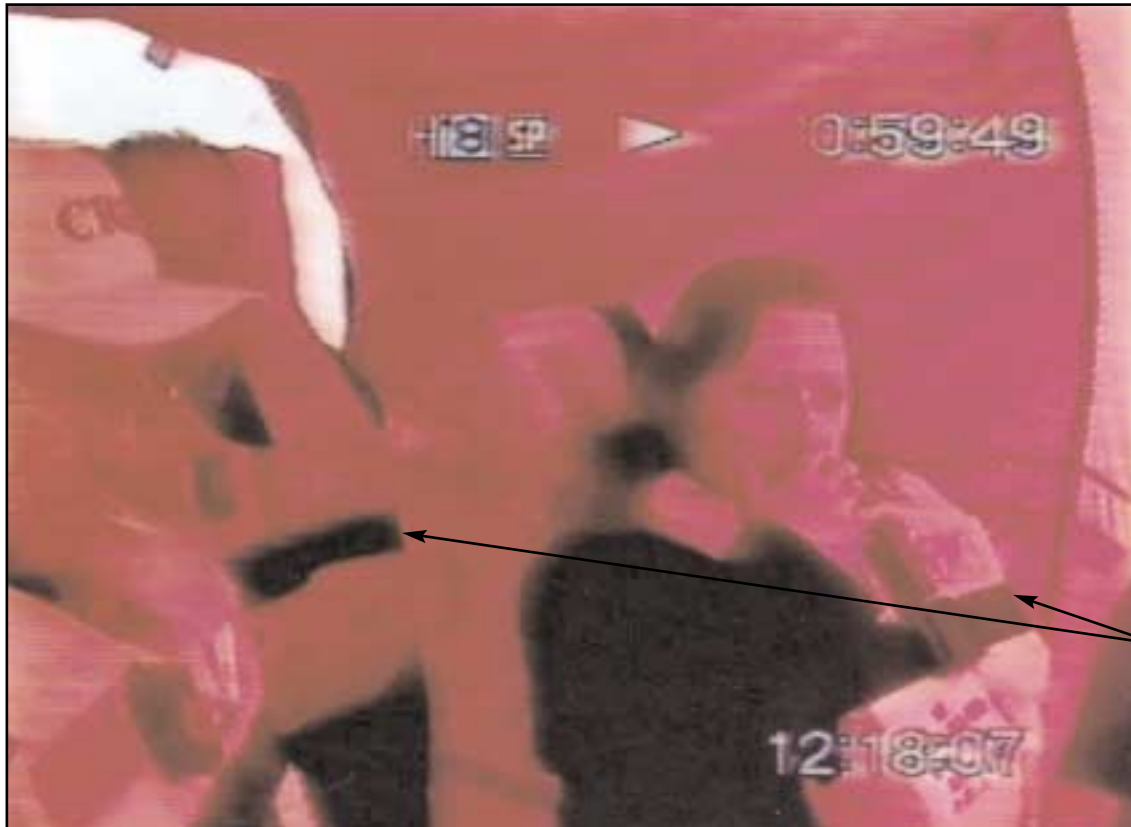
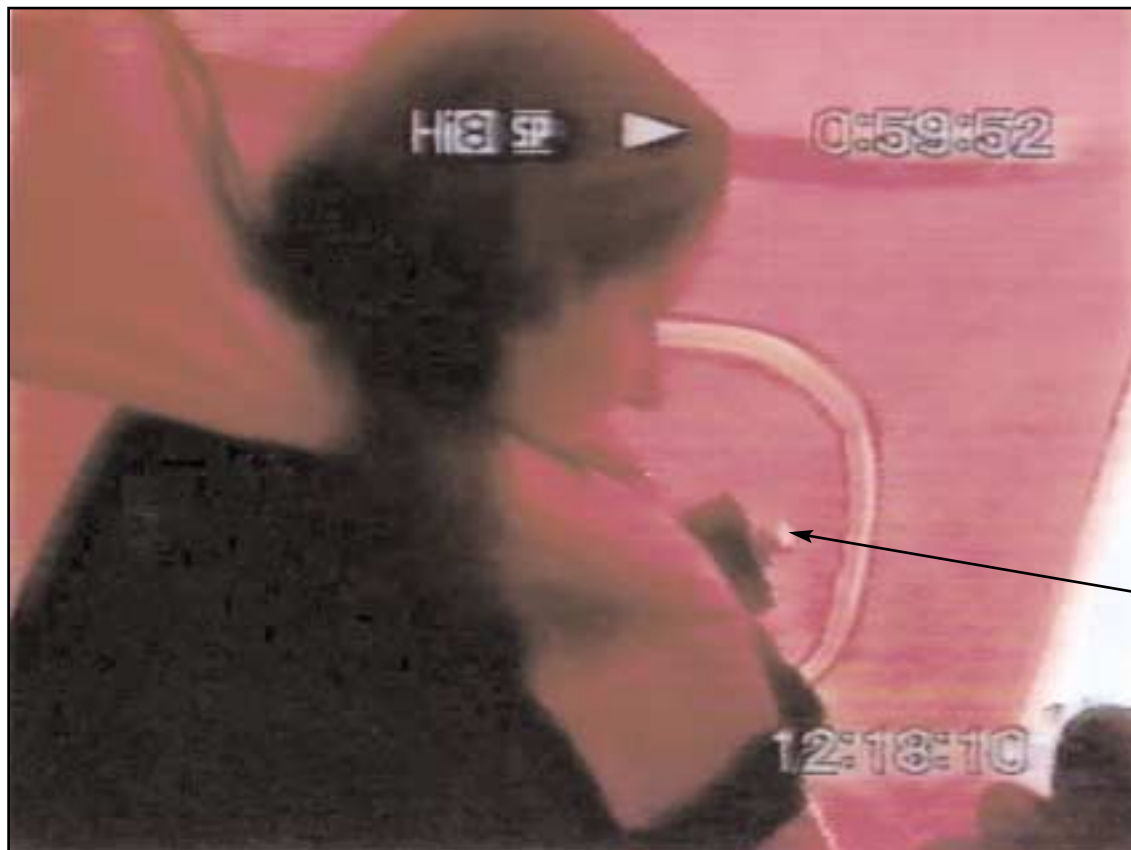
Photographs 3a and b

Mrs McCabe-Jones waiting in the queue near the top of the chute

Mrs McCabe-Jones entered the top of the chute with the front of her lifejacket projecting out, because of the type of lifejacket she was wearing and also her body shape. The video recording shows the webbing restraining strap secured quite high up towards her neck compared with other people (**see photographs 3a and 3b**).

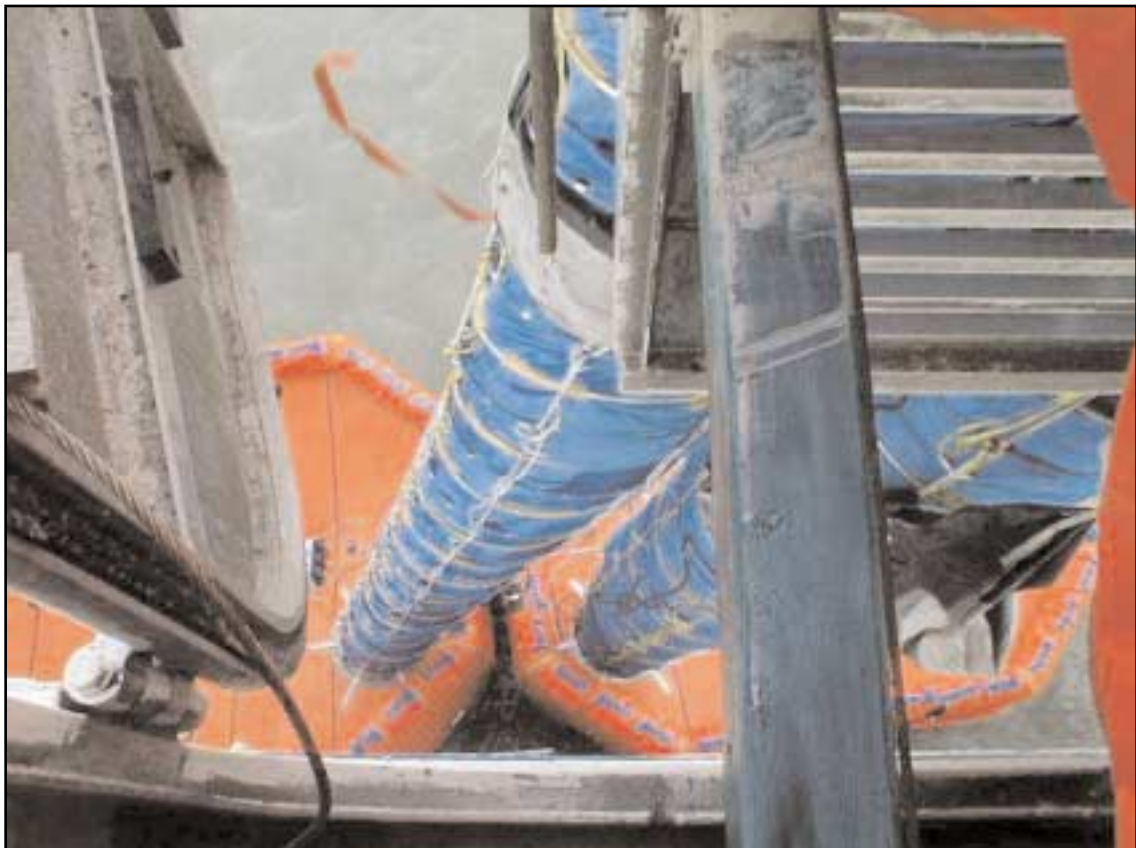
Photograph 4

When the sweeper found Mrs McCabe-Jones again, he looked out through the gaps in the chute's outer wall and saw that they were well down the side of the ship, and near the top of the liferaft (**see photograph 4**). He called for someone to cut Mrs McCabe-Jones out of the chute.

Looking down from the assembly station to the top of the liferafts

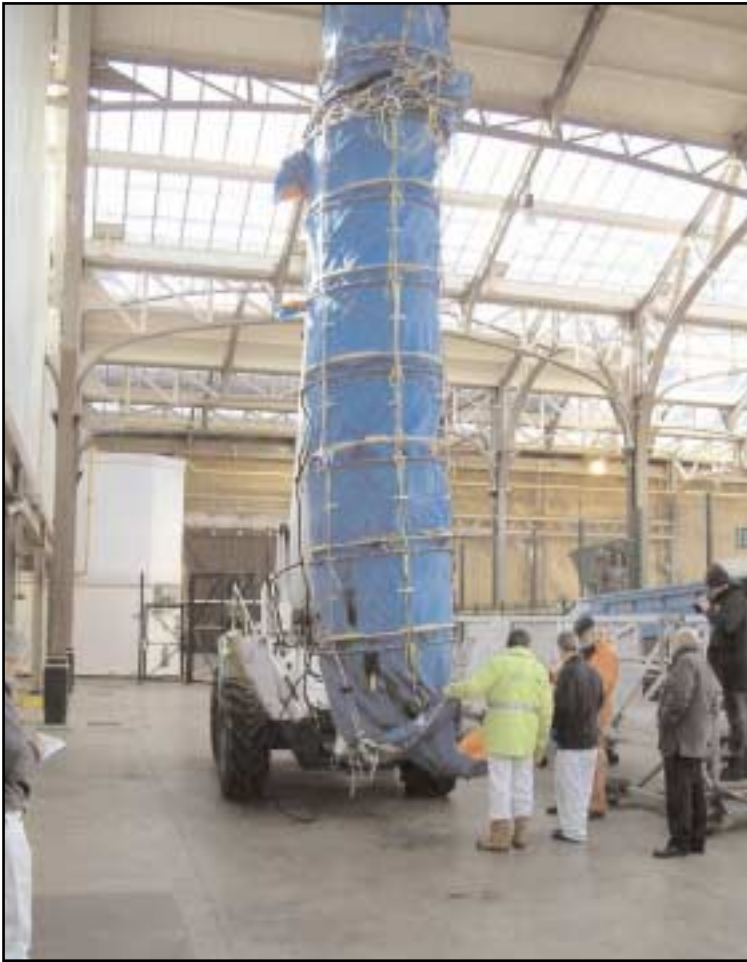
Photograph 6

- Vertical cuts were found in the external walls of cells 1 and 2. These were made by one of the RFD representatives during the rescue attempt.
- Cuts were also found in the elasticated sections of the socks in cells 3 and 4. These were also made by a rescuer.
- A vertical tear was found in the whole vertical length of the sock in cell 14, which is very near the top of the chute.
- The top of the slide path section in cell 4 had not been completely stitched during manufacture, and was not in compliance with RFD's specifications.
- Fraying of the woven nylon material at the bottom of a number of socks was found, but only at cell 1 was a stirrup¹ found.
- The inside of the chute was in good condition.
- The stitching of a number of the yellow mid hoop supports had partially, or totally, come undone.

The actual chute used in the drill hoisted up by crane for the inspection

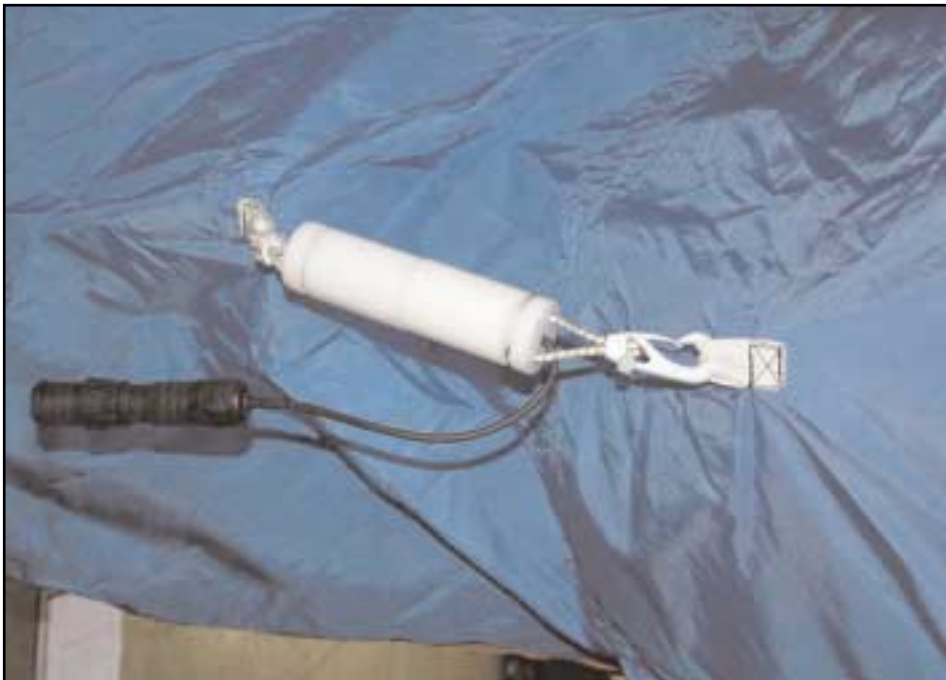
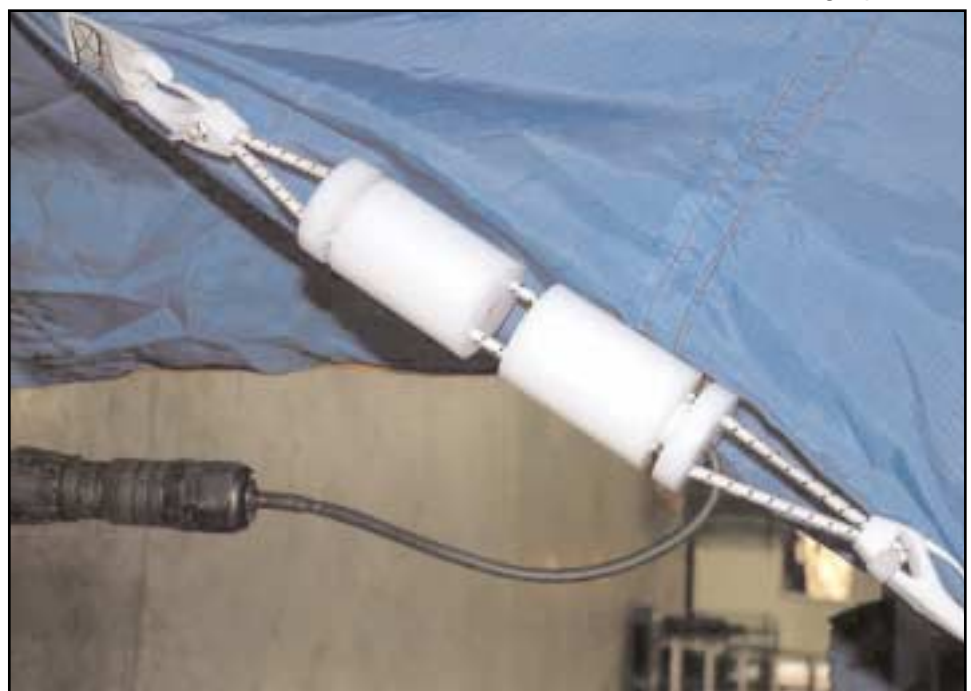
A traffic light system is fitted in the chute. This has sensors in the lower cells, which indicate that the descending evacuee is about to exit the chute. This was not working on the day of the drill (**see photographs A1/4 and A1/5**); an alternative means of communicating with the top of the chute was being used.

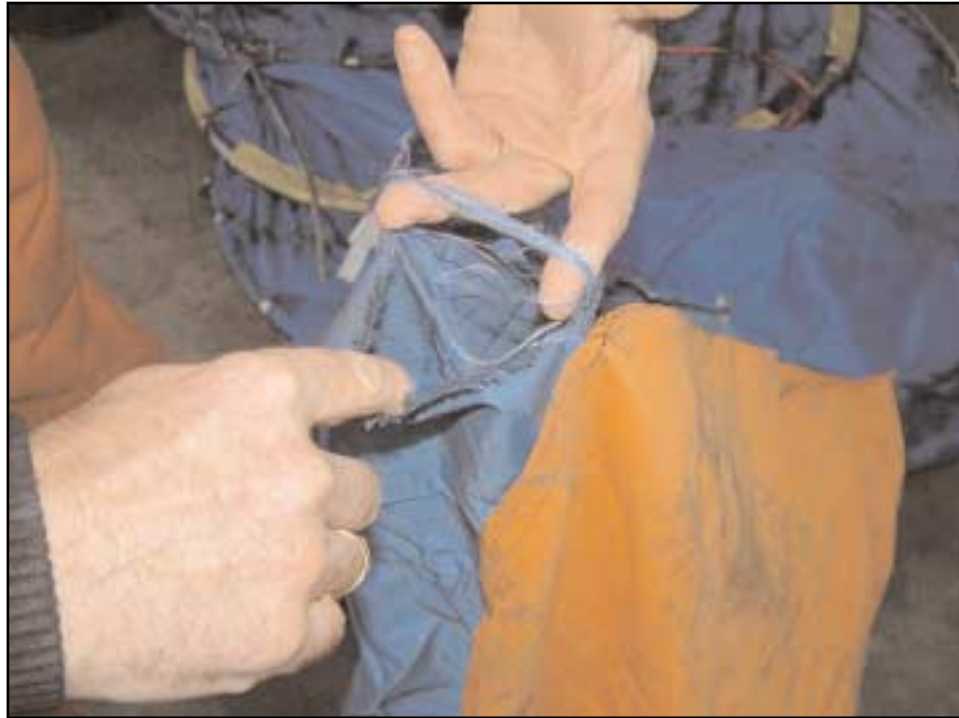
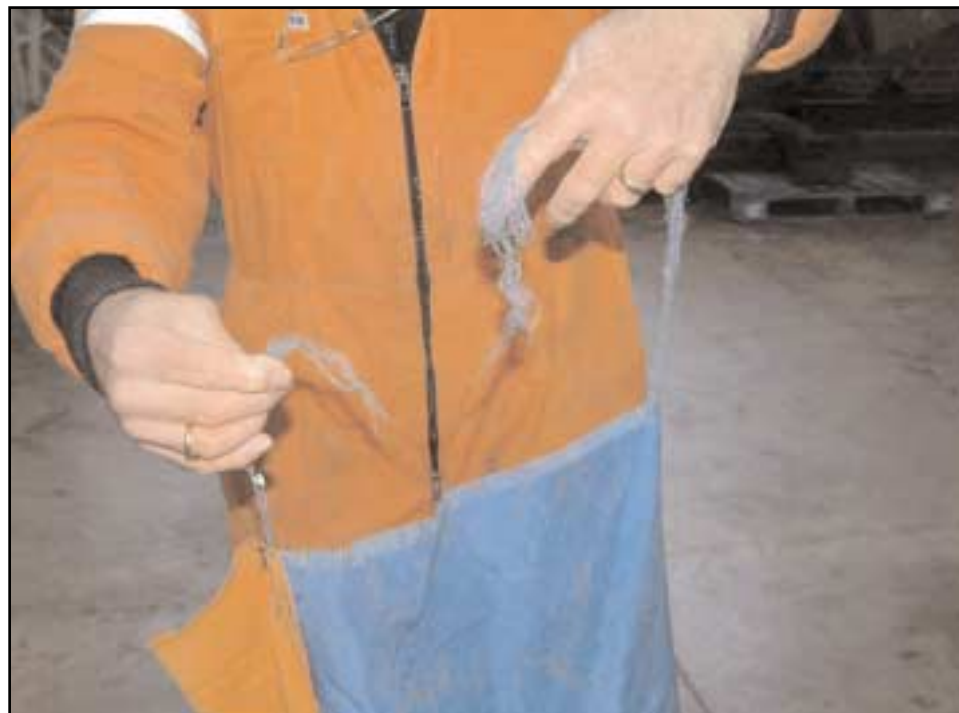
Cell No.1 The lower end of the external section connects around the opening in the liferaft. There is a 94cm vertical slit between bungee positions 3 and 4.

The blue fabric has frayed at the bottom of the sock, with the cross-threads forming a stirrup, and in another area where the threads have possibly formed a stirrup but then parted at one end, **see photographs A1/6 and A1/7.**

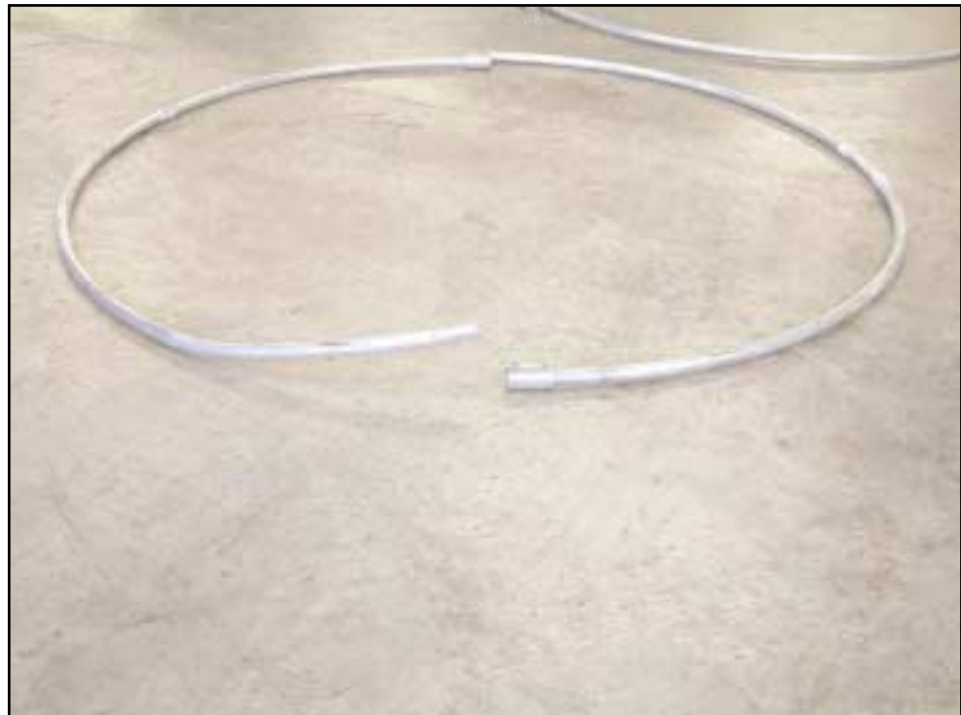
Photograph A1/16

After dismantling, it was noted that there is a 10 to 15 degree set at one end of a section of the upper joining hoop (**see photograph A1/16**).

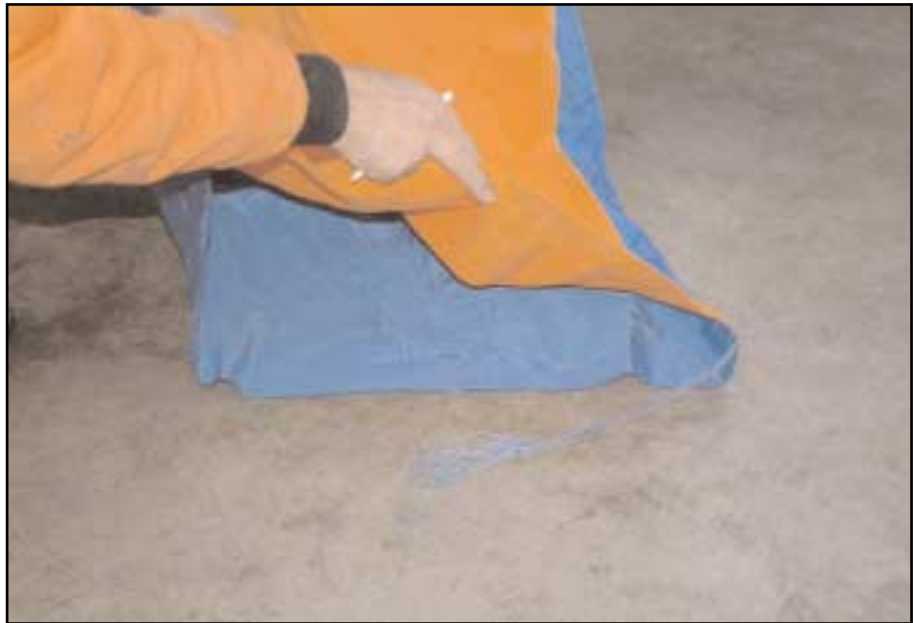
Photograph A1/17

- Cell No.7** The mid-height hoop attachment between bungee positions 3 and 4 is 10% detached, and between bungee positions 1 and 2 it is 99% detached.
- There is fraying across 60% of the blue fabric at the bottom of the sock where the threads might have formed a stirrup, before becoming detached at one end (**see photograph A1/17**).
- Cell No.8** The mid-height hoop attachment between bungee positions 2 and 3 is 10% detached.
- No. 1 bungee guide loop is detached at one end (**see photograph A1/18**).
- There is minor fraying of the blue fabric at the bottom of the sock.
- Cell No.9** The mid-height hoop attachment between bungee positions 2 and 3 is 10% detached, and between bungee positions 3 and 4 it is 75% detached.
- The No. 3 bungee guide loop is detached at one end (**see photograph A1/18**).
- There is minimal fraying of the blue fabric at the bottom of the sock.

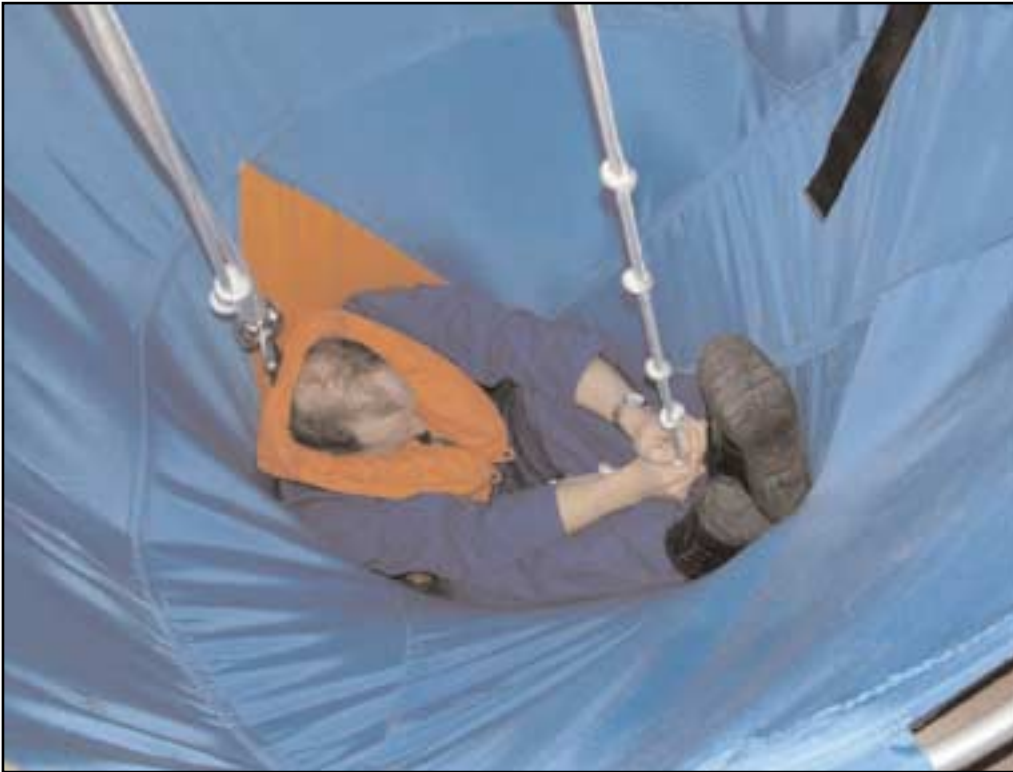
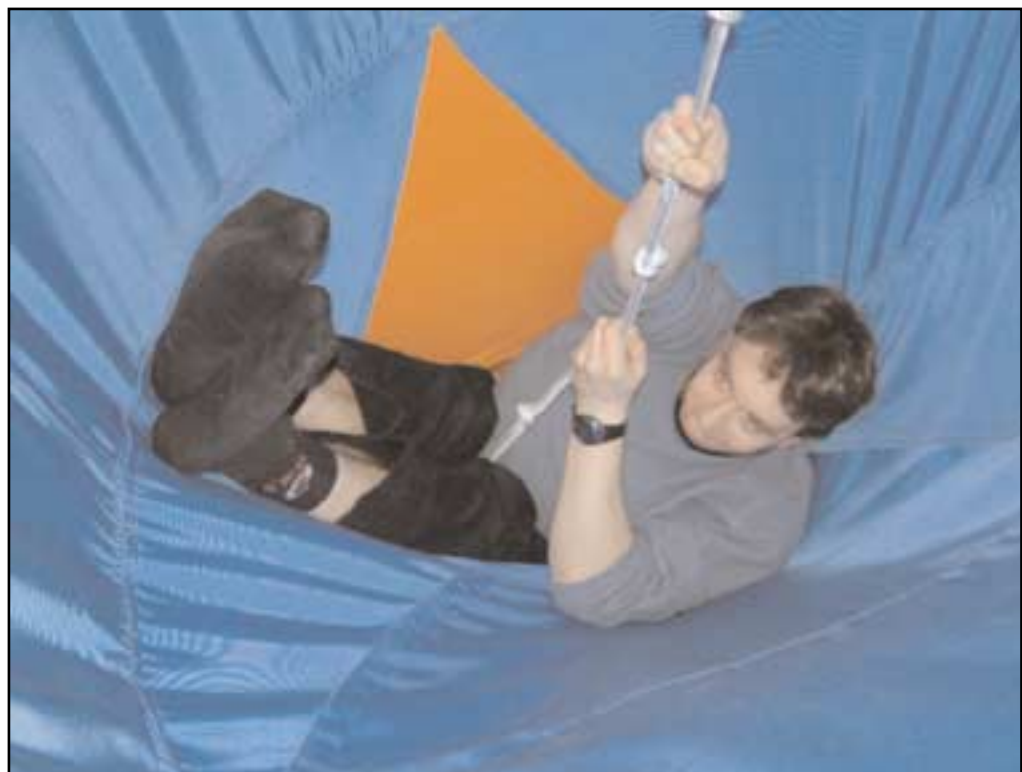
The first task was to recreate the position in which Mrs McCabe-Jones was found. After a couple of positions, the sweeper agreed the most likely position adopted was that shown in **photographs A2/2 and A2/3**, as he could not remember precisely. The sweeper adopted the piked position himself without the safety harness but with the safety rope in position. Although the piked position was uncomfortable, it did not cause any undue concern for those who tried it.

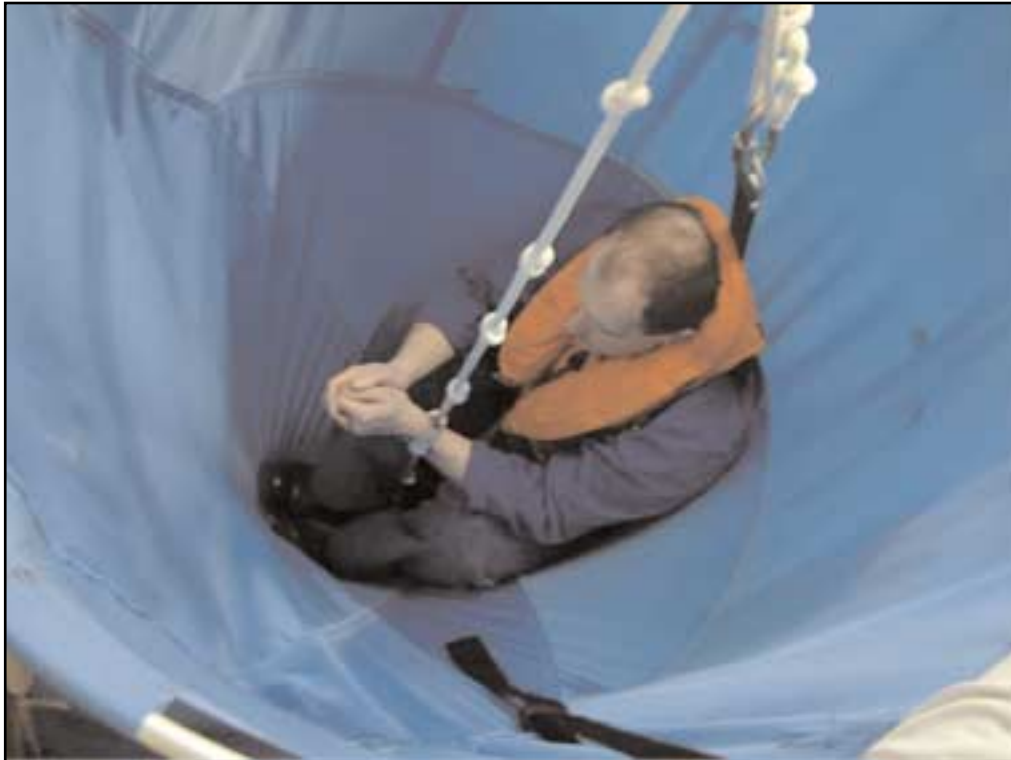
Photograph A2/4

The likely options that would lead to a person assuming the piked position were then pursued. If a person was stuck such that the knees were brought up to the chest, it appeared impossible for the person to move the feet above the waist. **(See Photograph A2/4.)** The person could become stuck in this position but by leaning forward the person starts to slide down feet first.

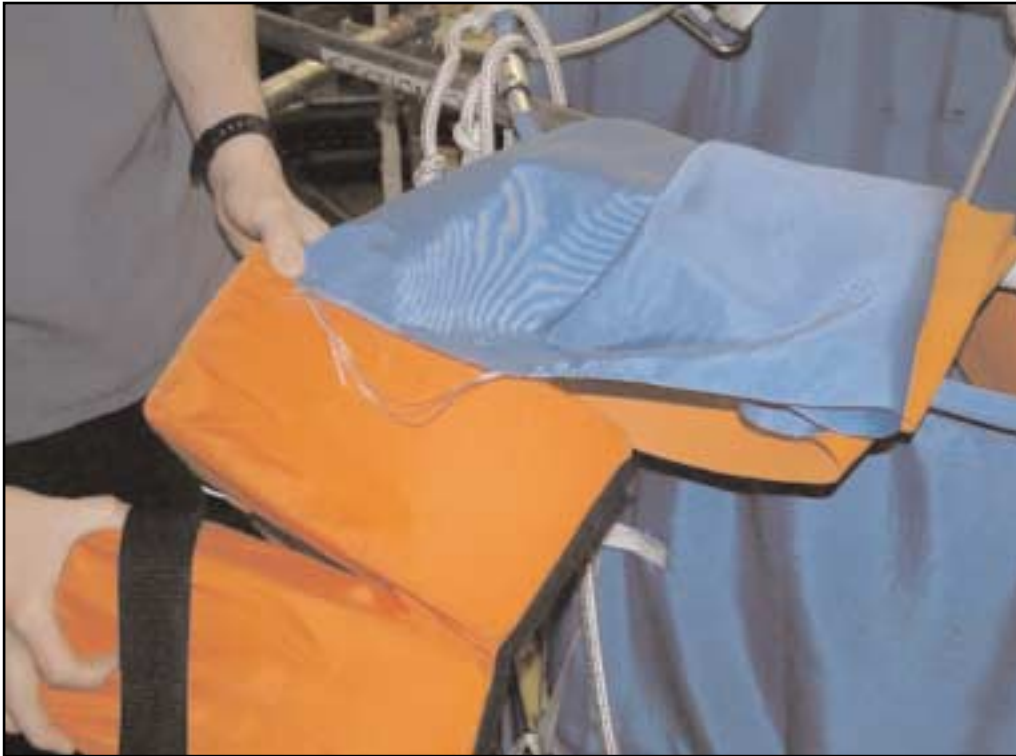
Photograph A2/5

The cross-threads in the fraying at the bottom of a sock, if of sufficient number, could have formed a loop/stirrup large enough for an evacuee's foot, or feet, to have become caught. This would have caused the body to continue past the feet - into the piked position - the threads either parting or pulling free at their ends during the event. This scenario must be investigated further, so I have included this as one of my recommendations.

The inspection of the actual escape chute, in Dover, after the accident had highlighted the possibility of stirrups of material threads at the exit of the socks. It may be possible that an evacuee's feet could become stuck in the stirrup. A stirrup of 4 threads was formed in the reconstruction since cell 7 in the inspection had been found with 4 loose threads on it. **(See Photograph A2/5.)**

Investigate the impact stress on stirrups formed by the cross-threads formed 1, 2, 3, 4 and 5 mm of weave from the blue chute fabric and establish the possible amount of fraying necessary to cause an evacuee to become stuck in the piked position, such as occurred to the casualty in this incident.

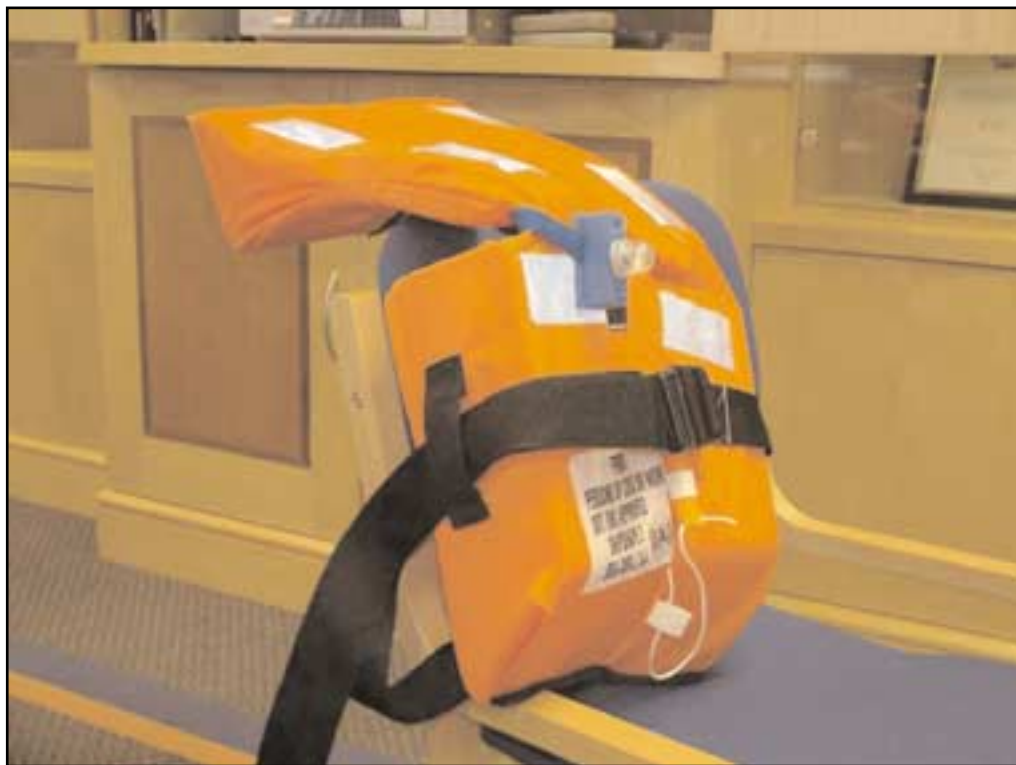
Photograph A2/7

Unlike the lifejacket shown in **Photograph A2/7**, the lifejackets used in the evacuation trial had no webbing guide loops on the side.

In the case of Mrs McCabe-Jones, both her jacket and lifejacket came off. The material of jacket may have made the process of losing the lifejacket even easier. If the lifejacket worn at the time of the accident had the small webbing guides present, or had leg straps, her lifejacket might not have come off.
