Report on the investigation of
the fire and subsequent sinking of

Lady Candida

off Corsica

Report No 4/2008
February 2008

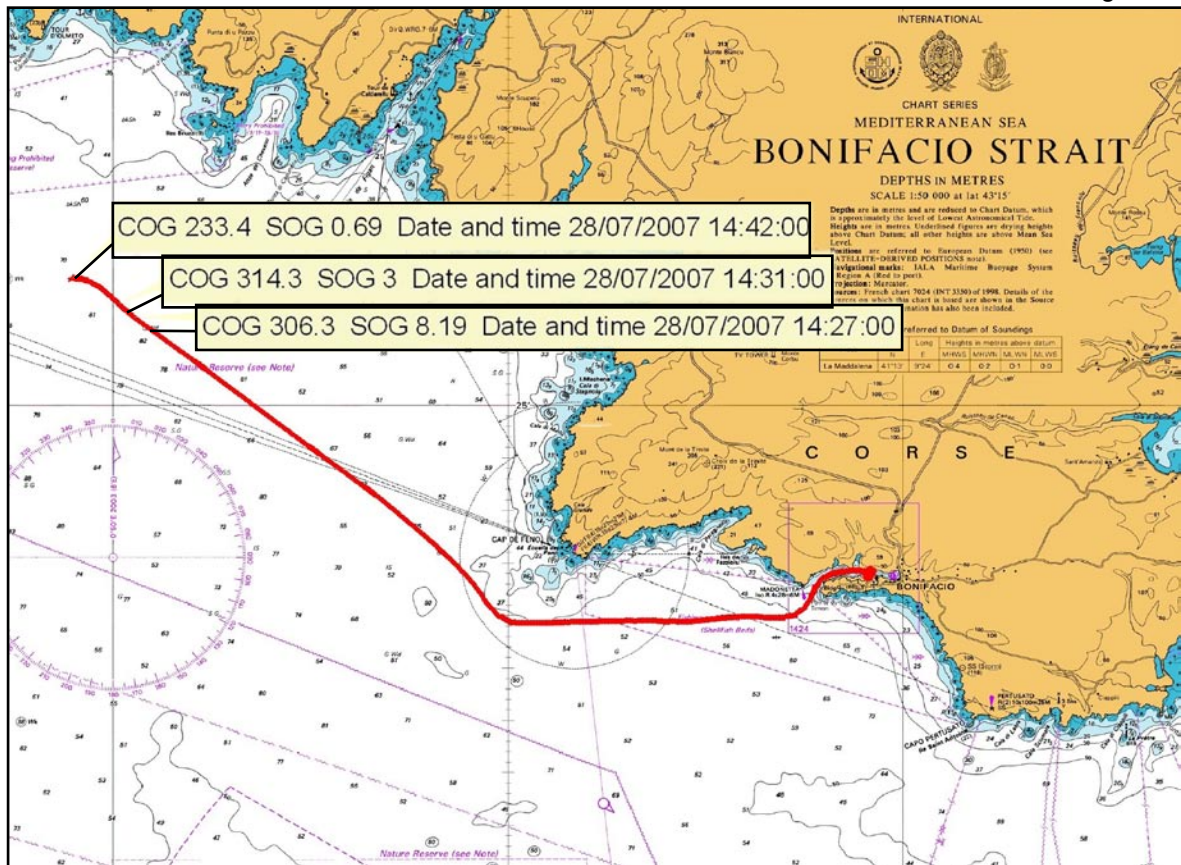
Figure 1

During the afternoon of 28 July 2007, *Lady Candida* was on passage from Bonifacio to Campomoro, Corsica on a north westerly heading at a speed of 8 knots (**Figure 1**). The wind was westerly at 23 knots and the sea was calm. On board were six crew, comprising the captain, a senior deckhand, a junior deckhand, a chef, and two stewardesses. Also on board were 11 passengers from the same family, comprising 7 adults and 4 children between the ages of 6 and 8 years. The adult guests were on the vessel's aft deck and the children were inside the accommodation. The captain and senior deckhand were on the bridge deck.

ECDIS extract taken from the captain's laptop computer

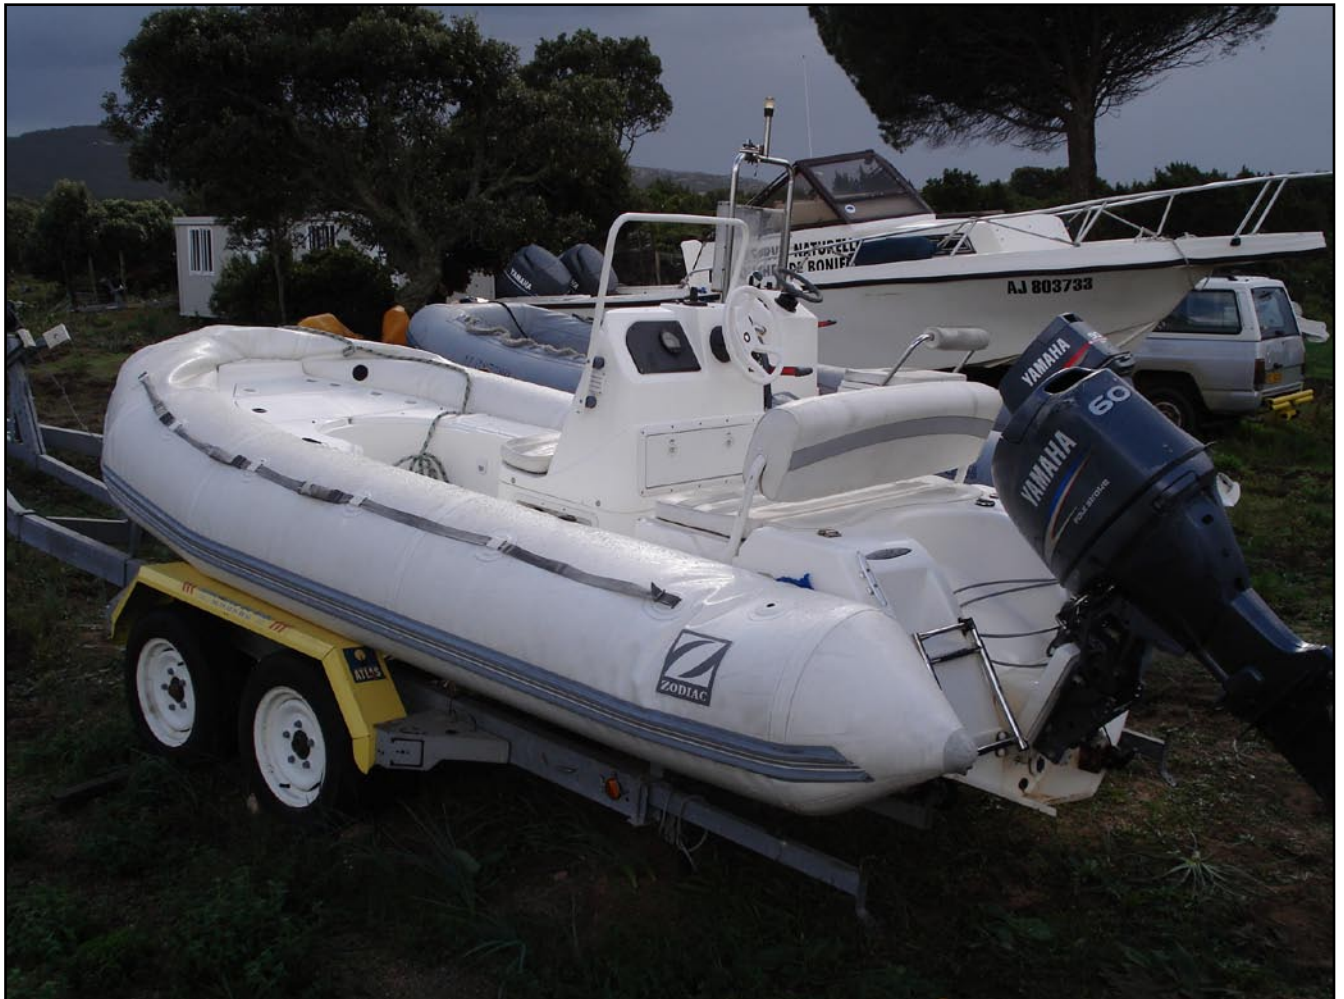
Figure 4

The captain decided to evacuate the guests using the vessel's tender (**Figure 4**), which was being towed. The guests were assembled on the aft deck, where the adults donned lifejackets and the children donned buoyancy aids; no children's lifejackets were carried. Driven by the junior deckhand assisted by one of the stewardesses, the tender transported the guests about 3nm to Chevaneau, Corsica.

Zodiac tender model YL 480 DL

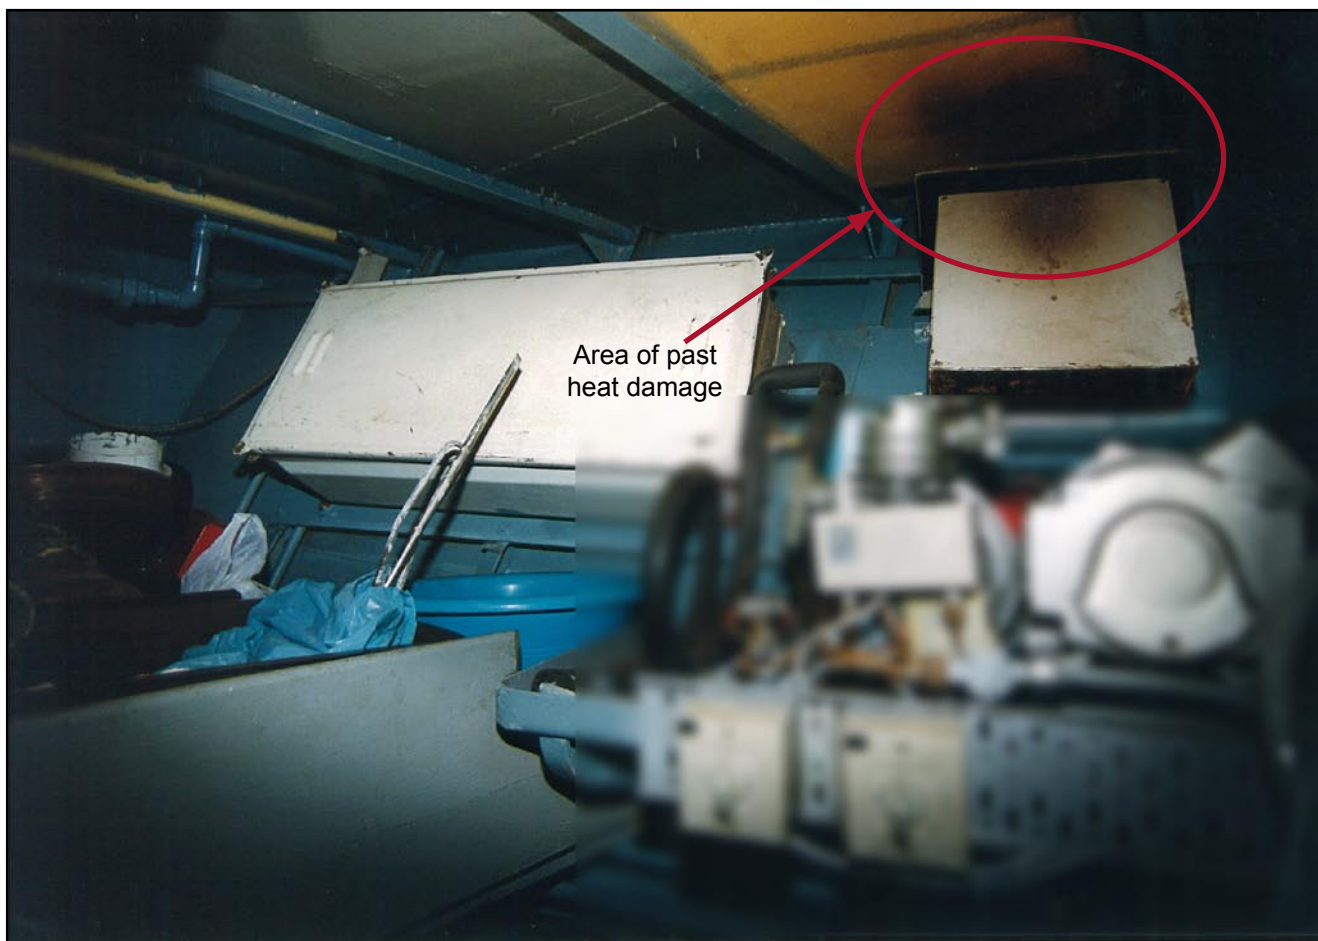
Figure 7

Internal access to the laundry was by an alleyway (**Figure 3**). At the forward end of the alleyway, a flight of three steps led to the laundry room and a crew cabin, which shared a common two-way door (**Figure 6**). The main control panels for the 110V DC windlass (**Figure 7**), which had a history of overheating, were sited behind the stairs.
