Report on the investigation of
The machinery space fire on board

Oscar Wilde

In Falmouth Bay

Report No 3/2011
March 2011

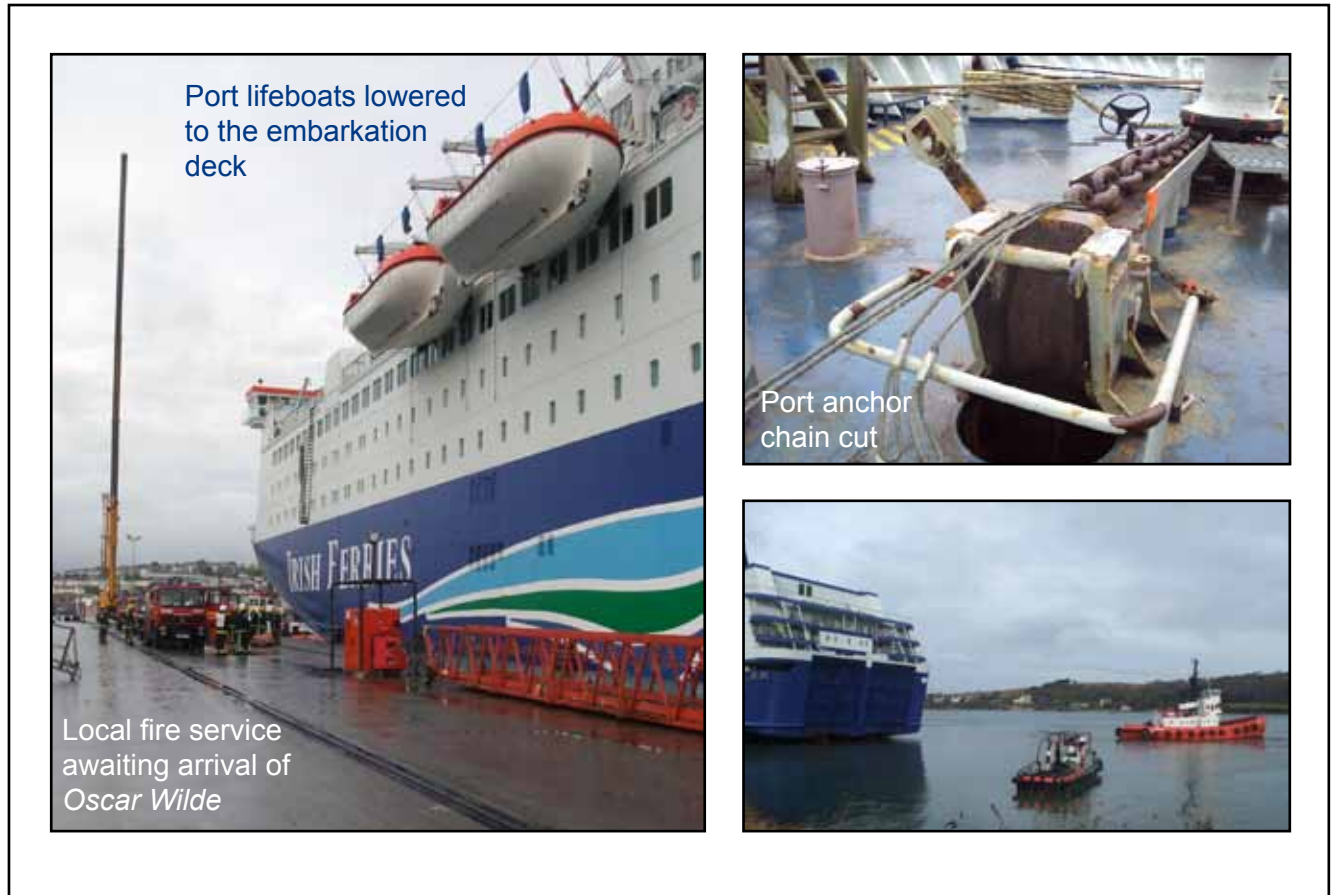
Figure 9

Due to the extent of the fire damage it was not possible to restore main electrical power to the vessel. Therefore, the anchor could not be recovered. At 0555 the following morning, the port anchor chain was cut to allow the vessel to be towed back to Falmouth (**Figure 9**).

Oscar Wilde towed back to the Falmouth ship repair yard

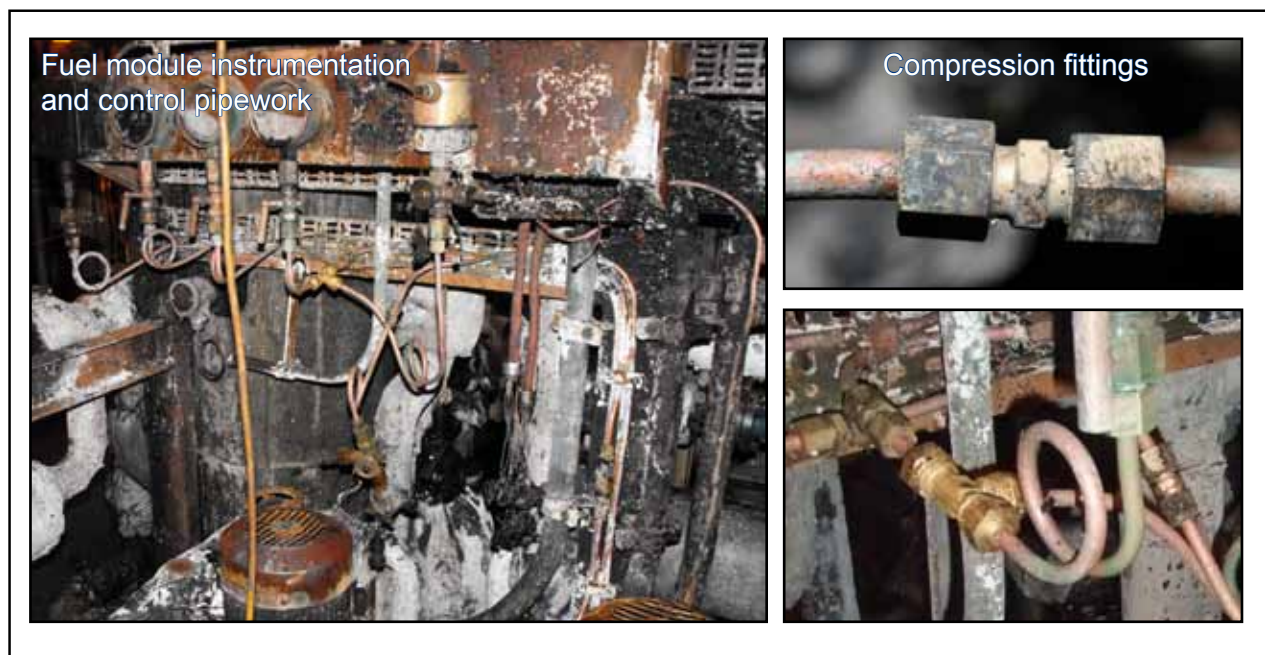
Figure 18

Copper pipework was used extensively on both the auxiliary engine and main engine fuel modules to connect the pressure gauges and sensors to the main fuel oil circuit (**Figure 18**). The copper pipes were interconnected by compression fittings and, although many of the fittings were found to be loose, none of the connections appeared to have failed and no breaks or fractures were identified.

Fuel module copper pipework and compression fittings

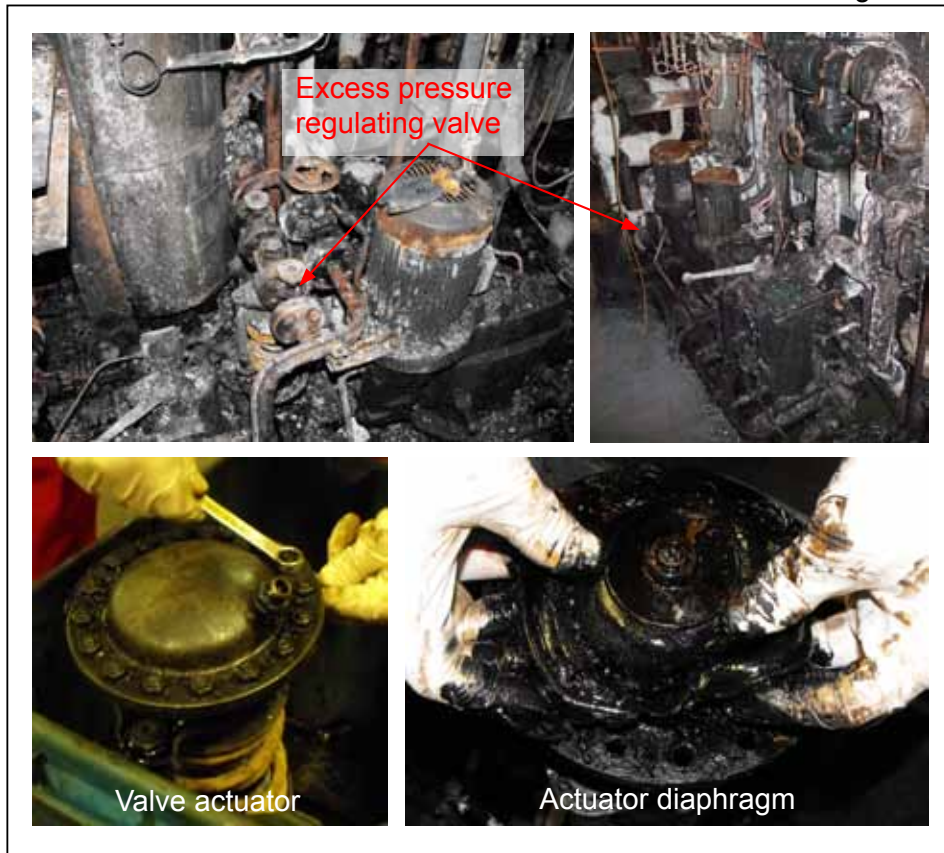
Figure 20

The excess pressure regulating valve's actuator was positioned close to the seat of the fire. The valve was removed and its actuator inspected (**Figure 20**). The rubber diaphragm was in poor condition and had suffered heat damage.

Location of the fuel system's excess pressure regulating valve

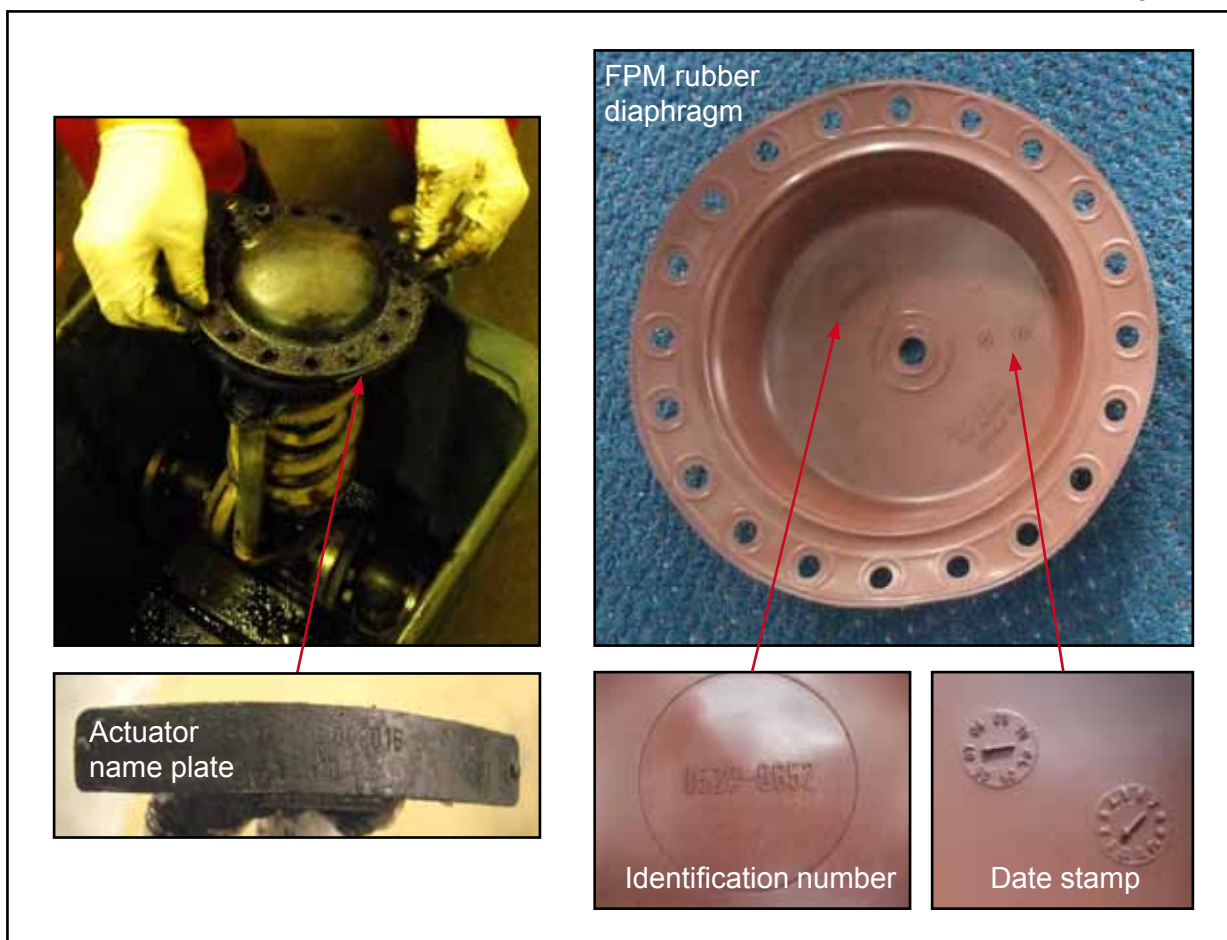
Actuator name plate and diaphragm markings

The test report on the diaphragm removed from the valve actuator identified deterioration of the rubber and a tear in its main flex region (**Annex B**). This damage was remote from the fire damage evident at its outer edge. The diaphragm was made from EPDM rubber and was therefore not suitable for use in fuel oil systems. The actuator had a diaphragm area reducing plate which increased the valves' operating pressure range to 4.5 to 10bar (**Figure 23**). The actuators fitted to the fuel modules on board *Oscar Wilde* were not fitted with any optional safety features.

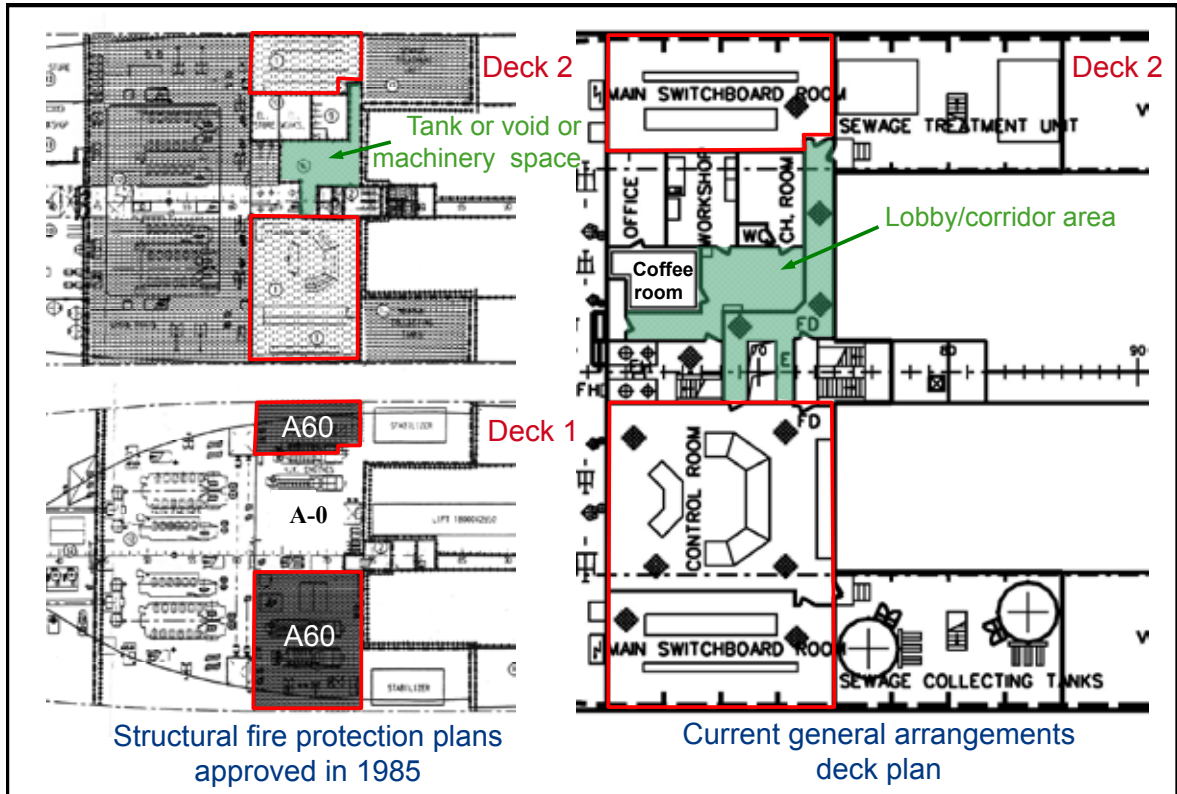
Structural fire protection plan

The lobby and corridor area on the port side of the ECR was classified as a *tank, void or auxiliary machinery space having little or no fire risk*. As such, the deck and bulkhead boundaries between it and the AER required A-0 structural fire protection. Therefore, no thermal insulation was provided. Some of the compartments had changed use over time; an electrical store had been converted to an office and a coffee room had been provided for the engineers (**Figure 29**). The deck between these areas and the AER also had no thermal insulation. Following the fire, and prior to *Oscar Wilde* returning into service, Irish Ferries fitted an additional section of A60 insulation to the deck between the AER and the corridor area next to the ECR (**Figure 30**). This additional insulation has subsequently been extended to cover the whole of the AER boundary.

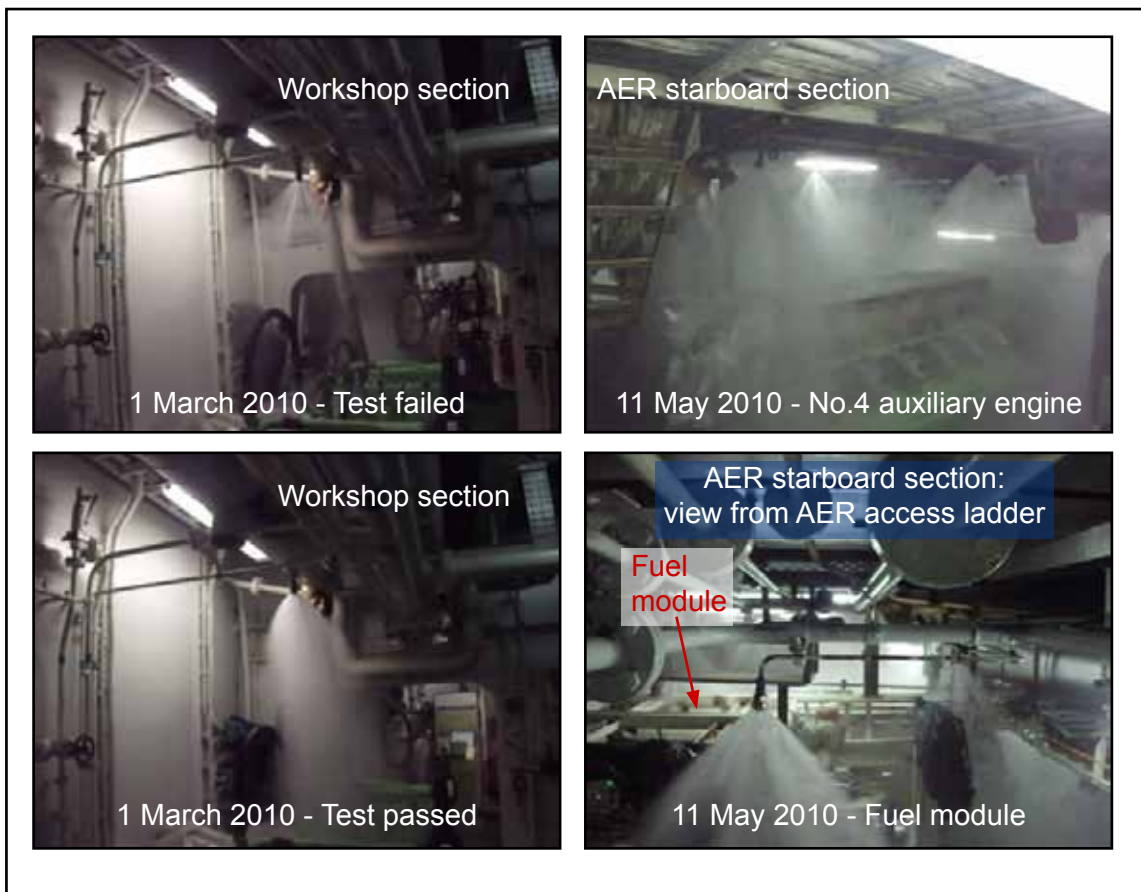
Figure 33

- the initial stand-by pressure was equal to the gas bottle pressure of 195bar
- the gas bottle low pressure alarm was set at 100bar
- the automatic CCTV function did not work
- the water-mist coverage appeared to be less substantial over the fuel module compared to the auxiliary engines (**Figure 33**)
- one gas cylinder was sufficient to conduct the test.

Hi-fog system discharge tests

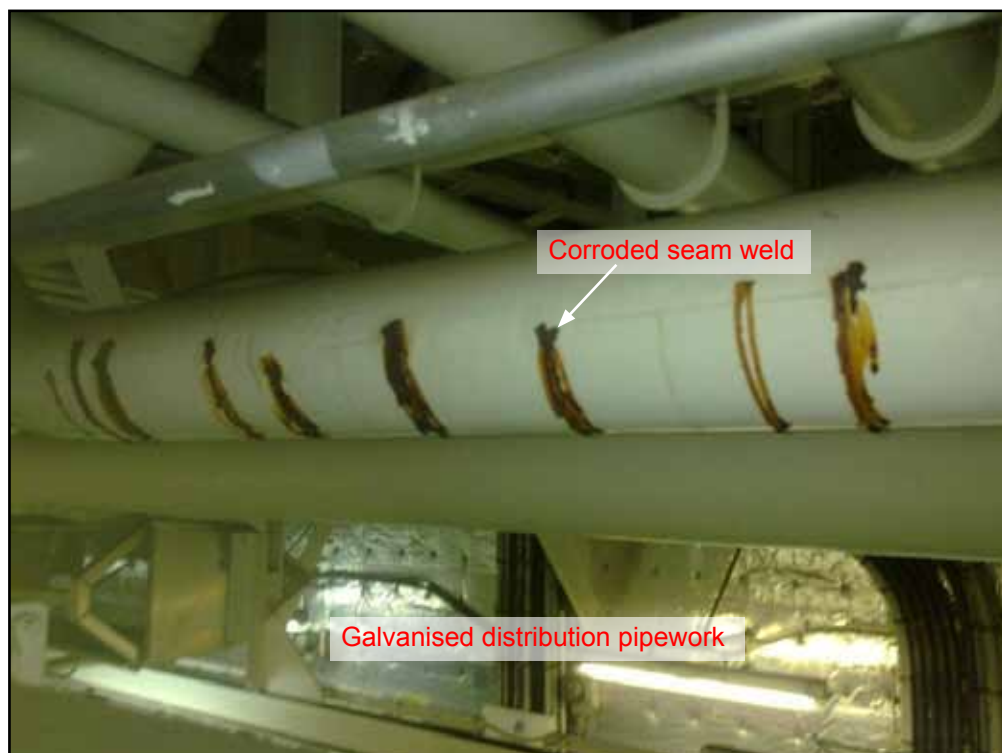
Figure 38

As a result of its findings on board *Oscar Wilde*, Wilhelmsen carried out several enhanced surveys of *Hotfoam* systems fitted to other vessels. Its service engineers closely inspected the distribution pipework and foam generator nozzles and identified that water traps were common, and that corrosion was prevalent within the dry pipe systems. They also found that welded seams within galvanised systems were particularly prone to corrosion (**Figure 38**). In addition, many foam generators could not be accessed to allow nozzles to be inspected, particularly on the larger tankers.

Hotfoam system survey on other vessels

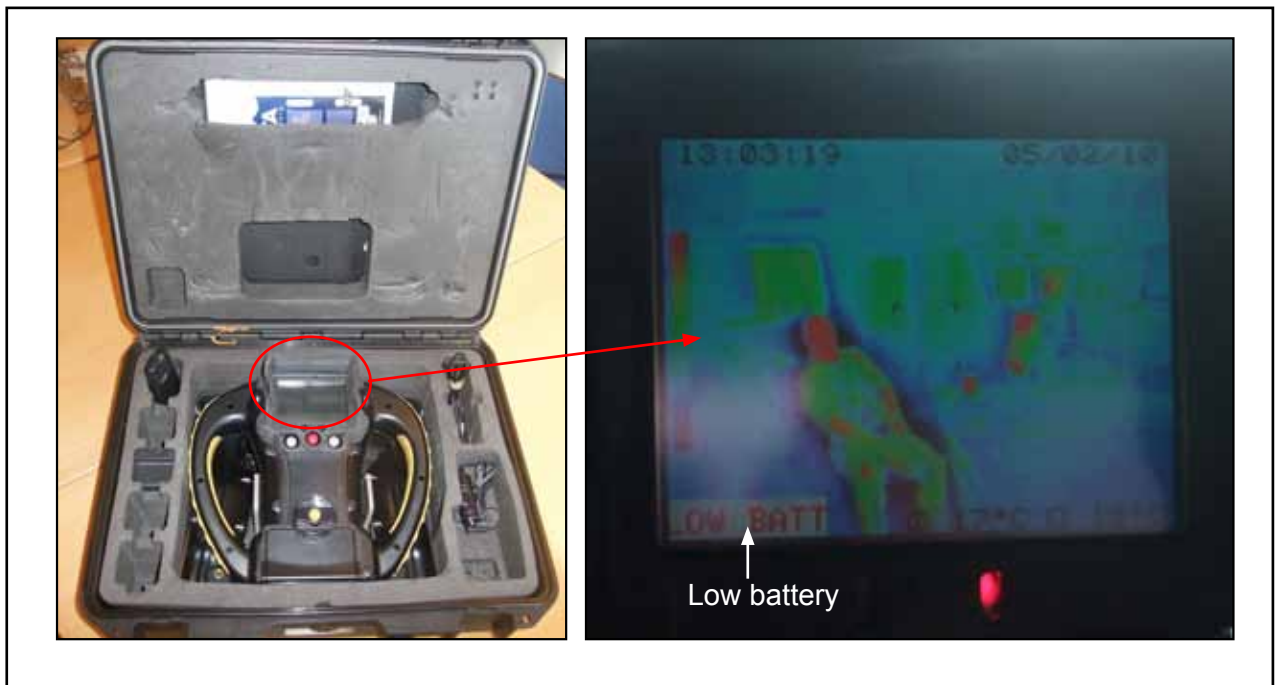
Figure 41

The ship held a thermal imaging camera which was located at the deck fire party's muster point. It was standard practice to take the camera to a scene of a fire. On this occasion, the fire party forgot to take the camera to the lower hold and it remained unused in the fire store throughout the incident. After the fire, it was found that the camera's battery had not been charged prior to sailing and only had sufficient charge to power the camera for 1 to 2 minutes (**Figure 41**).

Thermal-imaging camera

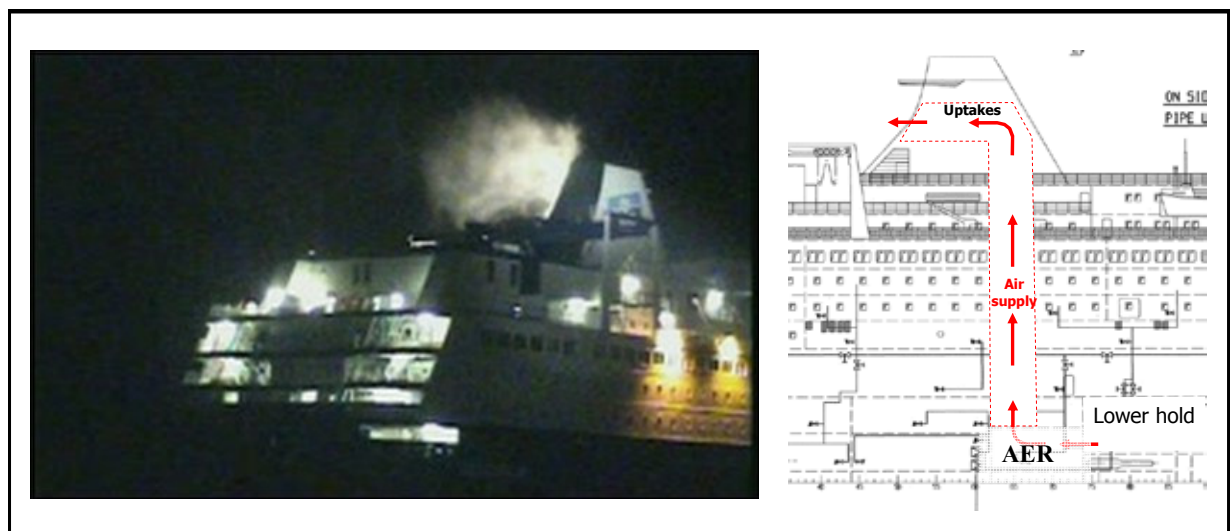
Figure 42

However, when the OSC opened WTD3 a draught was induced from the vehicle deck, through the AER, as the hot combustion gases rose up the funnel casing and escaped through the exhaust louvres. In addition, as the vehicle deck ventilation dampers had not been closed, the 25 knot winds over the deck of the anchored vessel served to create a forced draught through the compartment (**Figure 42**). The OSC was aware that the draught was keeping the smoke out of the lower hold, but the implications of fanning the fire were not considered. Consequently, the air flow from the lower hold ventilated the compartment before it had been adequately cooled, and contributed to the fire's re-ignition.

Air supply from the lower hold to the AER
