Extracts from ABB Turbocharging's Turbo Magazine 1990 – 2009

## ABB Turbocharging Tips for the operator

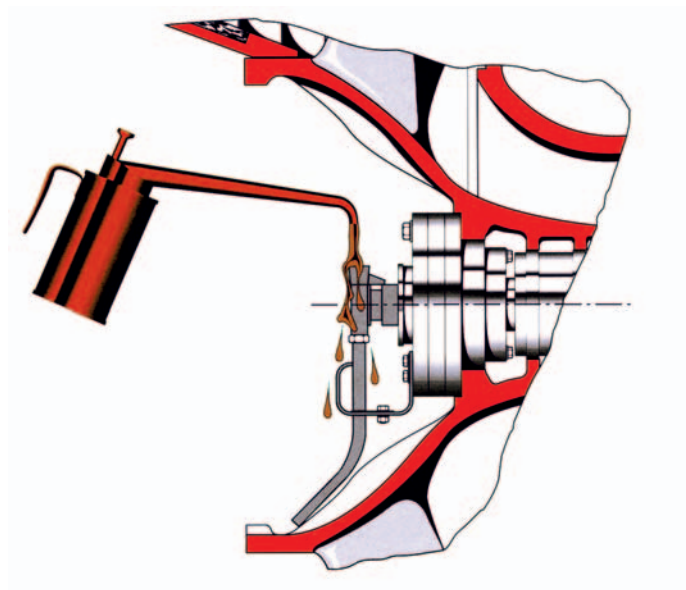
Priming

It is reported from time to time that gear-type oil pumps on VTR turbochargers do not supply any oil. These pumps have been thoroughly checked at the Baden works, and no faults have ever been found. All the pumps supplied oil as normal, beginning already at very low speed.

To function properly, the pump body must always be filled with lubeoil. Therefore, before a pump is fitted to the turbocharger, it must be primed before the bearing cover is fitted (see picture on the right).

We also recommend that gear oil pumps be checked for tightness and proper functioning every 16,000 running hours in one of our Service Stations.

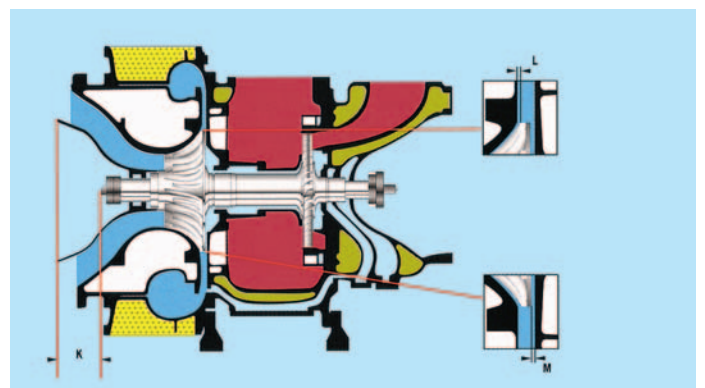
Fig. 1

When rotor clearances are out of tolerance, the rotor will not be able to rotate and there will be a risk of breakdown and serious damage. Exact measurement of the clearances is necessary in order to determine that the rotor is in its correct working position:

- Measure dimension K (see Fig. 1).
- Withdraw bearing about 5 – 6 mm.
- Push the rotor towards the compressor.
- Measure dimension K<sub>1</sub> (see Fig. 2).
- Pull the rotor towards the turbine.
- Measure dimension K<sub>2</sub> (see Fig. 3).

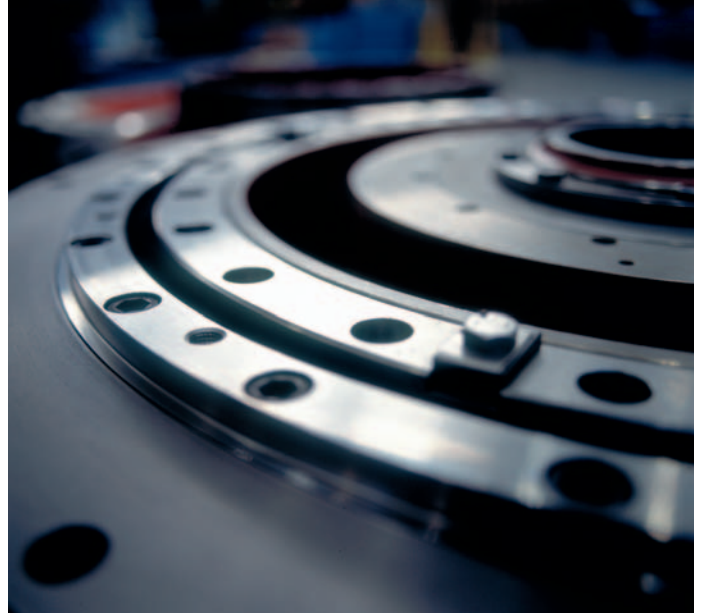
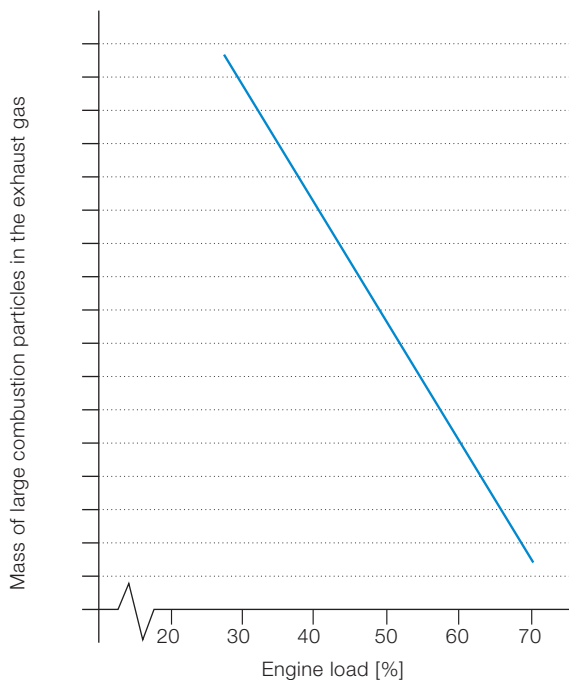
Erosion of nozzle and cover rings can be a problem, particularly for installations that run on heavy fuel oil. If left unattended, the erosion will eventually lead to a drop in turbocharger efficiency and to the premature replacement of parts.

This kind of erosion is caused by particles being formed during the combustion process and conveyed to the turbocharger by the exhaust gas. The quantity and size of the particles depend on a number of factors, ranging from the properties of the fuel to engine operation.

Factors with a major influence on particle formation are the fuel property CCAI (Calculated Carbon Aromaticity Index) and the asphaltene, vanadium and sulfur content of the fuel oil.

Also significant are the fuel oil preheating, compression ratio, injection equipment wear and engine load. The engine part load, in particular, plays a major role in the formation of the larger particles causing erosion (see figure).

The best way to avoid erosion is to restrict the formation of particles.

- Start by ensuring that your engine is top fit.
- Have a fuel oil analysis performed by a noted laboratory. This will help you to avoid fuels with inferior properties.
- If you are running more than one generator or auxiliary engine, avoid running them for prolonged periods at low loads (see figure). If possible, run fewer generators at higher loads.

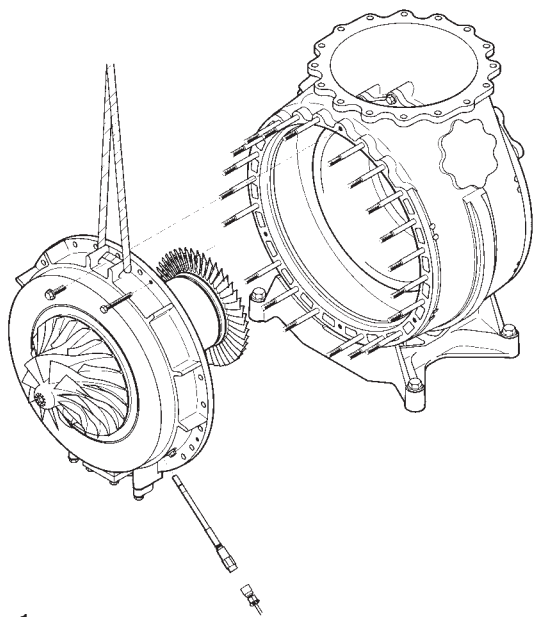
Fig. 1

Did you know that the turbocharger could be blanked off without affecting the power more than is absolutely necessary? For example, with our new TPL turbocharger, the cartridge group (rotor block, Fig. 1) can be removed and the open gas outlet casing closed with a blanking cover (Fig. 2). This will allow the engine to at least be used – with a lower power – until the next repair opportunity arises.

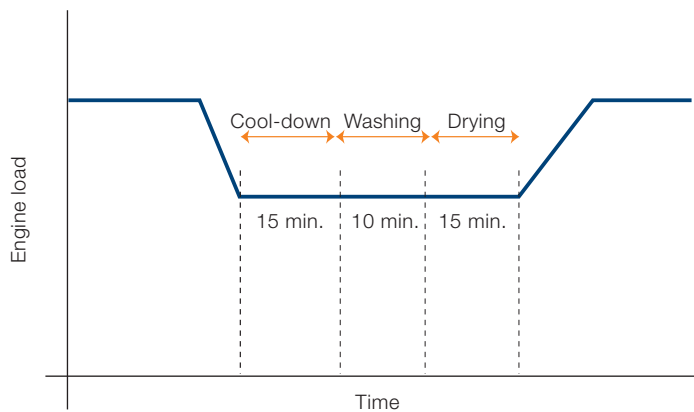
Washing a turbine which is still at a high gas-inlet temperature and/or too frequent washing can cause cracks and deformation of the turbine-end components, thereby drastically shortening their useful life.

ABB recommends waiting for a certain length of time (see diagram) before and after washing. Wait at least 10 minutes (preferably 15 minutes) after reducing the temperature before injecting water, and again after washing to give the material time to adapt to the exhaust-gas temperature. Following this procedure will significantly reduce stressing of the turbine and other components exposed to the exhaust gas, as well as reduce the formation of thermal cracks.

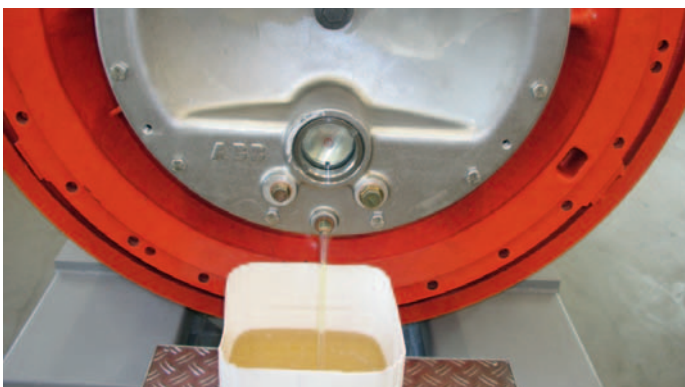
**Drain the lube oil at both ends.**

First make sure the containers for catching the oil are absolutely clean. After draining the lube oil into the containers, check the oil for anything unusual, like metal particles. After 100 hours running time the oil should still look perfect. If it doesn't and you see metal particles, contact your nearest ABB Service Station and request an inspection. If the inspection shows that something's not right, ask for a correction.

If inspection and subsequent correction by an ABB Service Station aren't possible, replace both bearings as a precaution. This work has to be done in accordance with the instructions in the Operation Manual. Then check the lube oil again after about 100 running hours for signs of anything unusual. Providing everything looks good, refill with fresh lube oil. Afterwards, carry out oil changes according to the engine builder's instructions.

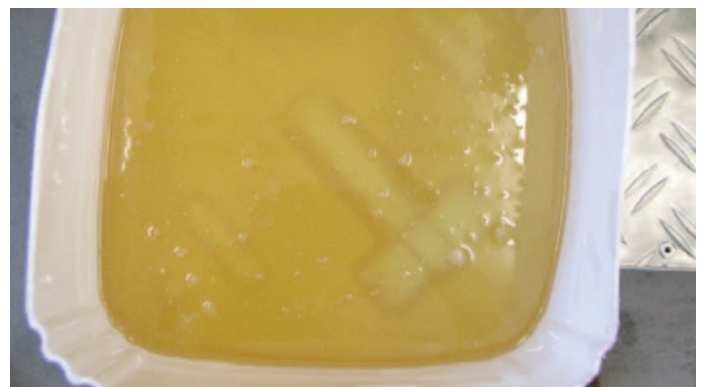
**The oil should look like this.**

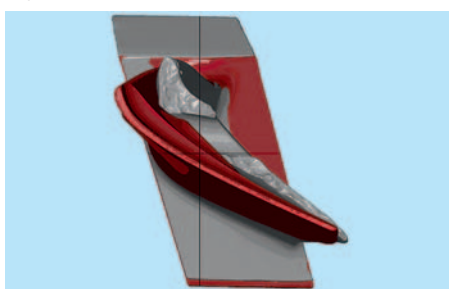
Fig. 1

Turbine blades have complex geometries and any deviations can quickly affect their mechanical integrity. A geometric comparison (Fig. 1) of the failed copy part (grey) and an ABB reference turbine blade (red) revealed the following:

- The foot geometry of the copy part differed distinctly, causing excessive stress-loading in this vital area of the blade.
- The difference in the geometry of the copy part’s blade foil meant that the turbocharger could never have achieved the original thermodynamic performance.
