The Tankship Tromedy

**The Impending Disasters in
Tankers**

Jack Devanney

2006

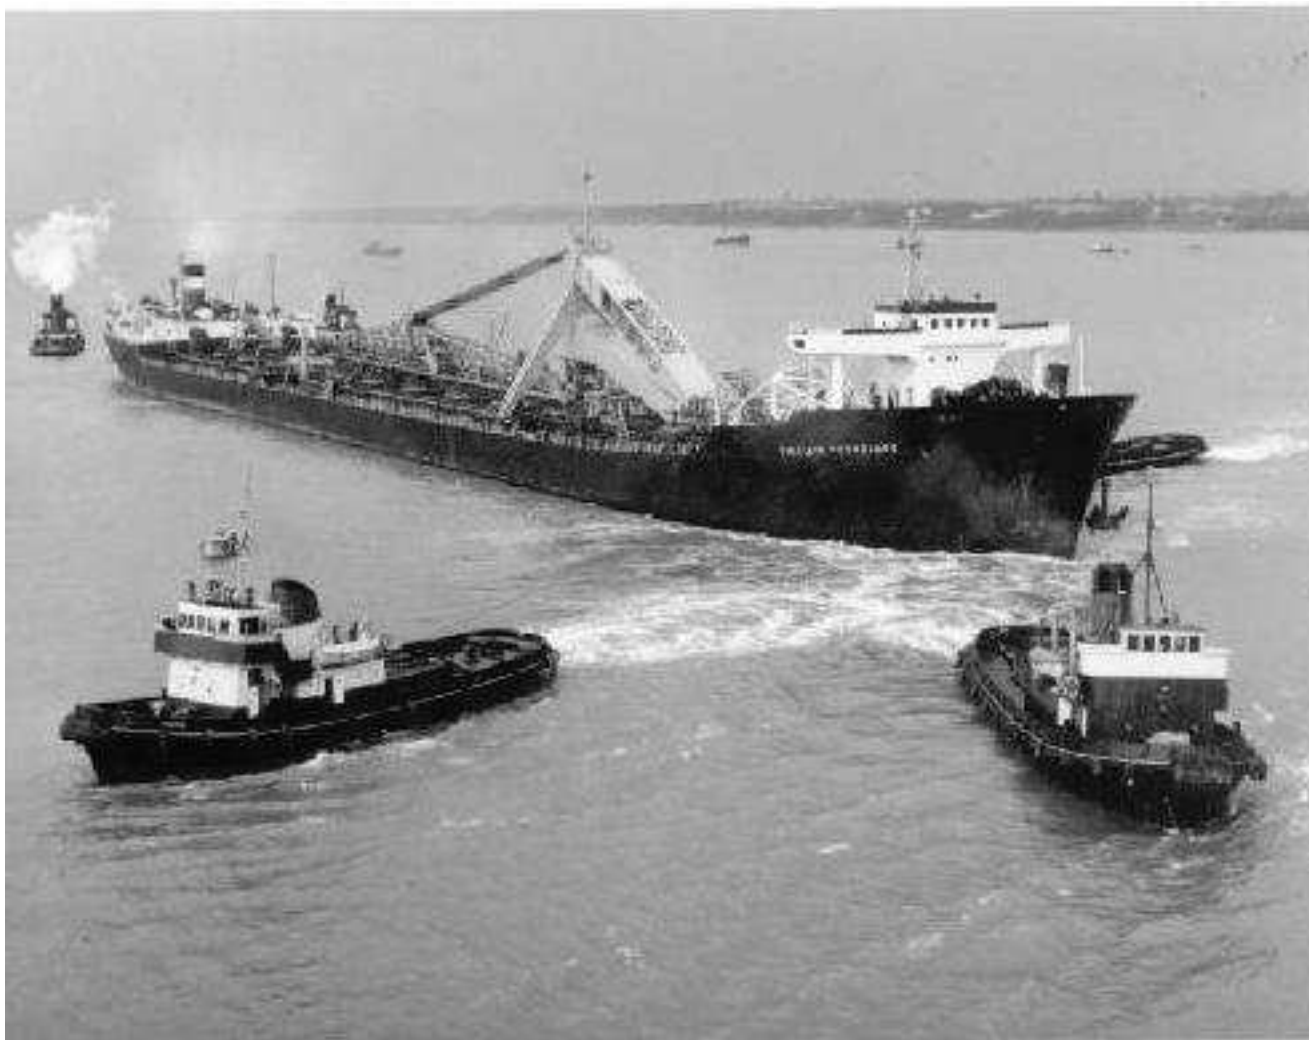
Figure 2.2: Sinclair Petrolore: Self-Unloading Ore-Oil Carrier. Source: www.solentwaters.co.uk

¹¹ The SINCLAIR PETROLORE, Figure 2.2, was truly unique; not only the biggest ship in the world but a self-unloading ore/oiler. The world has never seen anything like her before or since. In 1960, she exploded off Brazil spilling 60 million liters. This was the largest oil spill ever at the time by at least a factor of two. Most likely cause was cargo leaking into the double bottom.

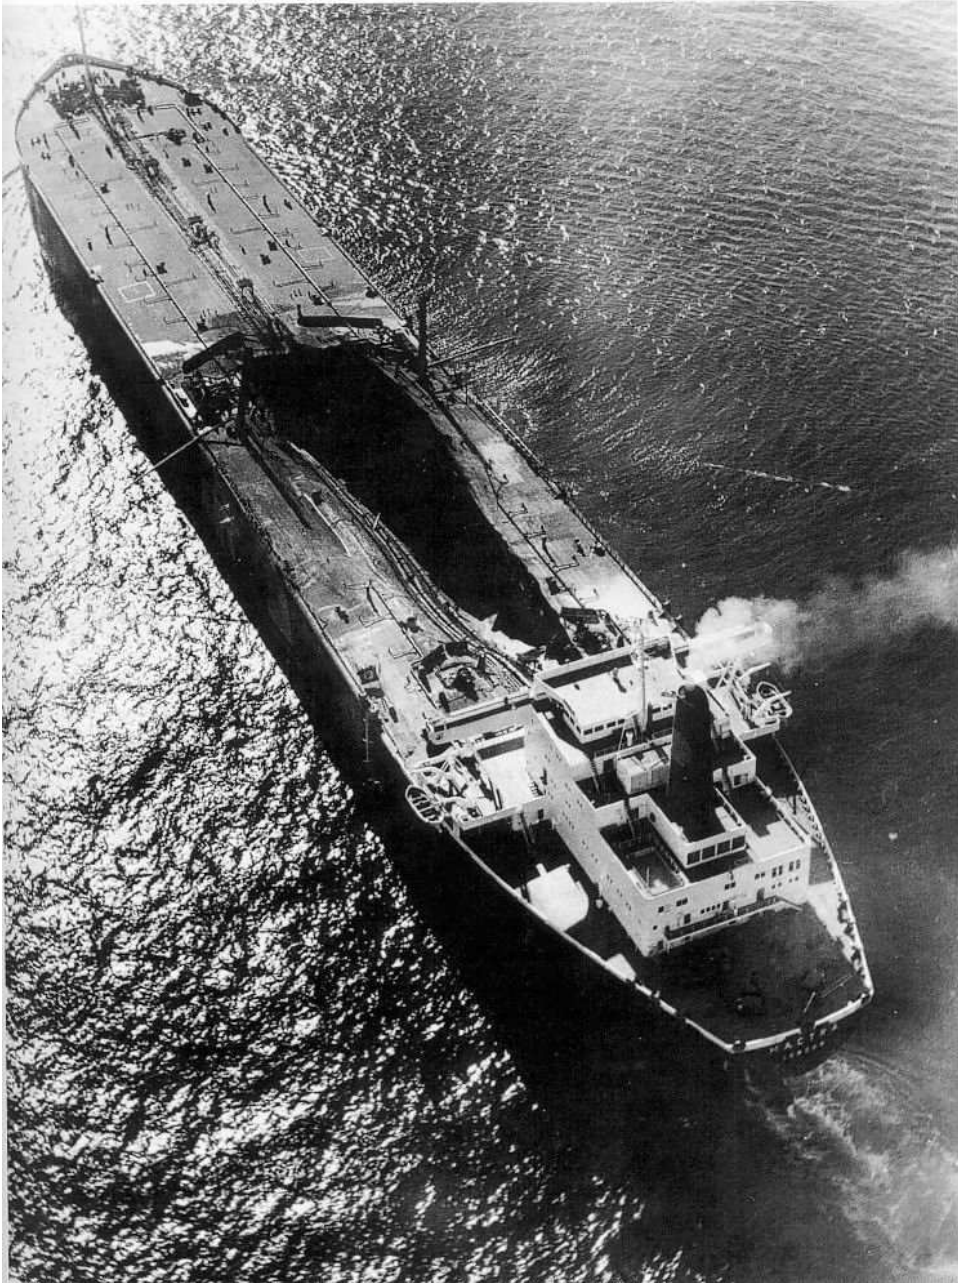
Figure 2.4: Mactra deck after tank cleaning explosion. Two killed.
Source: Auke Visser, supertankers.topcities.com

Cargo tank cleaning is accomplished by machines that look like and work like enormous lawn sprinklers. These gadgets shoot a revolving high pressure jet of sea water around the tank, in theory blasting the surfaces clean of oil. Two of the tankers involved, the MARPESSA and the MACTRA were Shell ships. The third was the brand new KONG HAAKON VII. The MARPESSA, on her maiden ballast leg, sank killing two crewmen. The MACTRA, Figure 2.4, and the KONG HAAKON VII, Figure 2.5, had a large portion of their main decks blown away but survived.

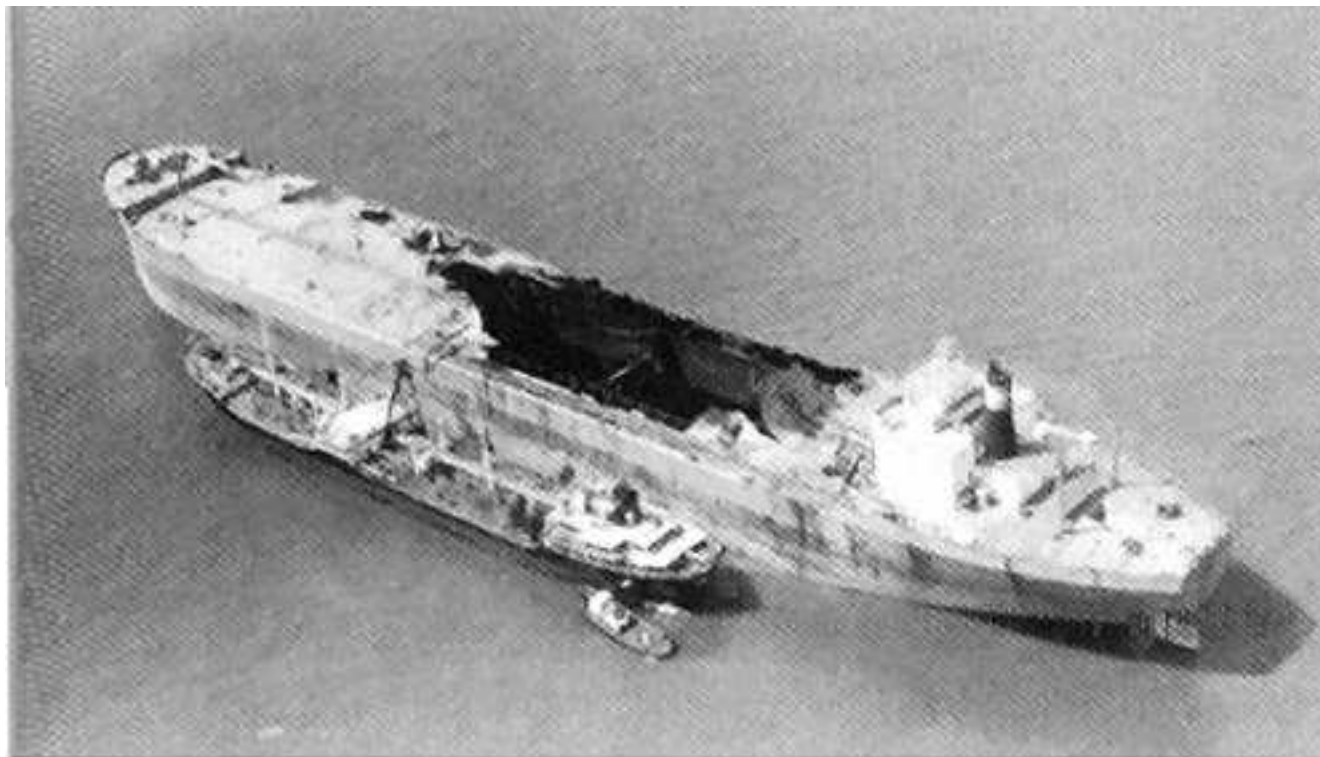
Figure 2.5: Kong Haakon deck after tank cleaning explosion. Obvious similarity to Mactra. Source: Auke Visser, supertankers.topcities.com

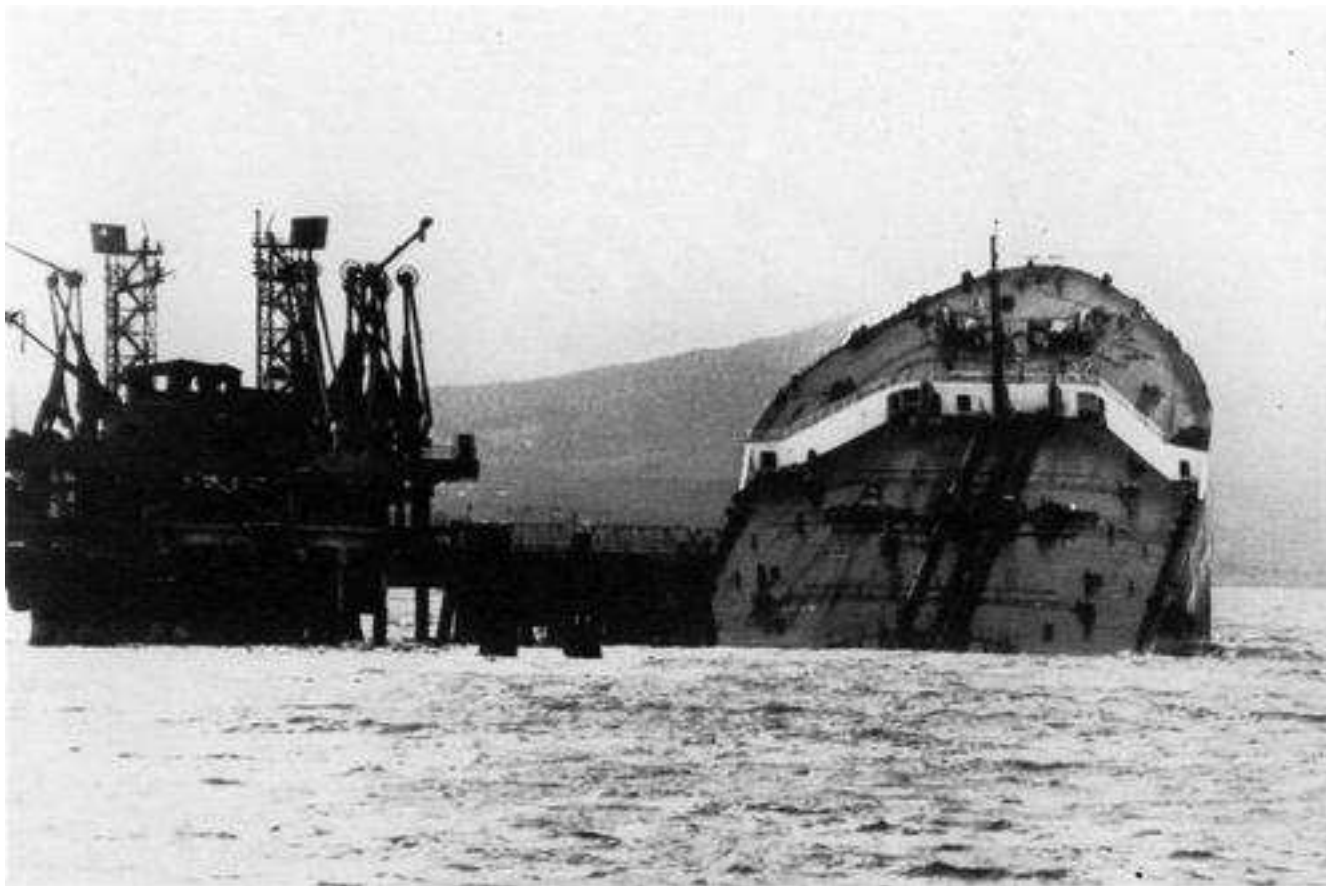
Figure 2.6: The Betelgeuse at Whiddy Island. Horribly corroded segregated ballast tanks. Uninerted. Fully Class Approved. 50 dead. Source: Auke Visser, supertankers.topcities.com

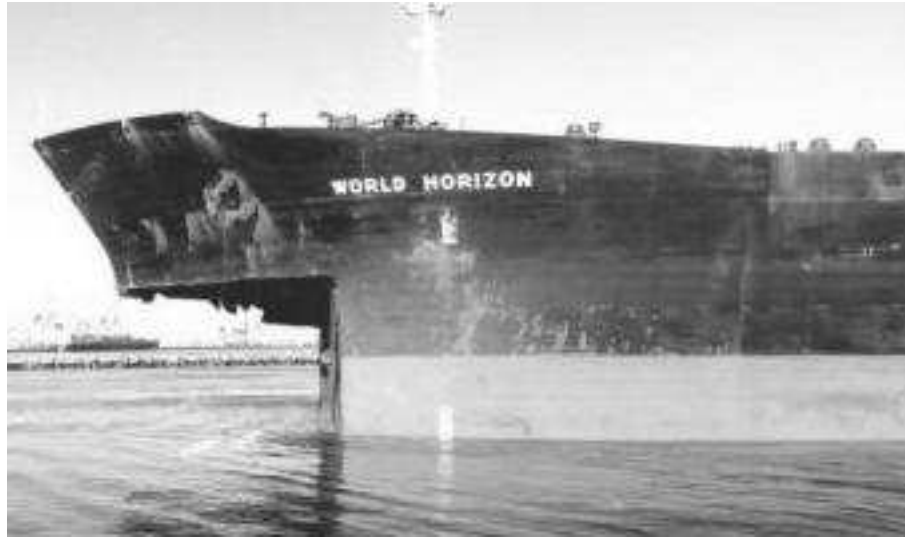
Figure 2.8: World Horizon after “freak wave” removed forepeak tank. This wave was able to excise only the forepeak tank with almost surgical precision. The true cause was that this segregated ballast tank was very badly corroded. The surrounding spaces were not. Spill was about 850 kiloliters. Source: University of Capetown.

We also started seeing big failures in the forepeak tank, the other segregated ballast tank in a pre-Marpol tanker. In several of these cases, the forepeak tank simply fell off. Examples include the WORLD HORIZON, Figure 2.8, the GALP FUNCHAL, the TOCHAL, Figure 2.9 and the ENERGY ENDURANCE

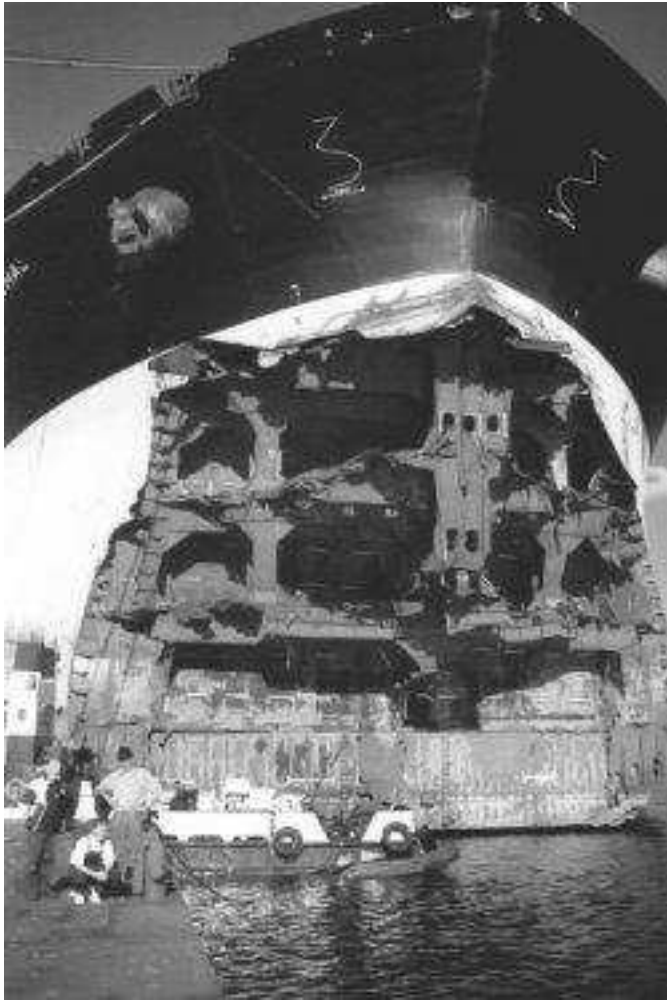
Figure 2.9: Tochal sans forepeak tank. The cut is not quite as clean as the World Horizon, but the boundaries of the forepeak tank are clearly delineated. And this picture gives a better view of the forepeak tank corrosion. The ship was towed stern first into False Bay and lightered. About two hundred kiloliters of fuel oil was spilled from the forward bunker tank. Without a port of refuge, this could easily have been a 300 million liter spill. The Tochal was fully approved by her Classification Society. Source: University of Capetown.

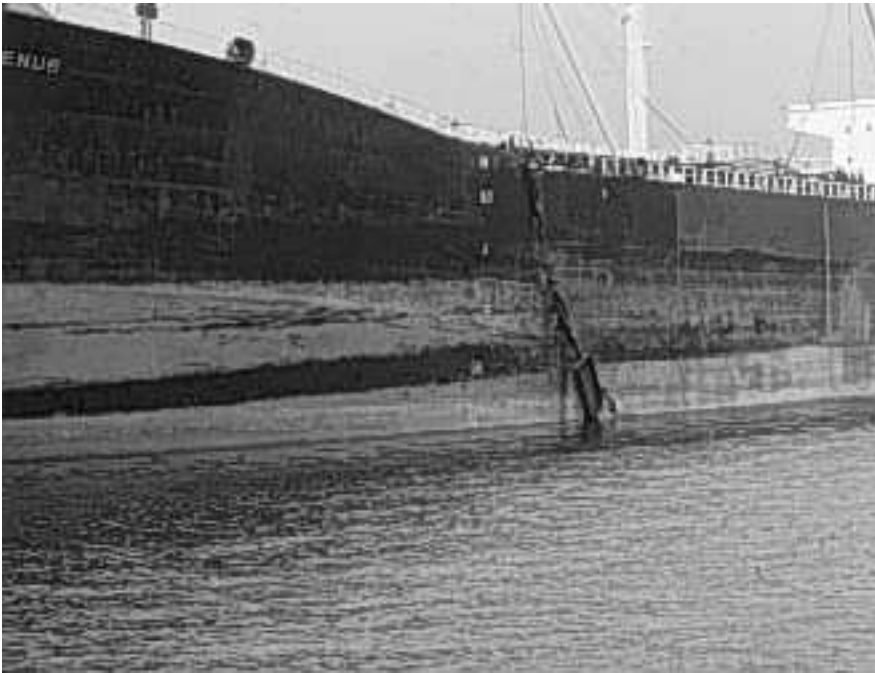
Figure 3.3: Alvenus buckled after grounding. Source: R. Hamm.

⁷³ The ALVENUS is an example of a grounding in which we can be confident a double bottom would not have helped. The ALVENUS hit the sea bottom in a manner that the bow was pushed up. The main deck split open forward with the rupture extending down to the waterline on either side. See Figures 3.3 and 3.4. The ship's single bottom was never penetrated. Paik has shown that modern double hulls are very weak when it come to deck buckling.[63]

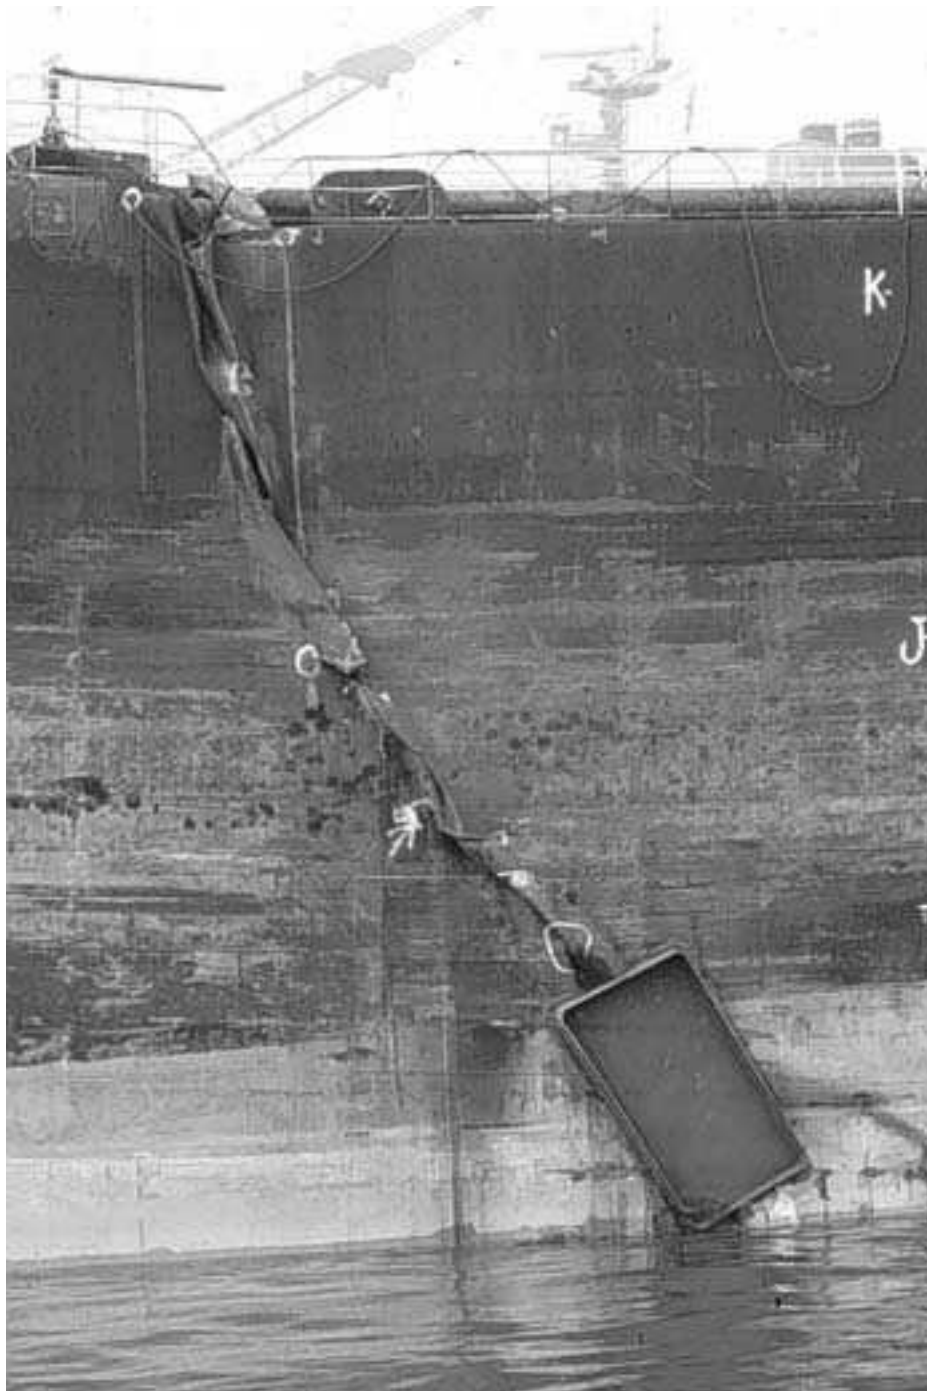
Figure 3.4: Alvenus fracture extended down to waterline. Source: R. Hann.

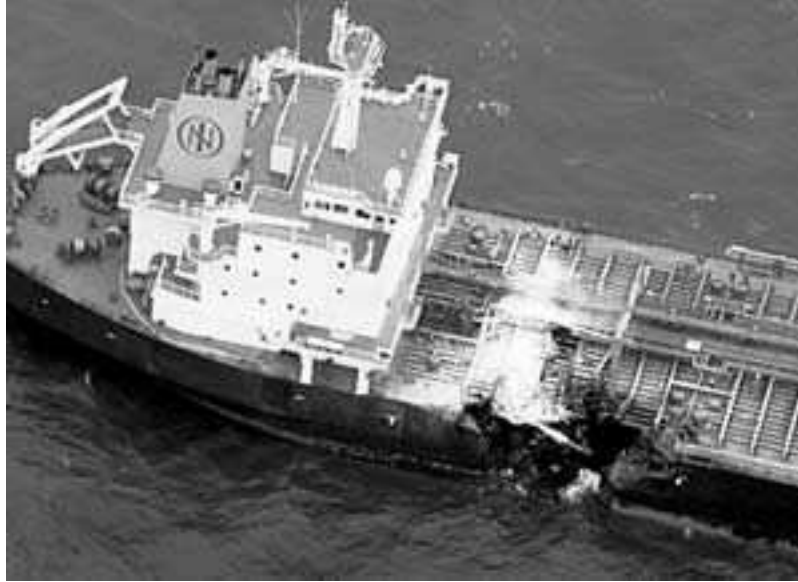
Figure 3.5: Helo view of double hull Baltic Carrier. Source: DR.

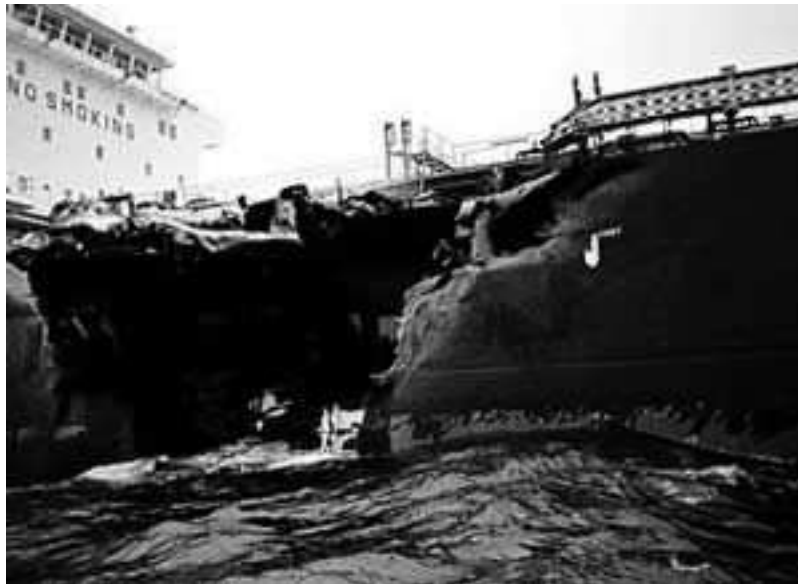
Figure 3.6: Close up view of Baltic Carrier penetration. Source: DR.

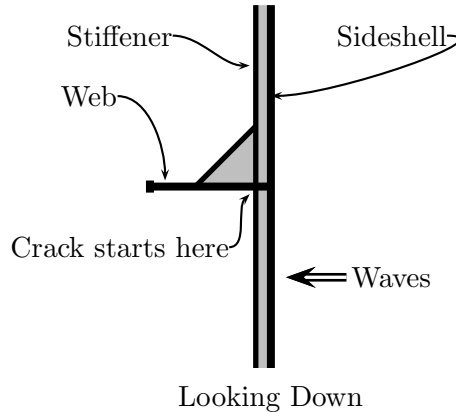
Figure 4.2: Design for Producability

It also created a big hinge. Figure 4.2 looks down on this design. On the forward side of the web, the structure was very rigid. On the aft side, the shell plating was free to flex back and forth with the wave action. Think of the forward side of the web as the lip of the coffee can; the aft side as the lid. Not surprisingly it wasn't long before cracks started appearing on the inside edge of the shell stiffeners just behind the web, and only a matter of time after that that the crack would work its way thru the stiffener out to the shell.

is that there is nothing subtle about this error. You don't have to be as structural engineer to know that Figure 4.2 is a terrible design. So why did the ship's Class, Lloyds, approve it? You will have to ask the Tromedy. All I know is that you will see the same kind of lousy design just about wherever you look in a modern tanker.

When we reactivated the *Enterprise* in 1985, we installed soft-nosed backing brackets on the aft side of the web to balance the brackets on the forward side. This eliminated the hinge, and we had no more cracks in this area. Unfortunately the *Enterprise* only traded for seven months before she was exoceted by the Iraqis in the Iran-Iraq War. The whole engine room was destroyed. No one was hurt. But the ship was a total loss. My guess is that, if we had been able to keep her, cracks would have shown up somewhere else. The structure was just too weak and too ugly.

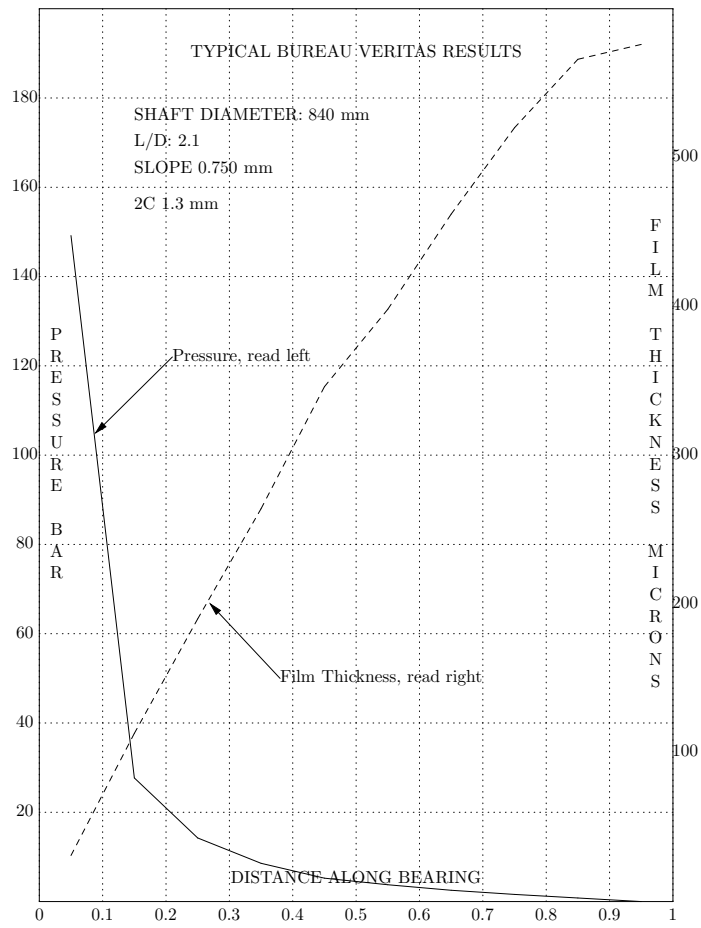
Figure 5.1: Sterntube bearing pressure and oil film thickness

Figure 5.1 is the reason why the composite bearings failed immediately while the white metal bearings have taken longer. There is only one area where white metal bearings are better than composite; but in that area they are far better. That area is heat conductivity. The conductivity of white metal is over 30 times higher than that of the composite material. The composite bearing relies on the lubricating fluid to conduct away the 7.5 KW of heat generated in a VLCC stern tube bearing. But most of that heat is generated in the high pressure portion of the bearing where the film thickness is much too thin to do the job. The composite bearing burns out almost immediately. White metal has a great deal more ability to conduct

FIGURE 13.1 AFT STERN TUBE BEARING PRESSURE AND FILM THICKNESS

There are no Class restrictions on shaft bending within the bearing. However, there is one Class that has the capability to study at least a part of this problem. Bureau Veritas (BV) has a program which has the ability to model bending within the bearing and determine the resulting pressure distribution and oil film thicknesses within the bearing. Figure 5.1 shows a typical result. Figure 5.1 is based on an alignment that was acceptable to class on the grounds that the misalignment at the aft end of the bearing was small ($1.0e-4$ radians) and the nominal pressure (bearing load versus overall bearing area) was a reasonably conservative 6.3 bar, well below the Class limit of 9.0 bar. But what counts is the distribution of the pressure within the bearing and the standard Class approved method simply cannot address that issue. In this case, the BV results show the pressure on the aft 10% of the bearing averages 140 bar, well over BV's recommended (and none too conservative) maximum of 100 bar. At this pressure, the lubricating film thickness is a miniscule 31 microns.

the heat away itself, so there is no immediate burn out despite the thin film thickness. But that doesn't change the fact that the pressures are very high, in fact far above the yield point of the white metal. Rapid wear down will occur, and premature failure is inevitable. We will see a lot of VLCC's dead in the water due to bearing failures. The only real question is: how many will drift ashore?³¹

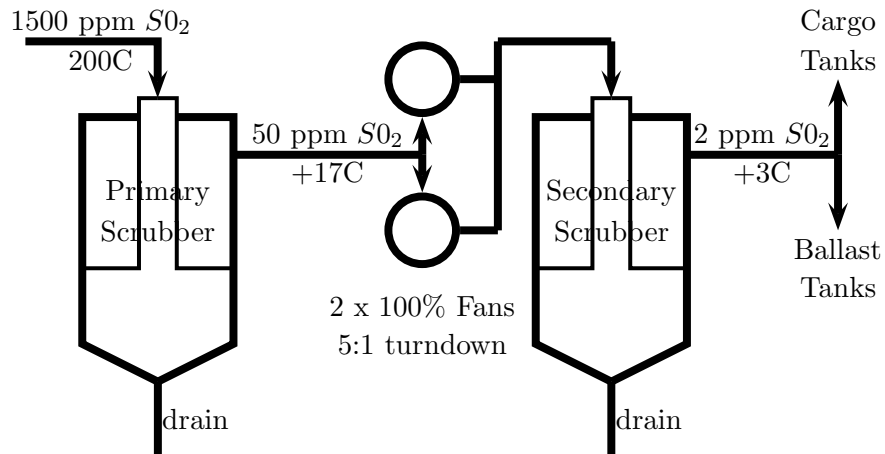
Figure 6.1: Double Scrubbing Schematic

The reason why the second scrubber is so effective is that it reduces the stack gas temperature from about 17C above seawater to only 2 or 3C above seawater as shown in Figure 6.1.¹⁶ This condenses a very large portion of the water vapor in the gas which in turn pulls out most of the remaining sulfur.

¹⁶ Figure 6.1 is based on full cargo discharge rate which for a VLCC will be about 15,000 cubic meters per hour. When the ballast tanks are being inerted, the deballast rate is normally 4,000 cubic meters per hour or less. At these rates, the SO₂ content of the double scrubbed gas will be less than 0.3 ppm.

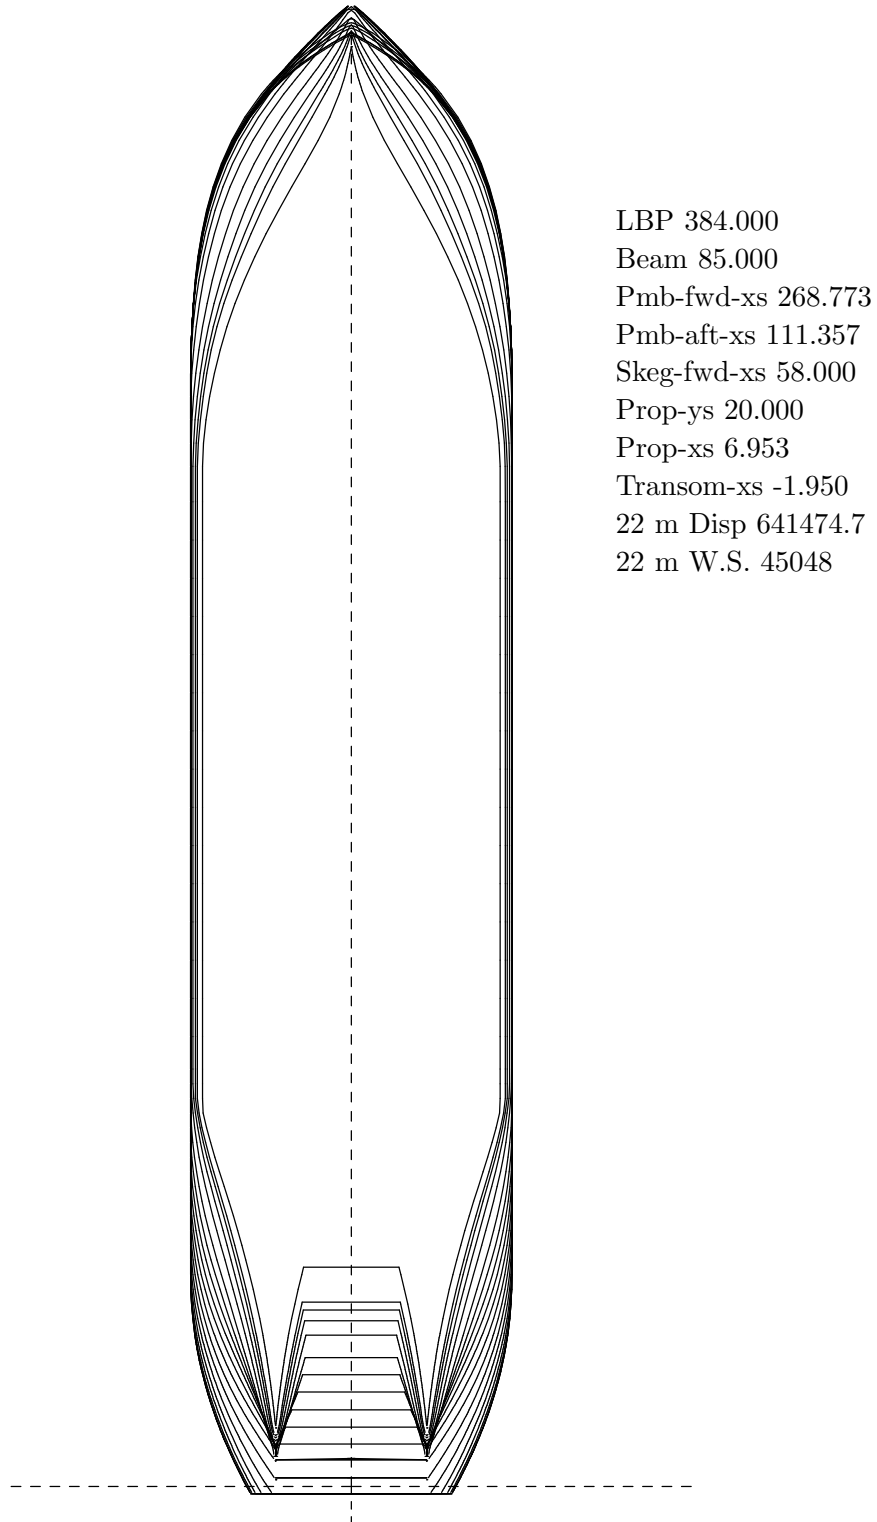
Figure 6.2: Twin Skeg Hull Form

Bystedt solved this by utilizing a *twin skeg* design. An example is shown in Figure 6.2. In effect, each propeller has its own hull. Properly implemented, the flow into the propellers is as good as that for a well-designed single screw stern. But the ship can be much beamier. For the same deadweight, this means a shorter ship which generates important savings in hull steel. It also partly compensates for the additional wetted surface of the twin screw. And it results in a shallower draft ship, allowing larger cargoes into draft limited ports.²⁶ Finally, the propellers are more lightly loaded which increases the propeller efficiency.²⁷

²⁷ Twin skeg ships are wider and *less tall* than a standard double hull of the same capacity. This means less outflow in casualties in which the inner bottom is breached. The depth and draft of the Stena V-Max (see below) is 25.6 and 19.0 m, The depth and draft of a single screw VLCC is about 31.25 and 22.25. The single screw VLCC with a 2.4 m higher oil column will spill something like 15 million liters more oil in an EXXON VALDEZ type casualty. See Section C.3.

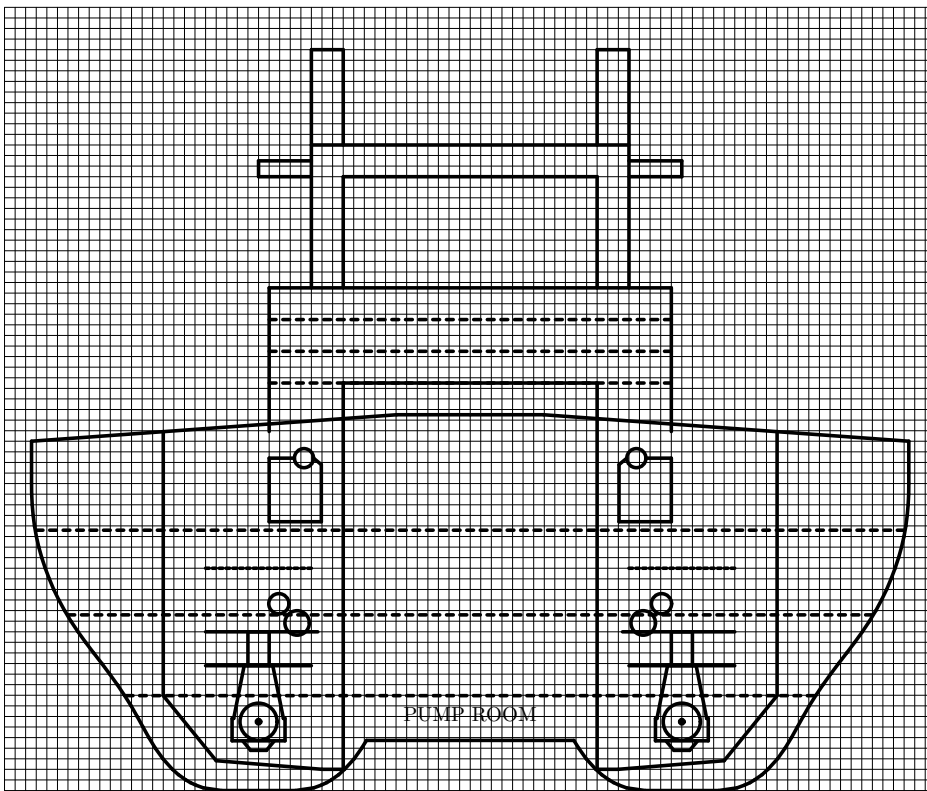
Figure 6.3: Section at Aft End of Pump Room

But for a twin skeg ship, the wording does not match the intent. Figure 6.3 shows the problem. In a twin skeg design, there is a sort of ramp between the skegs. This ramp extends from the transom down and forward. The angle and curvature of this ramp is critical to the hydrodynamic performance of the twin screw. When the ramp reaches the forward end of the engine room (the aft end of the pump room), the situation looks like Figure 6.3. The ramp is still well over 2 meters above the baseline. (In Figure 6.3, the baseline is the bottom of the drawing.) No problem. The cargo pumps in the pump room are above the inner bottom. The ramp continues forward and downward until it finally merges with the outer bottom.

However, putting a 2 meter double bottom under the pump room causes a serious problem, because the cargo pumps must be just above the level of the inner bottom in the cargo tanks to properly empty the tanks. (Figure 6.3 like all good twin skeg designs pushes the pump room bottom as high as it can and still have the cargo pumps at the correct height.) The double skeg designer has only two choices in complying with the new pump room inner-bottom rule:

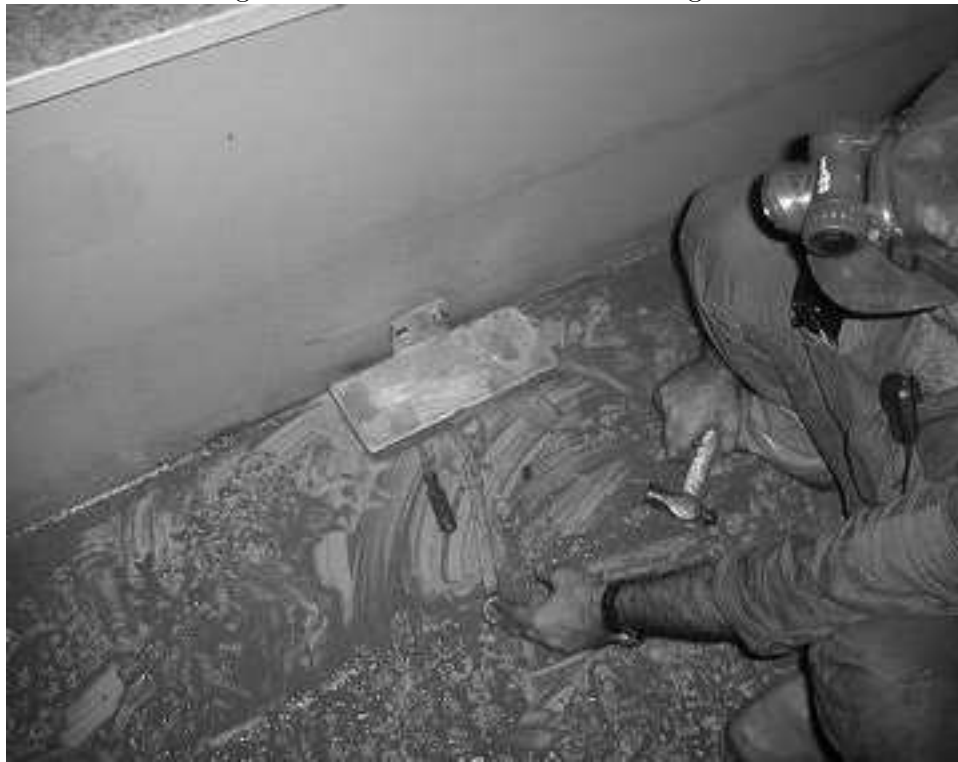
Figure A.1: Installation of Tsevas Pitguard

The normal anodes can do nothing about this layer of water, since they will not be immersed. To protect the bottom of the ballast tank we need a special kind of anode called a *pitguard*. Figure A.1 shows the system Hespont uses. The key is to get the bottom of the pitguard right on the

bottom of the tank, so that at least some of the zinc is always immersed.

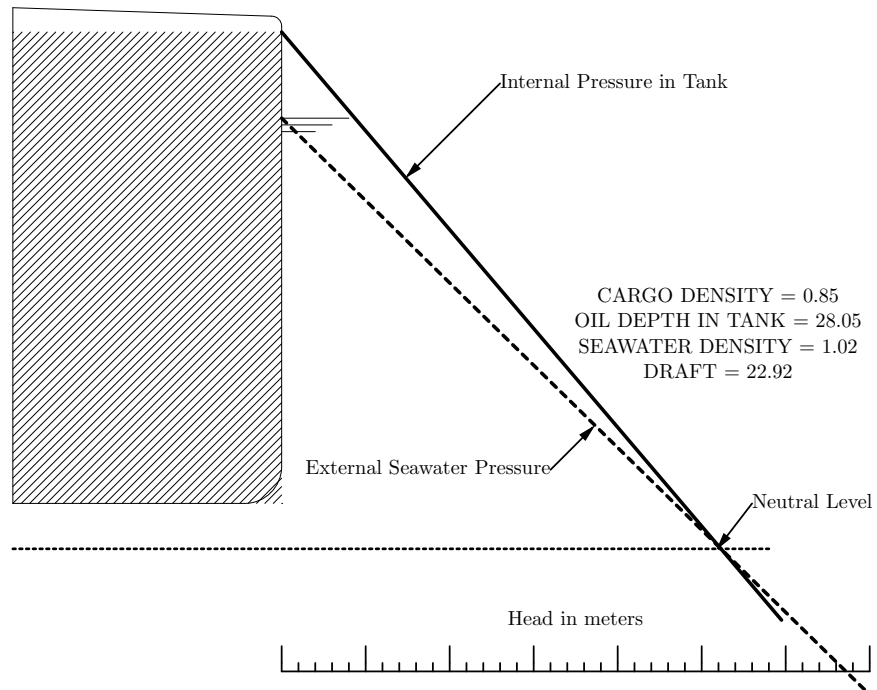
NEUTRAL LEVEL IS 2.7 M BELOW KEEL
 Hydrostatic outflow from damage anywhere in the tank including flat bottom

Figure C.1: Neutral Level, Fully Loaded Pre-MARPOL ULCC

In Figure C.1, the Neutral Level is 2.7 meters below the keel. This means that even at the very bottom of the tank the internal oil pressure is higher than the external seawater pressure. Damage anywhere in the tank, even at the very bottom, will result in a spill. Oil will flow out of the tank until the internal and external pressures at the top of the damage have equalized.

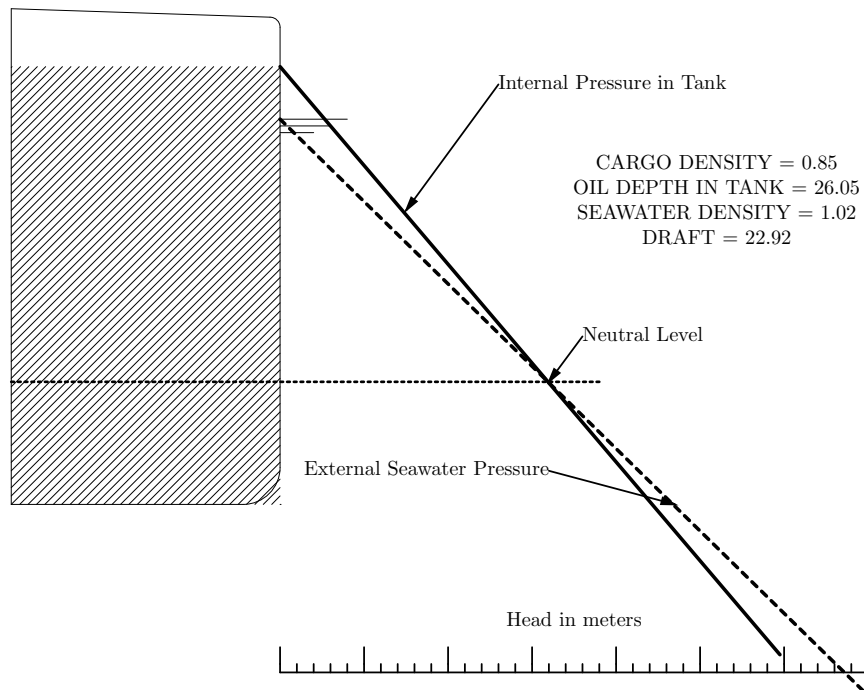
NEUTRAL LEVEL IS 7.3 M ABOVE KEEL
No hydrostatic outflow from damage below Neutral Level

Figure C.2: Neutral Level for same ULCC, Tank Drawn Down 2 M

Now suppose we draw down the initial level of cargo in this tank 2 meters. Figure C.2 shows the new situation, assuming the ship remains at the same draft. The oil has lost a considerable portion of its head start; and the

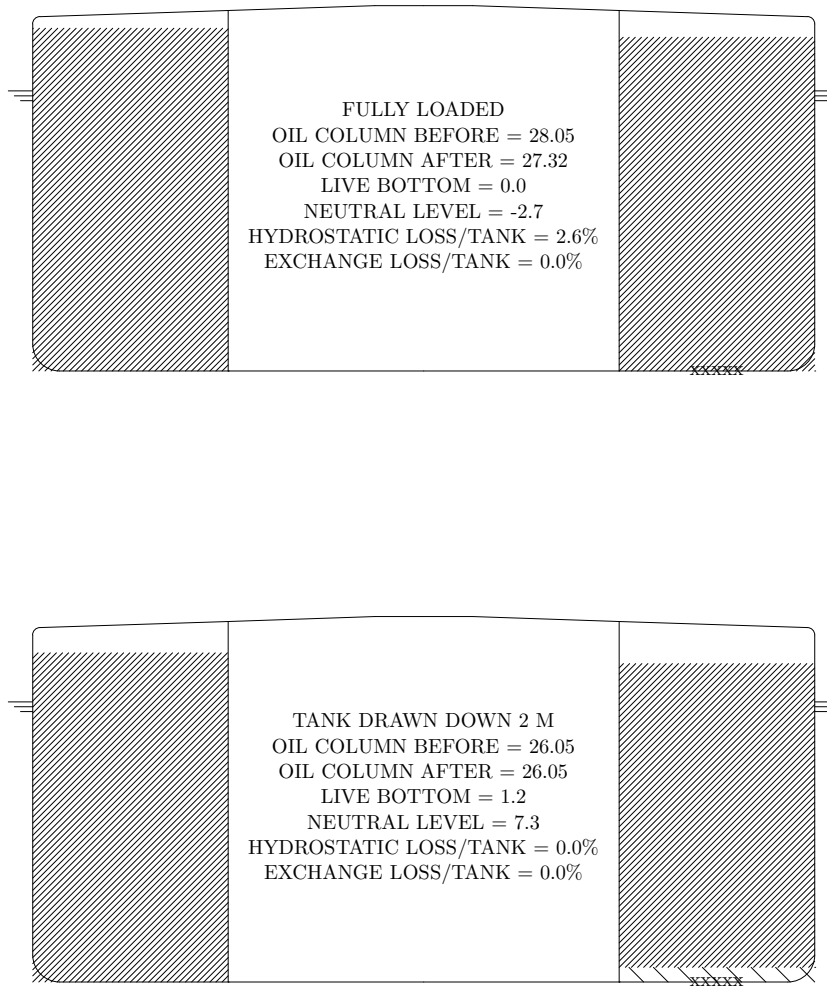
Figure C.3: Final situation, Full load vs Tank Drawn Down 2 M

The bottom half of Figure C.3 says we only had to underload such ships by about 7%, and they would have spilled nil oil if the damage is limited to the bottom. (Once again I'm assuming the underloading was accompanied by sufficient ballast to keep the ship at the same draft.)

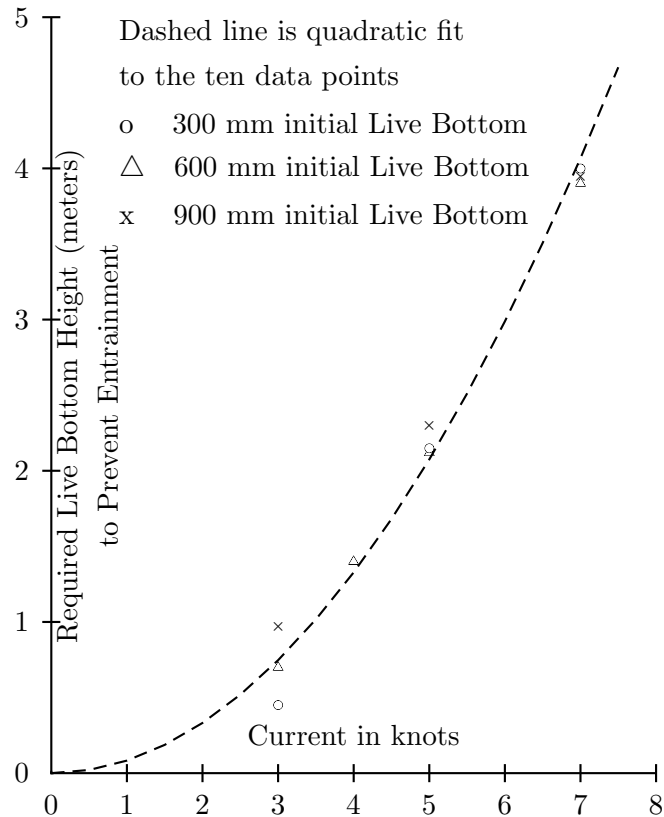
Figure C.5: Required Live Bottom Height versus Current Speed

and, for a high enough Live Bottom, even the trough in the wave is above the ship bottom, at which point current loss effectively halts. As Figure C.5 indicates for a three knot current, the Live Bottom has to be about 0.7 meters above the real bottom.¹⁰ For a 5 knot current, we need about a 2.2 m Live Bottom height. The required Live Bottom height goes as the square of the current velocity as would be expected from Bernoulli's Law.

I would not make too much of Figure C.5 for two reasons:

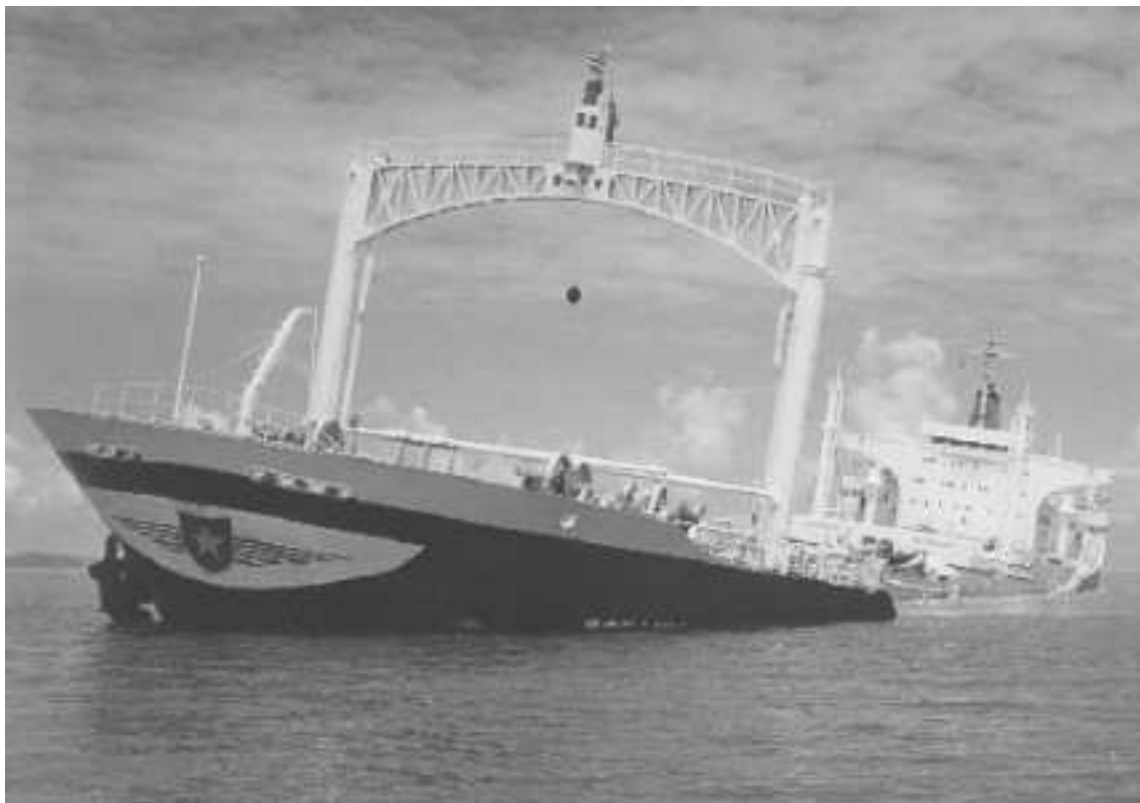
Figure C.6: Oceanic Grandeur after flooding. Hull is under extreme sagging moment but survived. No new tanker would. Note the extremely strong kingposts and the rare forward crowsnest, signs of an unusually well-sped ship. Source: Australian Maritime Safety Authority.

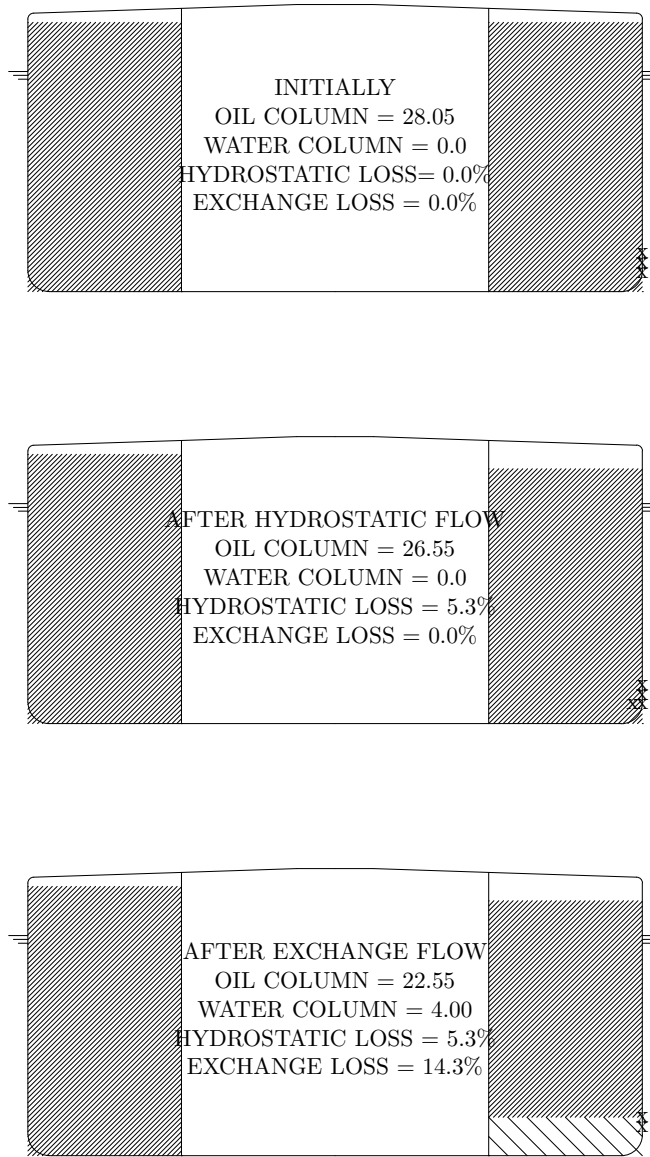
Figure C.7: Fully Loaded, Pre-MARPOL, Side damage up 4 M

And our troubles are not over. The situation after hydrostatic flow looks like the middle sketch in Figure C.7. The oil in the bottom 4 meters of the tank is below the top of the damage. This situation is unstable. The seawater pressure at the bottom of the damage is higher than the pressure inside the tank at the bottom of the damage. Sea water will push its way into the bottom of the damage forcing oil out the top. Unless we do something, this exchange flow will continue until we have lost all the oil in the bottom 4 meters of the tank, over 14% of the original cargo, for a total loss of about 20%.

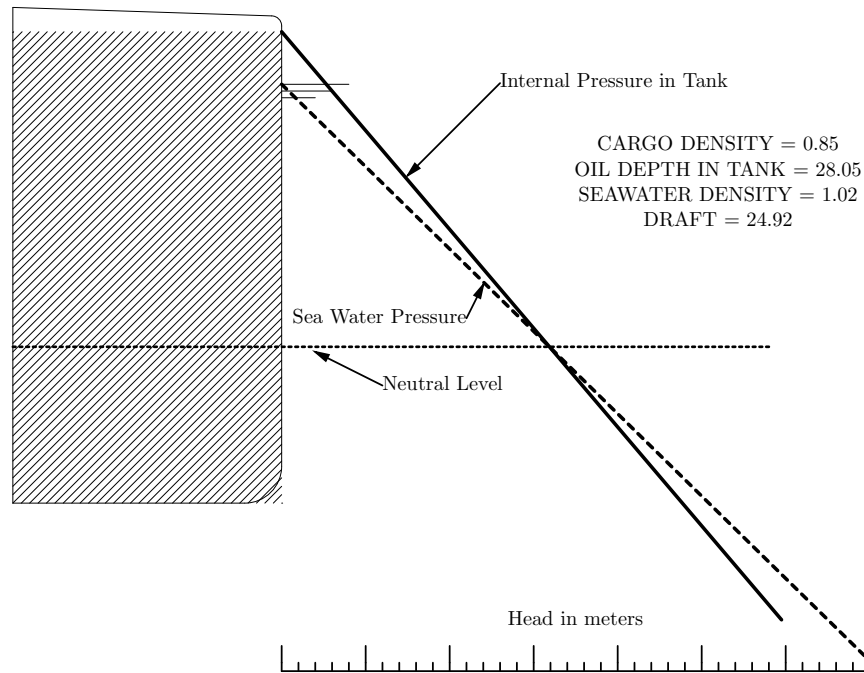
NEUTRAL LEVEL IS 9.3 M ABOVE KEEL

Figure C.8: Full load but ballasted down 2 M

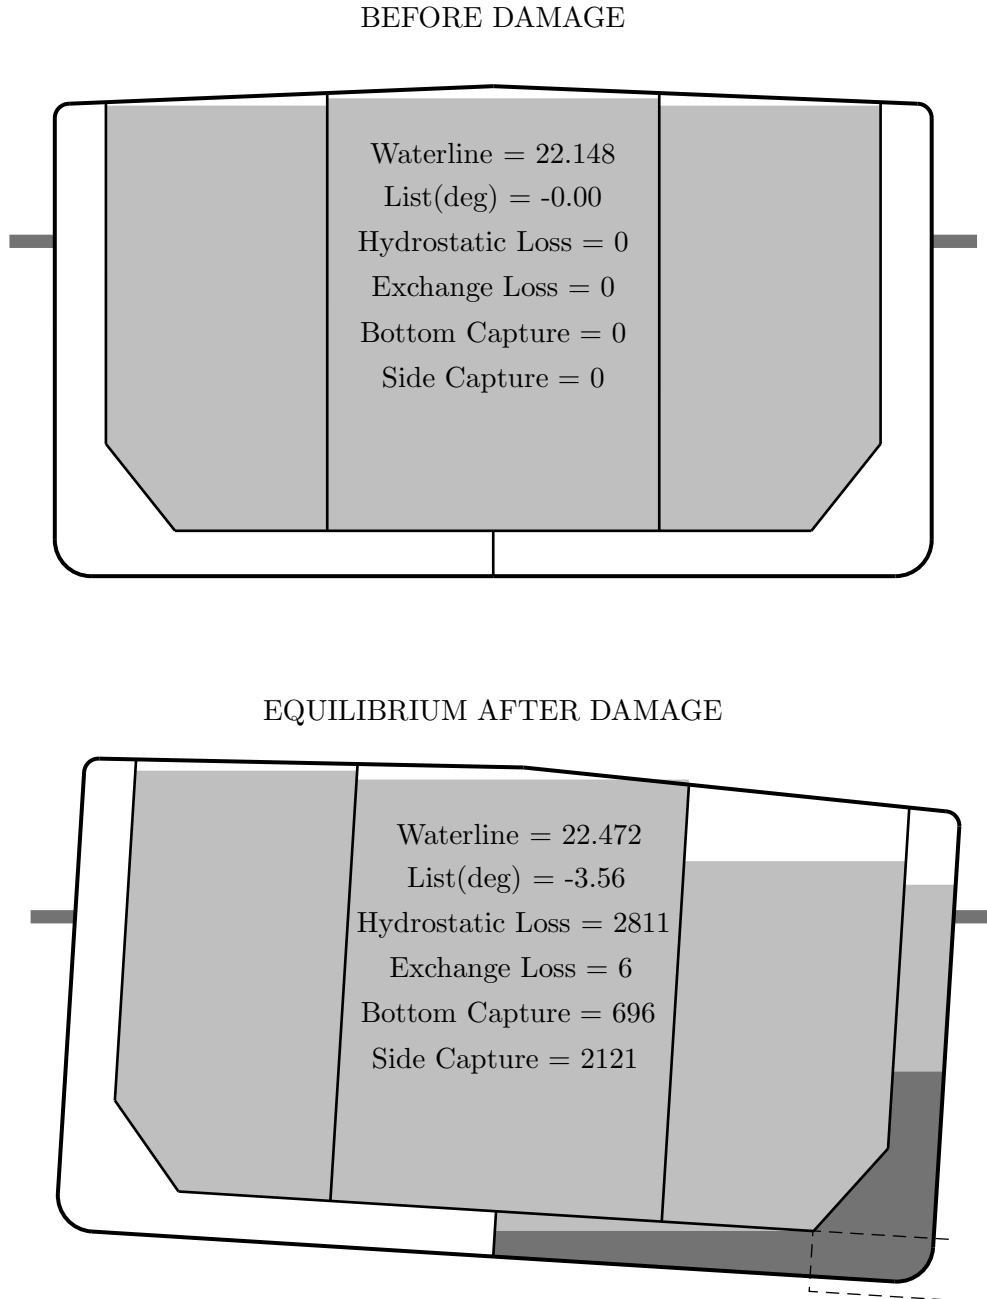
Figure C.11: Damage at hopper corner. Light gray is cargo. Dark gray is seawater.

³¹ As Figure C.11 shows, the top of the column in the double side will not be high as the top of the oil in the damaged tank because (normally) a larger portion of the double side column will be made up of seawater. However, the top of both columns will be above the sea-level.
