The Tankship Tromedy

**The Impending Disasters in
Tankers**

Jack Devanney

2006

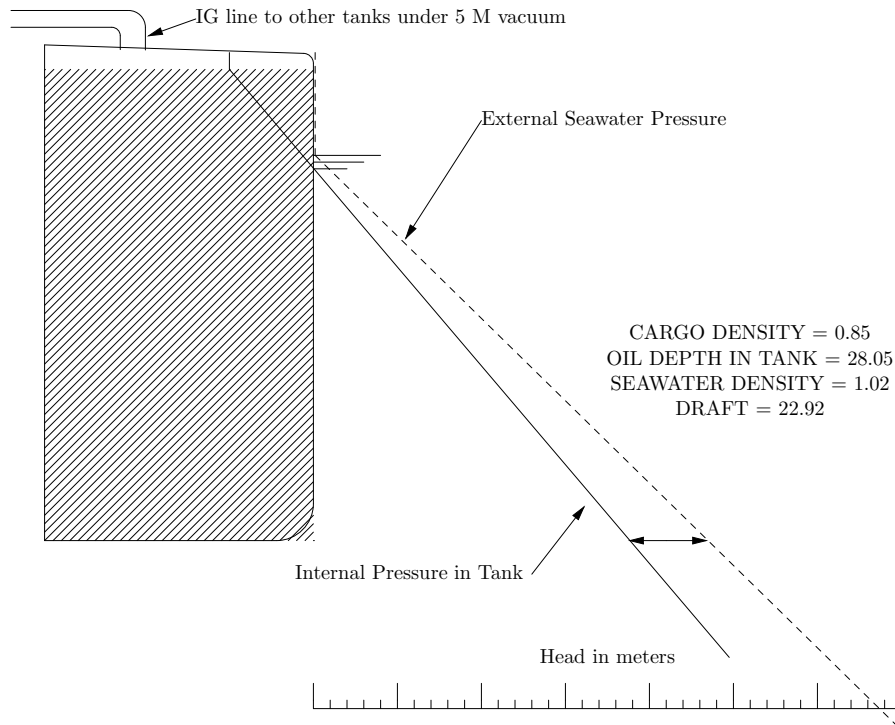
NEUTRAL LEVEL IS ABOVE THE TOP OF THE TANK
Internal pressure is lower than external pressure at all levels

Figure C.13: Active Full Vacuum(5M) Tanker, Full Tank

You are right. ***The damaged tank will automatically pump itself out to the undamaged tanks.*** This transfer will begin immediately upon damage with absolutely no intervention from anybody. Please re-read the last two sentences. The increase in pressure at the bottom of the damaged tank — indicated by the double arrow in Figure C.13 — will push cargo thru the IG lines to the other tanks. In the situation shown in Figure C.13, seawater will push an amazing 17 meters into the tank as long as there is

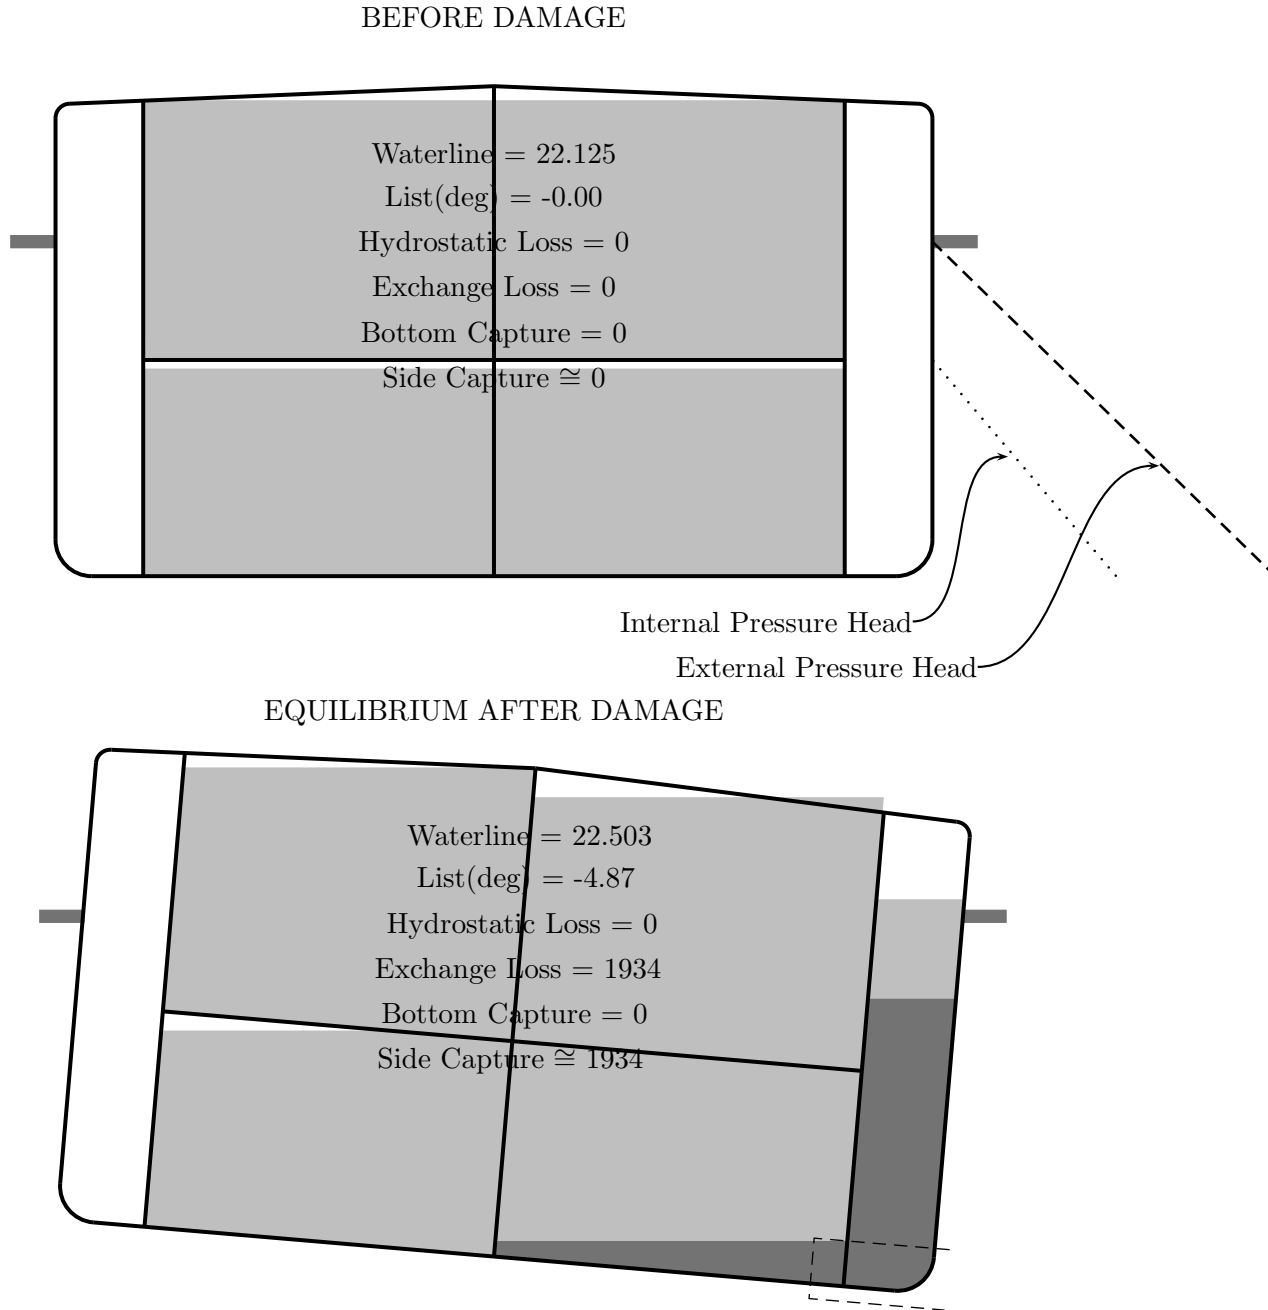
Figure D.1: Mid-Deck, Damage up 3 m. Light gray is oil, dark gray is seawater

The concept has excellent ability to withstand an ebb tide. Even after a 3 m drop in the tide, such as that experienced by the EXXON VALDEZ, the hydrostatic balance is still 7 meters in our favor. ***If the Exxon Valdez, had been a Mid-Deck ship, she would have spilled very little oil.***

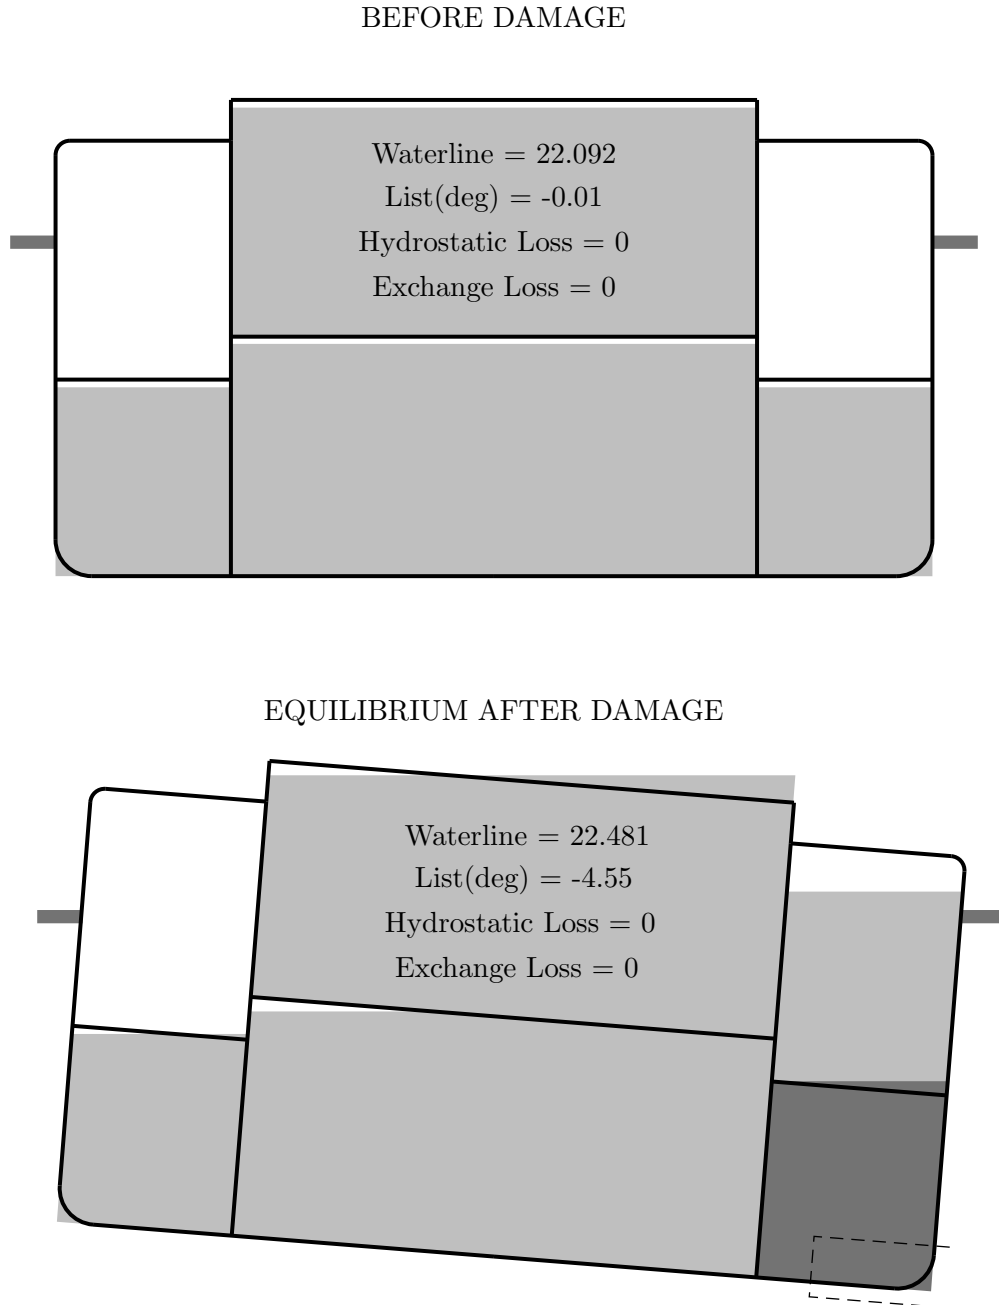
Figure D.2: Coulombi Egg, Damage up 3 m. Light gray is oil, dark gray is seawater

The Coulombi Egg is a mid-deck design, but the ballast tanks are set above the outboard cargo tanks as shown in Figure D.2. The lower tanks are connected to these ballast tanks by non-return valves. When a lower tank is damaged, the incoming sea water pushes the oil in the damaged tank up into the ballast tank. There is an automatic transfer out of the damaged tank much like the active full vacuum ship. If the damage is near the bottom of a lower cargo tank, the Live Bottom will end up about 9 m above the ship bottom well protected from current, wave action and ship motion. But what I really like about the Egg is that **a VLCC built to this design will have only 66,000 m² of ballast tank coated area, and less than 20,000 m² of cargo tank/ballast tank interface area.** Ballast tanks properly inerted, the Egg is about as good as it gets in terms of minimizing ballast tank explosions on a segregated ballast tanker. Notice also that you can use air to blow out the damaged tank without putting any oil in the water. This can be a big help in refloating the ship. (This description of the Egg is not quite up-to-date. IMO in its wisdom required some changes to the original design which in my opinion degraded the performance of the concept.)
