REDUCING THE RISK OF PROPULSION LOSS

Operational guidance for preventing
blackouts and main engine failures

The London P&I Club

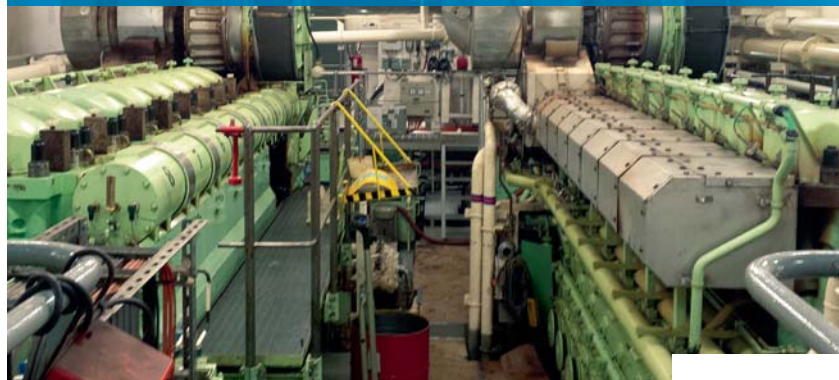
▲
Modern engine room with two medium speed main engines

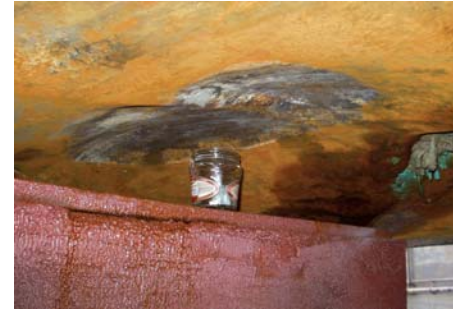
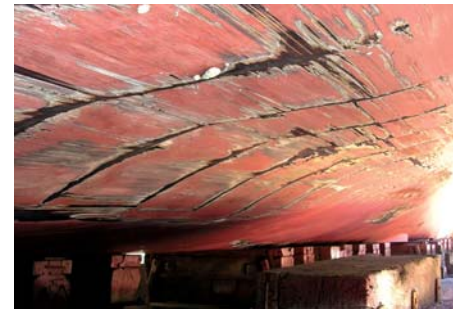
▲ Bottom damages as a consequence of machinery failures¹

¹ On the top photo, the glass jar is here to highlight the degree to which the shell plating is set in.

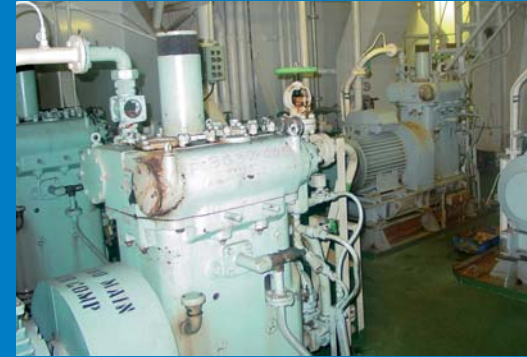
▶ Typical air compressors on a vessel

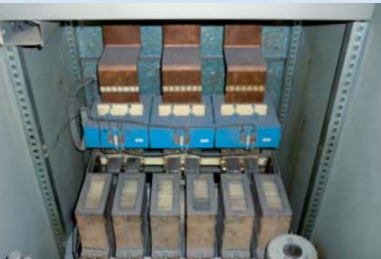
▲ Digital and thermal images of a switchboard breaker fault

- A regular thermographic survey of the switchboard should be carried out to monitor for loose connections or overheating equipment.
- The alarm printer, where fitted, should be maintained correctly, such that the printout is legible, as this is often a valuable source of information regarding the cause of the blackout.

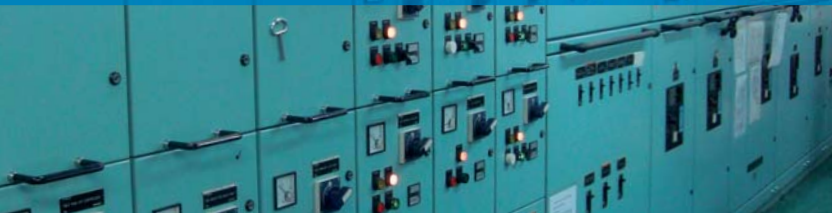
▲
Typical switchboard on a modern vessel

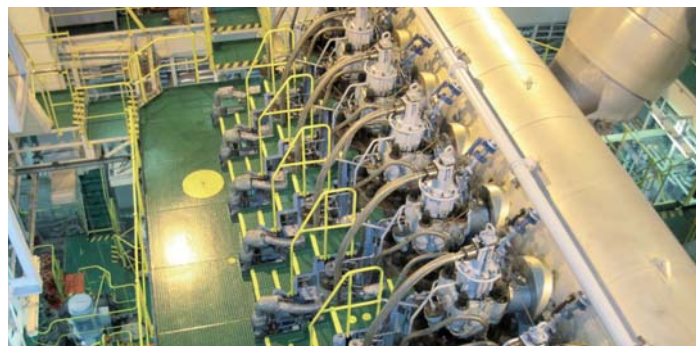
▼
Top platform of a large slow speed marine engine
